Tree Structural Integrity Report

5 Kewferry Road
Northwood
Middlesex
HA6 2NS

GD/220497

5th October 2022

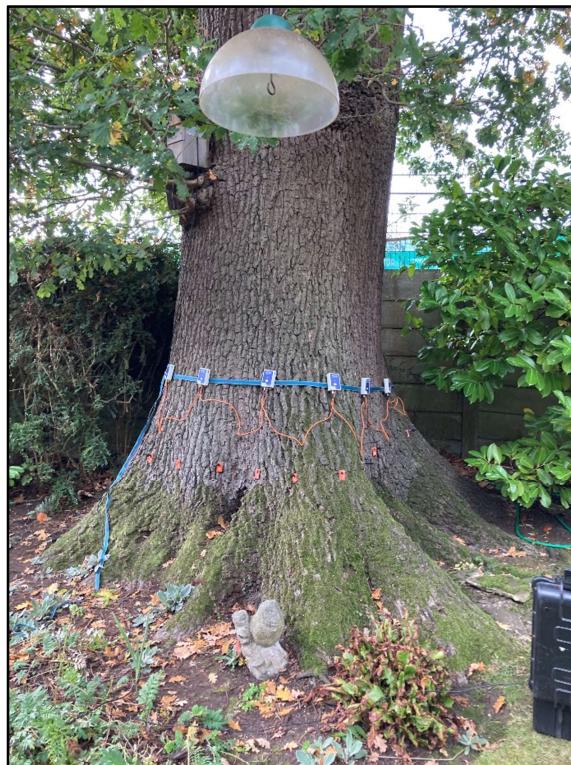
Figure 3: Image of PiCUS Test Plane Conducted on Common Oak

Test: When conducting the assessment, after establishing the 53 centimetre height of the test plane, Sensor 1 was positioned on the northern side of the main stem, with the subsequent 23 sensors then spaced at regular intervals at the same height to create a level test plane.

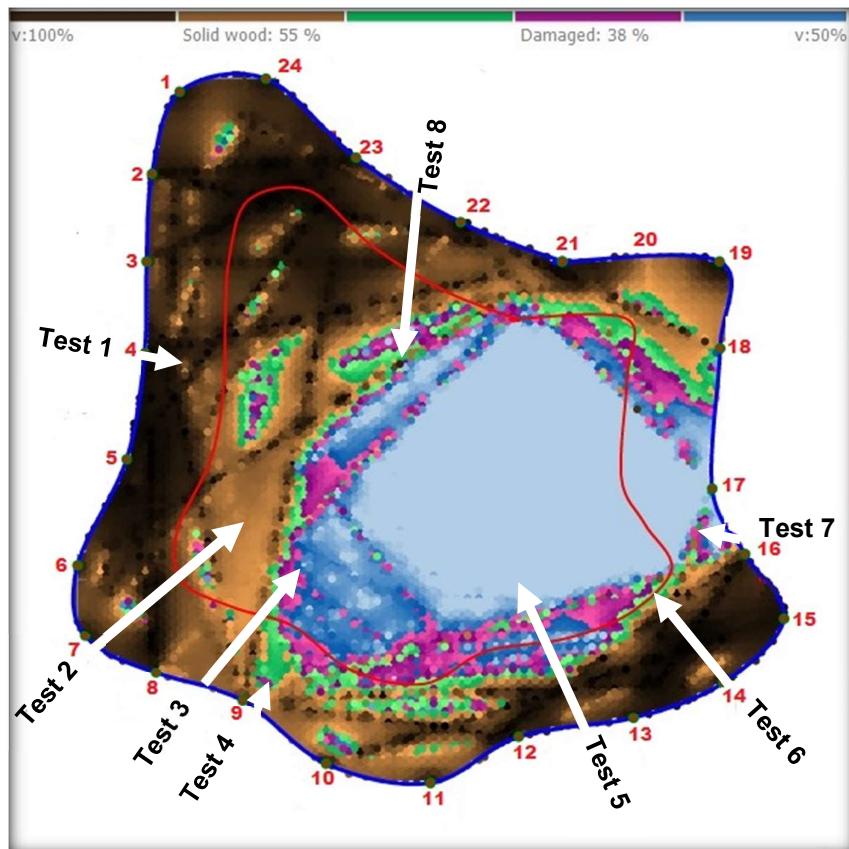
Figure 8: Showing test profile and location of the eight drill test locations

A total of eight tests were conducted on the main stem of Oak. at the same level as the PiCUS Sonic Tomography test plane. The test locations where position on or between the sensor locations and these numbers have been used for referencing.

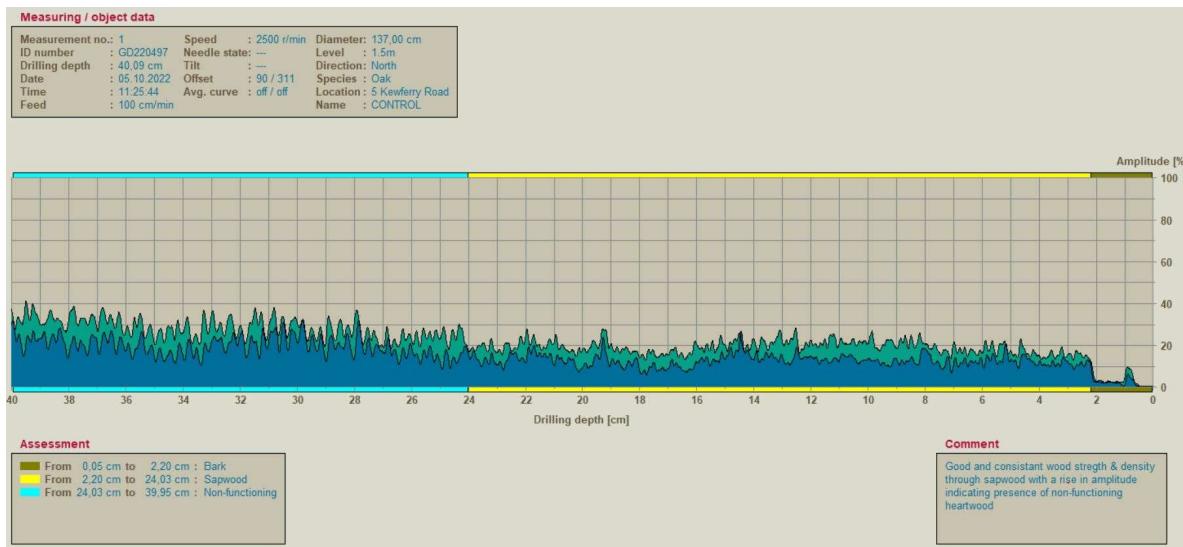
Control – 1.5 m North

NOTE: The above control test shows all the test data and interpretation, including Object Data, Assessment and Comments. The remaining test results will be cropped to show only the micro-drill assessment to reduce the number of pages within the report. Sections 6.3 & 6.4 below includes a detailed interpretation of the test results.

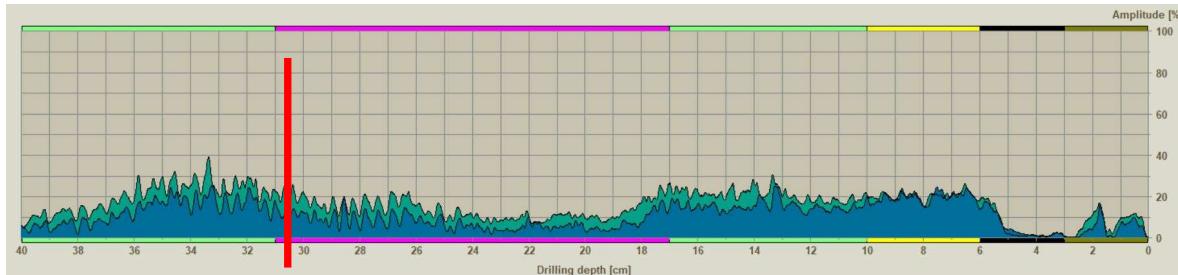
Test No.4 – At Sensors 9

The “t/R ratio”, as previously illustrated by the circumferential red line within the Tomogram and discussed in Section 6.4 is represented here by the red line.

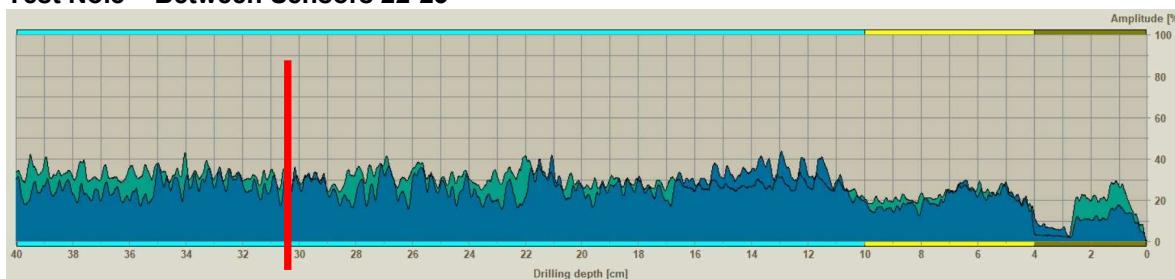
Test No.8 – Between Sensors 22-23

The “t/R ratio”, as previously illustrated by the circumferential red line within the Tomogram and discussed in Section 5.1 above is represented here by the red line.
