**Site Observation Report Form**

| <b>SITE:</b> | <b>Southall Western Access</b> | <b>JOB NO:</b> | <b>CG/28308</b> |
| <b>SVR 93</b> | | | |

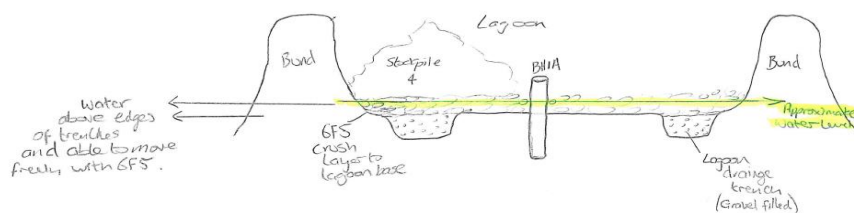
Flood water previously observed in the lagoon has subsided and was no longer observed above ground level. The water level does however remain above the capacity of the lagoon drainage trench and seems to be close to the ground surface when looking down the drainage trench extraction pipes. This was not the intended drainage trench design and so the capture and quarantine of runoff sits amid placed 6F5 at the lagoon base where lateral seepage is possible.
