## Record of Site Visit No. 021

| <b>Site:</b> Southall Western Access | <b>Job No:</b> | CG/28308 |
| <b>Client:</b> FM Conway | <b>Date:</b> 25/08/2017 | |

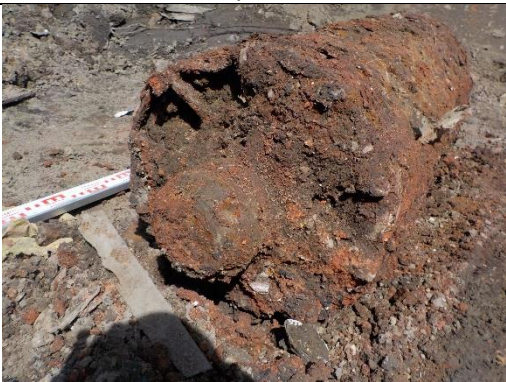
| Summary Photos: | |
|---|---|
| Showing the electrical core to the end of device | Device was hollow with a metal outer grill |

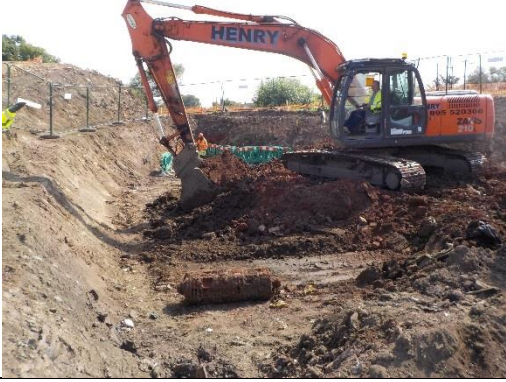
| Summary Photos: | |
|---|---|
| Position of engine/ component was found | Showing extent of completed West Brook pile mat |

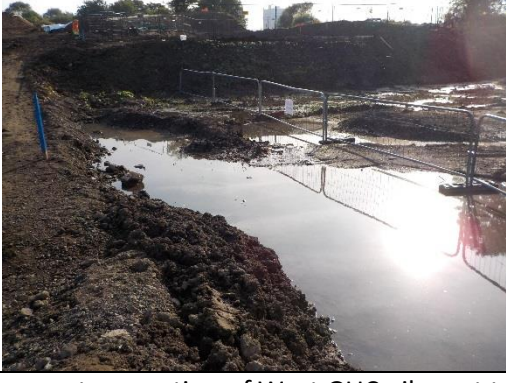
| Summary Photos: | |
|---|---|
| Lower eastern section of West GUC pile mat to be drained and filled with 6F5 crush | Surface rainwater in 'rail triangle' to be drained |

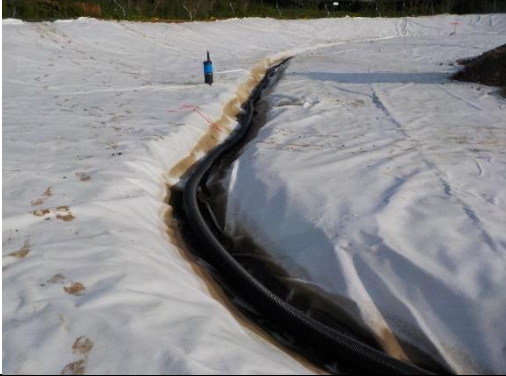
| <p>Drainage polypipe installed to trench in Lagoon 2</p> | <p>Existing borehole height raised to accommodation stockpiled material</p> |

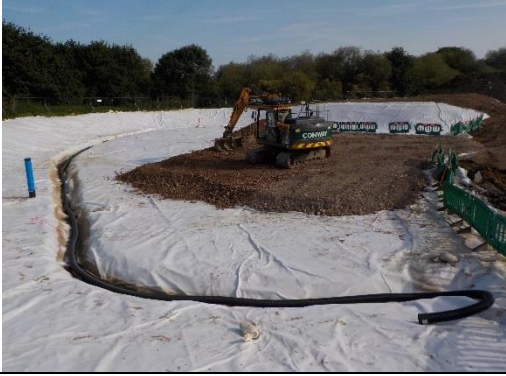
| <p>Layer of imported 6F5 crush added to the base of Lagoon 2</p> | <p>Lagoon 1 remained closed and inaccessible until second potential UXO device was found</p> |

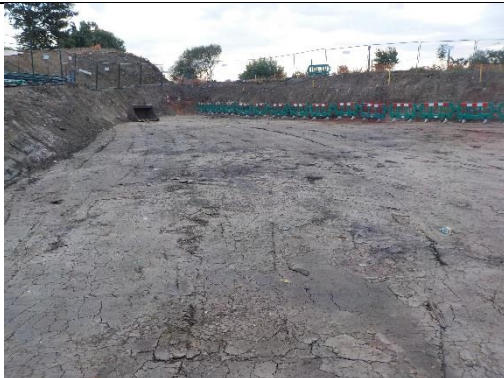
West GUC pile mat excavation completed in upper western section

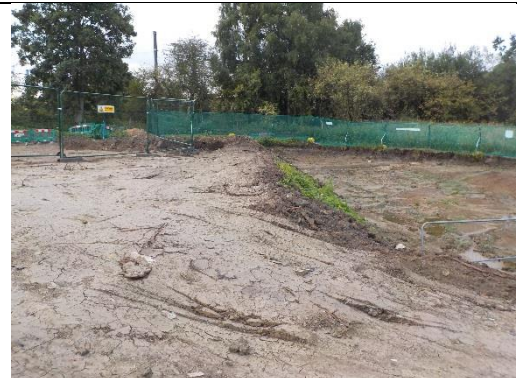
West GUC pile mat excavation in lower eastern fill section

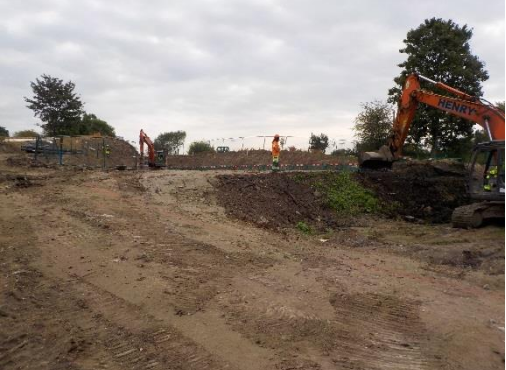
| <p>Isolated sections of soft dredged/ alluvium material at base of West GUC pile mat</p> | <p>Lower western section of West GUC pile mat to be filled up to base level</p> |

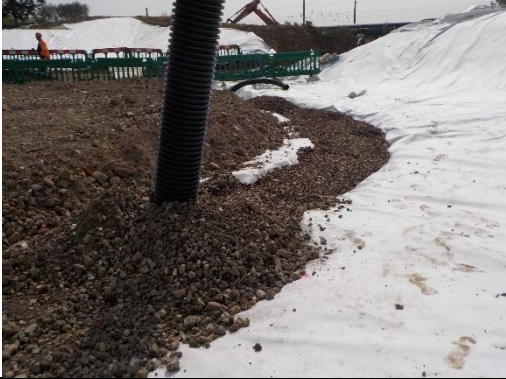
| <p>Type B gravel installed in Lagoon 2 trench burying drainage pipe and securing vertical extraction pipe</p> | <p>Geotextile added to base of west GUC pile mat, four layers added to sections with low CBR values</p> |

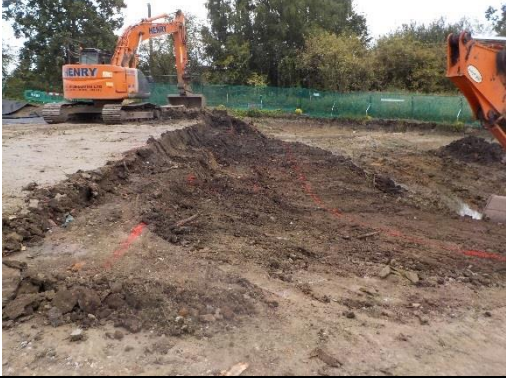
| <p>Bank between east and west sections is stepped</p> | <p>Lower fill section of West GCU pile mat stepped and sloped into haul road (left)</p> |

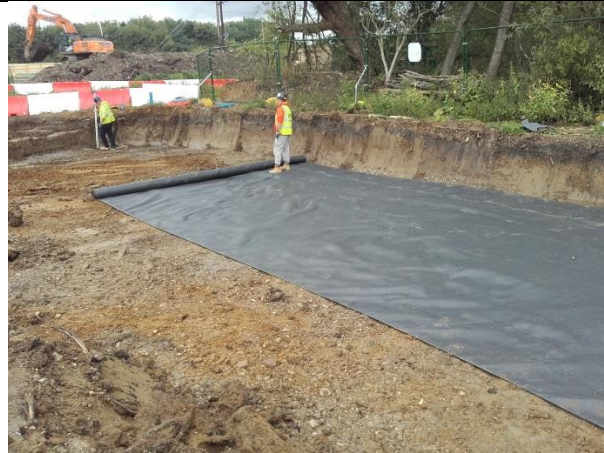
Pile mat 2 (river east platform) excavation and placement of geotextile

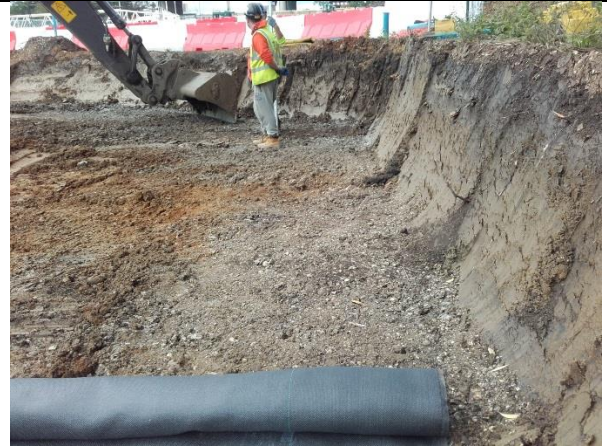
Pile mat 2 (river east platform) – formation level

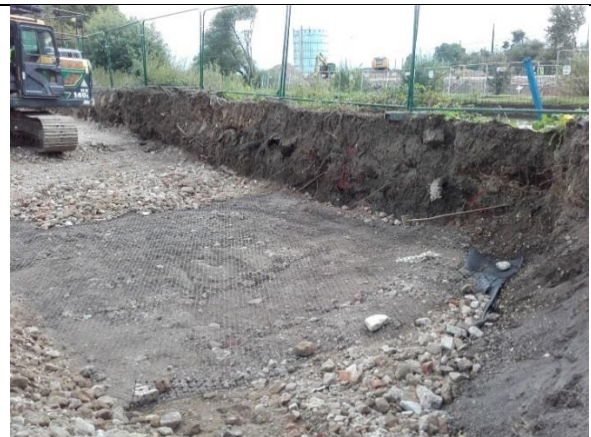
Pile mat 3 – placement of Class 6F2 on geotextile and lotrak geogrid

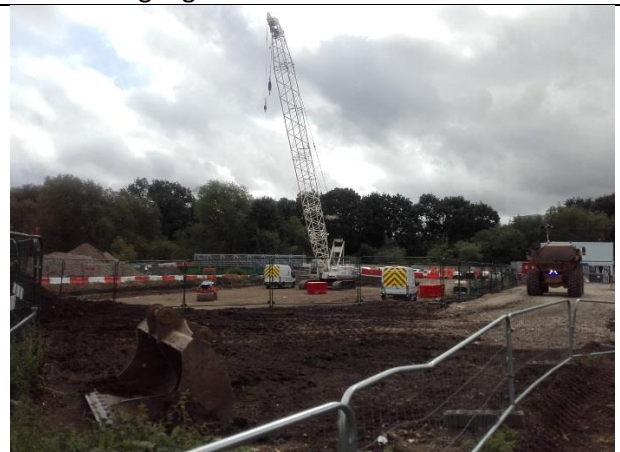
Pile mat 1 complete.
