# Arboricultural Consultancy for Lloyds Bank

| Insured | Dr Sundaramani Kumari | Address | 19 Woodgate Crescent, Middlesex, HA6 3RB | | |
| Client | Subsidence Management Services | Contact | Kevin Phillips | Claim No. | IFS-LBG-SUB-20-0088871 |
| Report Date | 17/12/2020 | | | | |

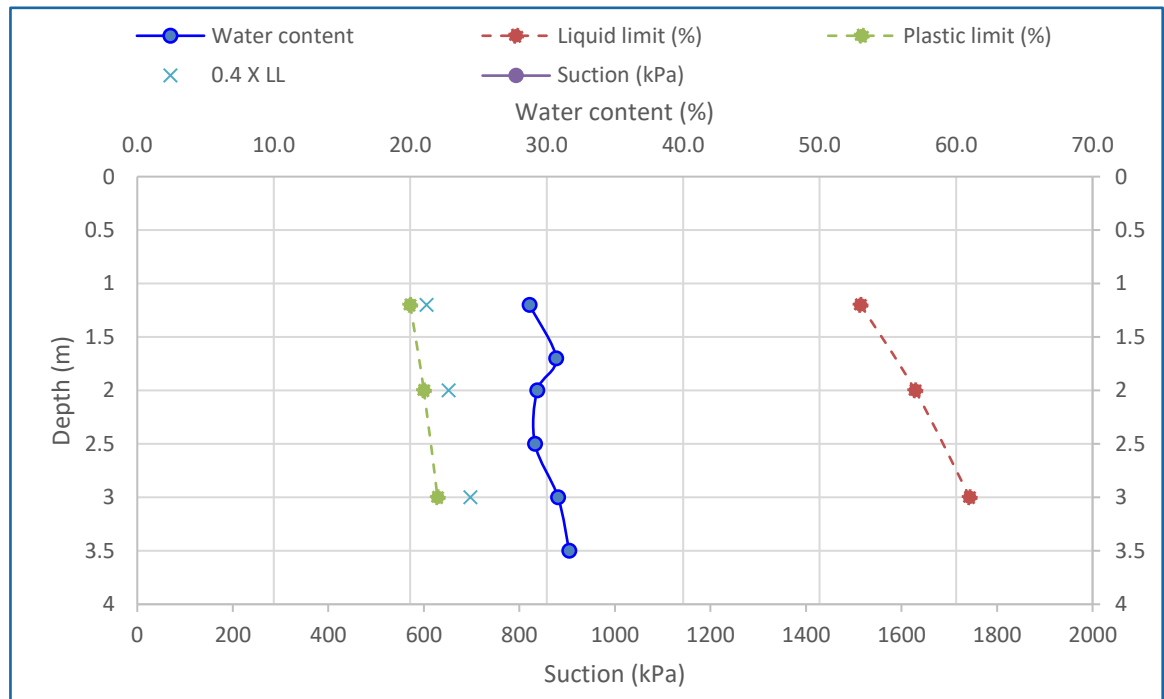
| Lab Ref | Depth (m) | MC (%) | LL (%) | PL (%) | PI (%) | .425 mm(%) | mod. PI (%) | Av. Suc. (kPa) | Description |
|---|---|---|---|---|---|---|---|---|---|
| 5 | 3 | 30.8 | 61 | 22 | 39 | 100 | 39 | | Firm to stiff brown/grey veined CLAY with rare gravel. Gravel is fine |
| 6 | 3.5 | 31.6 | | | | | | | Firm brown/grey veined CLAY with rare gravel. Gravel is fine |

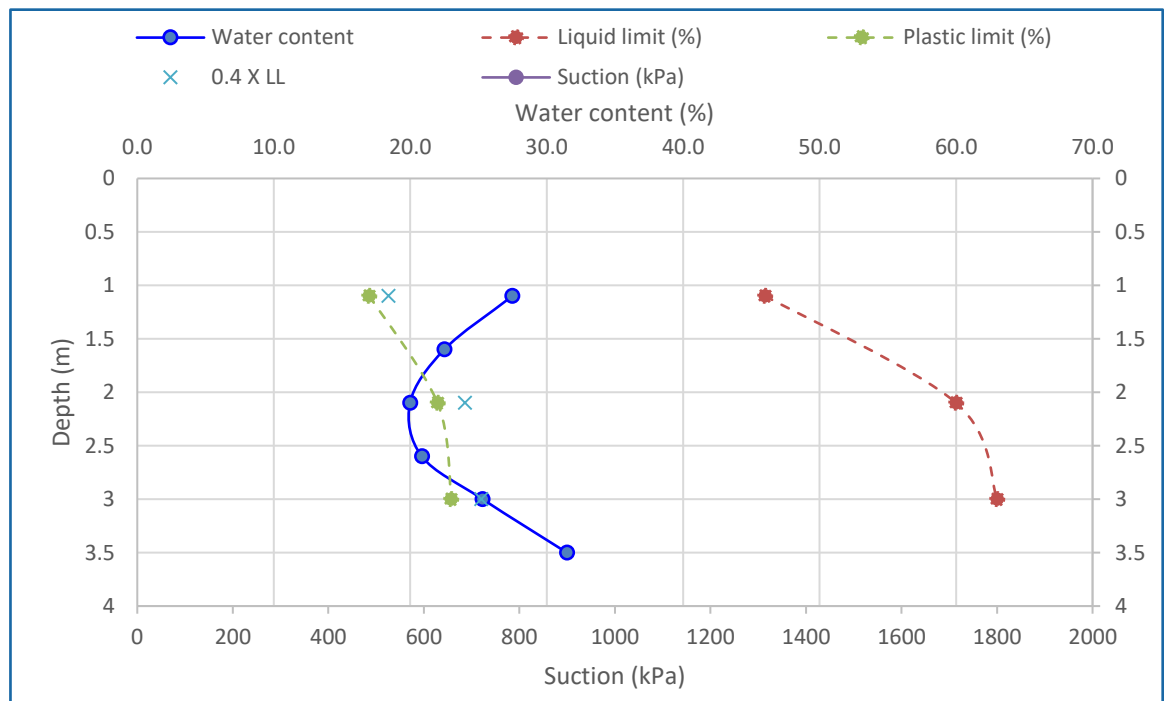
| Lab Ref | Depth (m) | MC (%) | LL (%) | PL (%) | PI (%) | .425 mm(%) | mod. PI (%) | Av. Suc. (kPa) | Description |
|---|---|---|---|---|---|---|---|---|---|
| 11 | 3 | 25.3 | 63 | 23 | 40 | 100 | 40 | | Stiff brown/orange-brown/light grey veined CLAY with rare gravel. Gravel is fine |
| 12 | 3.5 | 31.5 | | | | | | | Firm to stiff brown/orange-brown/light grey veined CLAY with rare gravel and sand. Gravel is fine |

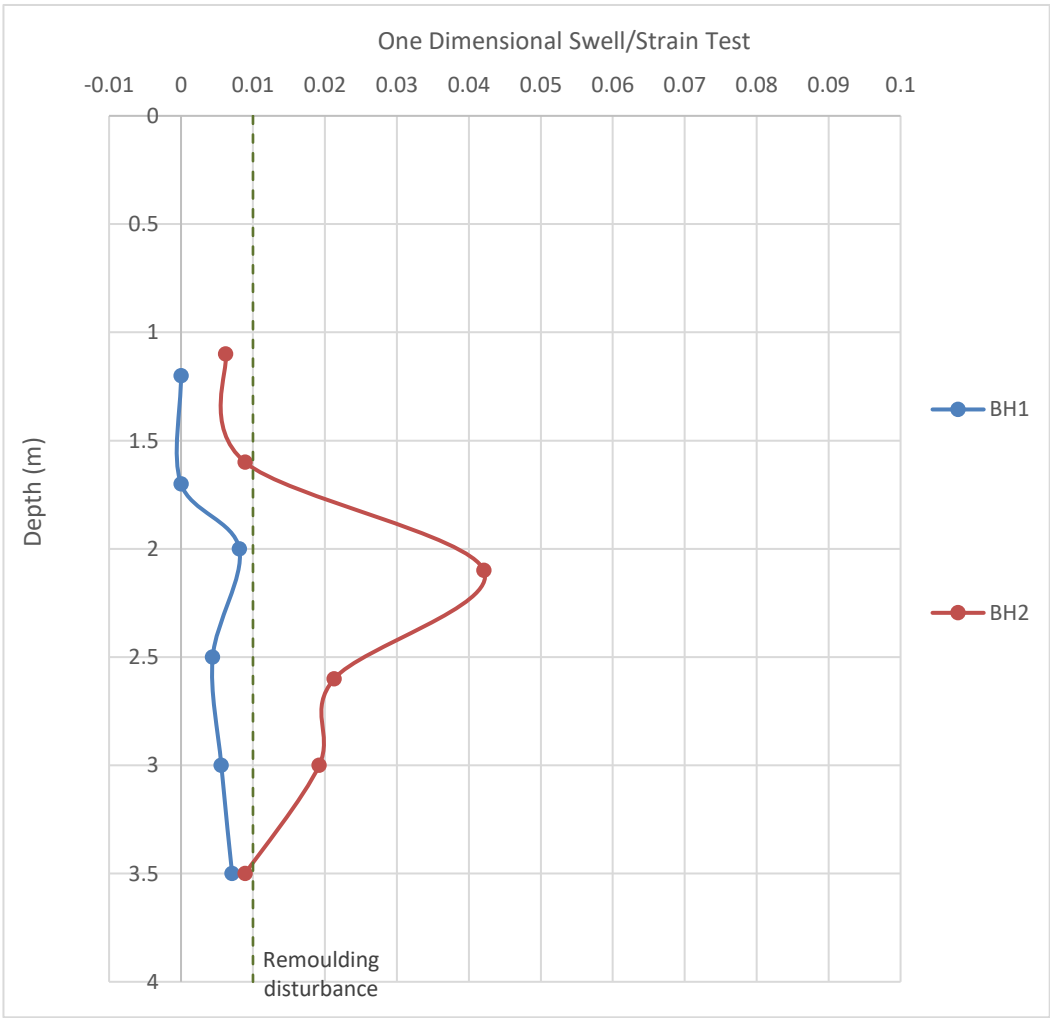
Summary of Oedometer Testing

| Lab Ref | Depth (m) | Strain | Heave (mm) | Remarks |
|---|---|---|---|---|
| 11 | 3 | 0.0192 | 1.8 | |
| 12 | 3.5 | 0.0089 | 0 | |
