## TIMBER ROOF STRUCTURAL SURVEY

| Client name | ITJ Development Ltd |
| Property address | Carpenters Cottage, Former RAF Uxbridge, St Andrews Park, Hillingdon Road, Uxbridge, London |
| Survey date | 12/02/2022 |

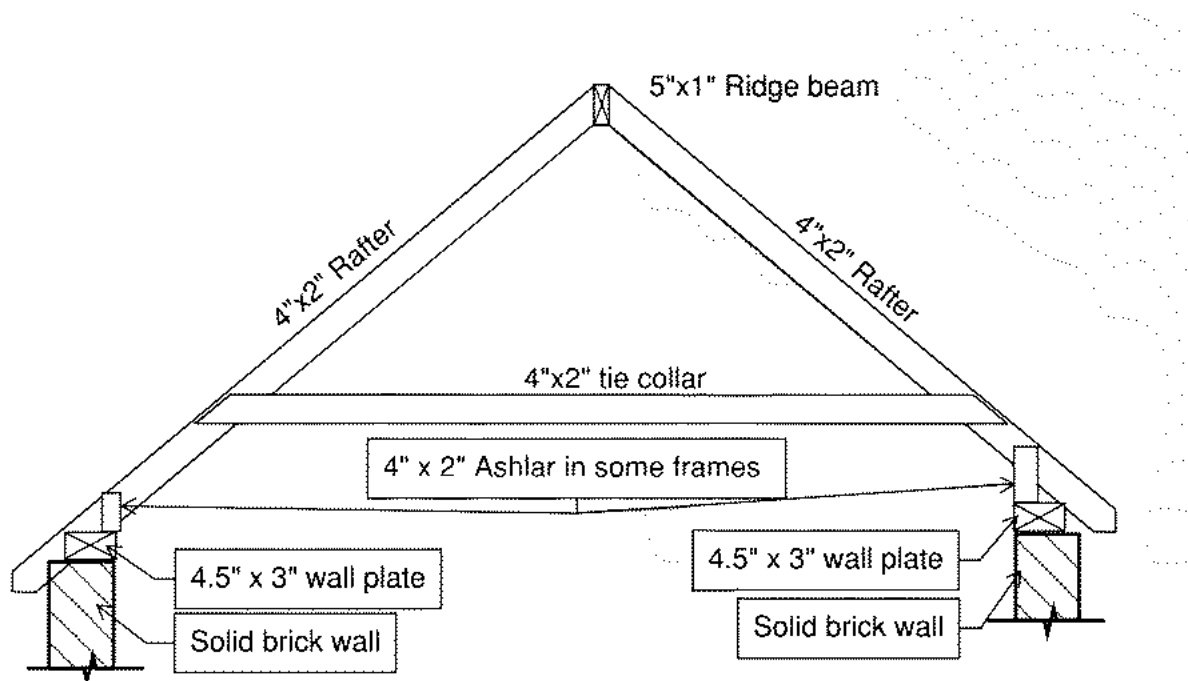
Typical roof frame structure

Roof frames is modern day graded timber and much younger age than rest of the structure. This shows that the roof structure has been replaced in the past; however, the wall plate was different timber and of the same age of the original cottage building.

Since the roof timber is of newer age, it is in good condition in majority of areas except localized joists where signs of decay were evident.

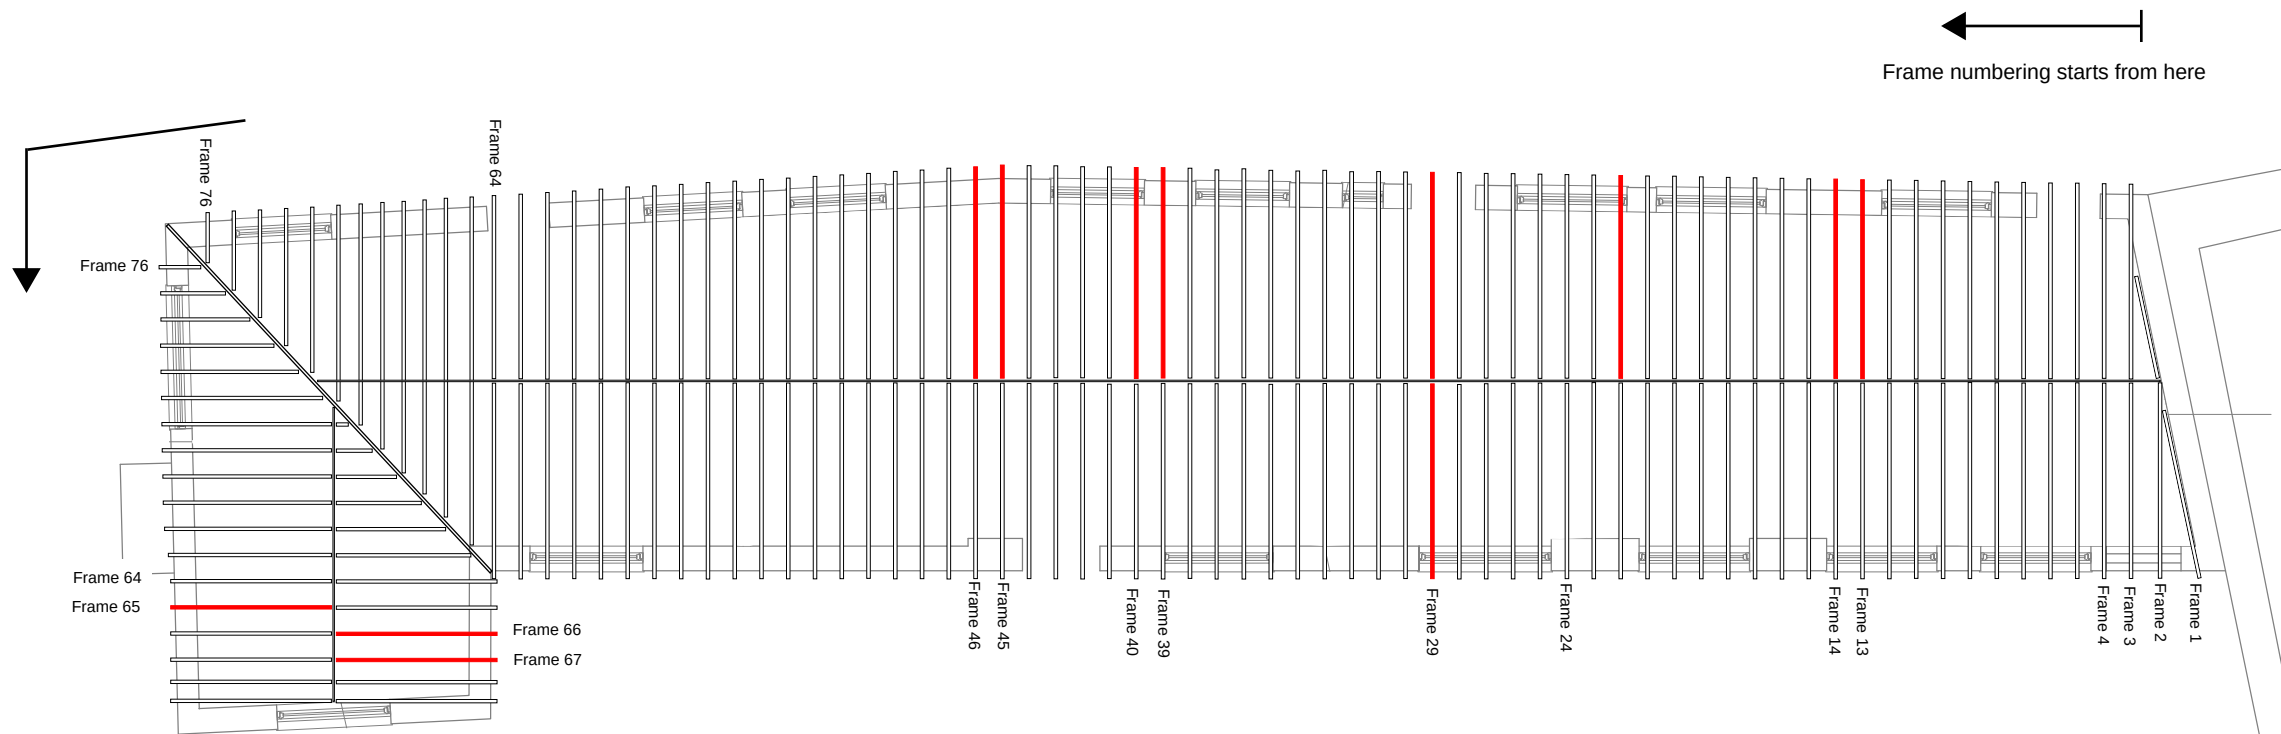
| PROJECT No. | 001107 | DRAWING No. | SK002 |

Rafter at frame No.24 is decayed and needs full replacement.

Roof Frame 29 decayed and should be fully replaced.

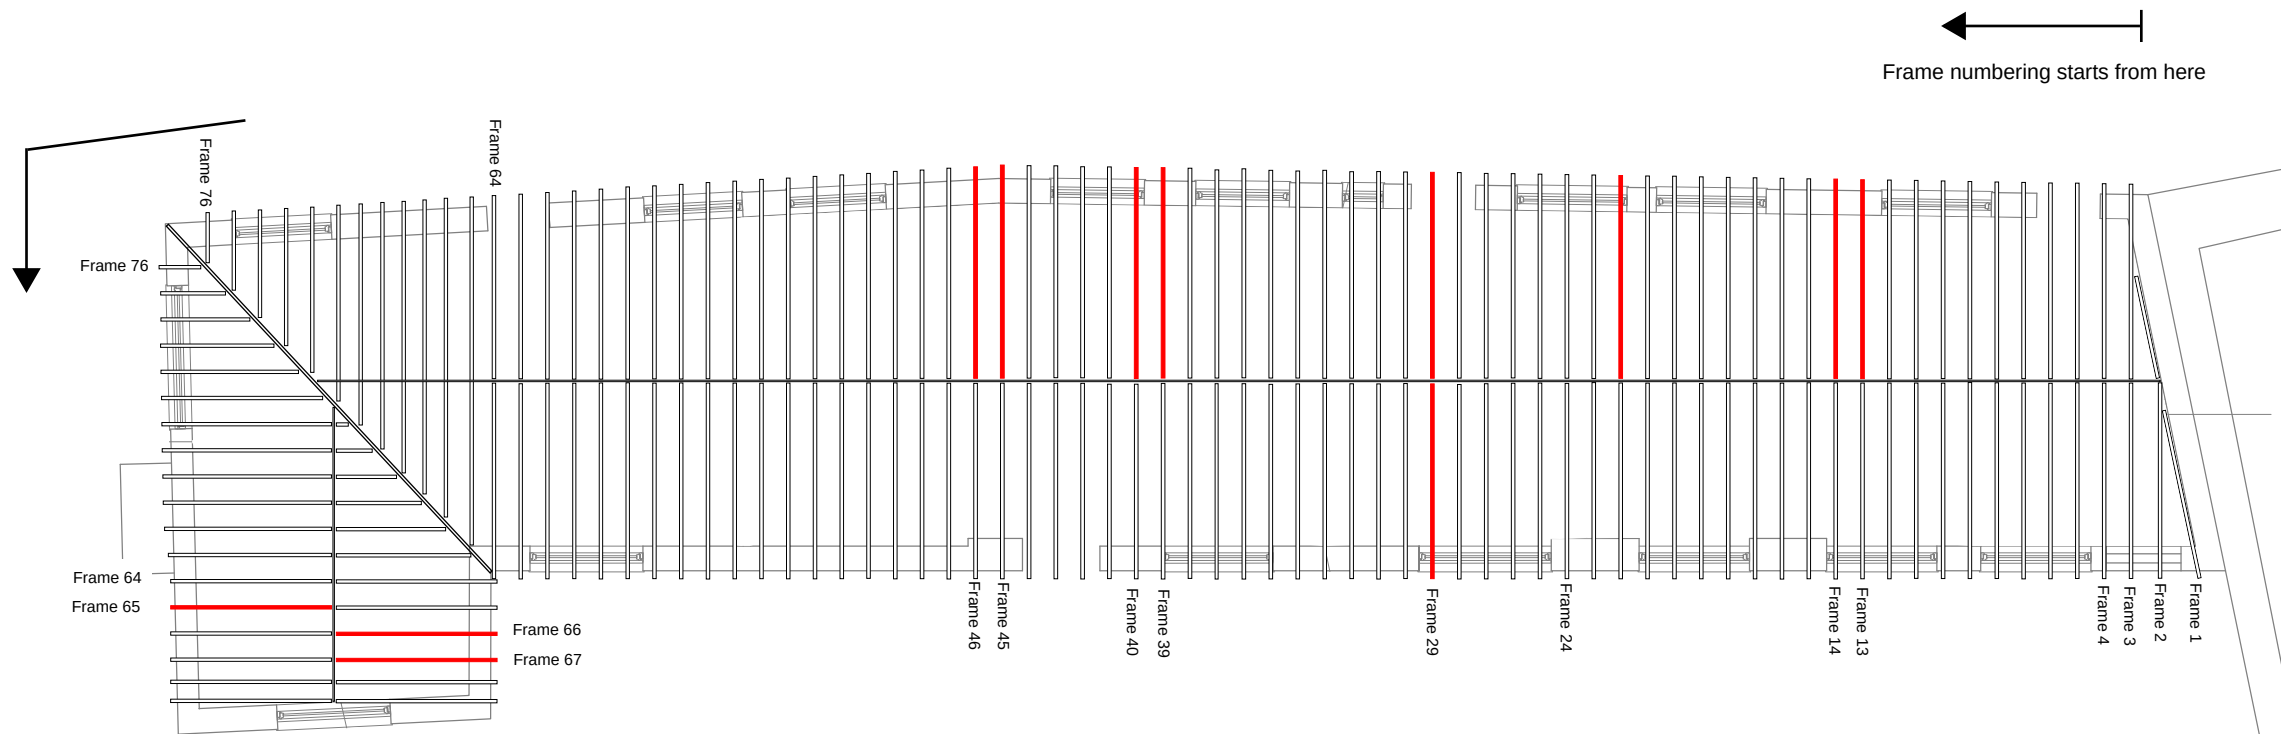
| PROJECT No. | 001107 | DRAWING No. | SK004 |

Rafter at frame No.65 is decayed and needs replacement.

Rafters at frame No.66 and 67 are decayed and needs replacement.
