Arboricultural Consultancy for Co-operative Insurance Society

Insured	Mrs Mary Merion	Address	26 Church Avenue, Ruislip, Middlesex, HA4 7HT		
Client	Subsidence Management Services	Contact	Kellie Ball	Claim No.	IFS-CIS-SUB-18-0080277
ES Ref	SA-242832	Consultant	Andrew Cayley	Contact No.	0330 380 1036
Report Date	04/01/2019	Revised:	02/05/2019

Scope of Report: To survey the property and determine significant vegetation contributing to subsidence damage, make recommendation for remedial action and assess initial mitigation and recovery prospects. The survey does not make an assessment for decay or hazard evaluation. This is a revised report following receipt of root analysis results.

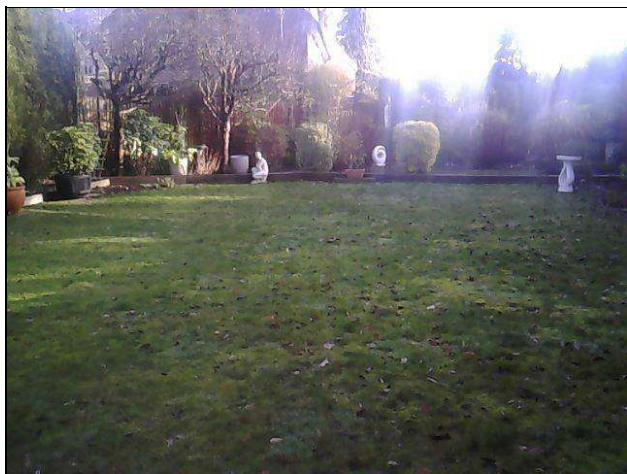
T1 - Cypress (Lawson)

Insured Garden - Back

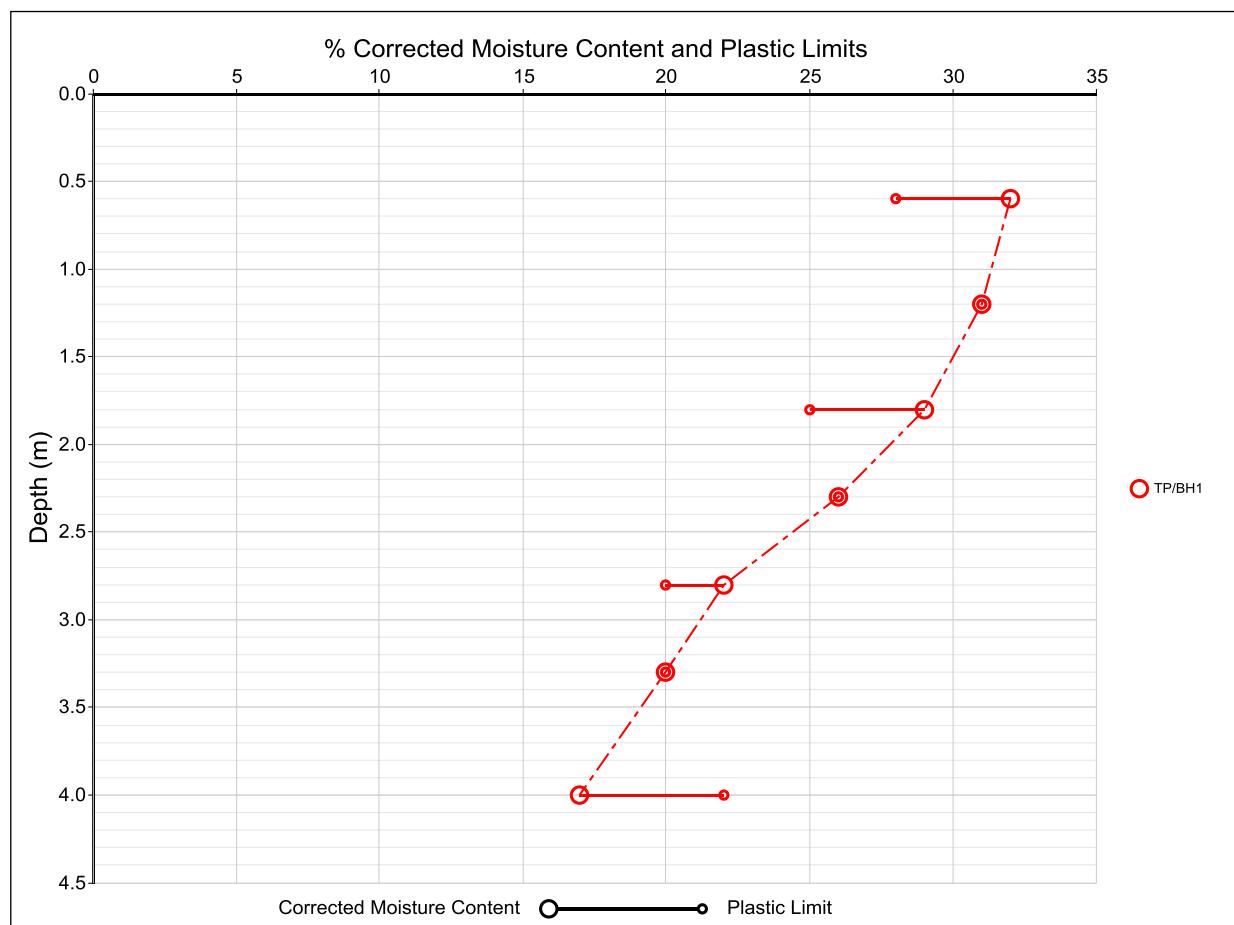
Corrected Moisture Content and Plastic Limits Graph

Lab Ref	Depth (m)	MC (%)	Corr MC (%)	LL (%)	PL (%)	PI (%)	% Passing .425mm
Samples from TP/BH1							
001	0.60	32	32	73	28	45	100
002	1.20	31					
003	1.80	29	29	76	25	51	100
004	2.30	26					
005	2.80	22	22	67	20	47	100
006	3.30	20					
007	4.00	17	17	72	22	50	100

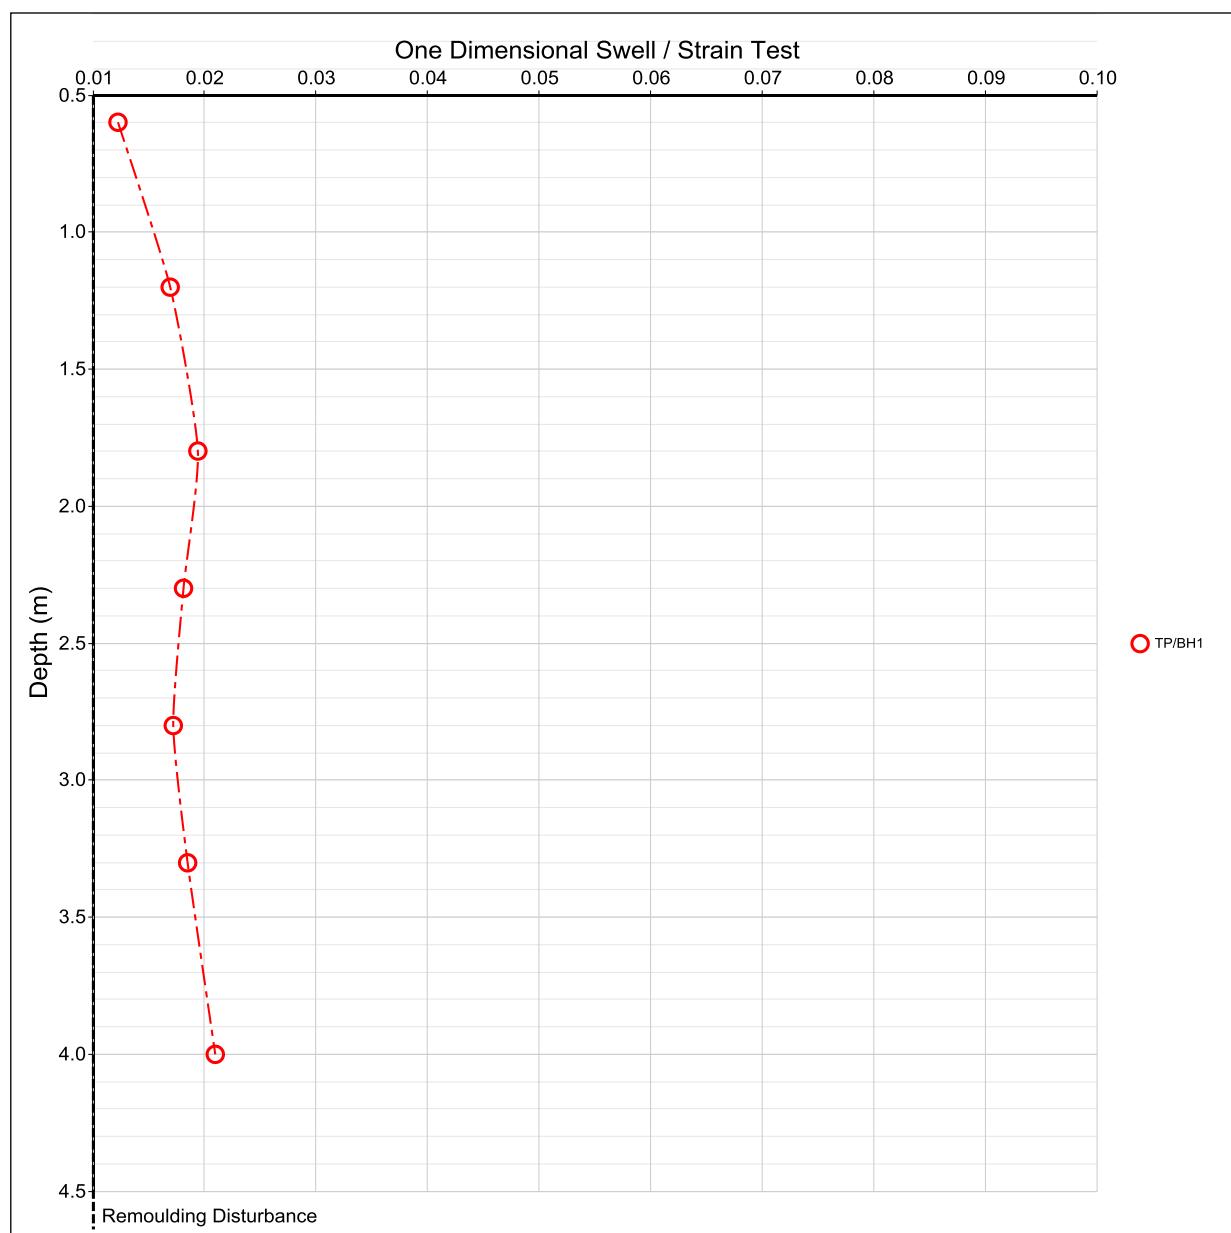
Oedometer Strain

Lab Ref	Depth (m)	Strain	Dd (mm)	Remarks
Samples from TP/BH1				
001	0.60	0.0123	3.7	
002	1.20	0.0170	5.1	
003	1.80	0.0194	5.8	
004	2.30	0.0181	4.5	
005	2.80	0.0172	4.3	
006	3.30	0.0185	4.6	
007	4.00	0.0209	7.3

TP/BH1 Dd Total: 35.4mm

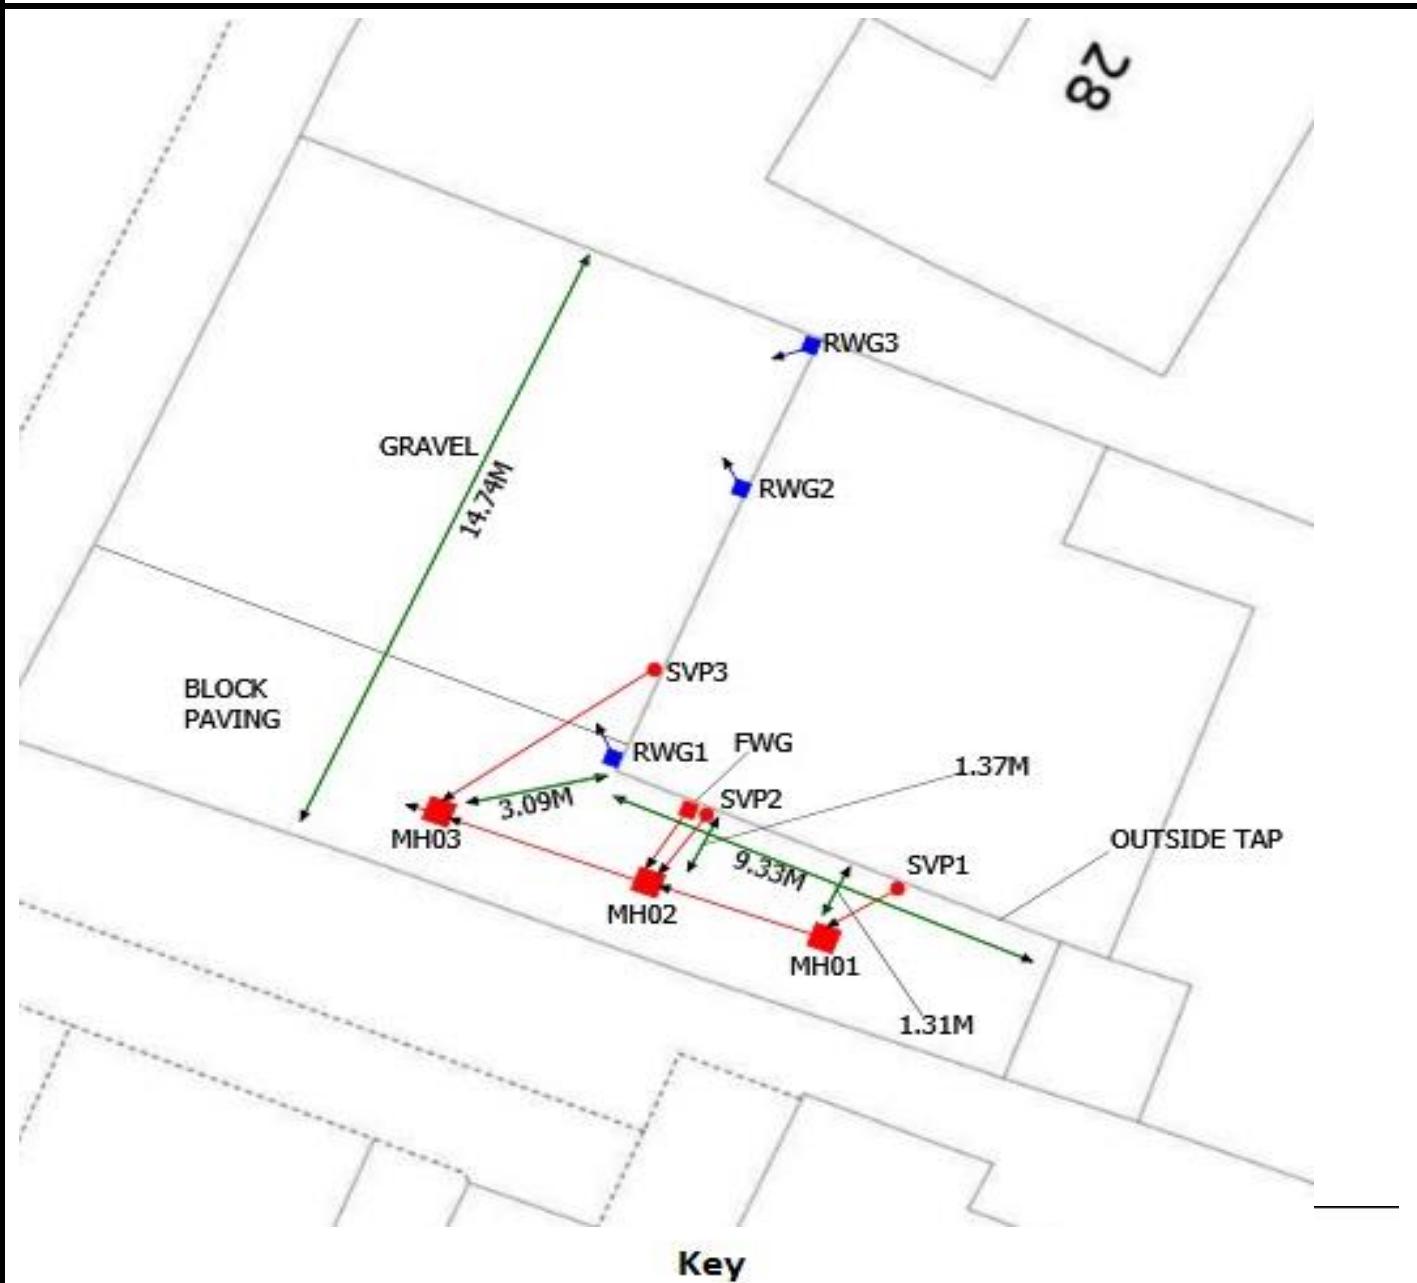
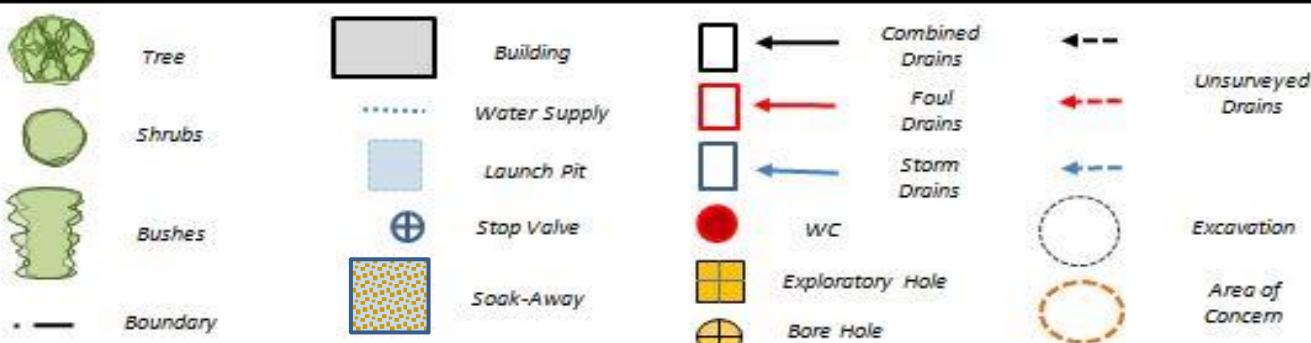
RUN	Start From :	MH1	Finish at :	MH3	Pipe Ø:	100mm
A	Invert Level (m):	0.58	Invert Level (m):	N/A	Material:	Clay
FOUL	Condition grade:	C	Direction:	Downstream	Responsibility:	Home Owner
Distance	Code	Hydraulic test - Fail

0.00	SN	Start Node from MH1				
0.00	WL	Water Level 5%				
0.18	JDM	Joint Displaced (Medium)				
0.18	CC	Crack Circumferential				
2.71	REM	Remark - Line enters MH2

6.07	FC	Fracture Circumferential				
8.92	FN	Finish Node at MH3				
RUN	Start From :	MH1	Finish at :	SVP1	Pipe Ø:	100mm
B	Invert Level (m):	0.58	Invert Level (m):	N/A	Material:	Clay
FOUL	Condition grade:	C	Direction:	Upstream	Responsibility:	Home Owner
Distance	Code	Hydraulic test - Not tested

0.00	SN	Start Node from MH1				
0.00	WL	Water Level 5%				
0.41	FC	Fracture Circumferential				
1.01	JN	Junction at 3 o'clock to				
2.16	RF	Roots Fine

2.16	LL	Line of drain deviates left				
2.71	LU	Line of drain deviates up - rest bend				
3.31	FN	Finish Node at SVP1				
RUN	Start From :	MH2	Finish at :	SVP2	Pipe Ø:	100mm
C	Invert Level (m):	0.62	Invert Level (m):	N/A	Material:	Clay
FOUL	Condition grade:	C	Direction:	Upstream	Responsibility:	Home Owner
Distance	Code	Hydraulic test - Fail
