## SITE INVESTIGATION FACTUAL REPORT

Report No: 311141  
Client: Crawford Claims Management  
Site: 40 Swakleleys Road, Ickenham

Client Ref: SU1505084-  
Date of Visit: 19/01/2016

# Investigation Layout Plan

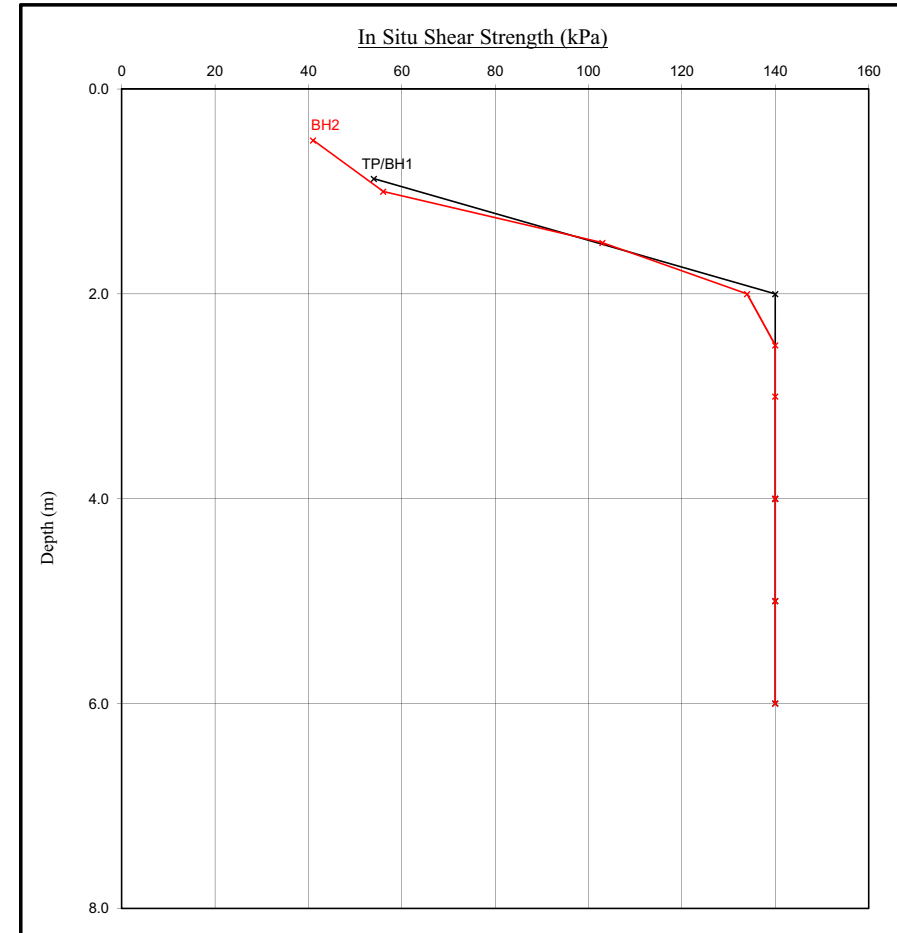
## Shear Strength Profiles

1. Unless otherwise stated, values of Shear Strength were determined in situ by CET using a Pilcon Hand Vane the calibration of which is limited to a maximum reading of 140 kPa.
2. Unless specifically noted the profiles have not been related to a site datum.

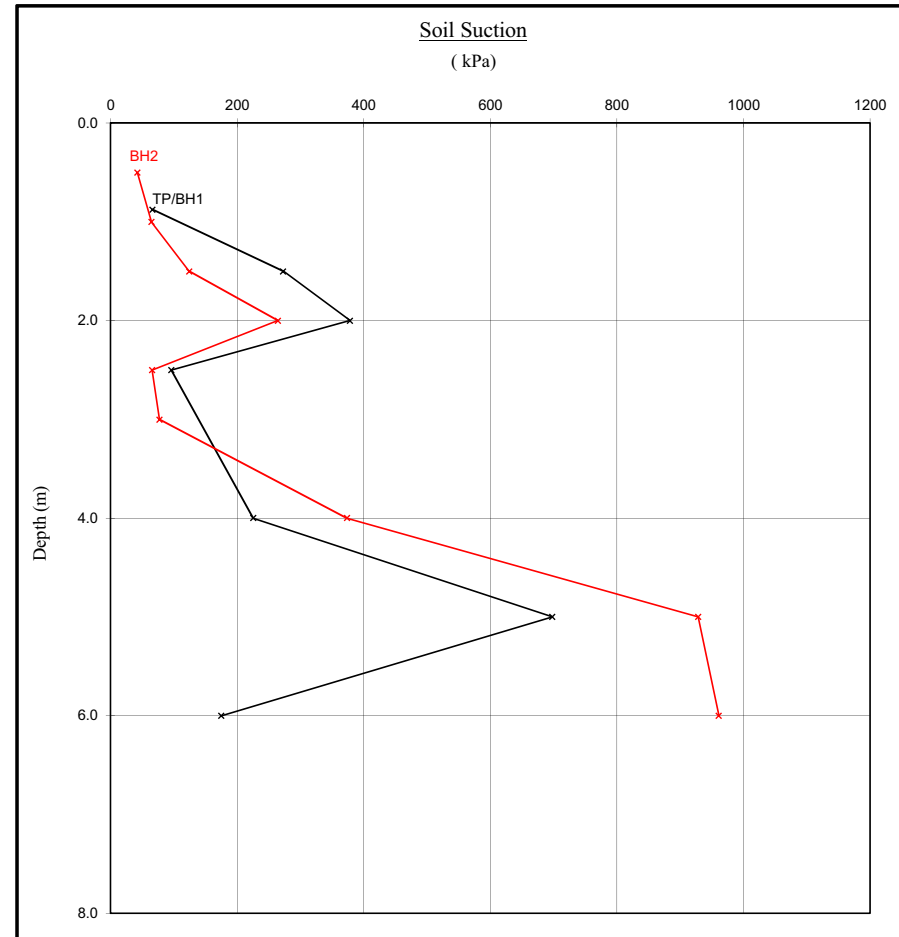
## Soil Suction Profiles

When shown, the theoretical equilibrium suction profiles are based on conventional assumptions associated with London Clay (and similarly overconsolidated clays) at shallow depths. Note that the sample disturbance component is dependant on the method of sampling and any subsequent recompaction. The above plots show this to be 100kPa which is the value suggested by the BRE on the basis of their limited number of tests on recompacted samples. This may or may not be appropriate in this instance and judgement should be exercised.
