**DOWER HOUSE, HIGH STREET, HARLINGTON**  
**STRUCTURAL ENGINEERING APPRAISAL**

## STRUCTURAL ENGINEERING APPRAISAL

SFK Consulting is appointed as Structural Engineer to advise Komfort Services Ltd (the property owner) on the repairs and alterations necessary to bring the Dower House building back into reuse as a residential property.

The Dower House is listed grade II and suffered a significant fire in May 2011. Since then the property has stood vacant and derelict. In 2018, a temporary scaffold frame roof was erected over the building, but no repairs have been undertaken following the fire in 2011.

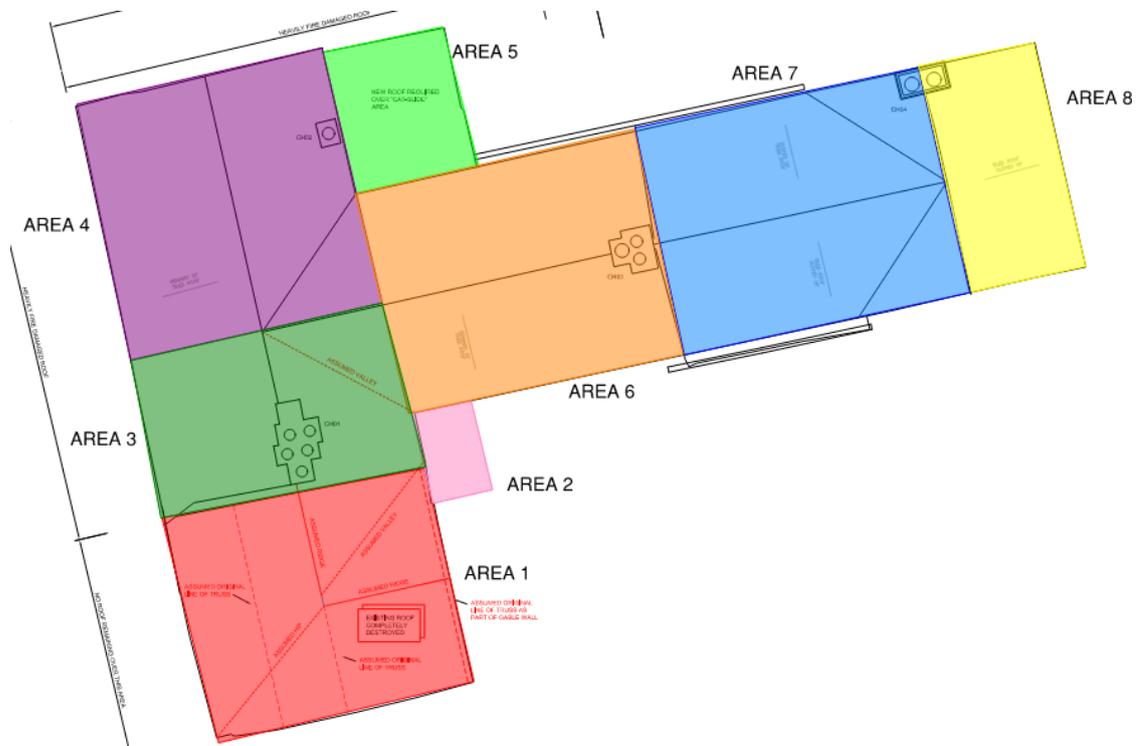
**Figure 2.1 - Roof plan split into reference areas**

The roof has been split into different areas reflecting their different nature and level of damage, shown in Figure 2.1.

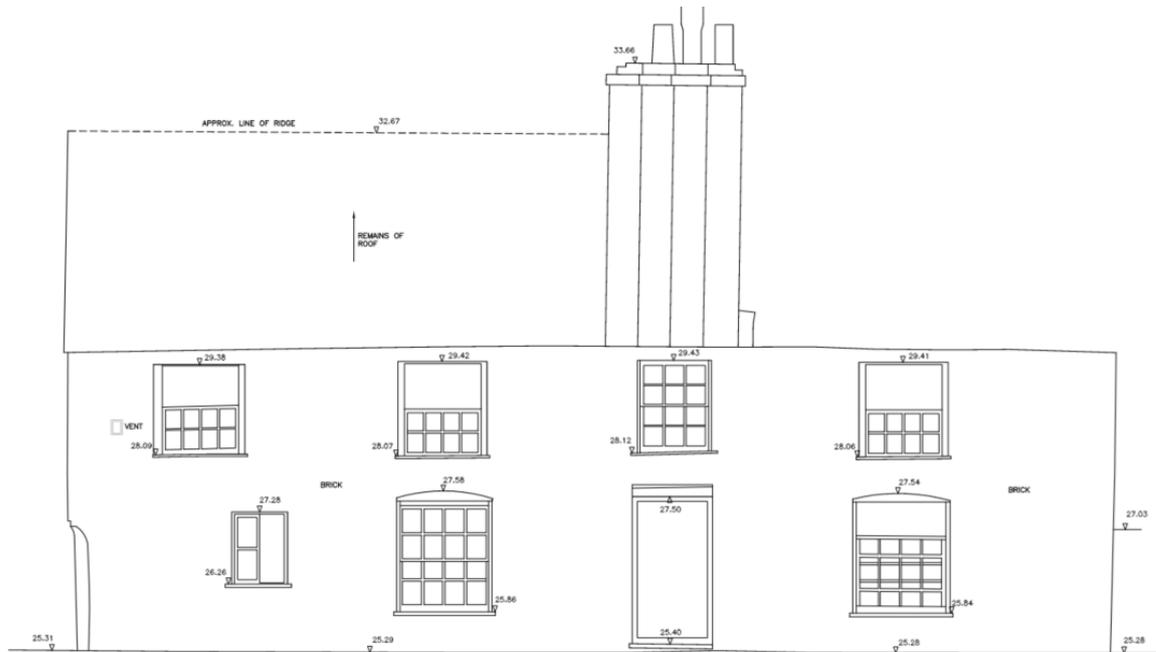
**Figure 2.10 - Western Elevation**

The western elevation forms the main entrance elevation to the property and shows evidence of various items of structural damage and failures that would require interventions, these are detailed below.

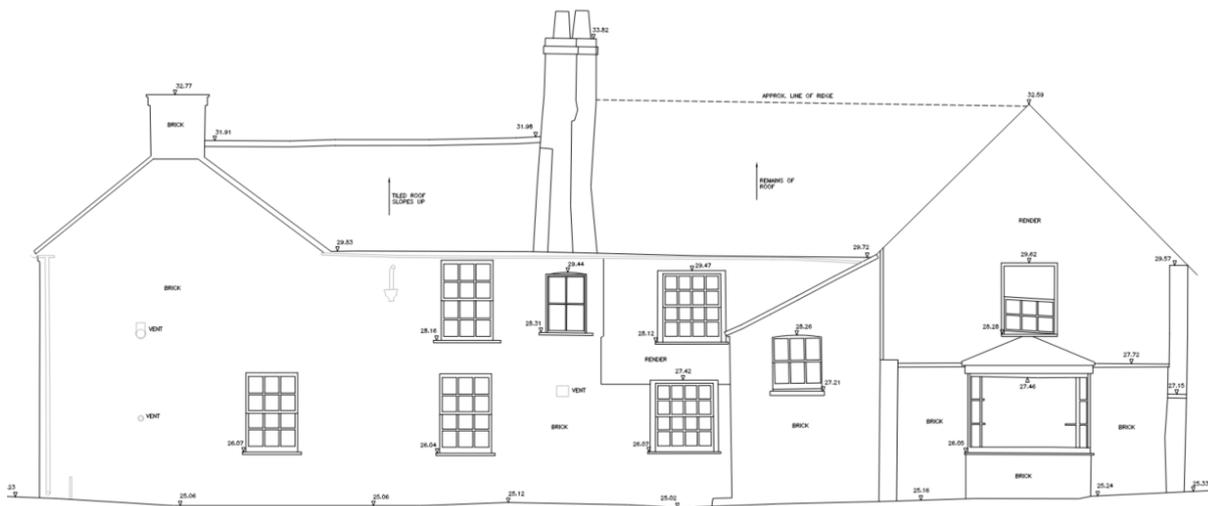
Figure 2.13 - Northern elevation

The first part of the northern elevation is part of the original building and is showing various signs of damage that require intervention. The first of these is cracking at the corner to the western elevation, where the return is separating from the elevation. This is

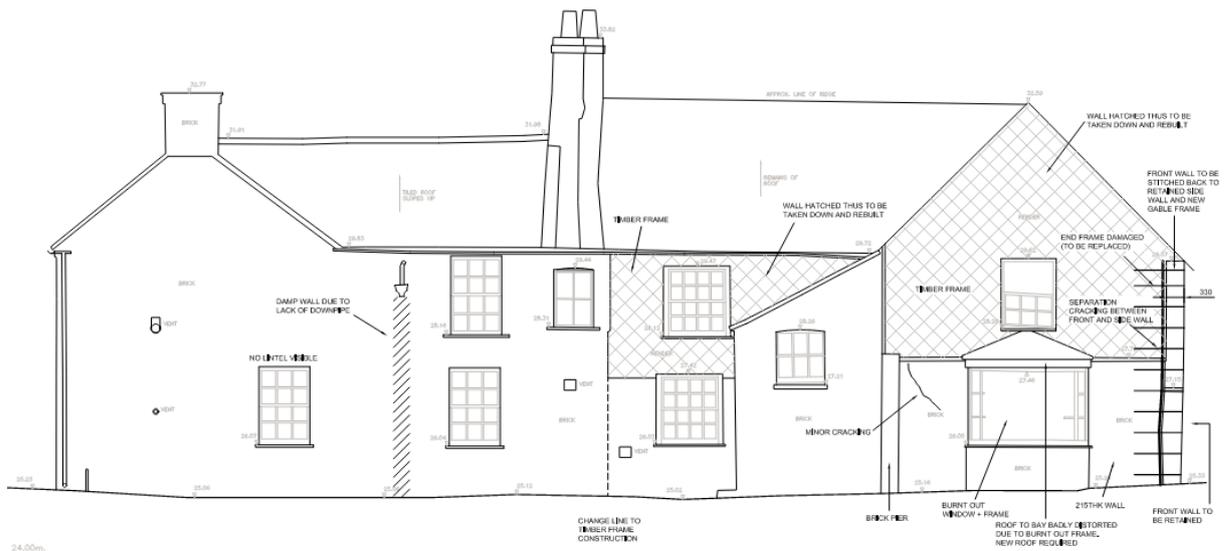
Figure 2.17 - The northern elevation identifying findings and repairs

The western portion of the wall at first floor and roof levels is constructed in a timber frame with an external pebbledash render, however this has exhibited damage to the point of needing replacement. The first floor and gable is fire damaged beyond repair and should be rebuilt in timber frame, also allowing for modern insulation to be incorporated for future habitation. The same applies to the portion of wall to the rear of the later extension at first floor level, see Figure 2.17.

The eastern part of the elevation is showing signs of water damage owing to damaged/missing guttering and downpipes. This requires replacement to ensure no further damage to the external masonry, see Figure 2.16, the brickwork will also require consolidation with local replacement and repointing.

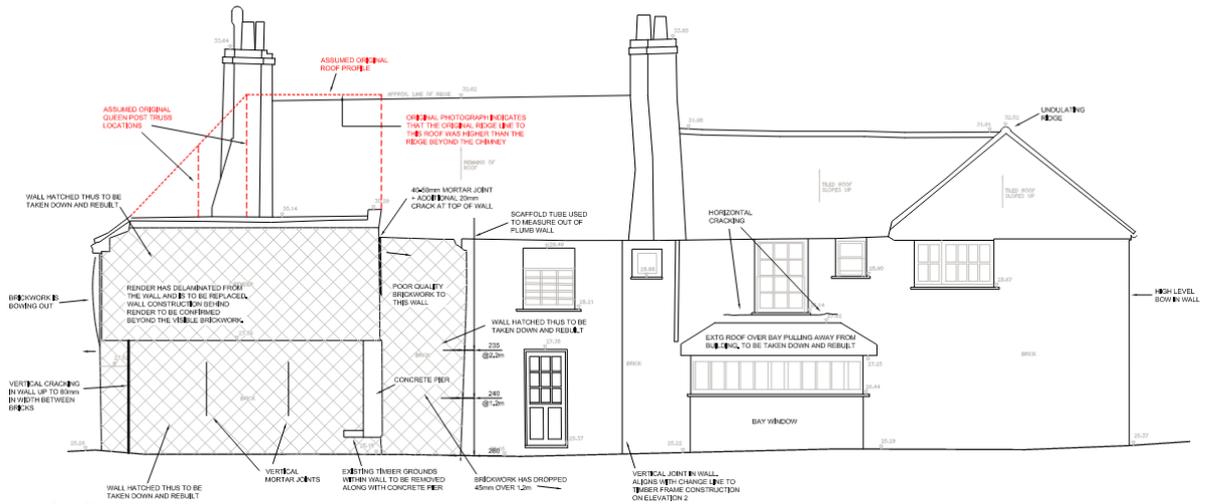
Figure 2.24 - The observations and repairs to the southern elevation

The eastern wing of the southern elevation has a bay window where the window structure is pulling away from the main building and will require to be replaced.

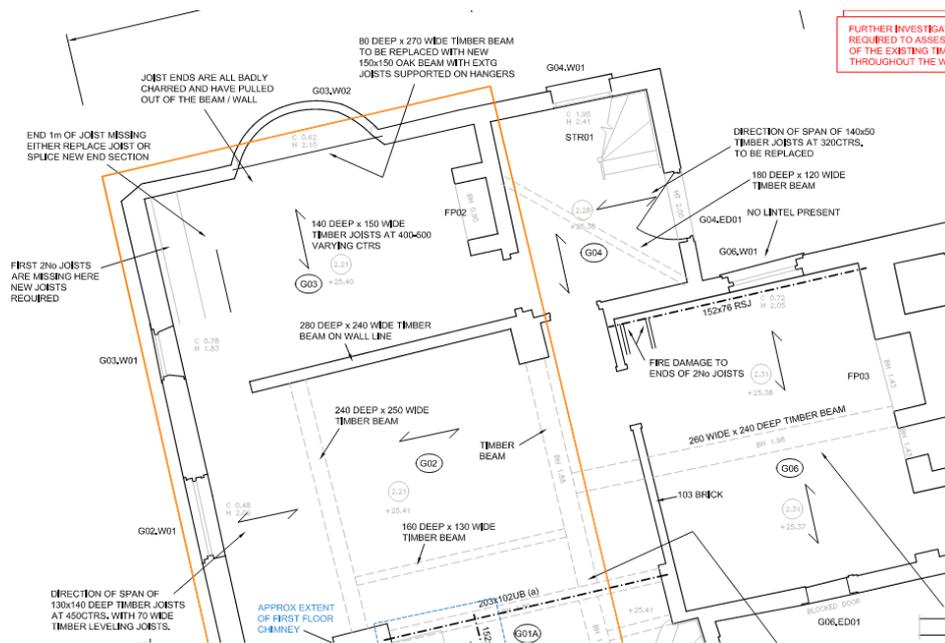
**Figure 2.26 - The northern part of the original house and part east wing**

The first floor structure to the northern part of the original house shows signs of fire damage, with some joists with charred/missing ends and some joists missing entirely. These are to be replaced where missing or spliced with new ends if possible where the ends are charred or damaged, alternatively, replaced entirely.
