# Site Investigation Report

**118594.1.TSI**

Client	Crawford & Co - Axa (Subsidence)
Client ref	SU2005239
Visit date	24/02/2021
Report date	25/02/2021

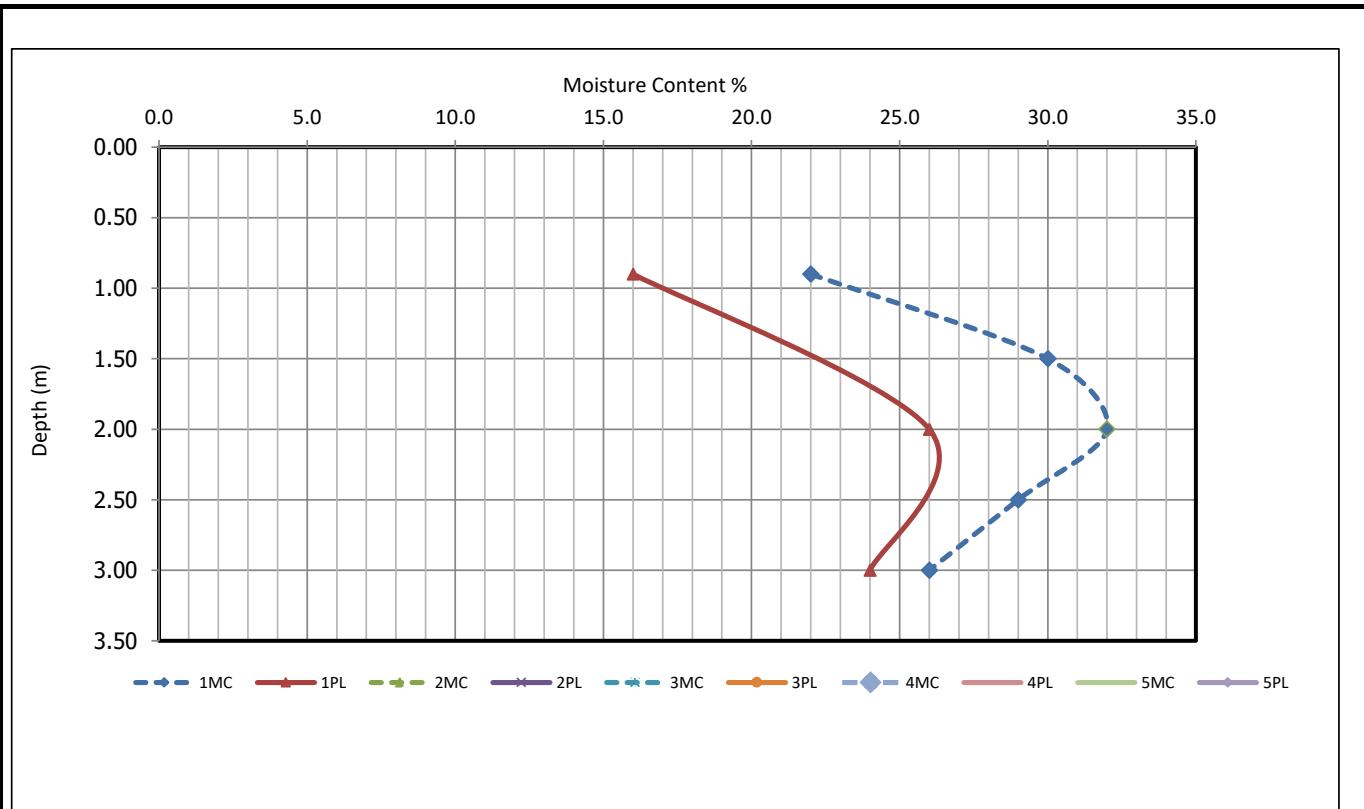
PLASTICITY CHART FOR CASAGRANDE CLASSIFICATION  
BS 5930:1999+A2:2010

Modified Plasticity Index (PI) <10 : Non Classified  
Modified PI = 10 to <20 : Low volume change potential (LOW VCP)  
Modified PI = 20 to <40 : Medium volume change potential (Med VCP)  
Modified PI = 40 or greater : High volume change potential (HIGH VCP)
