## SD - Damage:

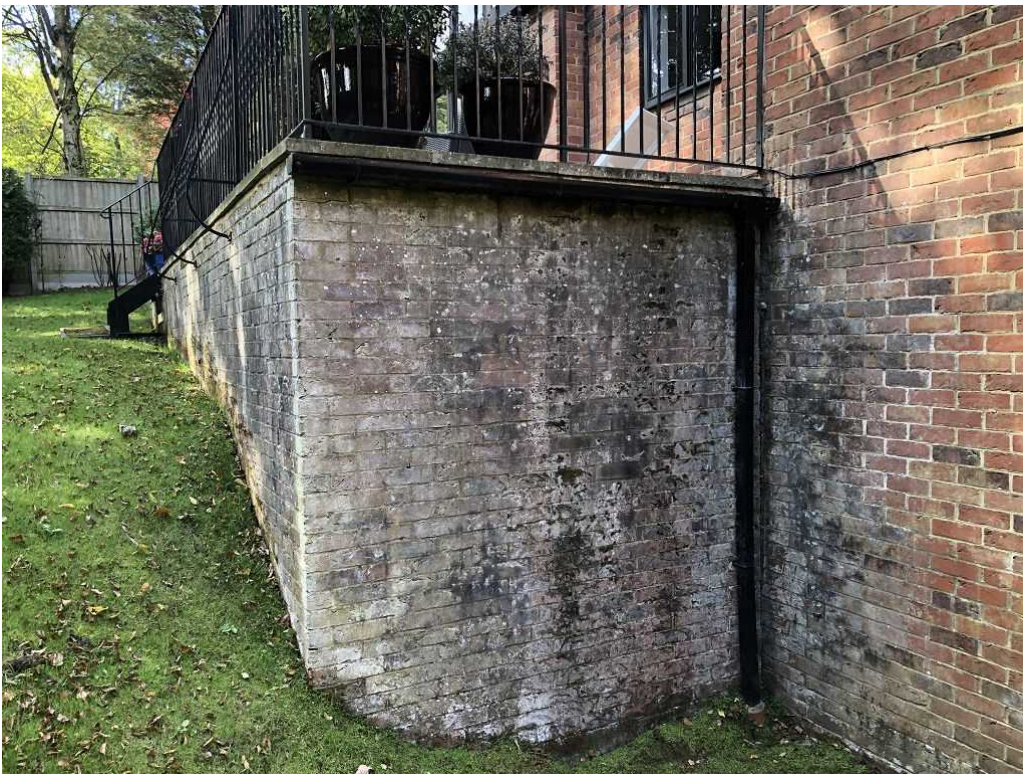
36

Back raised terrace junction with the main house- large 40mm rotation type gap as described in the engineer report

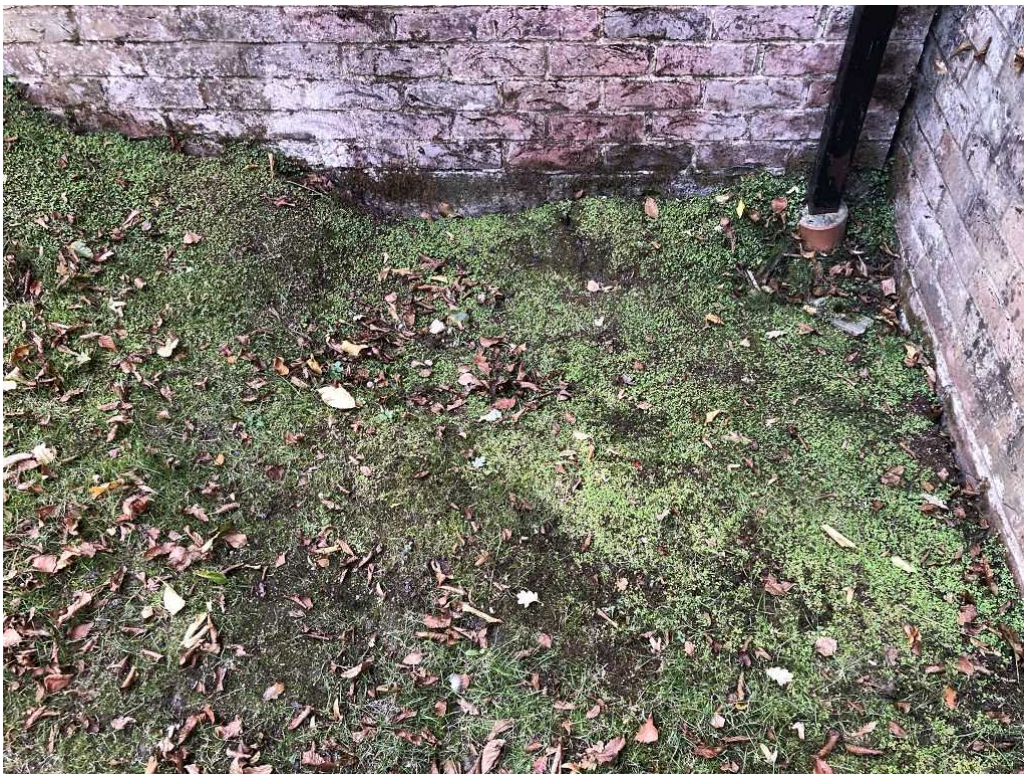
42

The ground in this corner sunken and very damp but it is a low point
