# Geotechnical Survey Report

FSI Ref: 29914  
Issue Date: October 2025

Risk Address: 4 Teal Drive  
Northwood  
Middlesex  
HA6 2PT

Company: Crawford  
Claim Ref: 1875934

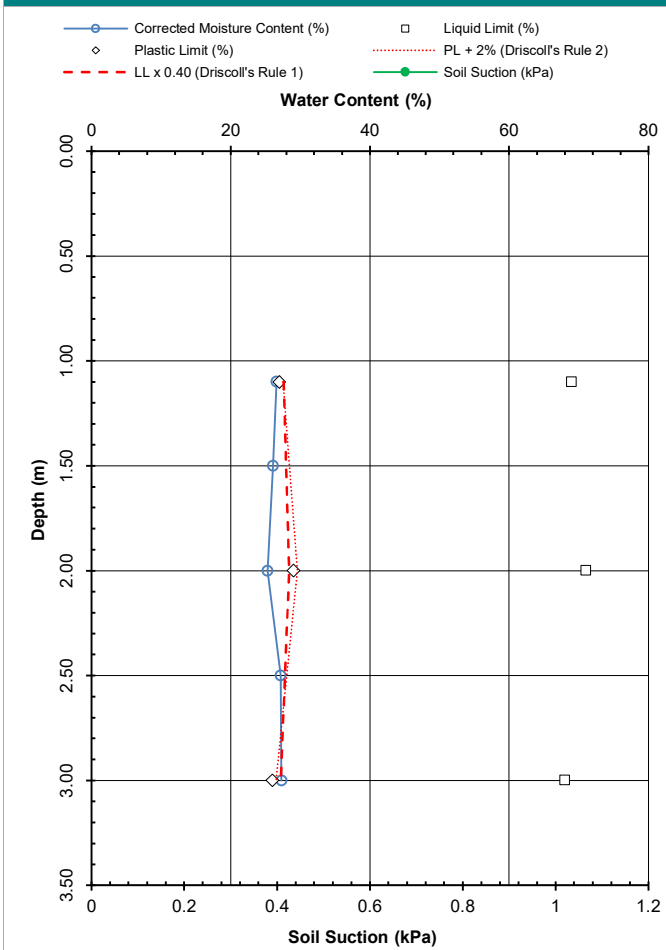
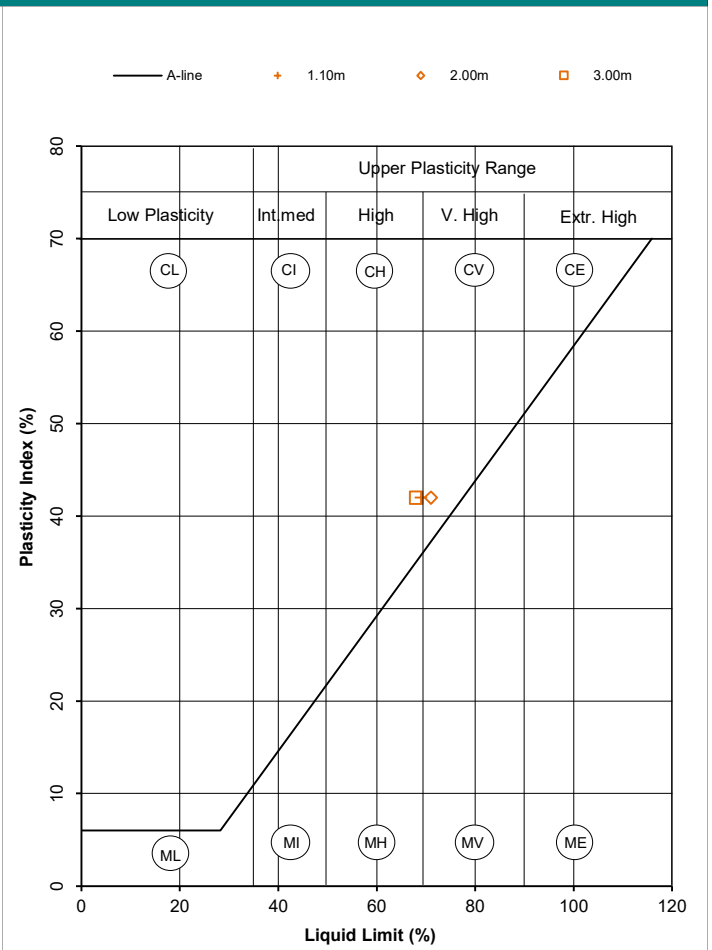
**BOREHOLE 3**

Depth (m)	WC (%)	Corr. WC (%)	LL (%)	PL (%)	PI (%)	Class	% Retained (425µm)	Soil Suction (kPa)	Condition of test	Soil Description
1.10	26.6	26.6	69	27	42	CI	0		Natural	Firm grey / brown silty CLAY containing orange mottle and sand pockets
1.50	26.1	26.1					0		Natural	Firm grey / brown silty CLAY containing orange mottle and sand pockets
2.00	25.3	25.3	71	29	42	CV	0		Natural	Firm grey / brown silty CLAY containing orange mottle and gypsum
2.50	27.2	27.2					0		Natural	Firm grey / brown silty CLAY containing orange mottle and gypsum
3.00	27.3	27.3	68	26	42	CH	0		Natural	Firm grey / brown silty CLAY containing orange mottle and gypsum

Comments: Samples dried in oven not exceeding 50°C due to the presence of gypsum

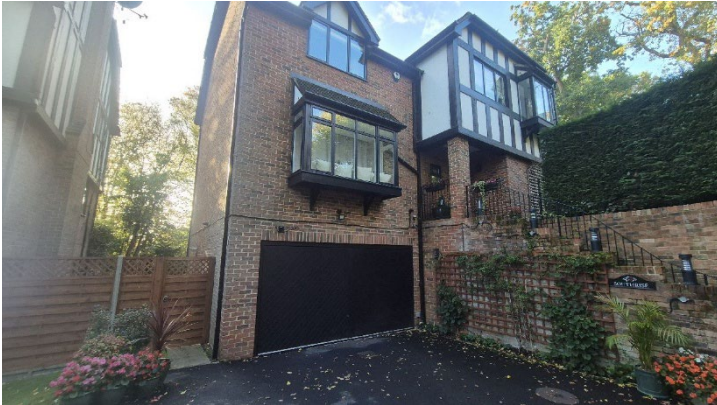
Photo 1 (Showing front of property)

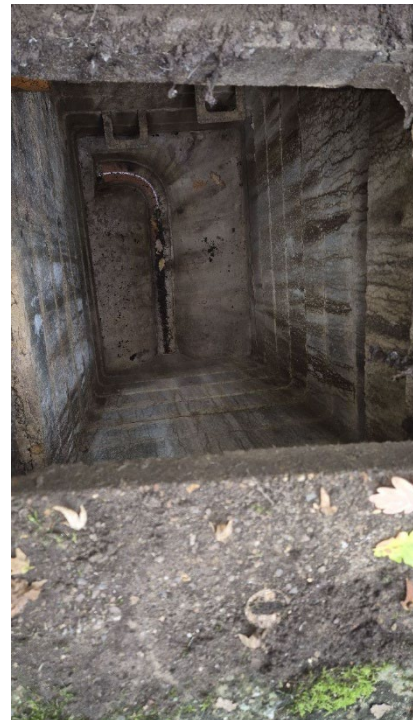
Node	Invert Level (m)	Manhole Construction	Pipe Size	Pipe Material	Manhole Condition	Type of Cover	Size of Cover
MH1	2.00	Concrete	100mm	Clay	FAIR	Concrete	690x540mm
MH2	2.90	Concrete	100/110mm	Clay/UPVC	FAIR	Concrete	690x540mm
MH3	0.30	UPVC	110mm	UPVC	GOOD	Iron	500x500mm

Photo 4 (Showing MH1)

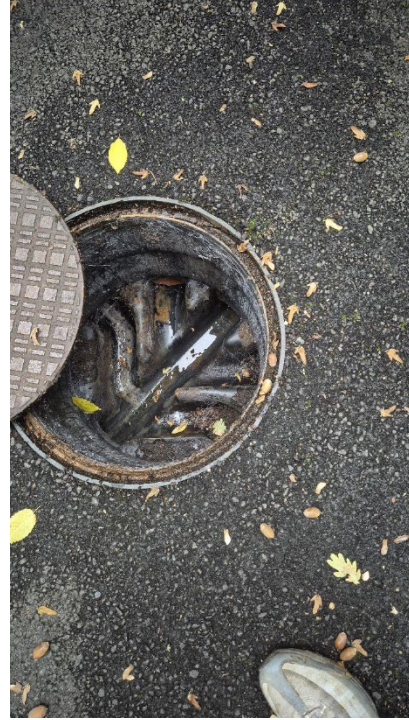
Photo 6 (Showing MH3)

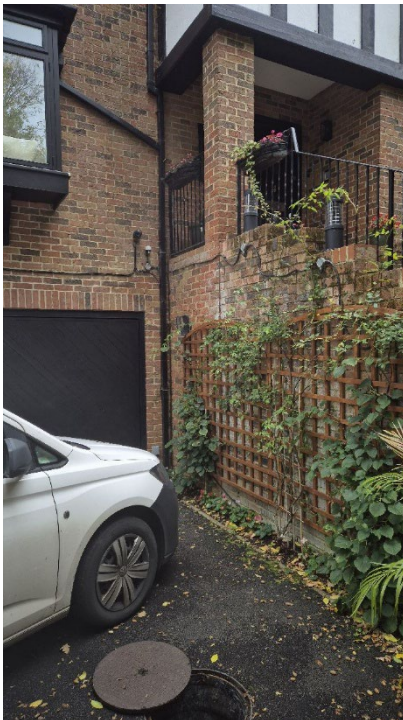
Photo 7 (Showing RWP1)

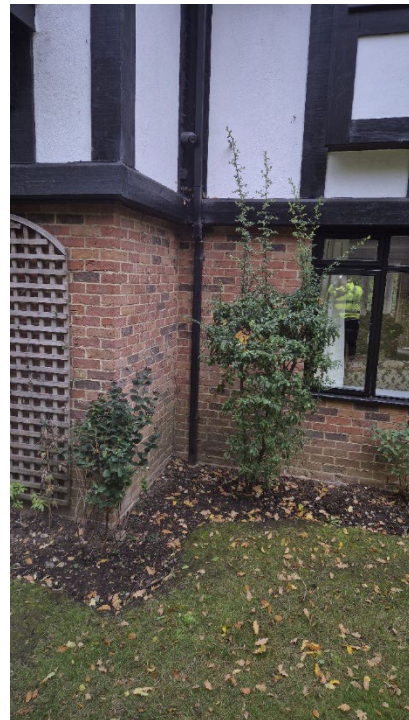
Photo 8 (Showing RWP2)

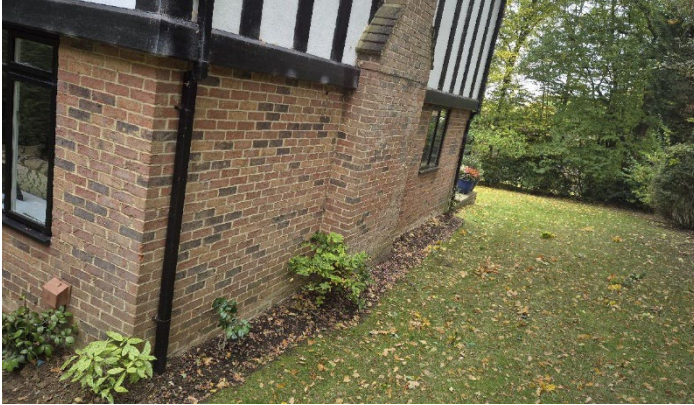
MH2 noted to contain roots. RWP4, RWP5, RWP6 & RWP7 require break-ins to survey. The operative performed the mains test on the water outlet at the rear of the property, they were unable to locate the policy holders water meter this resulted in a pass.

Photo 9 (Showing RWP3 & RWP4)

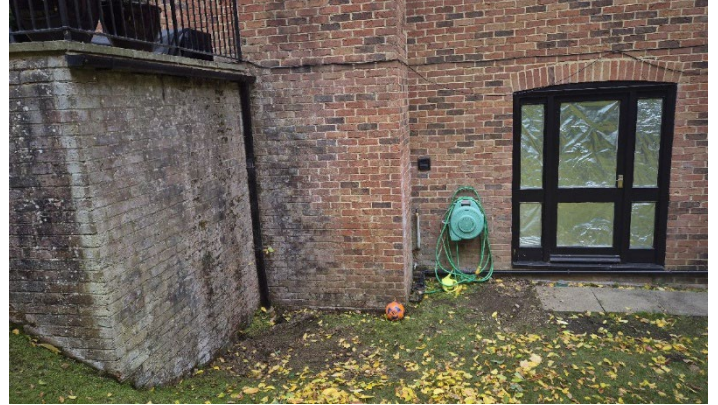
TP3 moved due to FWG1 running through it, there are no leaks detected in Run1 but standing water is noted in the first attempt of TP3.

Photo 10 (Showing RWP5 & FWG1)
