ARBORICULTURAL IMPACT ASSESSMENT

**SITE: Corner of Fore Street and High Road, Eastcote,
Pinner HA5 2ET**

CLIENT: Watervale Property Ltd

17th January 2023 EAS-062v3

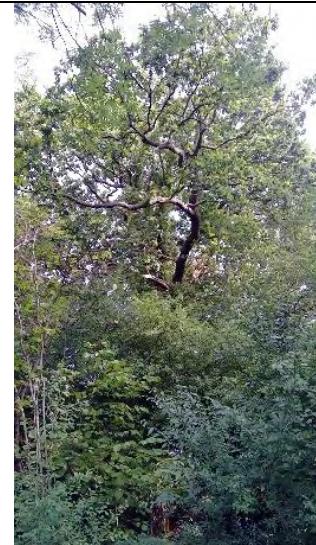
<p>T15 - Ash (Common) – Innonotus bracket on ground</p>	<p>T16 - Oak (English)</p>

7.1.4 Three of the 'U' category trees, T15, T27 & T30, identified to fell due to their dead / dangerous condition are protected by the TPO on the site and will need to be replaced by TPO condition, separate to any tree replacement conditions that may be subject to any planning decision.

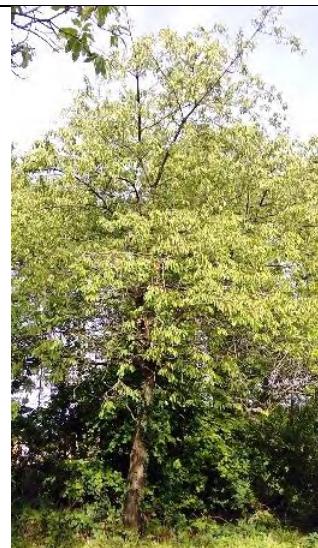
T23 - Pissard Plum

T23	Pissard Plum	6	2	2	5	3	200	1	18	2	27	U	Early Mature	<10	Poor suppressed asymmetric canopy. Poor condition. Sparse crown showing signs of stress with upper crown retrenchment and major deadwood.	Fell to ground level and treat.

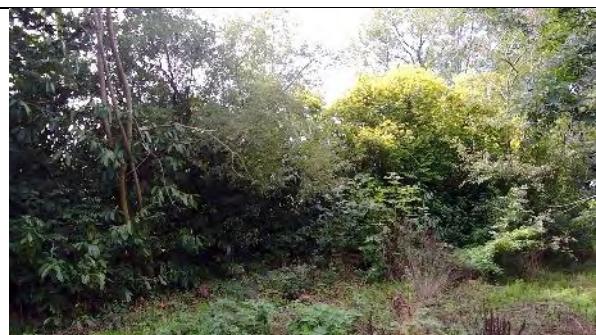
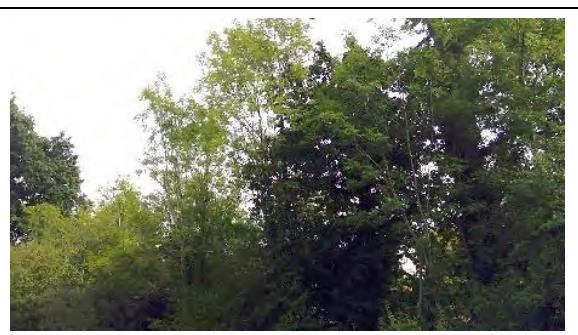
<p>TG2 - Mixed species group; Blackthorn, Hawthorn, Holly, Ash seedlings, Cherry</p>	<p>TG3 - Mixed species group; Blackthorn, Hawthorn, Holly, Ash seedlings, Cherry, Elm</p>

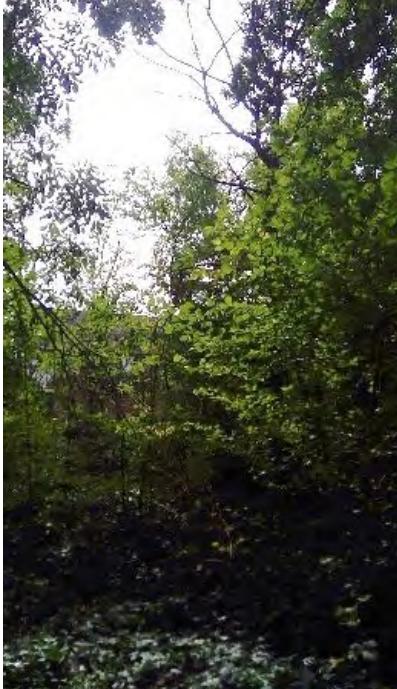
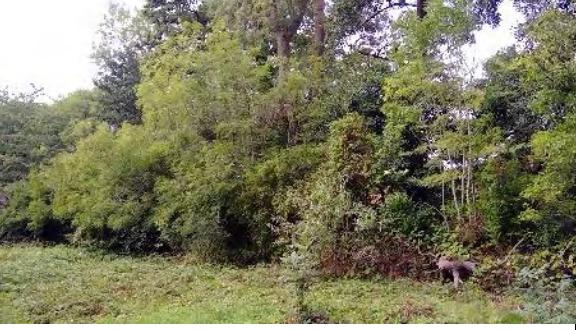
<p>TG4 - Mixed species group; Hazel, Blackthorn, Hawthorn, Holly, Ash seedlings, Cherry, Elm</p>	<p>TG5 - Mixed species group; Blackthorn, Hawthorn, Holly, Ash seedlings, Cherry, Elm</p>

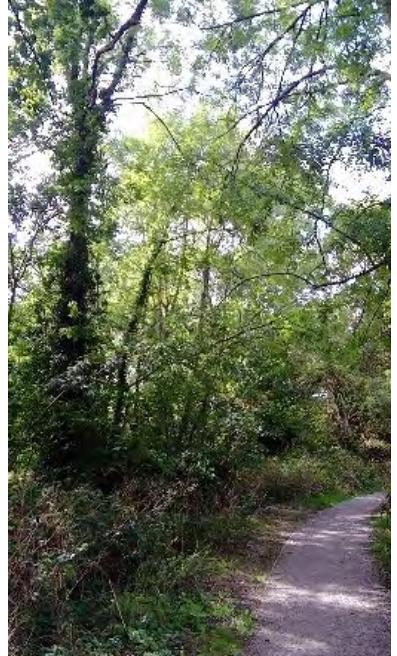
<p>TG6 - Mixed species group; Sycamore, Ash, Elm</p>
