**Demolition Works at**

**501-504 Stone Close,  
West Drayton  
UB7 8JU**

Unit 501  
Stone Close  
Horton Road  
West Drayton  
UB7 8JU

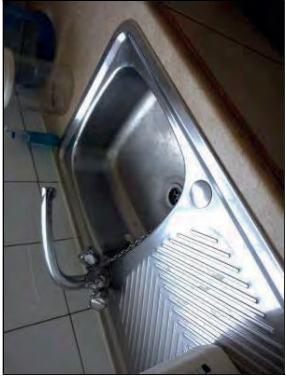
| | Survey Date: | 11 Apr 2017 | Lead Surveyor | Roy Pearce | Survey Type | Refurbishment & Demolition survey | Floor | 1st Floor | Analysis | No Asbestos Detected (0) |
| | Unit 501, Stone Close, West Drayton, UB7 8JU | | Kitchen 104 | | Acoustic Pads to underside of sink unit | | Typical | | | |

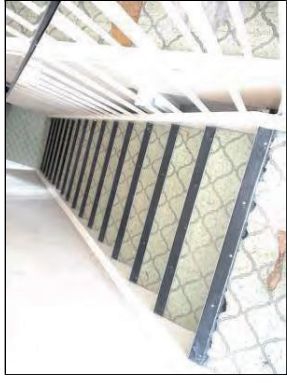
| | Survey Date: | 11 Apr 2017 | Lead Surveyor | Roy Pearce | Survey Type | Refurbishment & Demolition survey | Floor | 1st Floor | Analysis | Chrysotile (1) |
| | Unit 501, Stone Close, West Drayton, UB7 8JU | | Stairwell and Landing 105 | | Stair Nosings to steps | | 16lm | | | |

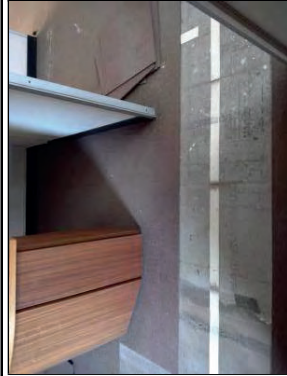
| | 11 Apr 2017 | Roy Pearce | Refurbishment & Demolition survey | Ground Floor | No Asbestos Detected (0) |
| | Building | Room | Item | Quantity | |

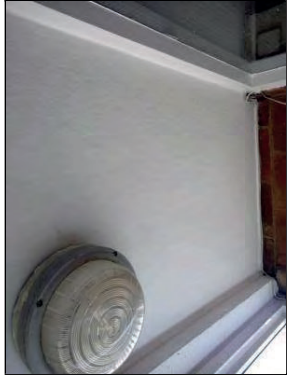
| | Survey Date: | 11 Apr 2017 | Lead Surveyor | Roy Pearce | Survey Type | Refurbishment & Demolition survey | Floor | Ground Floor | Analysis | Chrysotile + Amosite (2) |
| | Unit 501, Stone Close, West Drayton, UB7 8JU | | Entrance Lobby G03 | | Boarding to ceiling | | 2m² | | | |

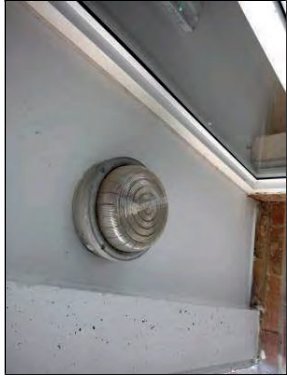
| | 11 Apr 2017 | Roy Pearce | Refurbishment & Demolition survey | Ground Floor | Chrysotile + Amosite (2) |
| | Building | Room | Item | Quantity | |

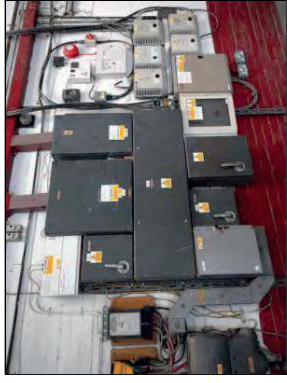
| | 11 Apr 2017 | Roy Pearce | Refurbishment & Demolition survey | Ground Floor | Chrysotile (1) |
| | Building | Room | Item | Quantity | |

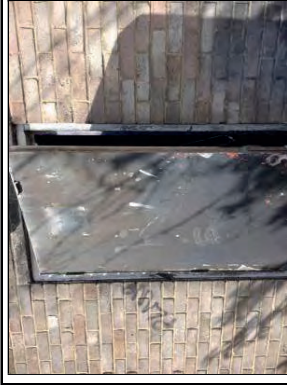
| | 11 Apr 2017 | Roy Pearce | Refurbishment & Demolition survey | Ground Floor | Chrysotile (1) |
| | Building | Room | Item | Quantity | |

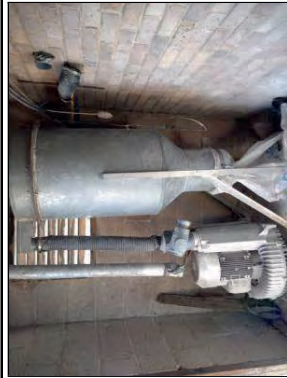
| | 11 Apr 2017 | Roy Pearce | Refurbishment & Demolition survey | Ground Floor | N/A |
| | Building | Room | Item | Quantity | |

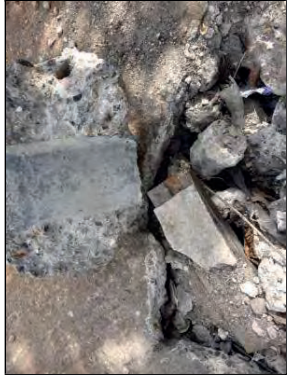
| | 11 Apr 2017 | Roy Pearce | Refurbishment & Demolition survey | External | Chrysotile (1) |
| | Building | Room | Item | Quantity | |

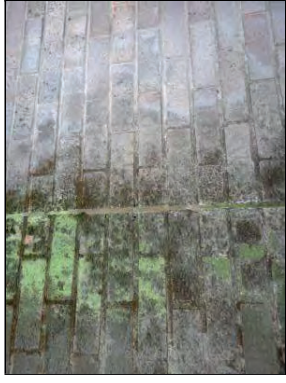
| | 11 Apr 2017 | Roy Pearce | Refurbishment & Demolition survey | External | Chrysotile (1) |
| | Building | Room | Item | Quantity | |
