**CANAL WALL INSPECTION GRAND UNION CANAL
HAYES - LONDON BOROUGH OF HILLINGDON**

ABOVE AND BELOW WATER INSPECTION OF
109M SECTION OF CANAL WASHWALL – GRAND
UNION CANAL HAYES. MIDDLESEX.

JUNE 2021

DIVERS SUMMARY/ REPORT
CANAL WASHWALL – HAYES
GRAND UNION CANAL

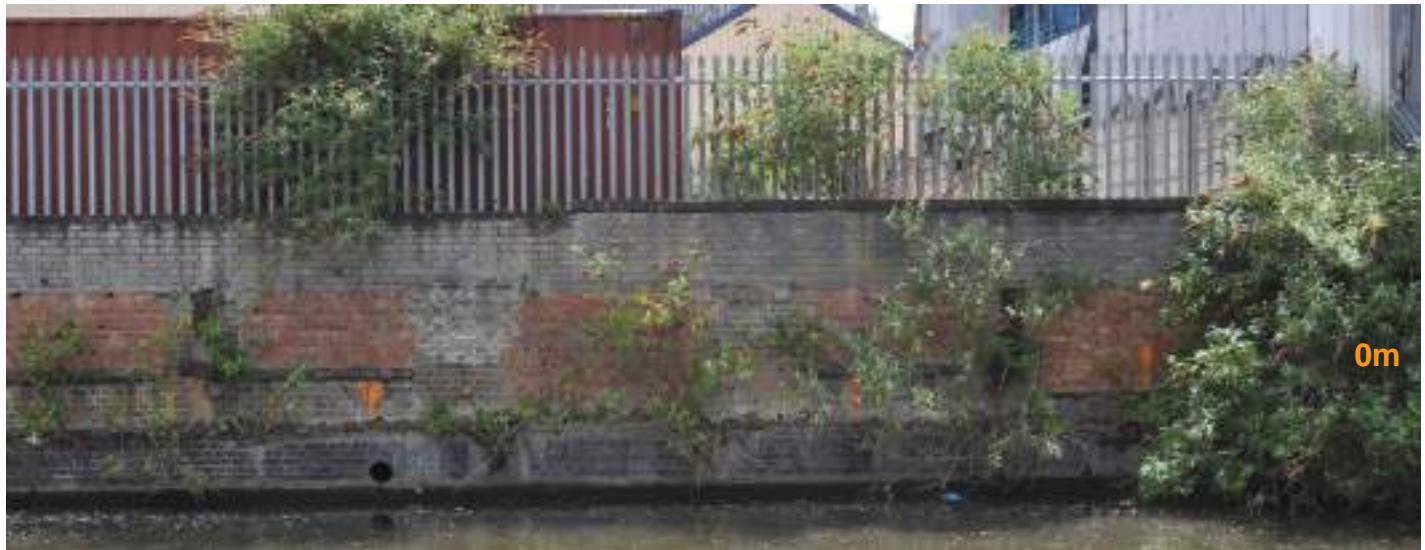
Chainage	Condition Detail	Photography / Detail
0m	Large bush access difficult very soft mud on canal bed. 6.5 courses of blue brick from W/L up - concrete coping insitu 330mm thick from 0m back and forward to chainage 3m.	DSC_2879.JPG DSC_2880.JPG

3.5m	Mooring ring and steel member with round rivet heads (x8) purpose / function unknown (possible wall retaing column) vegetation growing from wall and steel component (Requires De-Veg). Wall loose concrete capping leaving 9 courses blue brick at W/L up to small ledge with eroded bricks - then 6 courses of grey bricks to protruding concrete cill (100mm thick concrete) window bricked up with red brick (eroded bricks) window aperture - back to grey brick 10 courses with brick capping, vegetation at capping level (x2 Bushes) at steel boundary fence. Wall base satisfactory 0m to 7m (progression). 6.6m to 8.5m Concrete cill eroded with bricked up aperture (Red Brick)	DSC_2879.JPG DSC_2880.JPG
9m	Small tree growing from between brickwork 9.m to 11.3m. Redundant window cill.	DSC_2879.JPG DSC_2880.JPG
10m	Discharge drain appears clear 200mm diameter 2 courses above W/L	DSC_2879.JPG DSC_2880.JPG

11.6m	Site of steel member suspect mooring points for barges 1.3m above W/L spalled concrete infill cover.	DSC_2879.JPG DSC_2880.JPG
11.7m	Eroded brickwork adjacent to steel. 12m from W/L to bed defective missing pointing 250mm x 650mm soft mud 12m to 13.8m redundant cill bricked-up window location. 14.8 to 16.75 concrete cill ledge redundant window bricked-up (vegetation needs removing) - Blue bricks present note origional wharfage.	DSC_2879.JPG DSC_2880.JPG

11.6m chainage - Discharge drain appears clear 200mm diameter. Site of steel member suspect mooring points for barges 1.3m above W/L spalled concrete infill cover.

11.7m chainage - Eroded brickwork adjacent to steel. 12m from W/L to bed defective missing pointing 250mm x 650mm soft mud 12m to 13.8m redundant cill brickedup window location. 14.8 to 16.75 concrete cill ledge redundant window bricked up (vegetation needs removing) - Blue bricks present note original wharfage.

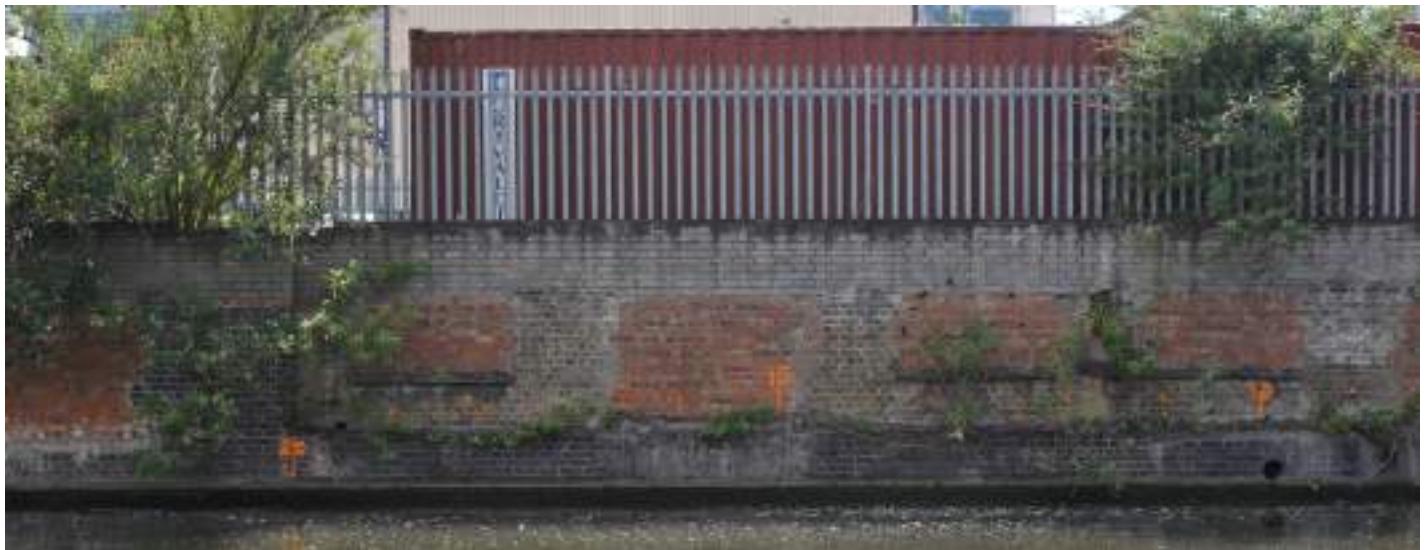
Chainage	Condition Detail	Photography / Detail
17.7m	17.7m to 19.5 Redundant cill bricked up window red bricks	DSC_2881.JPG
19.6m	Tree growing from brickwork needs removal	DSC_2881.JPG
20m	Wall alignment change by 180mm out towards canal - blue brick	DSC_2881.JPG
21m	Mooring ring location tree growing out - Requires Removal Defective mortar joint at W/L 21m to 22m Top 10 courses of brickwork pushing out at the top and leaning in towards canal suspected cause tree pushing root formation. Also defective joints at W/L 450mm.	DSC_2881.JPG

21m chainage - Mooring ring location tree growing out - Requires Removal
Defective mortar joint at W/L 21m to 22m Top 10 courses of brickwork pushing out at the top and leaning in towards canal suspected cause tree pushing root formation. Also defective joints at W/L 450mm.

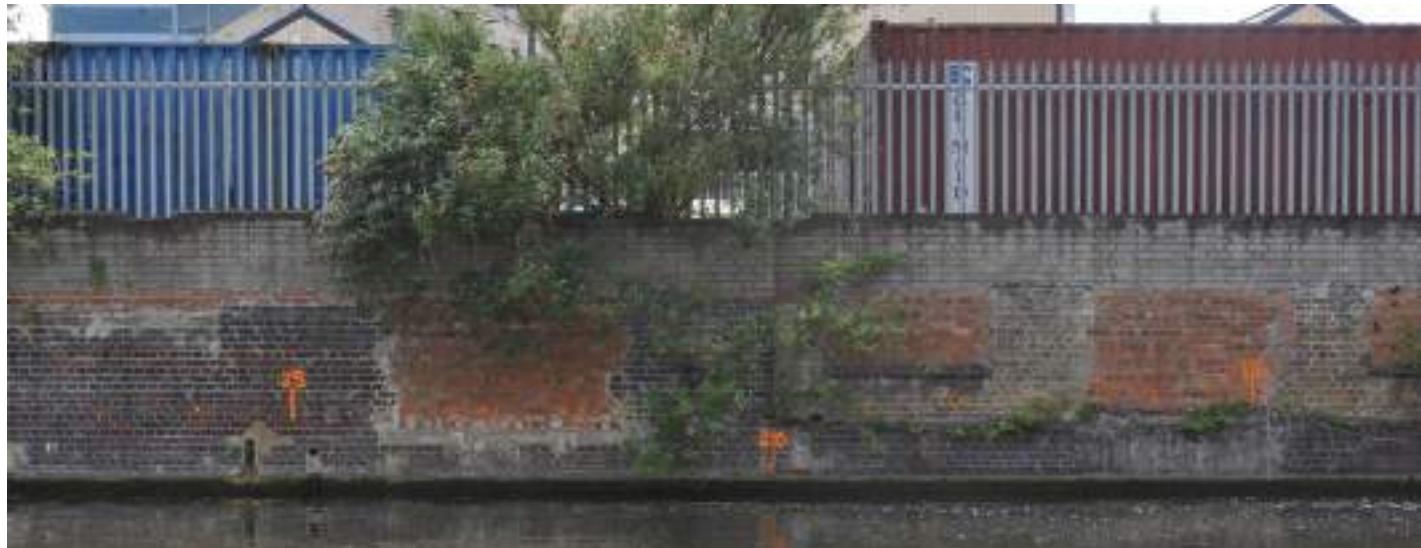
Chainage	Condition Detail	Photography / Detail
19m	19m to 24m Redundant cill 6 courses above W/L bricked up window	DSC_2882.JPG
22.5m	22.5m to 22.65 Defective joints with erosion of brickwork 100mm high x 100mm long x 2 courses down from W/L	DSC_2882.JPG
24.9m	Defective mortar joints from 2 courses below W/L to 4 courses above W/L at site of 100mm diameter drain discharge blocked at 450mm	DSC_2882.JPG
25.7m	2 x capping / coping stones in position 21 courses from underside to W/L dangerous misalignment to 30m chainage.	DSC_2882.JPG DSC_3210.JPG DSC_3217.JPG DSC_3219.JPG
26m	Some petrification and discolouration in blue bricks 13 to 21 courses above W/L	DSC_2882.JPG Detail Fig 17.

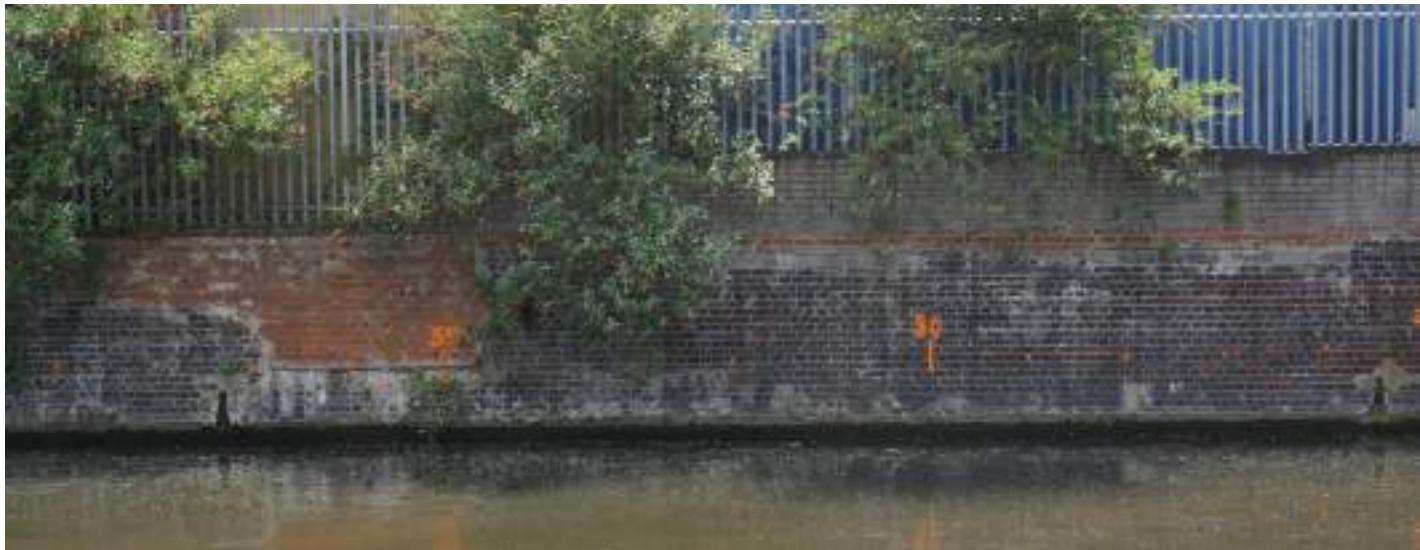
Chainage	Condition Detail	Photography / Detail
29m	26m to 29m Some petrification and discolouration in blue bricks 13 to 21 courses above W/L	DSC_2883.JPG
30m	30m to 32.8m 2 x capping stones in position 21 courses above W/L (Blue Bricks)	DSC_2883.JPG
34m	Mooring ring (Eye Bolt) 17 courses of bricks above W/L - Tree present at backplate. 33m - 34m 9 -10 courses of bricks missing from top of wall. Wall steps down.	DSC_2883.JPG
34.7m	Site of bricked up redundant window and redundant sill (Concrete) patched up into adjoining blue brick section to 39m.	DSC_2883.JPG
35.2m	Misalignment of brickwork protruding 20mm recessed back 3 courses. Bricks on canal bed adjacent and to foot of wall to 36.9m.	DSC_2883.JPG
37m	Tree roots at W/L 2 courses below and 2 courses above W/L 2 bricks wide. 37m to 38m Irregular alignment - erosion damage face of bricks.	DSC_2883.JPG

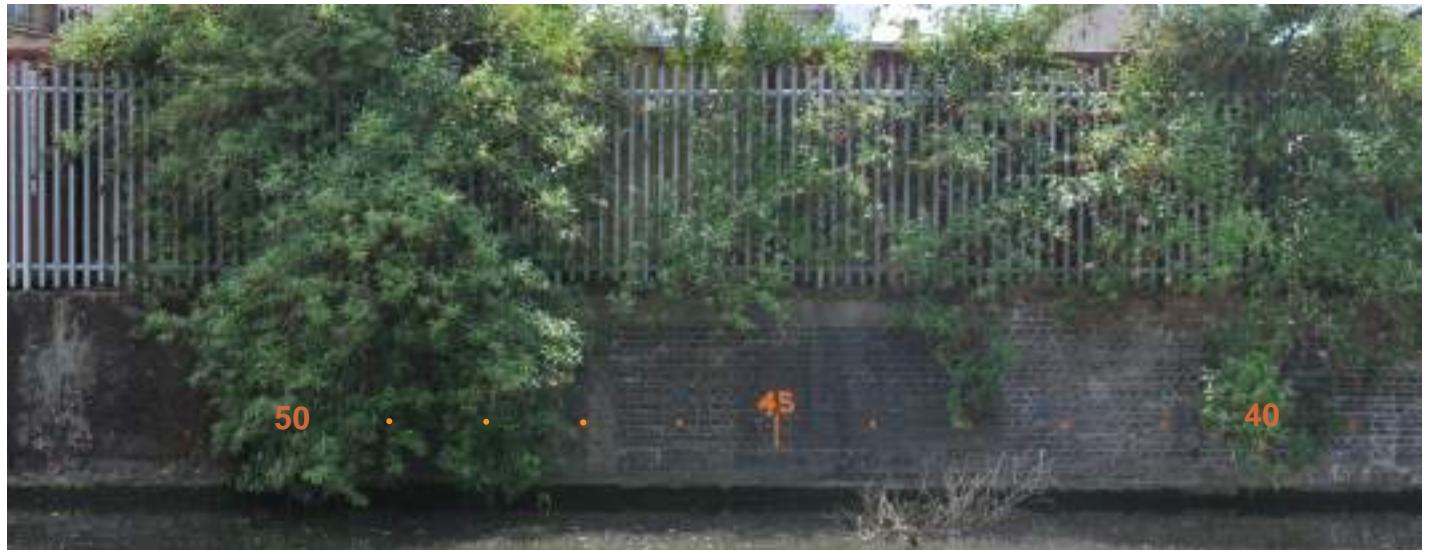
Chainage	Condition Detail	Photography / Detail
40m	Missing Mortar 2 bricks at W/L.	DSC_2885.JPG
41.6m	Hole drilled into brickwork (possible mooring area) No Ring 0.4m only spalled face 100mm x150mm	DSC_2885.JPG

42.1m	Tree to 46m missing mortar at W/L and above 2 courses bel W/L 3 courses.	DSC_2885.JPG
43m	40m to 49.5m trees ontop of wall irregular brickwork (spalled).	DSC_2885.JPG
48m	48m to 43m trees pushing out of alignment and perpendicular section of wall and end coping at interface of (Change of construction - to Concrete).	DSC_2885.JPG

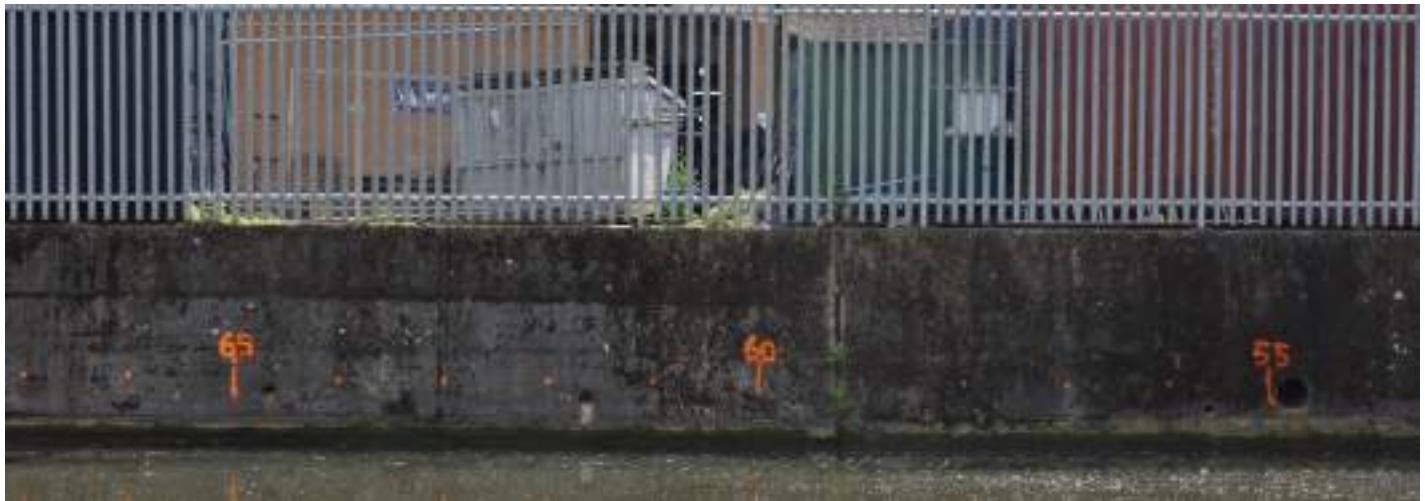
Chainage	Condition Detail	Photography / Detail Fig Ref.
54.8m	300mm diameter Salt Glazed Drain. (Datum Point 380mm invert to W/L) at time of survey. 55m to 57.2m Boulder stones debris in water course at toe of wall (Wall Sat).	DSC_2887.JPG
55m	55m to 57.2m Boulder stones debris in water course at toe of wall (Wall Sat).	DSC_3234.JPG
59.2m	Construction joint (vertical) with expansion joint material displaced at W/L upto 400mm - (Below water material missing to bed level gap 65mm.	DSC_2887.JPG
60.5m	Ring in wall for grab chains. Wall toe sticking out - all satisfactory upto 63m small toe reduces to 10mm.	DSC_2887.JPG
71.2m	Vertical construction joint with tree in place 300mm at W/L growing in joint displaced expansion joint material - Gap from bed level up to 400mm above W/L to tree location.	DSC_2887.JPG

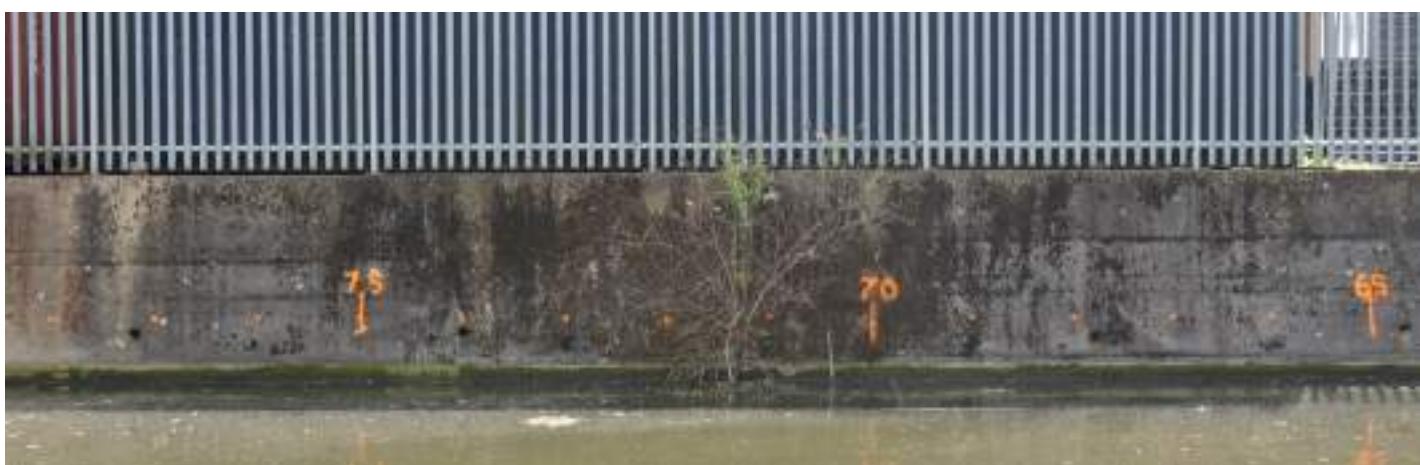
Chainage	Condition Detail	Photography / Detail Fig Ref.
78.6m	Ring in wall with detached chain in position to 109m upto this point all missing.	DSC_2888.JPG

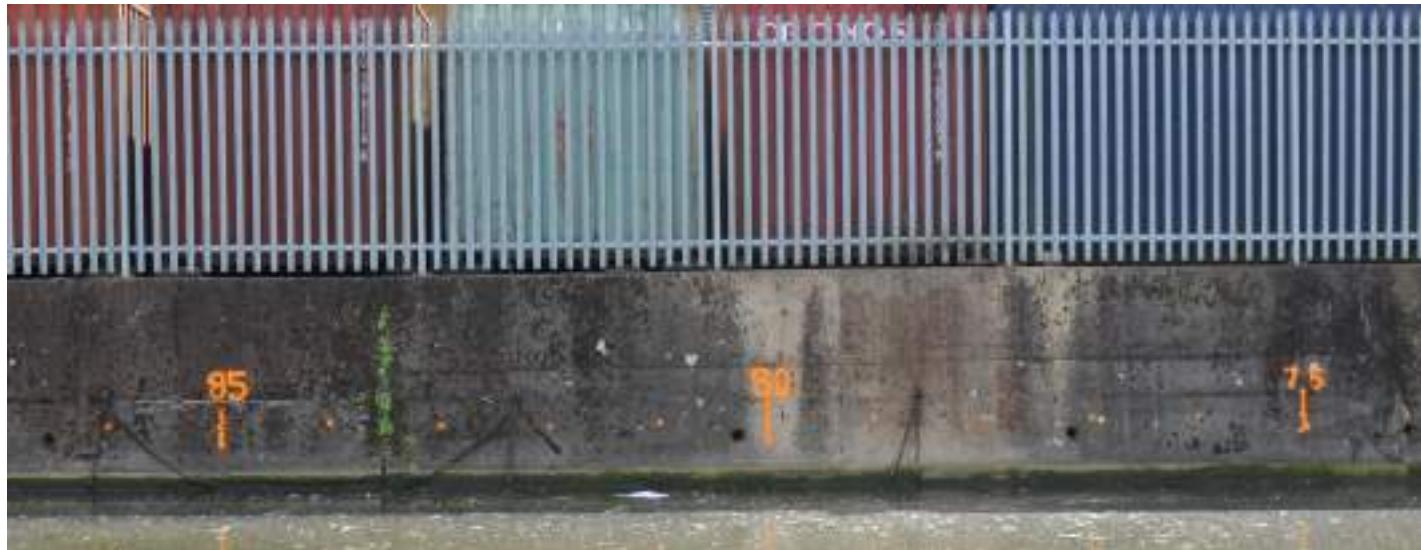
Chainage	Condition Detail	Photography / Detail Fig Ref.
83.3m	Construction joint (vertical) displaced expansion joint material from 150mm at W/L to bed level. From Construction joint at 83.5m to chain ring loop at 86m evidence of weepage at pour joint - slight spalling and petrification.	DSC_2889.JPG
85m	Debris steel tubing - on bed 10mm sticking out plinth along wall at base all satisfactory.	DSC_2889.JPG

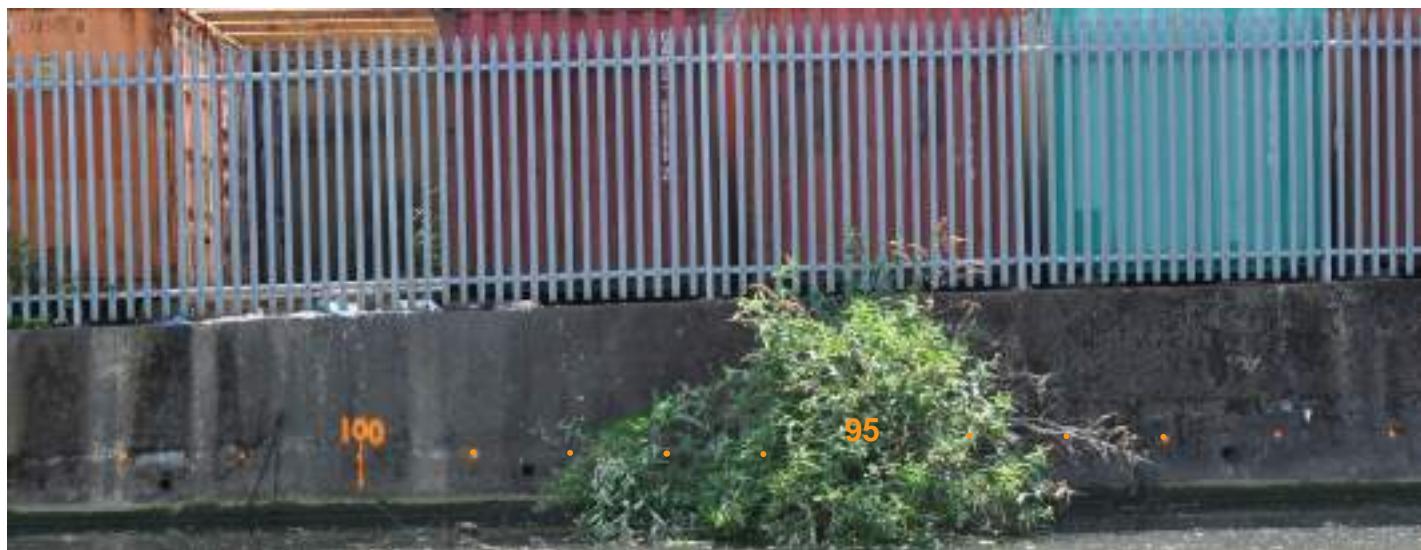
Chainage	Condition Detail	Photography / Detail Fig Ref.
95.9m	Vertical construction joint (in centre of Bush) 150mm above W/L to bed level.	DSC_2892.JPG

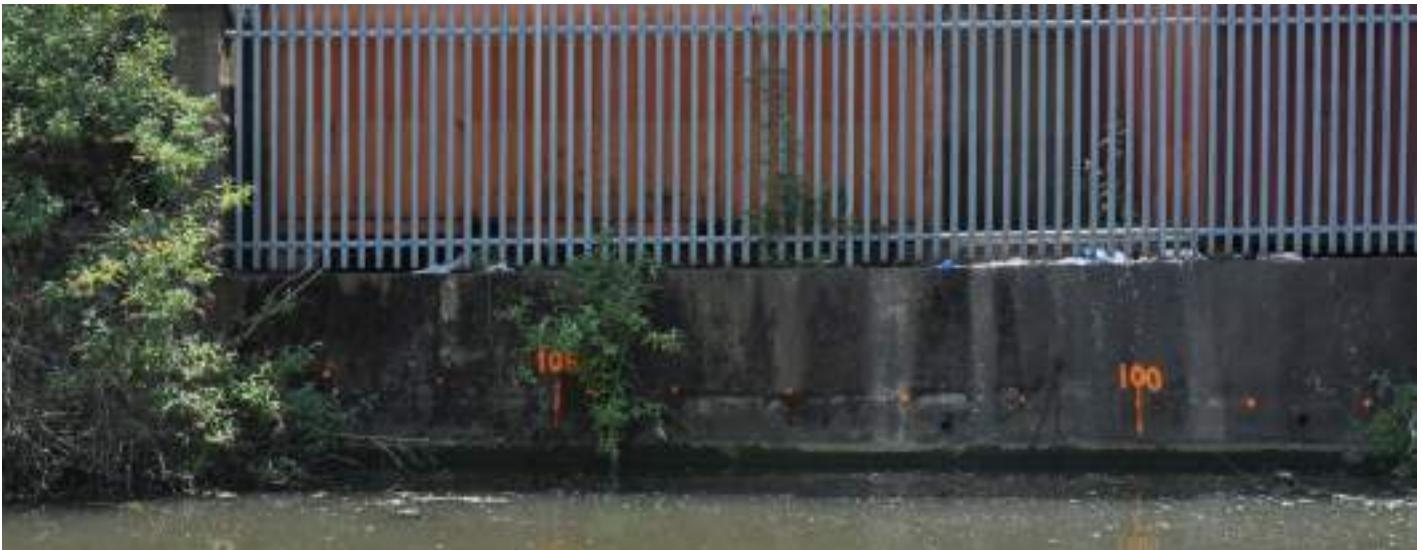
Chainage	Condition Detail	Photography / Detail Fig Ref.
106.9m	Wall angles back into banking 150mm towards Boundary end point.	DSC_2893.JPG
108.1m	Start of chain ring loops 35mm steel O bar. At corner tree growing from over boundary line pushing top 12 courses of bricks out of perpendicular - extension foundation block cast in site to accomodate boundary wall on concrete "Pad Stone" Boundary wall constructed of grey brick. Angle brackets at top carrying barbed wire boundary wall 29 courses of bricks and 4 inch (100mm) "Pad Stone".	DSC_2893.JPG

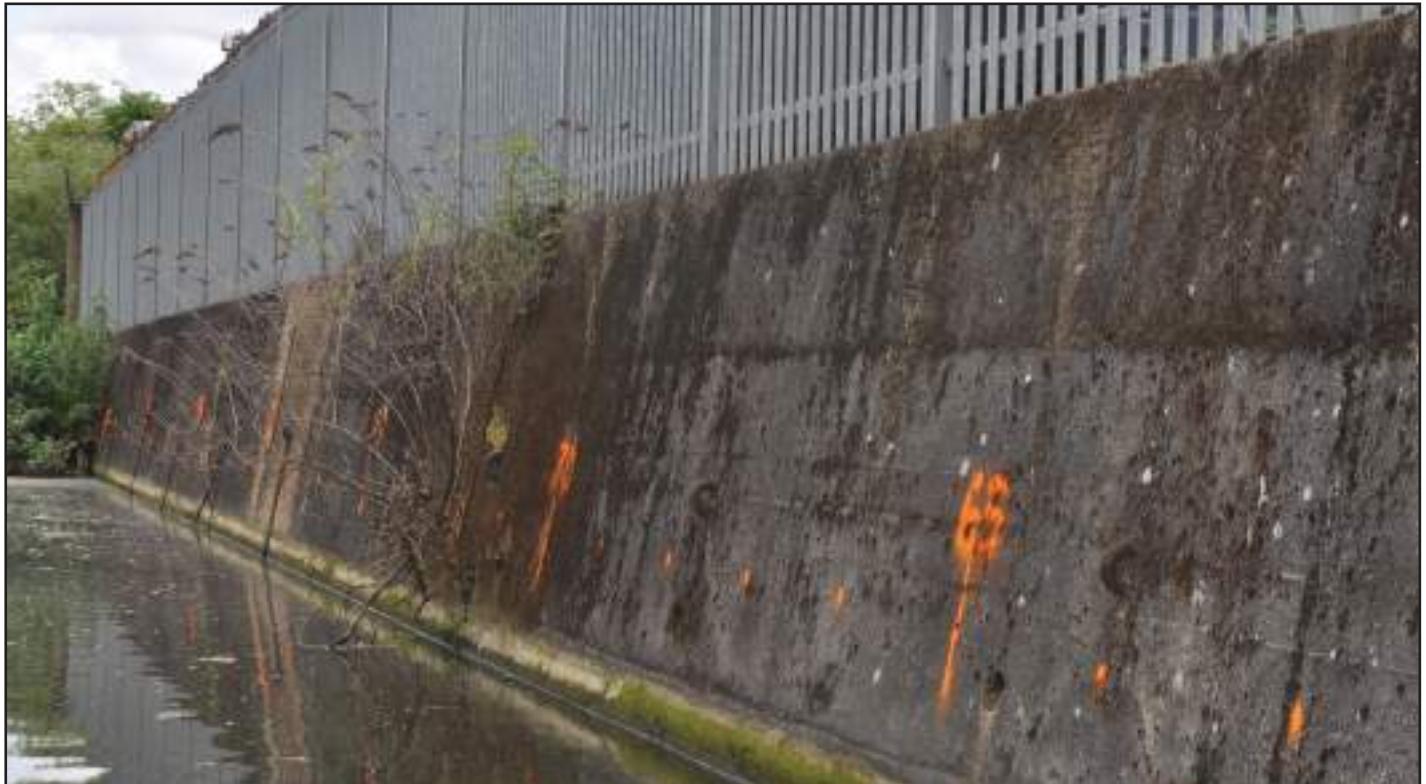
Fig.42A

50m to 109m chainage - General view of Wall angles back 101° into banking 150mm towards Boundary end point.

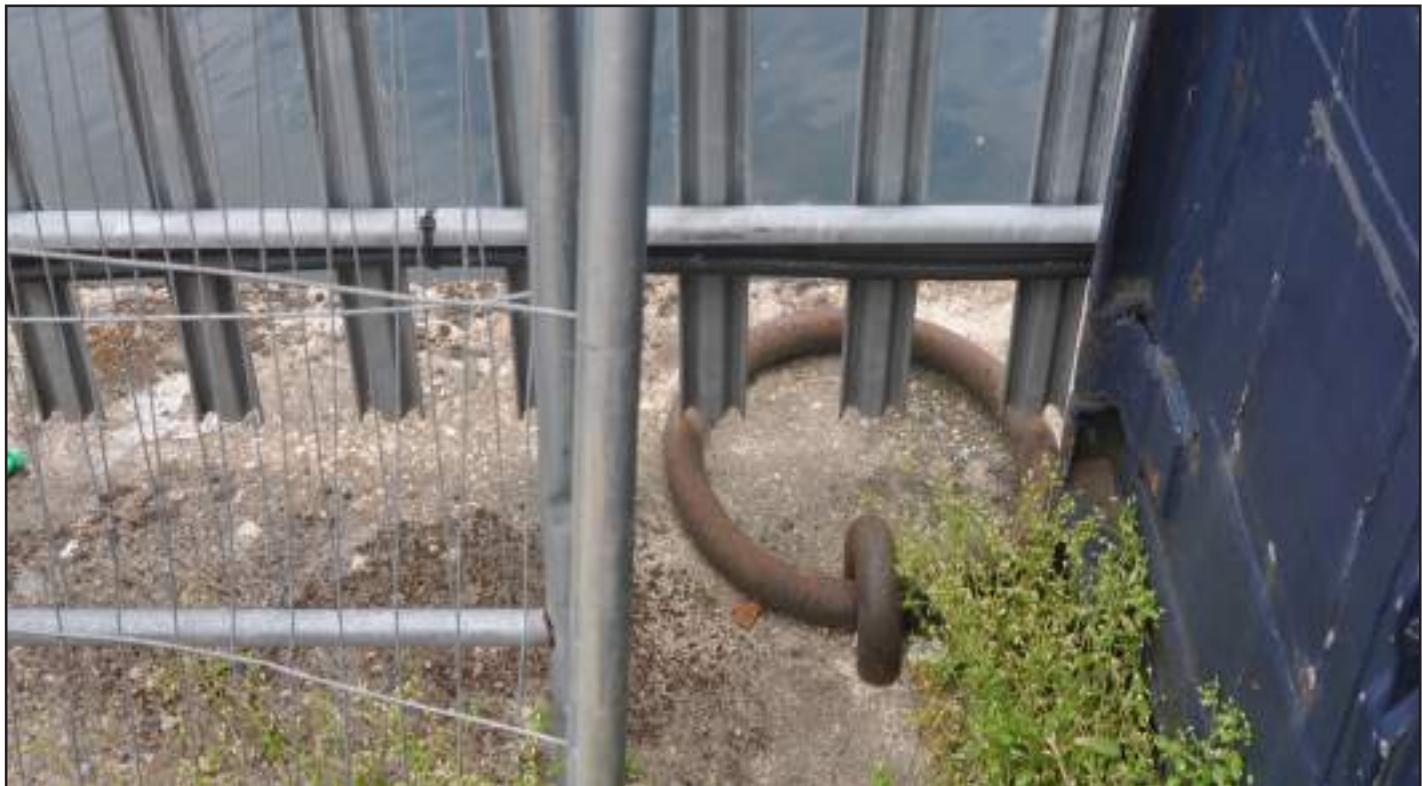
Fig.45
65m chainage - Heavy duty mooring ring on top of wharf.

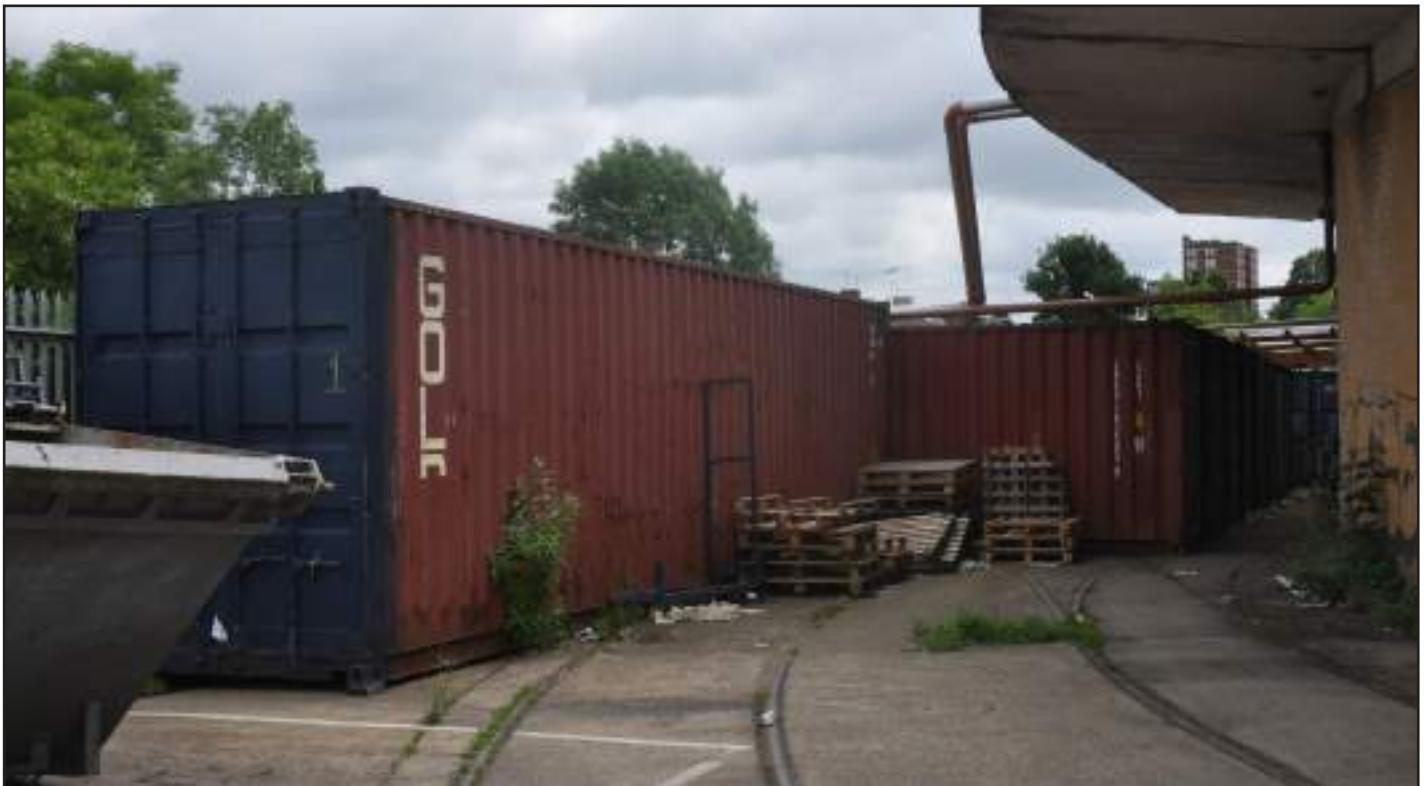
Fig.49

Section 2 is from 50m to 109m. This is of reinforced concrete and slopes back at the top of the wall at a 101 degree angle (see Sketch 1 & fig 42). Storage Sea Containers are in position along this section also preventing access. (see figs 49,50 &51). This section is in a generally satisfactory condition. Construction joints have displaced expansion joint material missing principally on the lower sections and some vegetation is present. (see fig 35)

General view on wharf showing twin railway lines and restricted access due to storage containers.

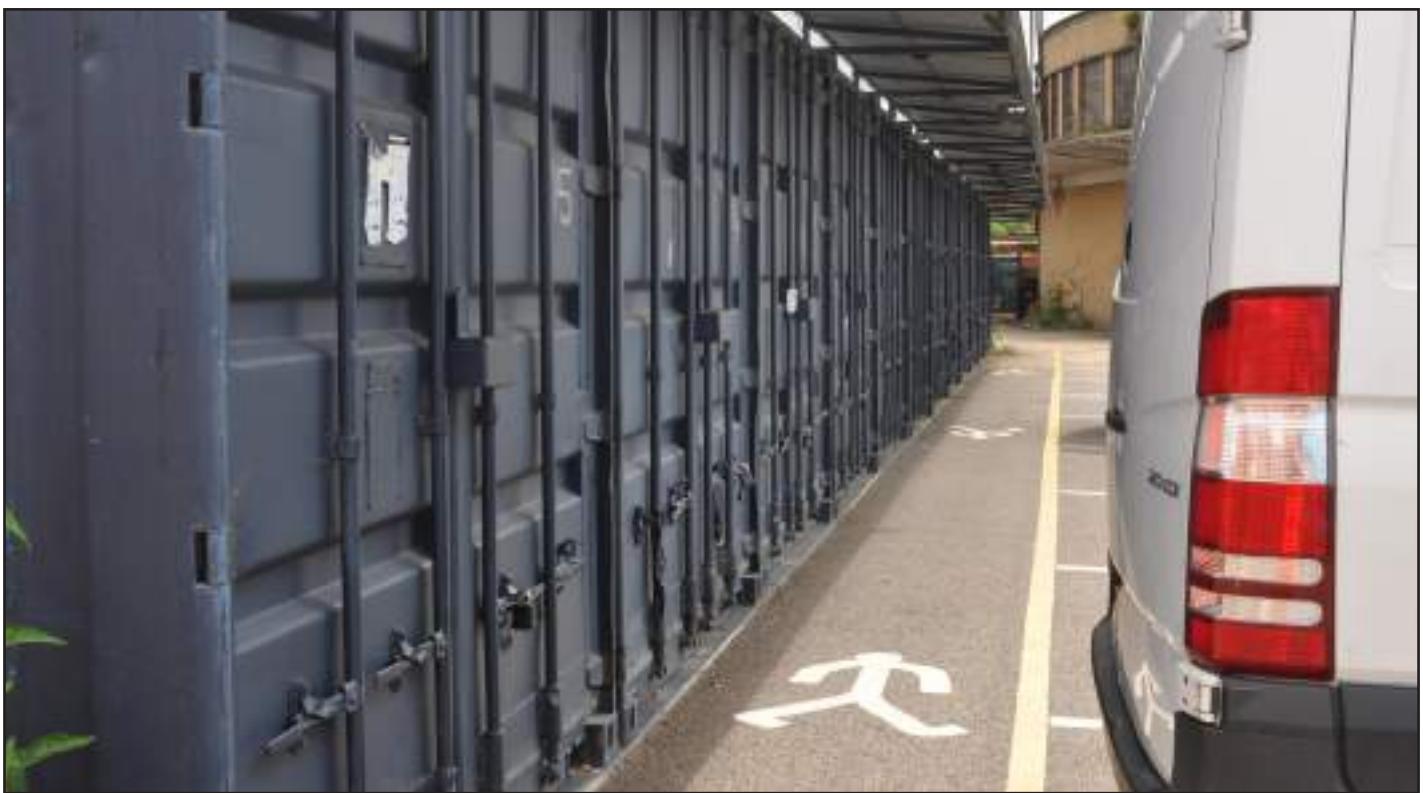
Fig.50

Full row of storage containers along the fence boundary - restricting rear access.

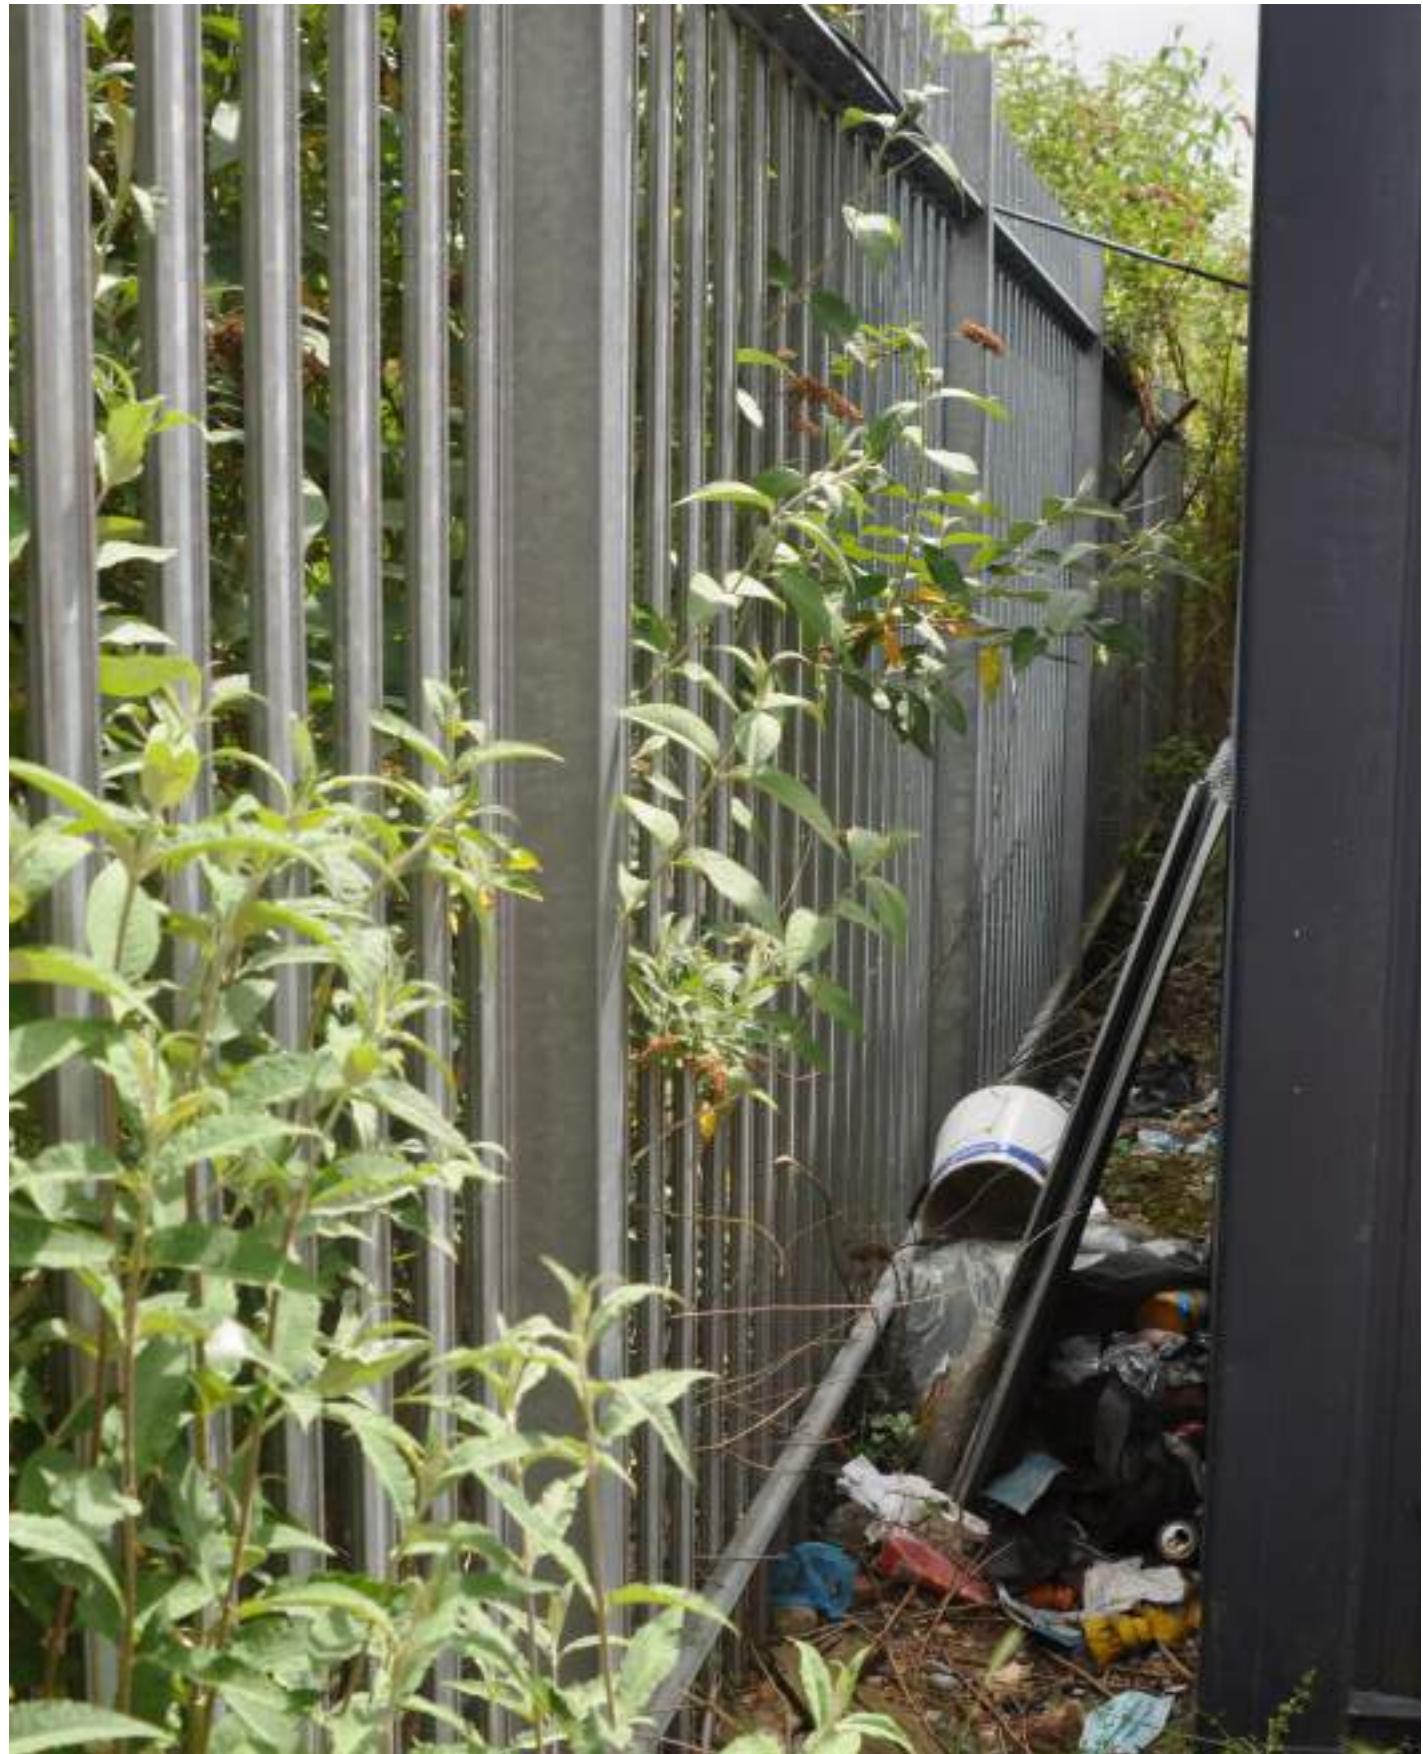
Fig.51

Back side view of containers as seen in Fig 50. Note trees growing on the reverse - canal side wall.
