CONDITION SURVEY AND REPORT ON GATE PIER TO THE SW OF CEDARS  
HOUSE HILLINGDON

REES BOLTER ARCHITECTS  
NOVEMBER 2020

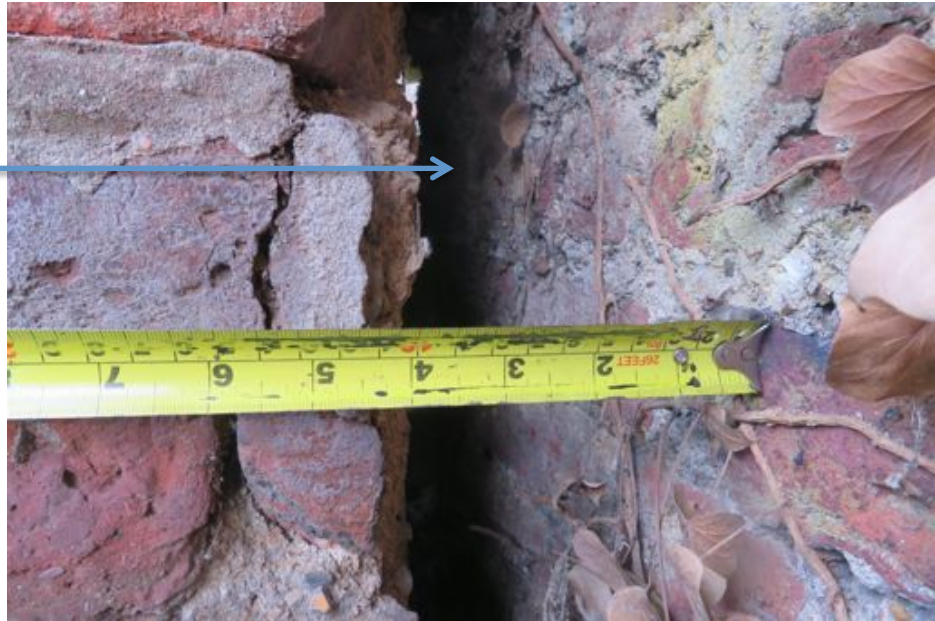
WEST FACE OF THE PIER

WEST FACE, AT LOW LEVEL, LOOKING NORTH.

Gap between the facing skin (left) and the original wall (right). Approx 100mm. Daylight can be seen through the wall.

Sketch plan at mid height of pier showing the extent of voids within the masonry.

The half brick facing skins which form the pier have bulged outwards, resulting in gaps between the brickwork of the east and west faces and the original wall and in significant cracking down the north face.

The bulging on the west side is considerably greater than on the east. Cracking in the infill on the east side indicates that this side is still moving. It is remarkable that the brickwork on the west side has not already collapsed. Any attempt at repair is likely to result in the loss of that section.

After considering the limited significance of the brickwork of the pier facings in comparison to the significance of the original wall, the health and safety risks in undertaking the work and the risk of failure we recommend that all of the facing brick skins should be rebuilt. The scope of work would then be

- Carefully take down the facing skins, including the solid pier and ball cap above.
- Investigate foundations and cast additional concrete pads if needed.
- Insert Helifix DryFix ties into the original wall at 300mm centres.
- Reconstruct the half brick skins and solid pier above, building in the Helifix ties. Reset the ball cap
