**Report on  
Structural Inspection  
at  
18 Roker Park Avenue, Ickenham UB10 8ED**

Ref: 015724/KC

Date: 04.08.2022

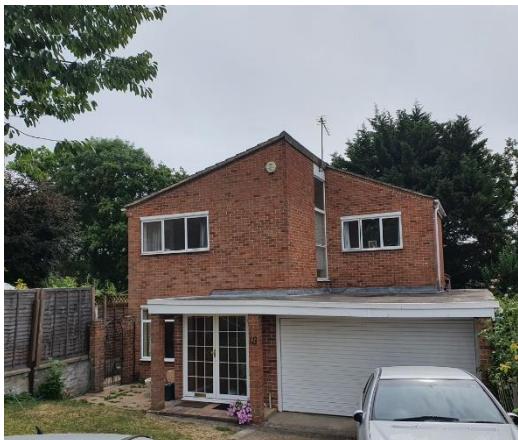
Front Elevation View of property

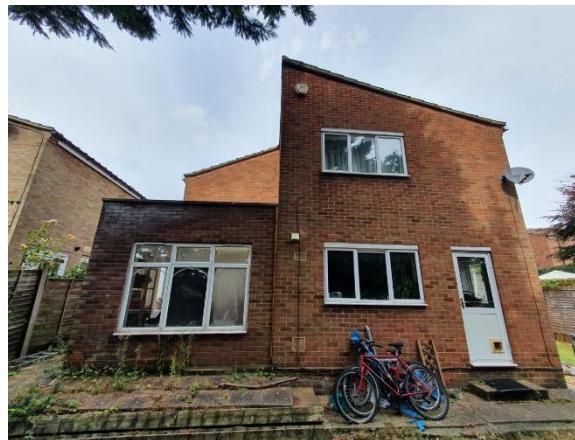
Rear Elevation View of property

- 2.8 There are two hairline cracks on the rear external walls of the main house. These cracks appear at the bottom corners of the window and run diagonally to the ground. crack widths range from 0.5mm to 2mm when viewed externally.
