TREE SURVEY - HEALTH & SAFETY

Proj. No 10077	7 Ravenscourt Close, Ruislip, Middlesex, HA4 7PP	
Client:	David Morrow	
Date of Report:	03/03/2023

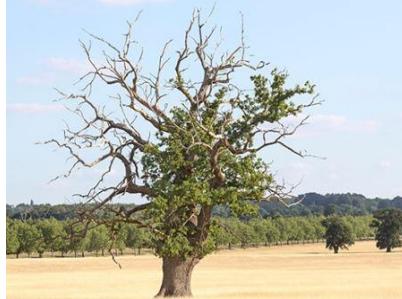
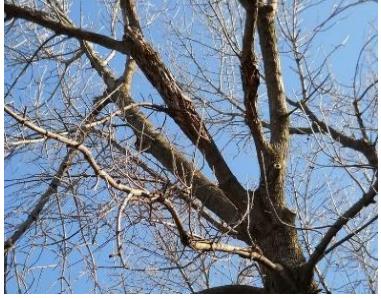
Name: Deadwood	
Symptoms/damage type and cause:	This relates to dead branches in the crown of the tree. In most cases, this is caused by the natural ageing process of the tree or shading due to its proximity to neighbouring trees. However, in some situations, it may be related to fungal, bacterial or viral infection.
Consequence:	Depending upon the location and mass of dead wood removal of the affected tissue may be necessary to prevent harm to persons or property as the wood will become unstable as it decays and in some circumstances is likely to fall from the tree with little or no warning.
Control:	Detailed monitoring should be undertaken on those trees showing signs of excessive deadwood production to identify the underlying cause.
Species affected:	Most tree species.
Images:
