Site Investigation Report

144286.1.USI

Auger were commissioned by Crawford & Co to undertake a site investigation and CCTV inspection of the underground drainage within the area of concern (AOC) at the property.

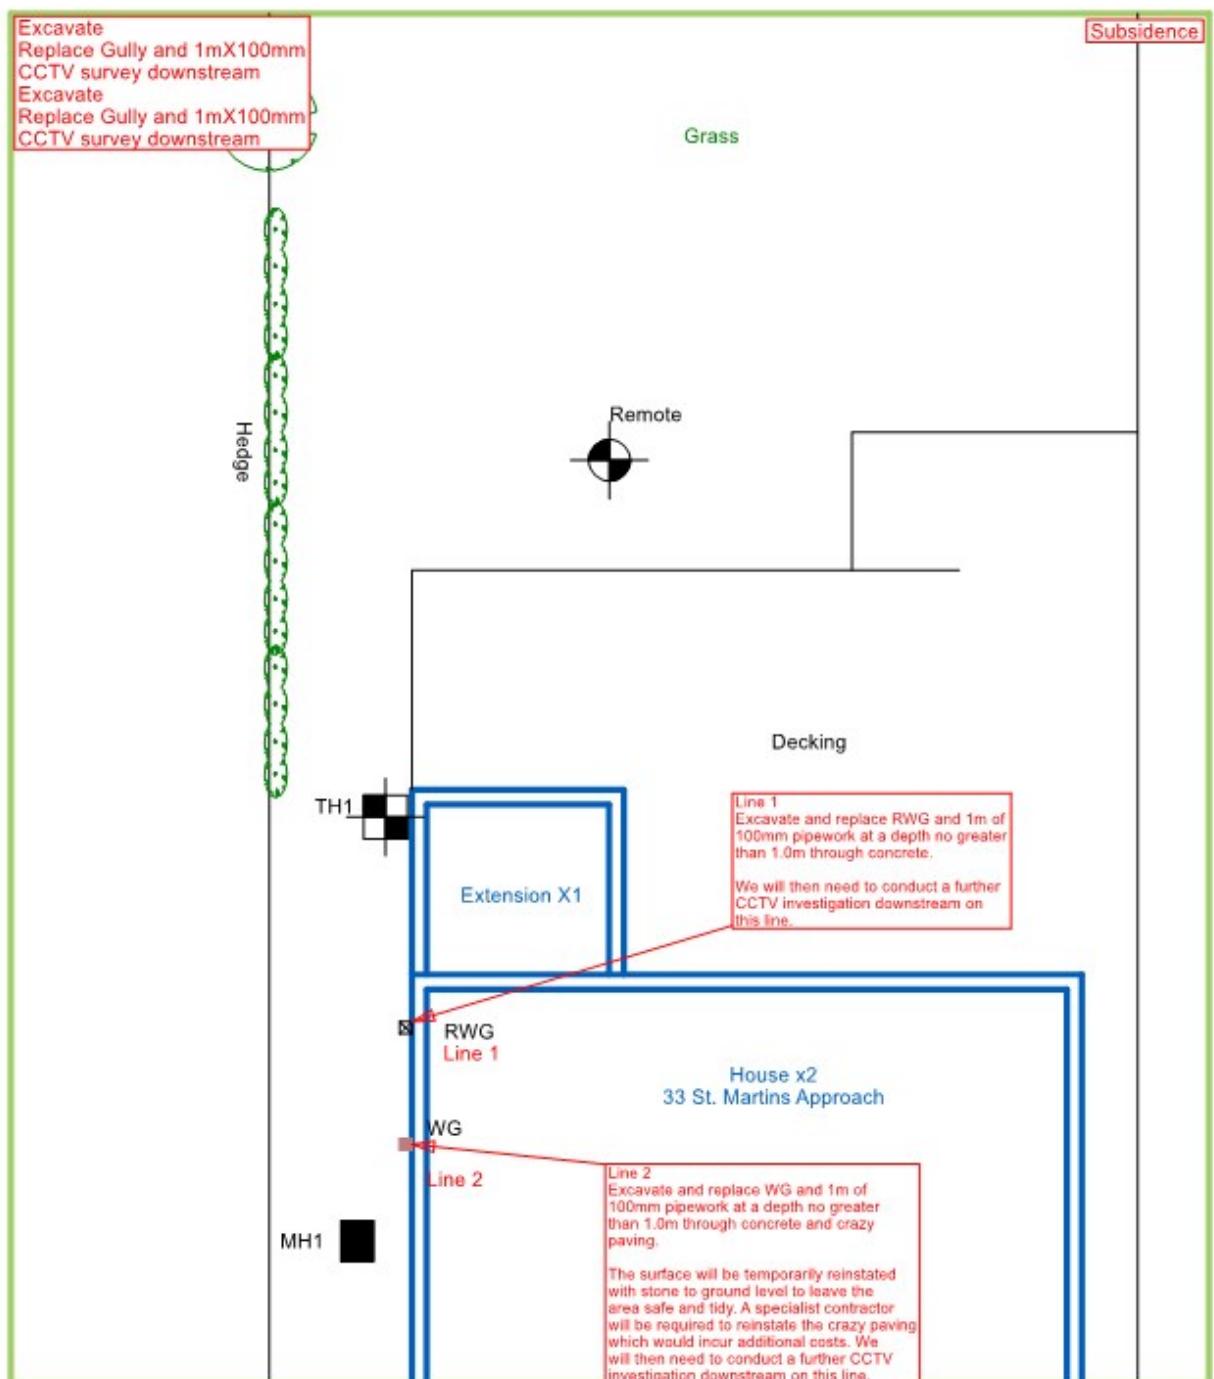
A visual inspection of the site revealed WG, which was noted to serve foul water, and RWG have sunken/ are displaced and both are leading to water escaping to the surrounding ground.

The visible defects identified are affecting the function of the system.

Refer Back to Client	<p>It is recommended that the following repairs are carried out to prevent an escape of water from the system:</p> <p>Line 1 Excavate and replace RWG and 1m of 100mm pipework at a depth no greater than 1.0m through concrete. We will then need to conduct a further CCTV investigation downstream on this line.</p> <p>Line 2 Excavate and replace WG and 1m of 100mm pipework at a depth no greater than 1.0m through concrete and crazy paving. The surface will be temporarily reinstated with stone to ground level to leave the area safe and tidy. A specialist contractor will be required to reinstate the crazy paving which would incur additional costs. We will then need to conduct a further CCTV investigation downstream on this line.</p> <p>Please note that the further CCTV investigation may reveal additional defects to the drainage system. This will be reported whilst on-site and could potentially cause an increase in repair costs and provide further inconvenience to the customer/occupants.</p> <p>Auger have not allowed or will not be held responsible for any alteration or modification to the above ground drainage following the removal of the existing gully and reinstatement of a new gully. The customer must ensure that the above ground drainage correctly expels into the gully pot and avoids overcrowding the gully with numerous downpipes which could lead to the gully overflowing.</p> <p>During the clean-up/reinstatement process we will endeavour to leave the area we are working in clean and tidy and as close to how we found it as possible. There will always be an element of general debris/mud/waste that will build up in the area which cannot be prevented. There may however be elements of this process that are outside our remit i.e., Repainting or cleaning. If this is the case, then we will need to speak to the customer's insuree to help in this regard.</p> <p>We will now refer the claim back to the client in order to progress the claim.</p>
