ADDENDUM ARBORICULTURAL REPORT

SUBSIDENCE CLAIM

Crawford Reference: 1784863
Insurer Claim Reference: 202209010214

33 St. Martins Approach, Ruislip, Middlesex, HA4 7QH

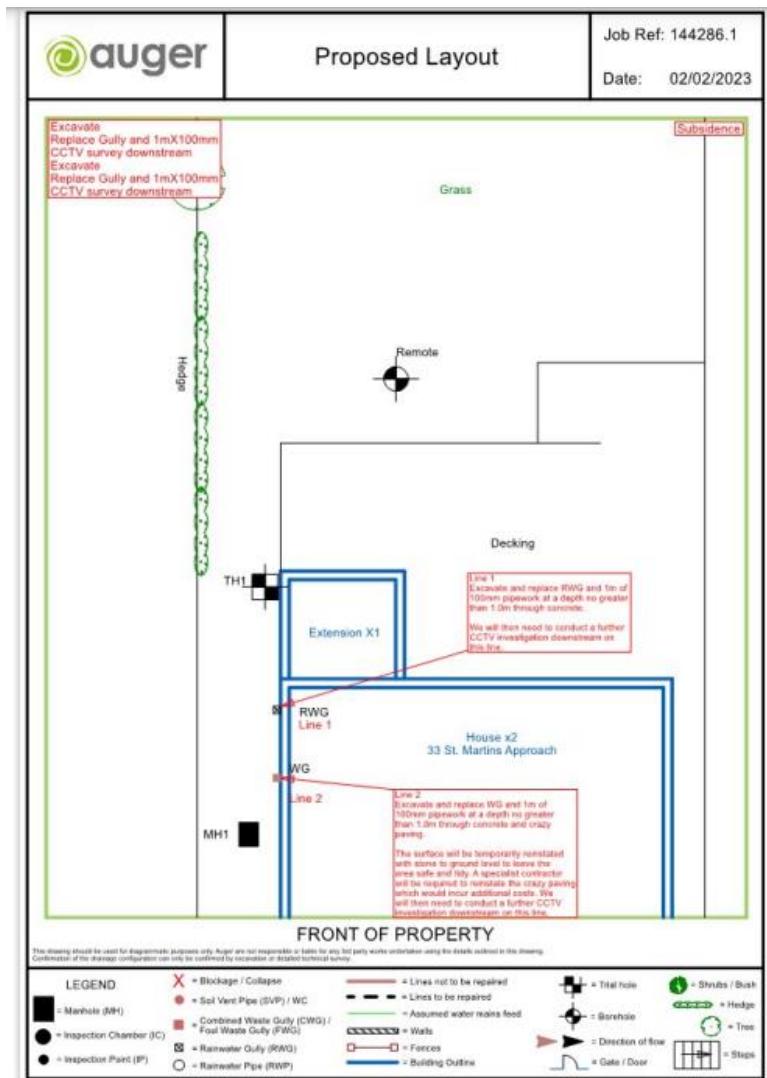
Site investigations confirm 800mm deep foundations bearing on clay that has high plasticity, meaning it can significantly change in volume due to seasonal variations in moisture content, particularly if influenced by tree roots extracting moisture.

Laboratory tests confirm significant desiccation has occurred where roots were observed, the moisture contents being at or significantly less than 0.5x the Liquid Limit, this indicates abnormal soil drying in the presence of tree roots.
