STRUCTURAL INSPECTION  
REPORT  
BARRA HALL, HAYES

December 2024

## BARRA HALL, HAYES

Ridge and Partners LLP  
3 Valentine Place  
London  
SE1 8QH

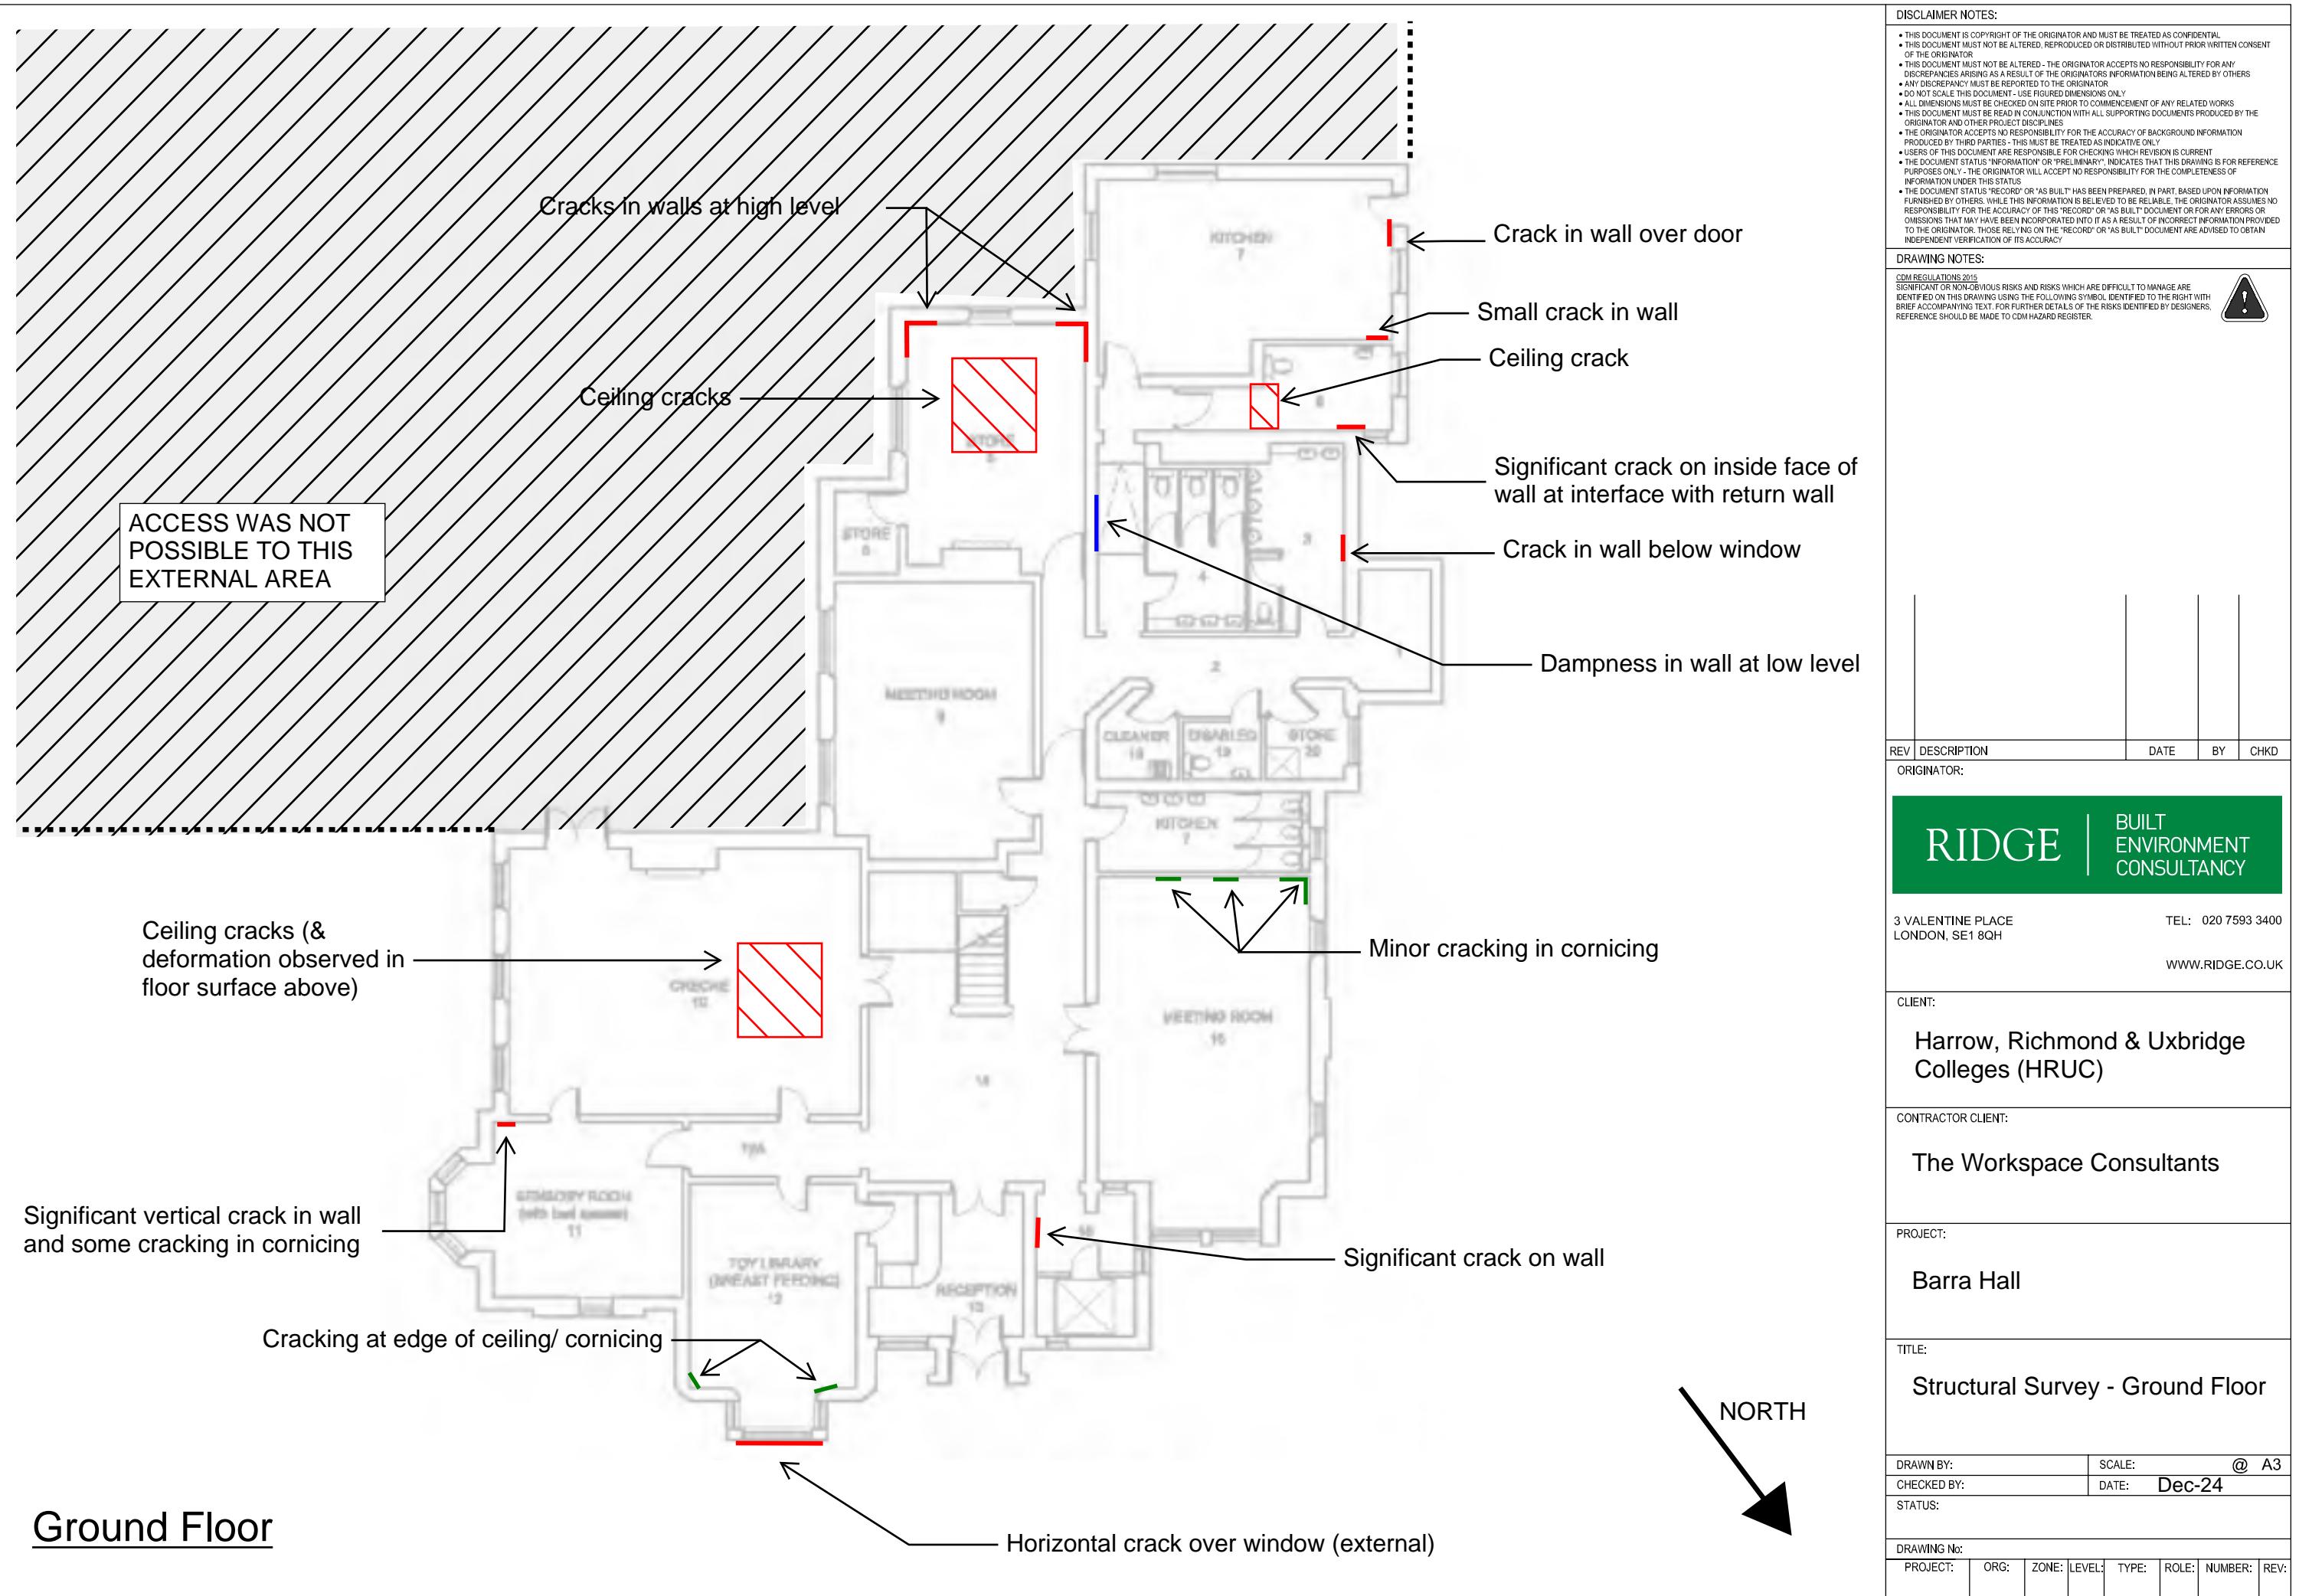
Observation record drawings

The observations are recorded in the drawings that can be found in Appendix 1 of this report.

- The crack locations marked in red on the observation drawings are to be repaired in accordance with BRE253 and using a recognised masonry repair system such as Helifix.
- The masonry over the window at the front elevation (Figure 4) should be exposed to investigate whether the crack is structural or just within the render.
