Tree Safety Survey & Report

St Raphael's Convent
Court Drive
Hillingdon
UB10 0BW

Client:	MCO Group Ltd
Job Ref.:	24 23491 St Raphaels Convent
Survey Date:	05/10/2024
Report Date:	08/10/2024
Rev. No.:	-
Checked By:	AA

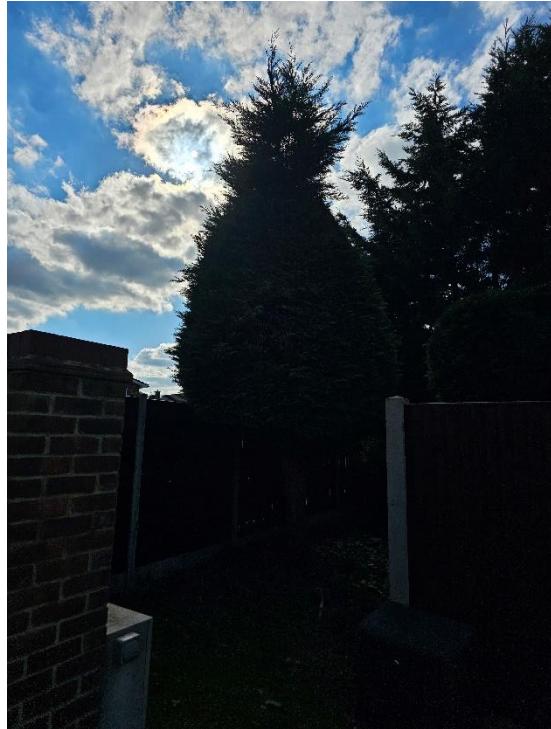
Photograph 26: T30, viewed from the northeast

05/10/2024	28	G	Leyland Cypress	0-5	100-200	Early Mature	1	Subject to regular management, managed as low-level hedge				
05/10/2024	29	G	Leyland Cypress	5-10	100-200	Early Mature	3	No significant recent management, branches close to structure	Cut back to achieve 2m clearance from structure	Routine maintenance	Low	1-Year
05/10/2024	30	T	Leyland Cypress	5-10	200-300	Mature	2	Subject to regular management			Low
