# High Point Village, Hayes

## Façade Remediation Design & Access Statement

Date: 4 August 2023

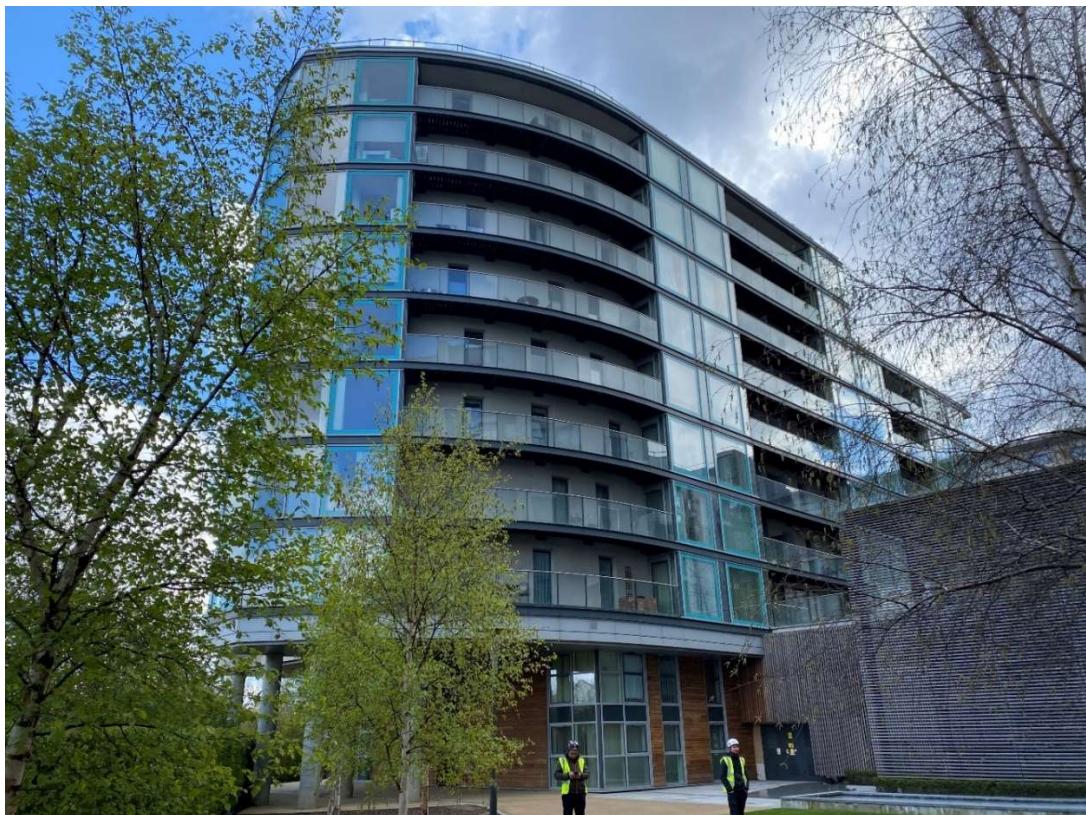
Fig. 5 – View of Block C West Elevation and recessed balconies

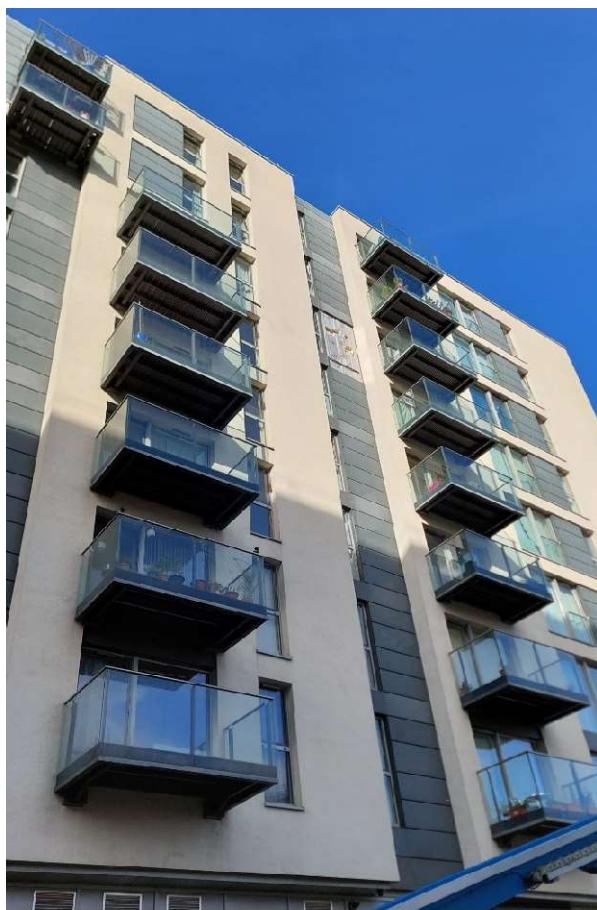
Fig. 6 – View of Block A East Elevation and projecting balconies

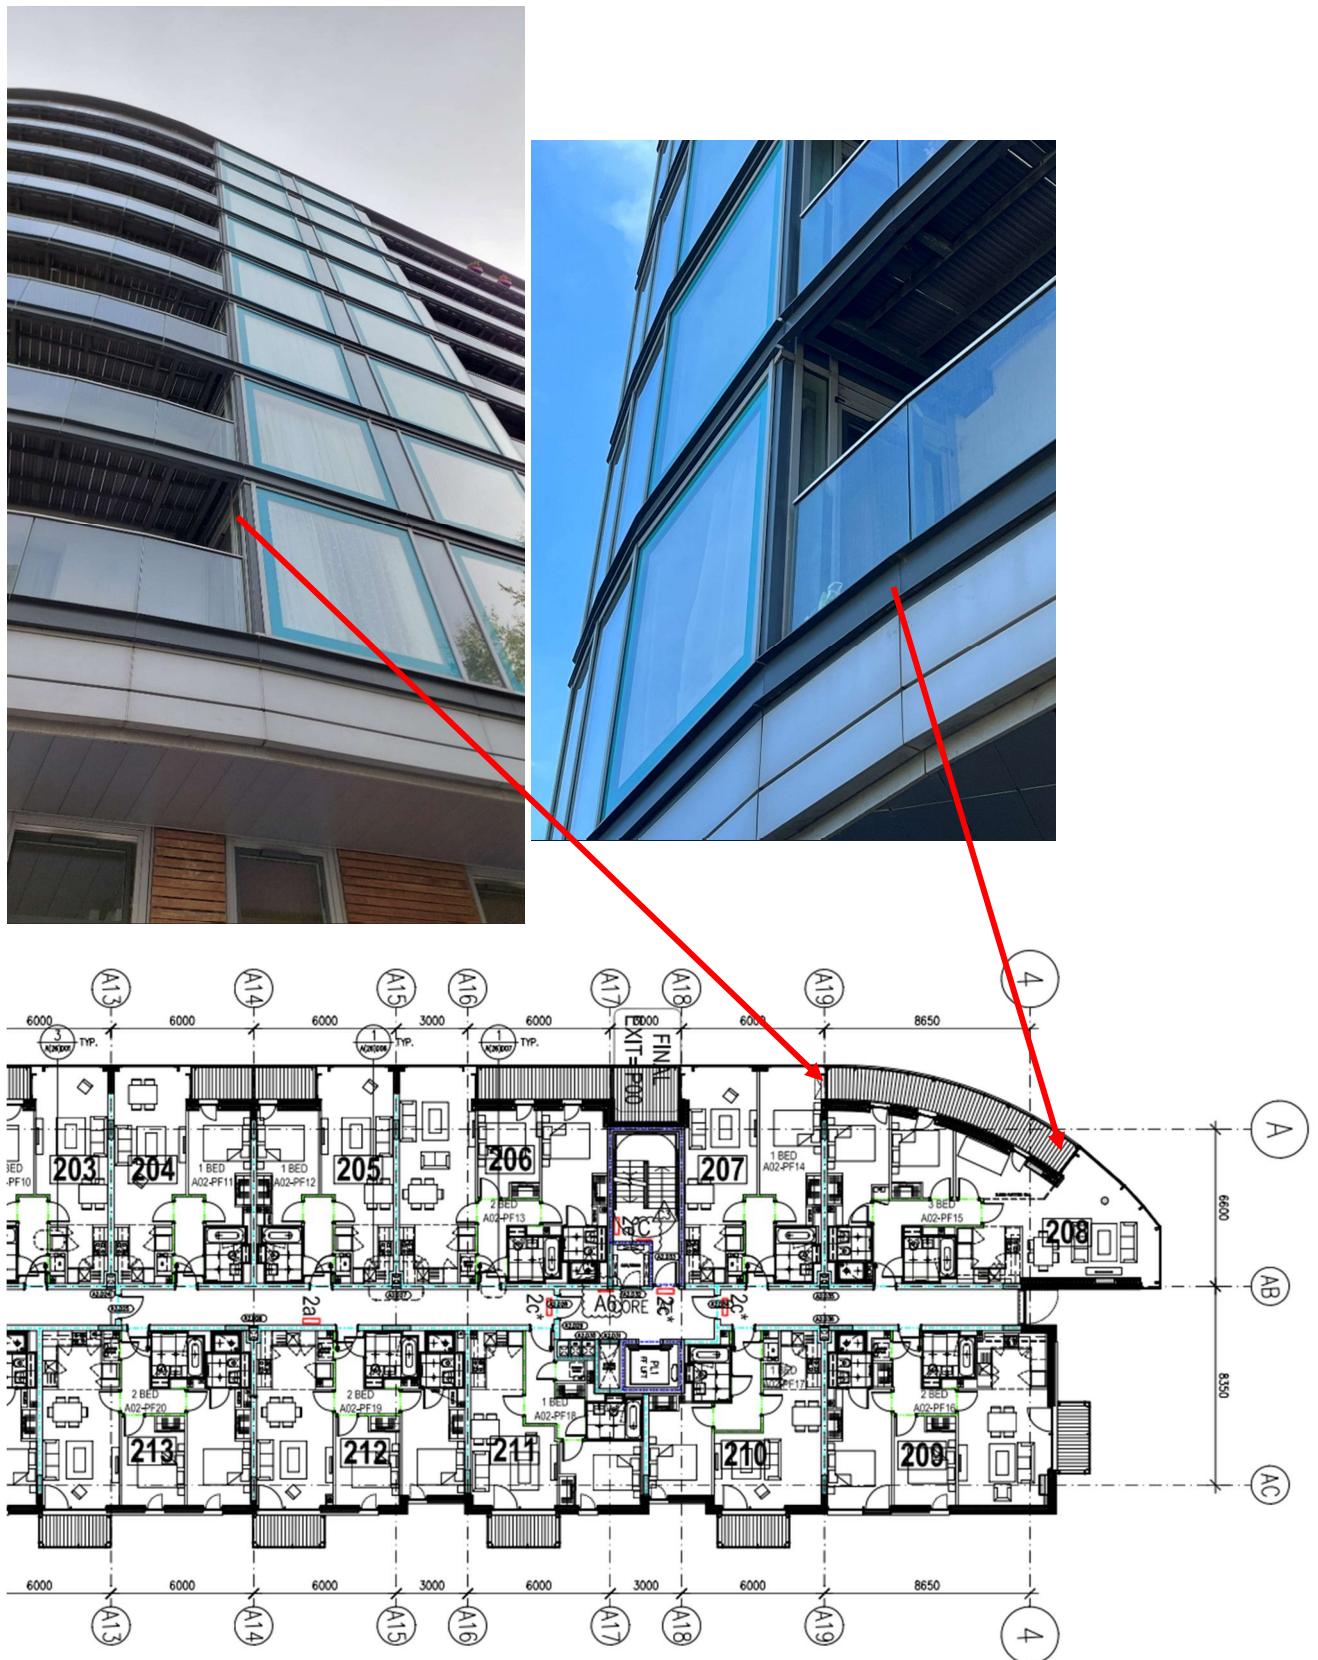
Fig. 7 – View and plan of West Elevation typical recessed balconies

The balconies on the west elevation of Block A are set in from the line of the external wall and will make the viewing of the decking (or underside) hidden from direct sightline (see image in Fig. 1).

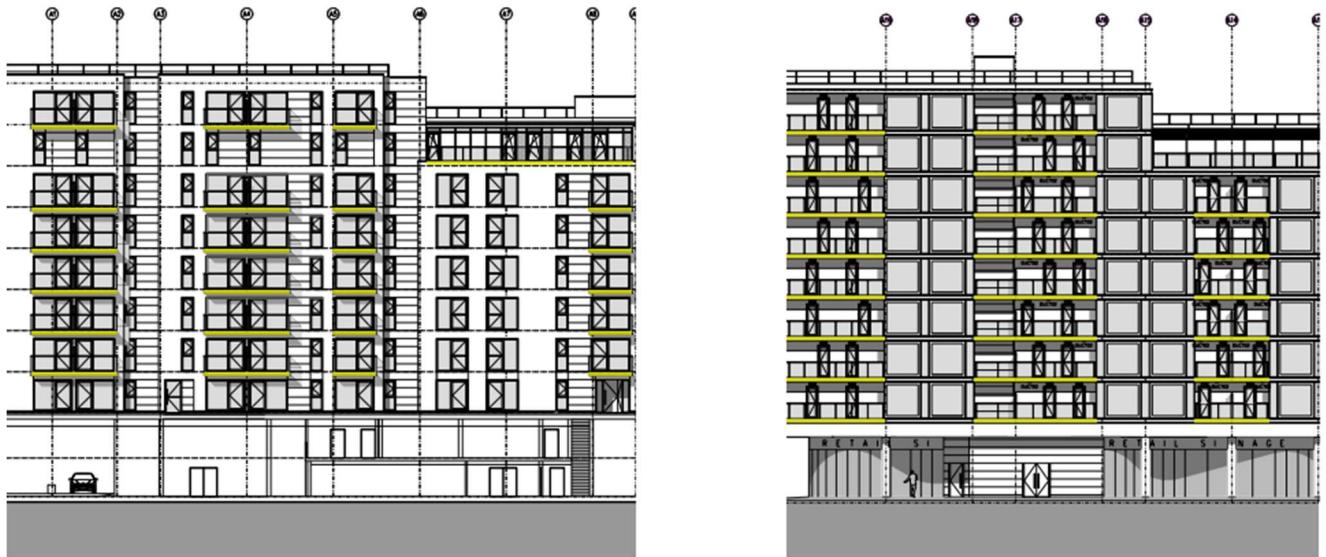
Fig. 8 – Typical East (Left Hand side) and West Elevations (Right Hand side) showing on the left-hand side the projecting balconies and on the right-hand side the recessed balconies

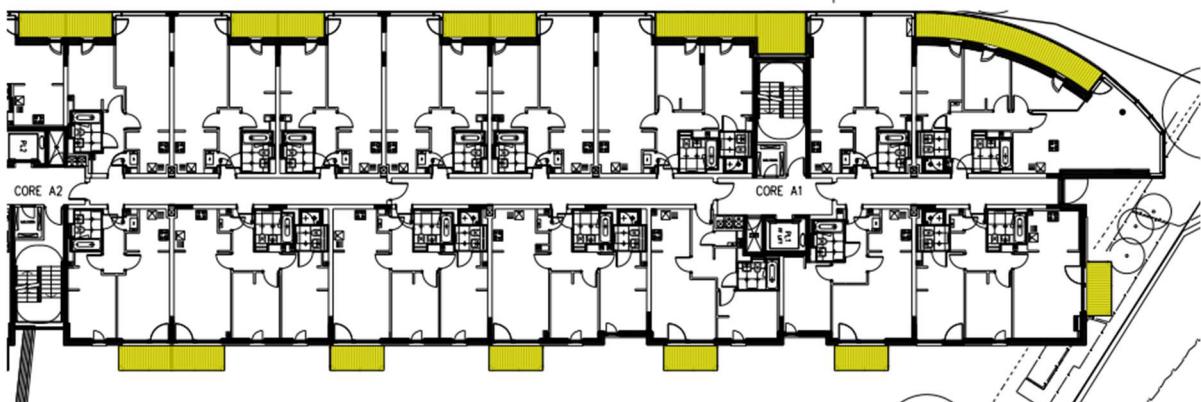
Fig. 9 – Typical floor plan highlighting the recessed balconies (West Elevations, top of the plan) and projecting balconies (East Elevations, bottom of the plan)

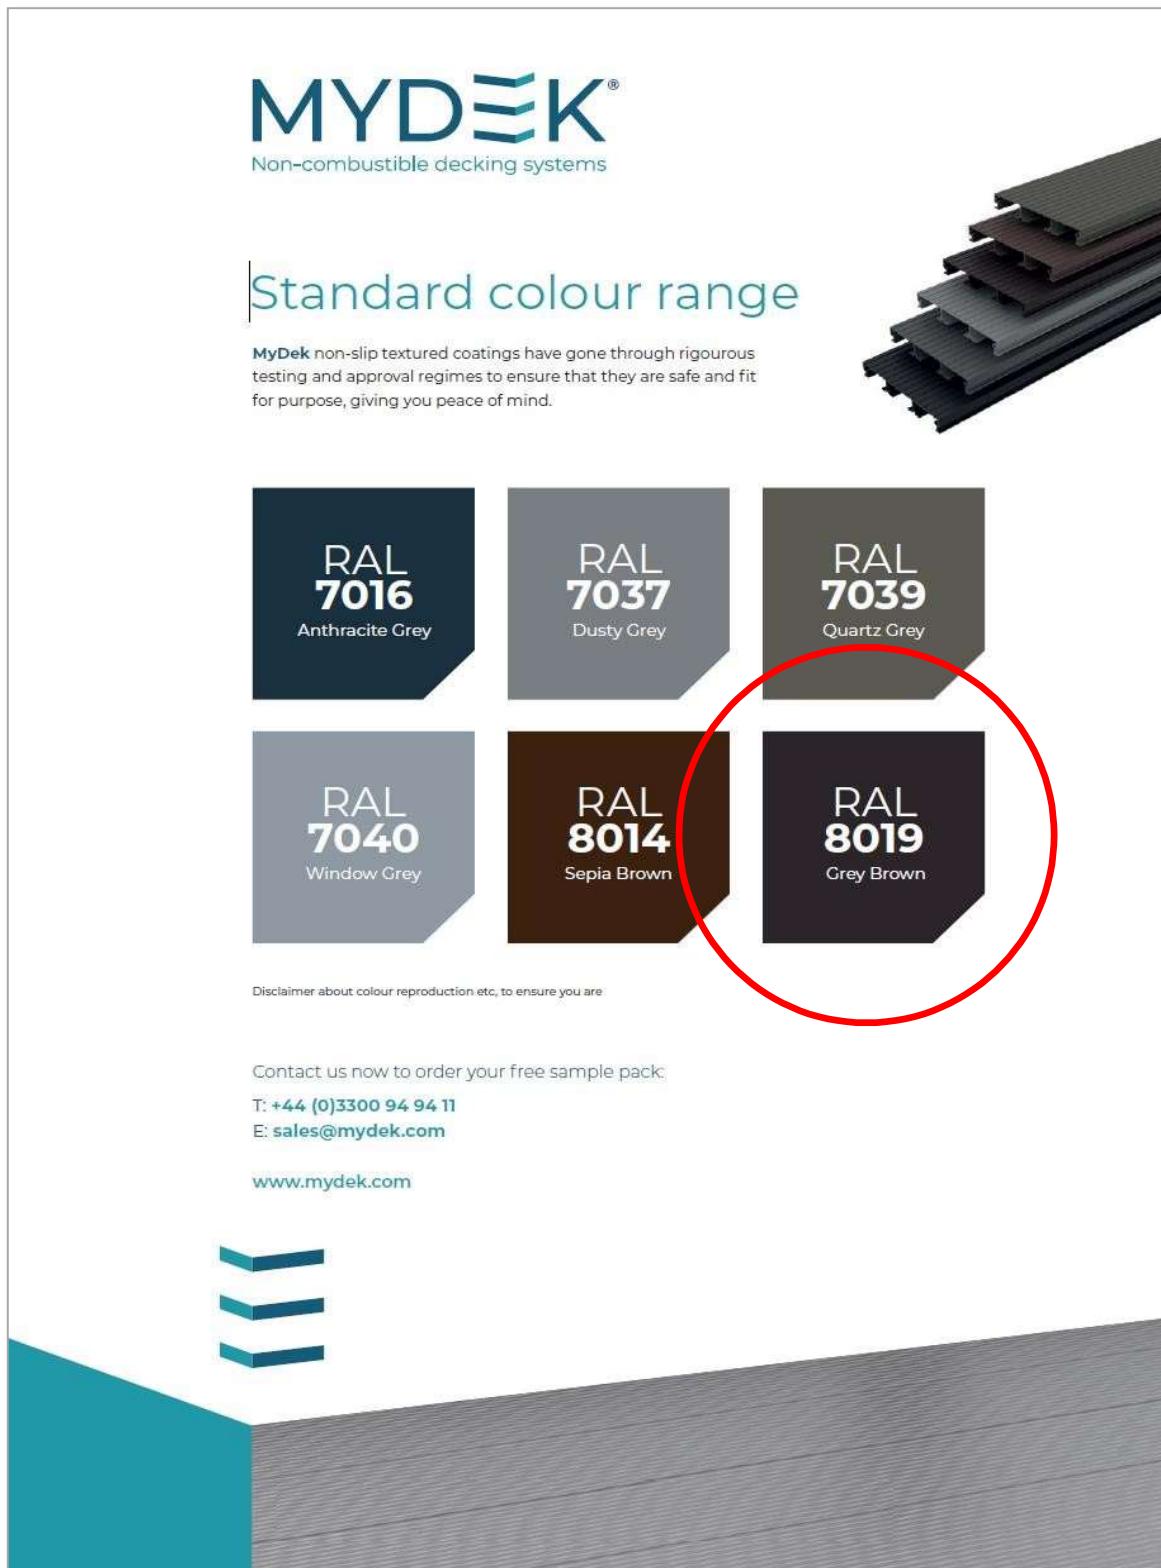
Fig. 10 – Excerpt from the MyDek Aluminium Balcony Decking Data Sheet

Board width x depth	144 x 30mm (150mm module)
Board length	4m or cut-to-length (subject to conditions)
Weight	12.47 kg/sqm

The non-combustible alternative proposed to replace the timber decking is a polyester powder coat aluminium plank, of the same plank width, colour tone (as the timber plank has weathered and greyed) and routed configuration from MyDek. Product specifics are listed below and full technical submittal is included in Appendix 1:

- **MyDek Delta 30** decking board, colour RAL 8019 Grey Brown
- Fully certified non-combustible decking
- Achieves Euroclass A2-s1, d0 fire rating.
- Coated to Qualicoat Class 1 standards for durability.

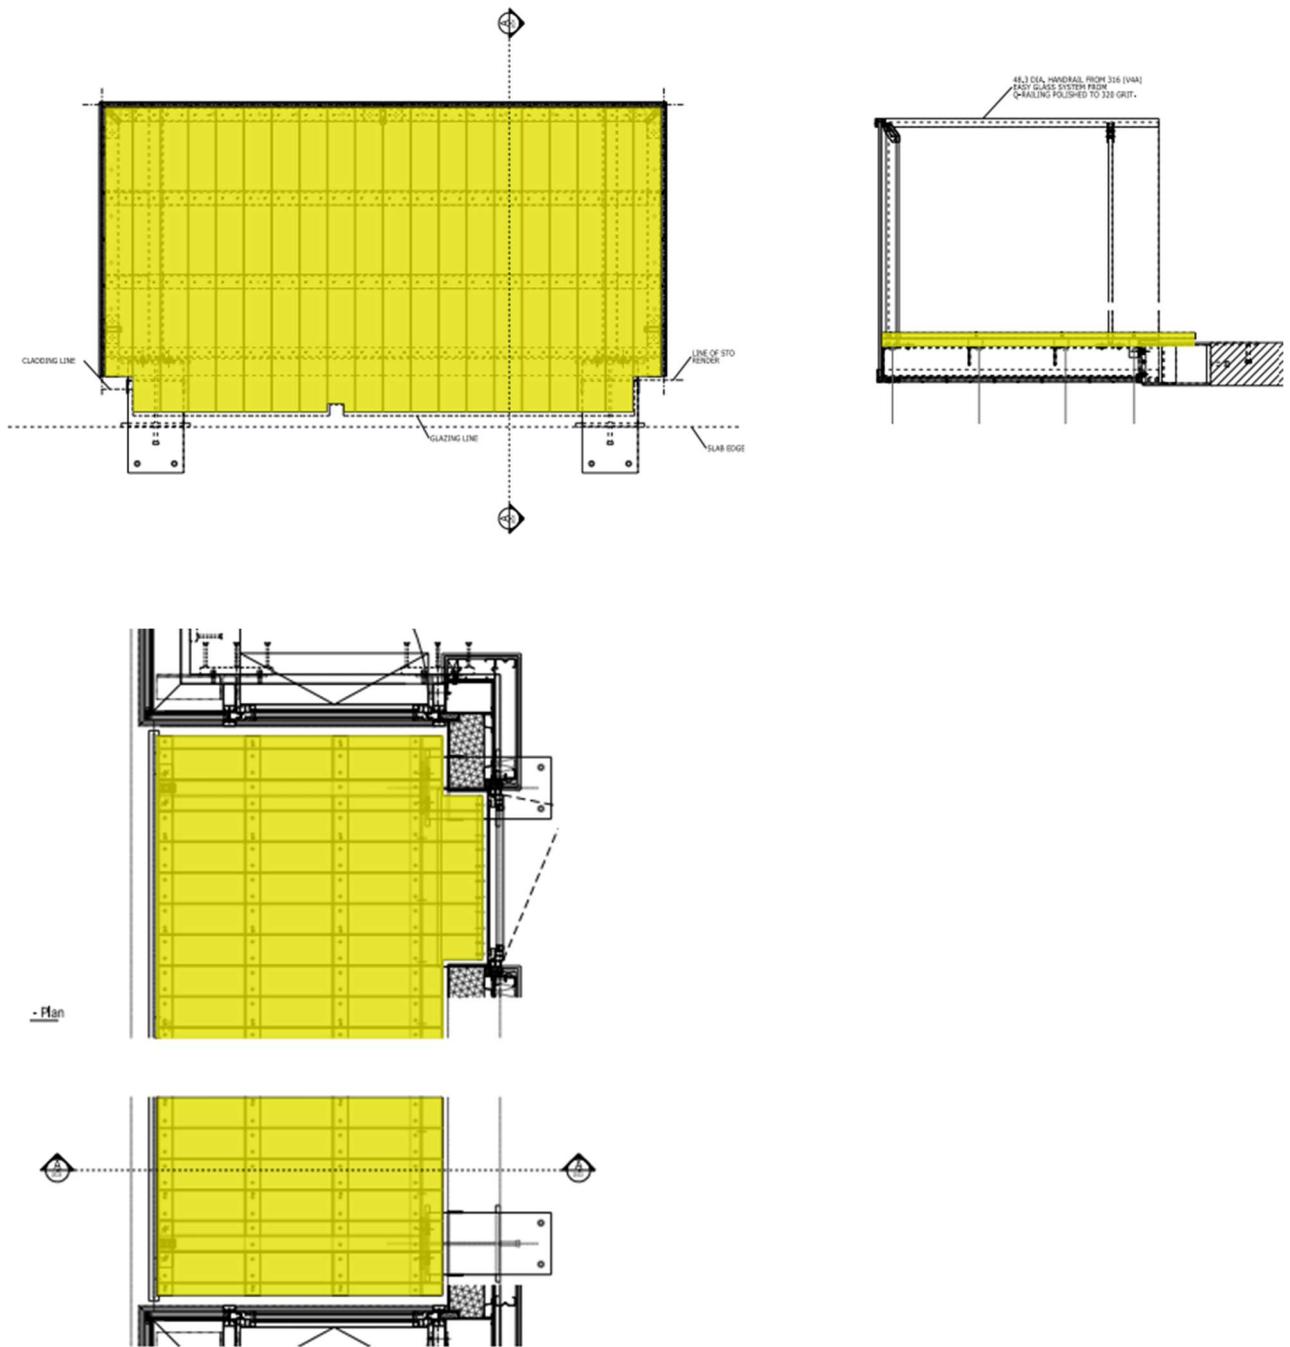
Fig. 13 – Excerpt from balcony decking drawings, showing the projecting (top) and recessed (bottom left hand side) balcony details

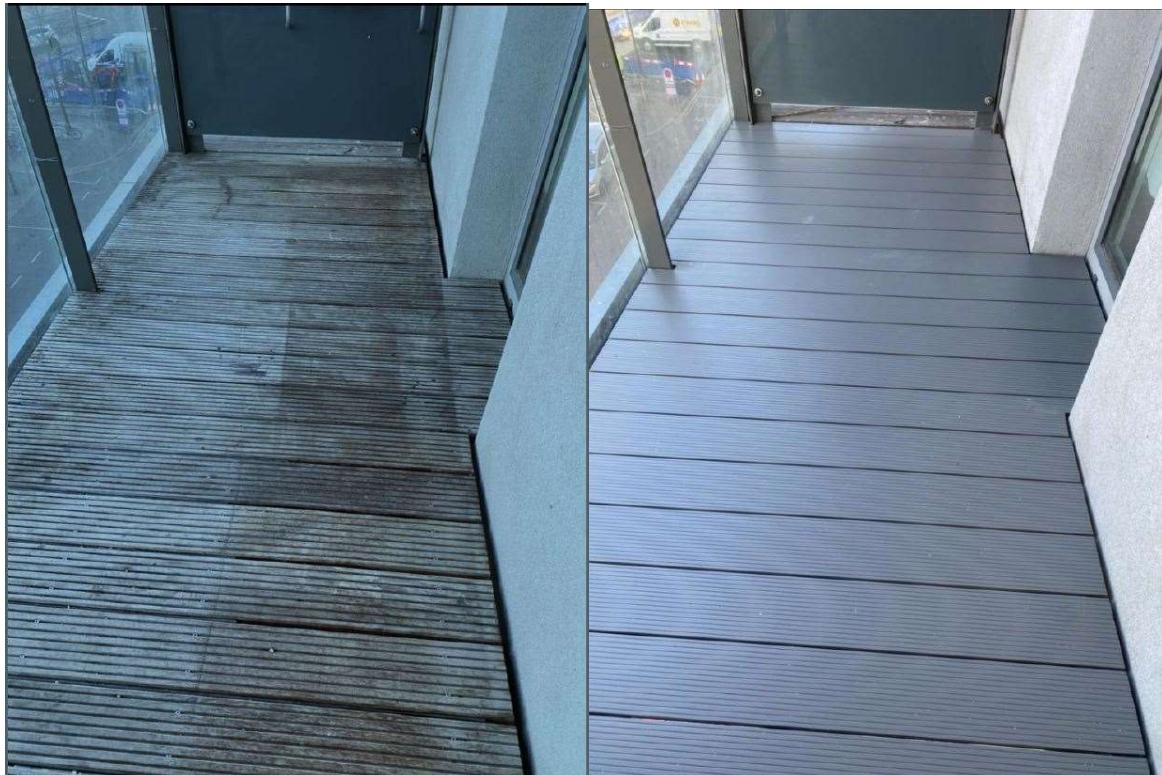
Fig. 14 – First Example of a completed balcony decking replacement; the left-hand side photo shows the original timber decking balcony, the right-hand side photo shows the same balcony and the completed aluminium decking replacement.

Side-by-side photographs of the before and after balcony works are included below. The photographs demonstrate the visual similarity of the existing and proposed material types and show that the works have not resulted in a significant visual change to the building's appearance.

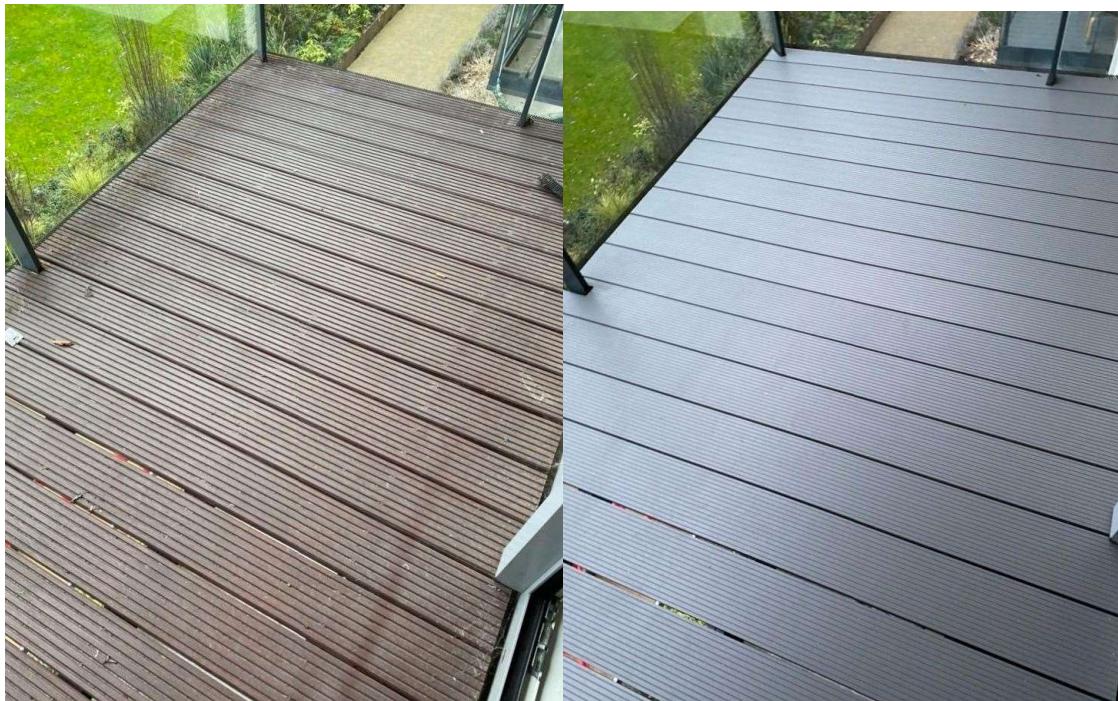
Fig. 15 – Second Example of a completed balcony decking replacement; the left-hand side photo shows the original timber decking balcony, the right-hand side photo shows the same balcony and the completed aluminium decking replacement.

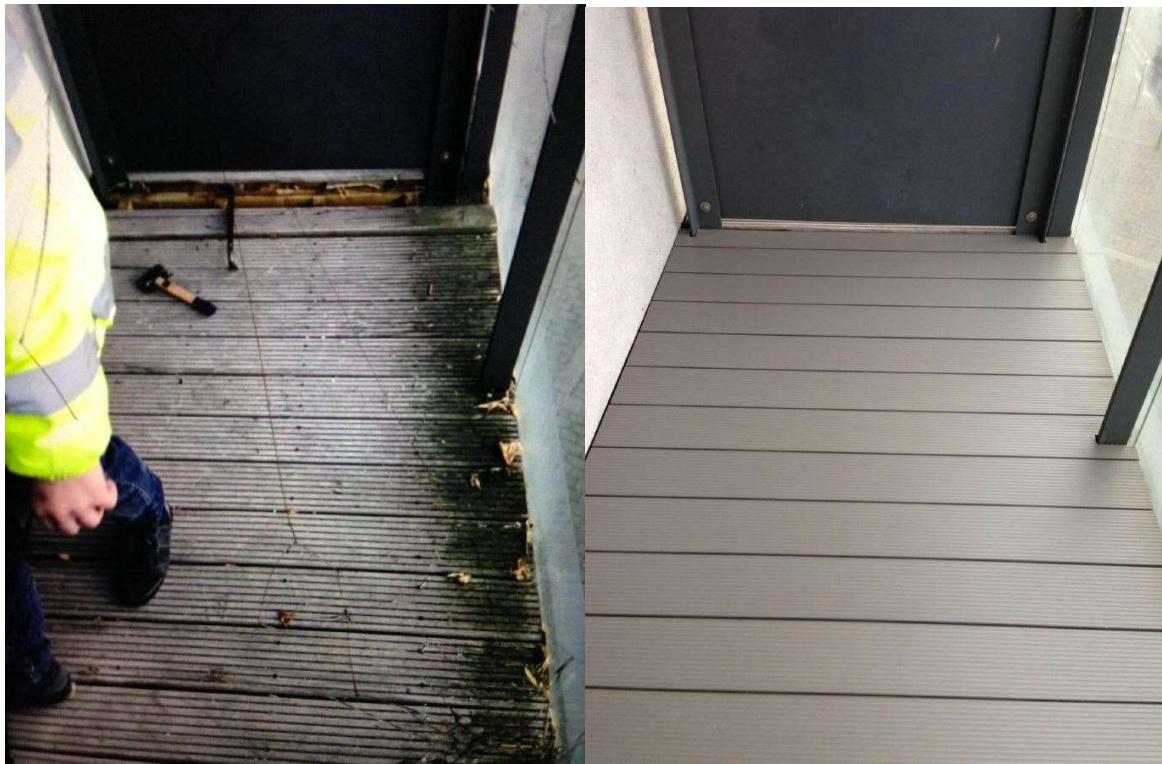
Fig. 16 – Third Example of a completed balcony decking replacement; the left-hand side photo shows the original timber decking balcony, the right-hand side photo shows the same balcony and the completed aluminium decking replacement.

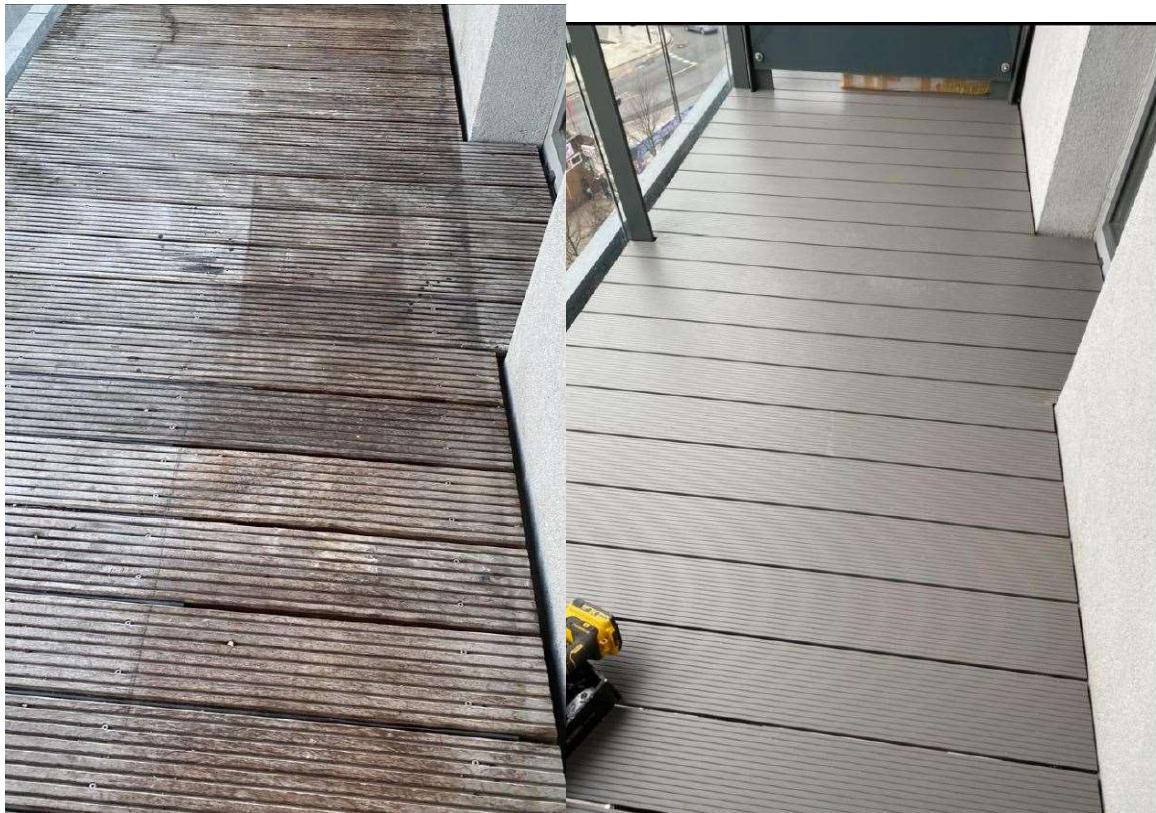
Fig. 17 – Fourth Example of a completed balcony decking replacement; the left-hand side photo shows the original timber decking balcony, the right-hand side photo shows the same balcony and the completed aluminium decking replacement.

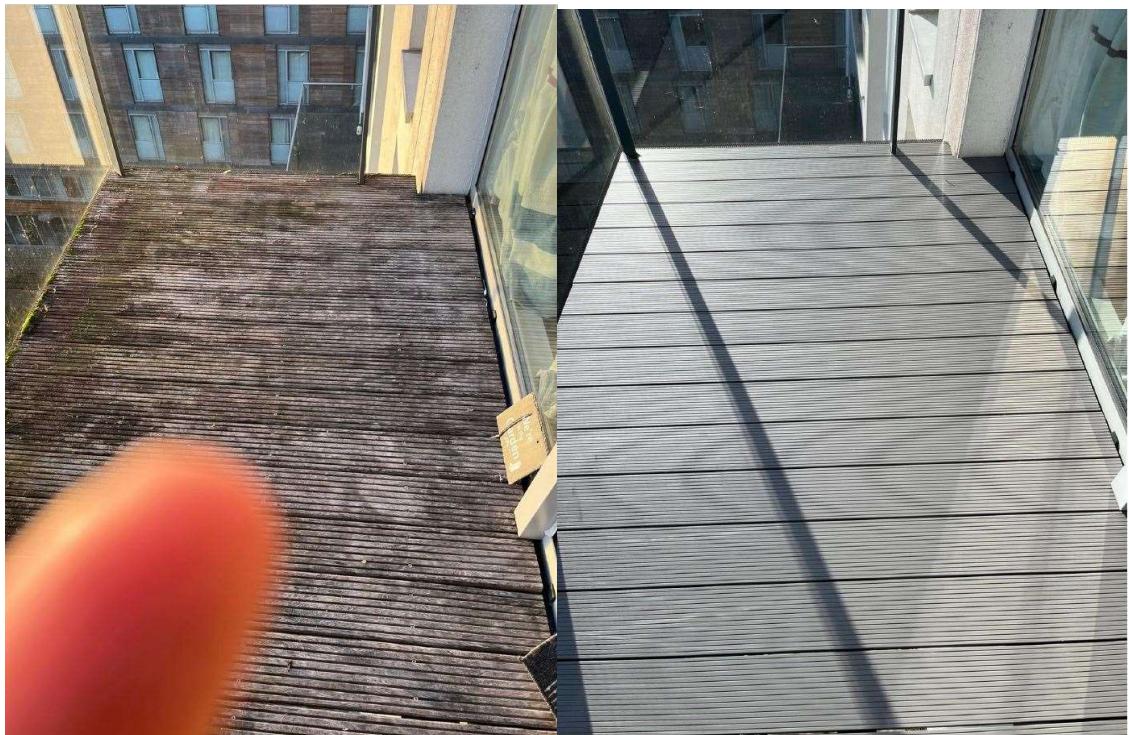
Fig. 18 – Fifth Example of a completed balcony decking replacement; the left-hand side photo shows the original timber decking balcony, the right-hand side photo shows the same balcony and the completed aluminium decking replacement.

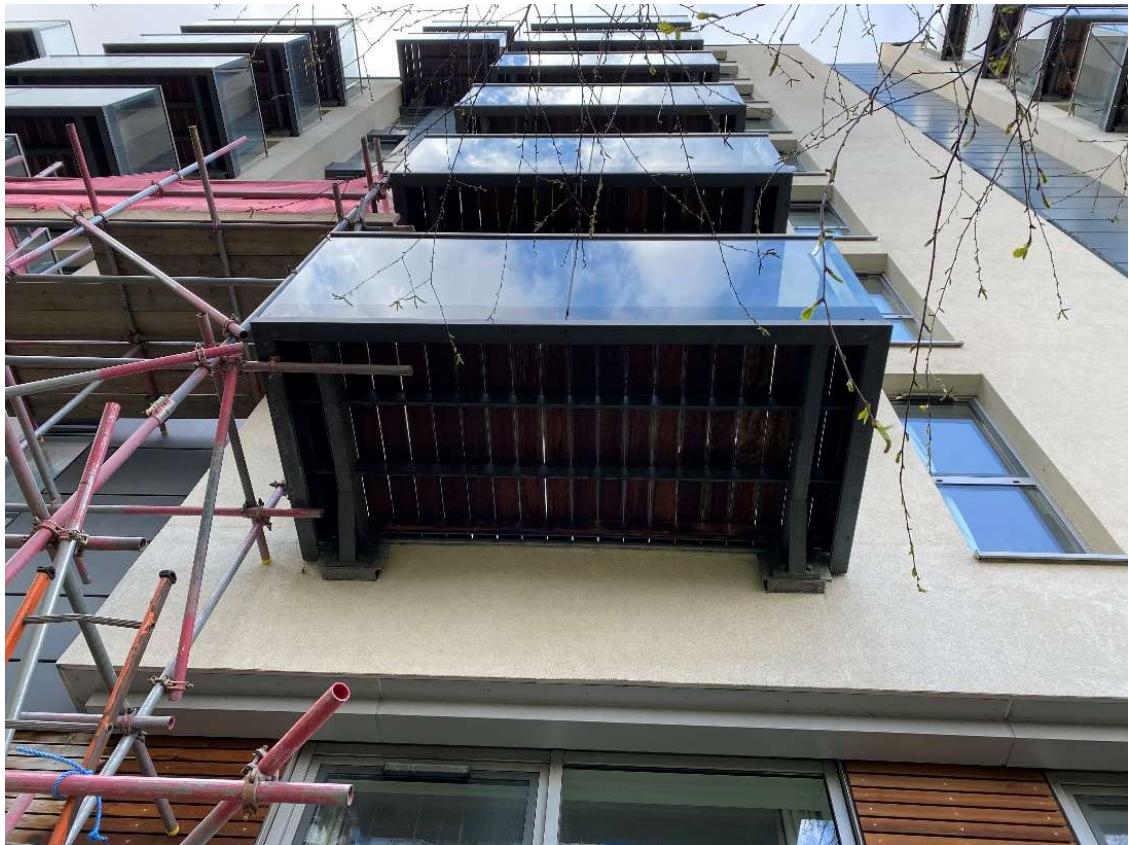
Fig. 19 – Photo of the underside of the projecting balconies, and the aluminium replacement decking installed (typical East Elevation of projecting balconies)

- Fixed directly onto balcony frame in the same way as the timber decking (i.e. no changes required to the steel framework, no additional steel members introduced, resulting in same configuration when balcony soffit is viewed from below, see Fig. 19)

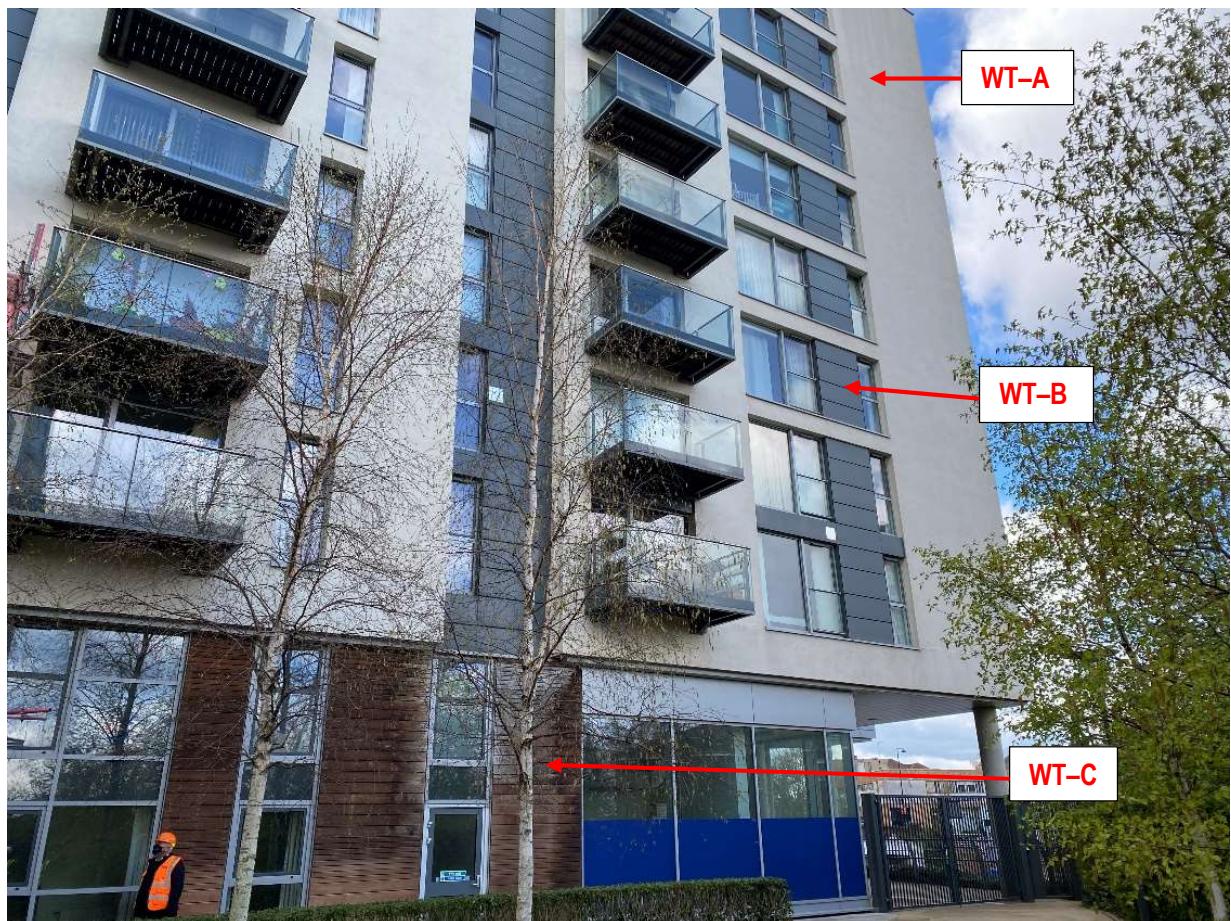
Fig. 20 – Photo above shows the East Elevation of Block B; this elevation and material configuration is typical for all east elevations of Blocks A – D)

The build-up of the external wall for the timber and aluminium rainscreen is based on combustible insulation (PIR). The EWI render system is also based on combustible insulation (EPS)

The remediation scope requires the replacement of the timber rainscreen and the combustible insulation (behind timber and aluminium rainscreen) with a non-combustible alternative. In addition, the remediation of the external walls will also refer to limited sections of the EWI render system, adjacent to the AOV windows.

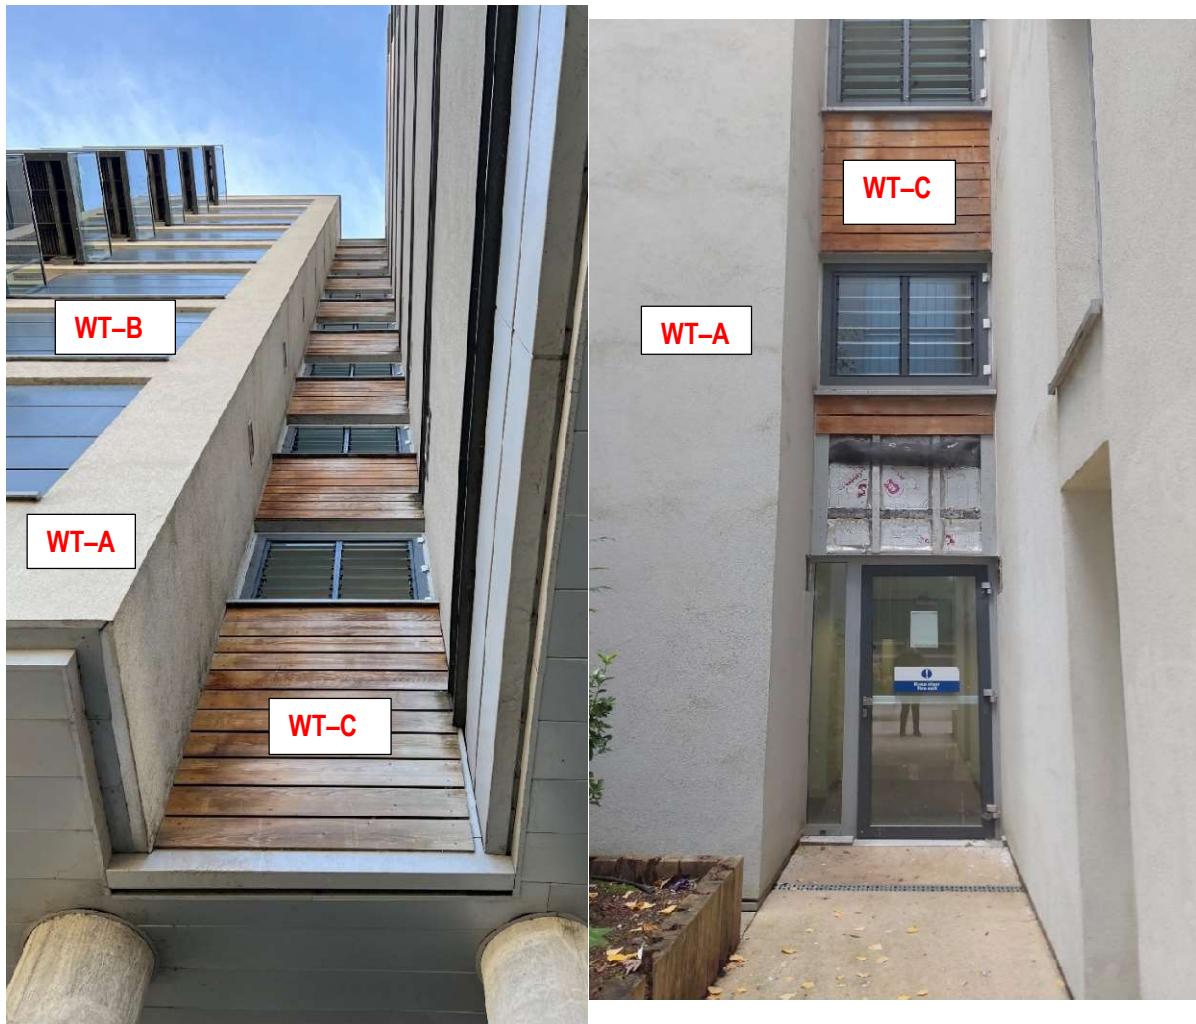
Fig. 21 – Photos above show the North (left hand side) and South (right hand side, above) short elevations and the AOV windows – the configuration is similar across all Blocks (A – E)

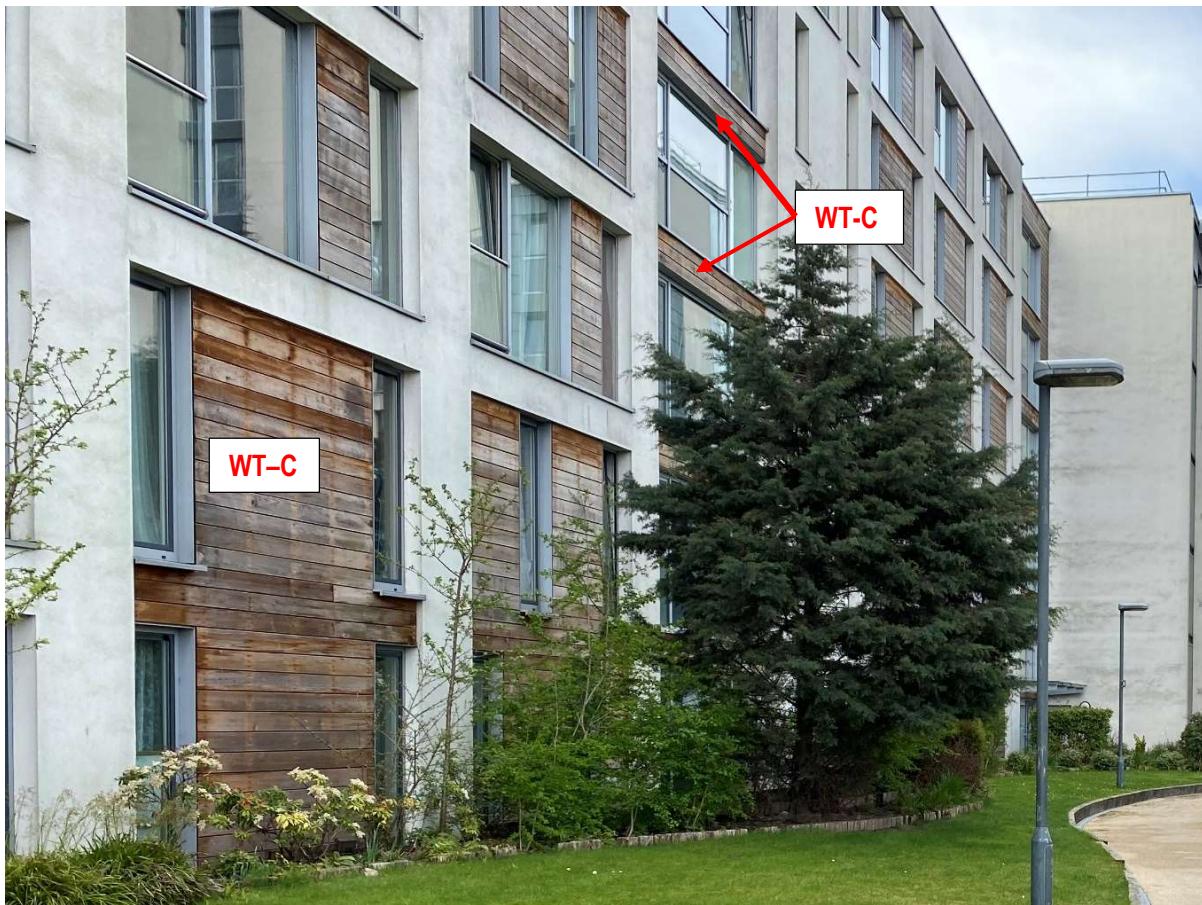
Fig. 22 – Photo above shows the North Elevation of Block E and the different configurations of the timber rainscreen (Wall Type C);

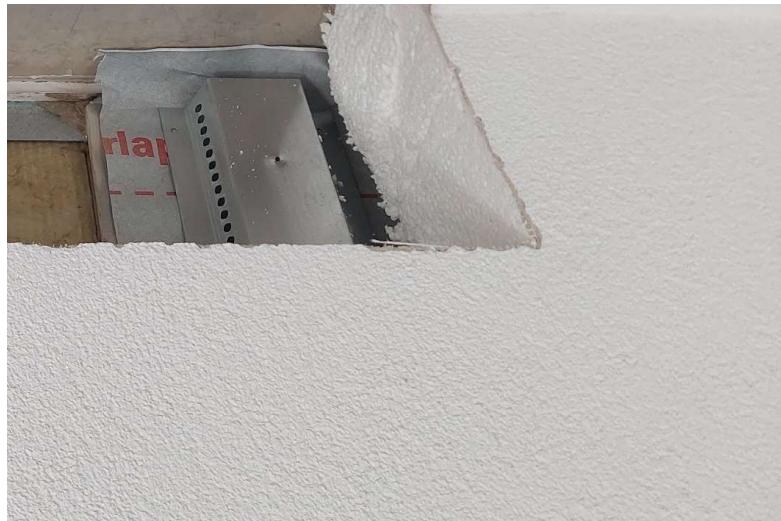
Fig. 23 – Photo above illustrates the Existing EWI Render System (WT-A); photo was taken following intrusive inspections.

The proposed render replacement is identical to the existing (same overall build up depth), but on a non-combustible insulation. The existing render is an Alumasc product, the proposed system comes from the same manufacturer (Alumasc has now become K Systems). The proposed render specification is a K System Exicco M Silkolitt silicone render. Photo below shows the existing and the proposed.

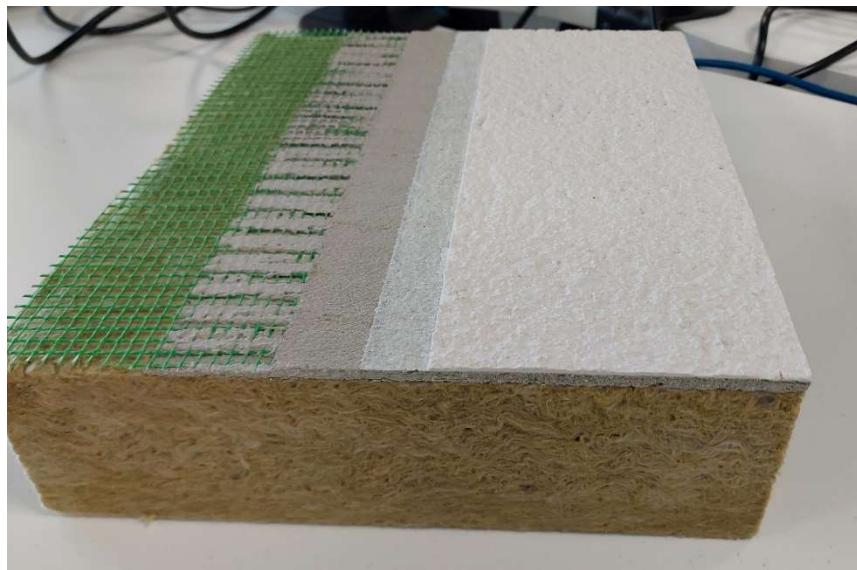
Fig. 24 - Photo above illustrates the Proposed EWI K System Render System (WT-A), showing the various layers which form the system, with the external white render identical to the as built.

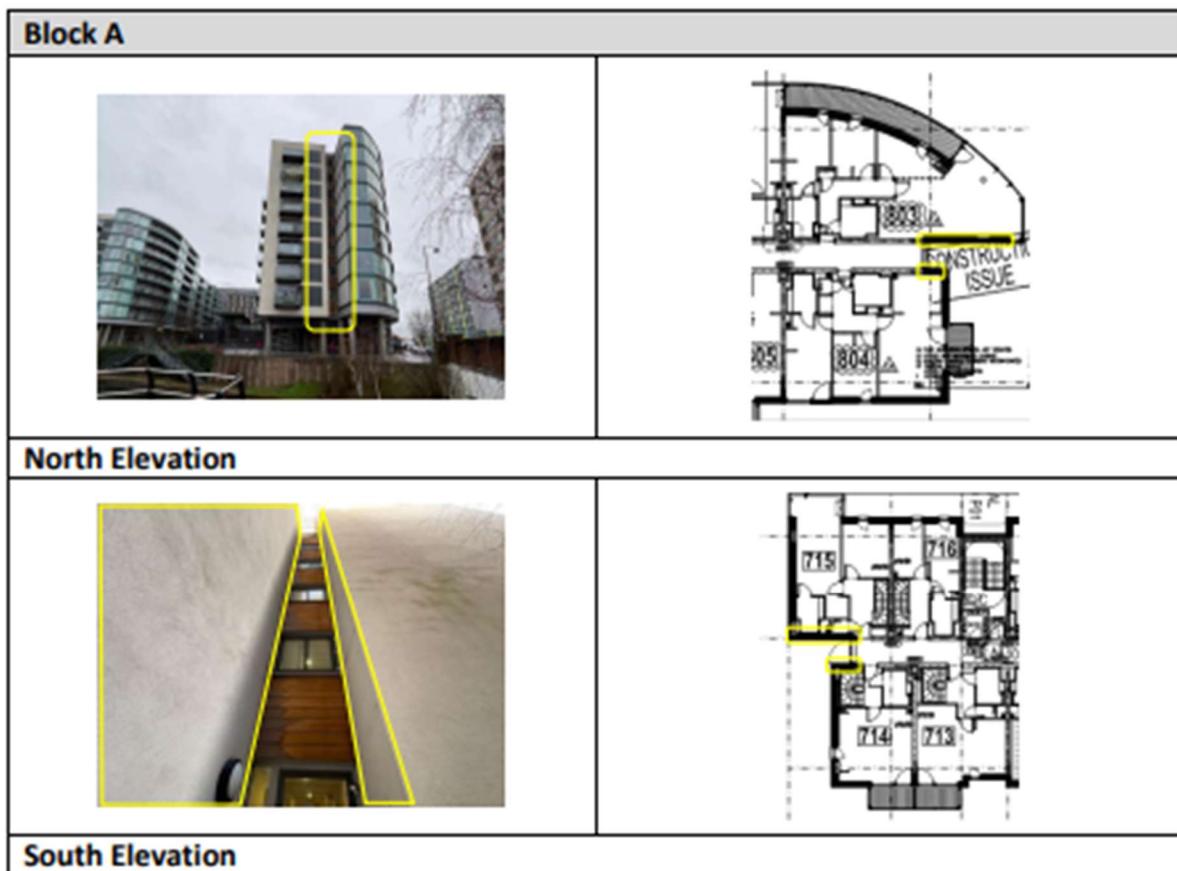
Fig. 25 – Excerpt from the FRAEW report for the EWI render system replacement scope to Block A.

The below diagrams indicate the extent of these render remediation works across all 5 blocks; these diagrams have been extracted from the FRAEW report. The yellow lines indicate the areas on the elevations/plans of the render replacement.

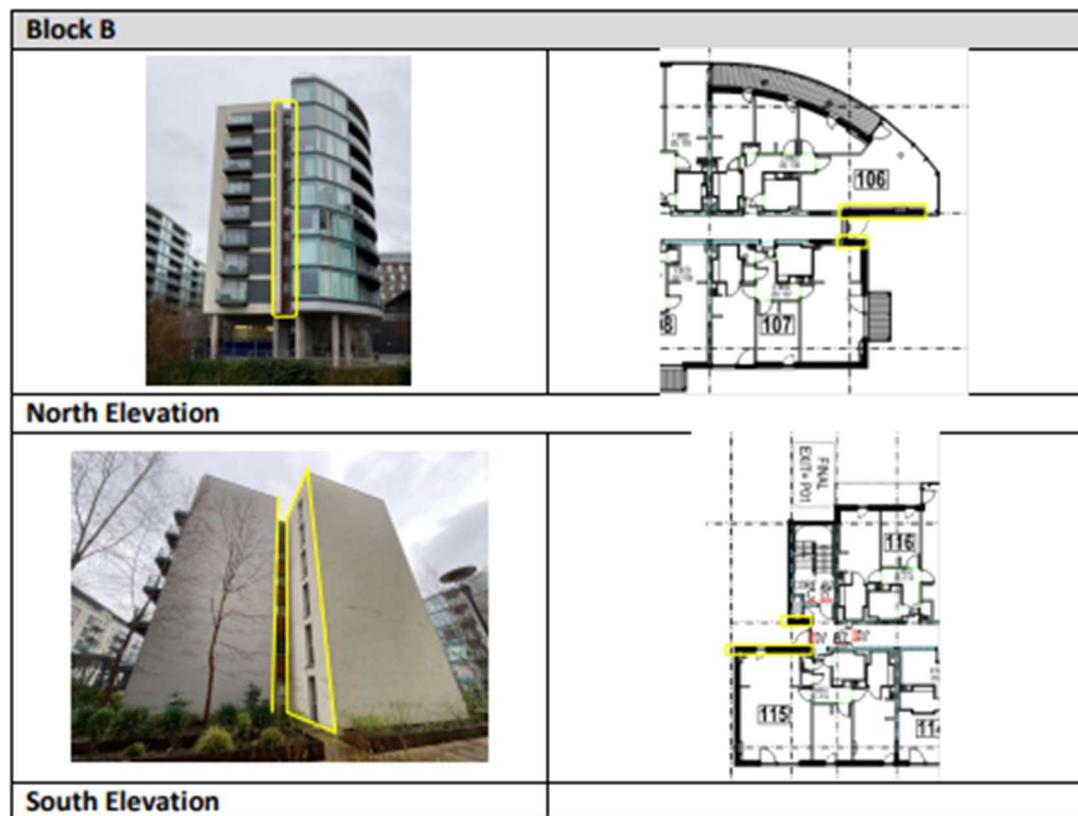
Fig. 26 – Excerpt from the FRAEW report for the EWI render system replacement scope to Block B

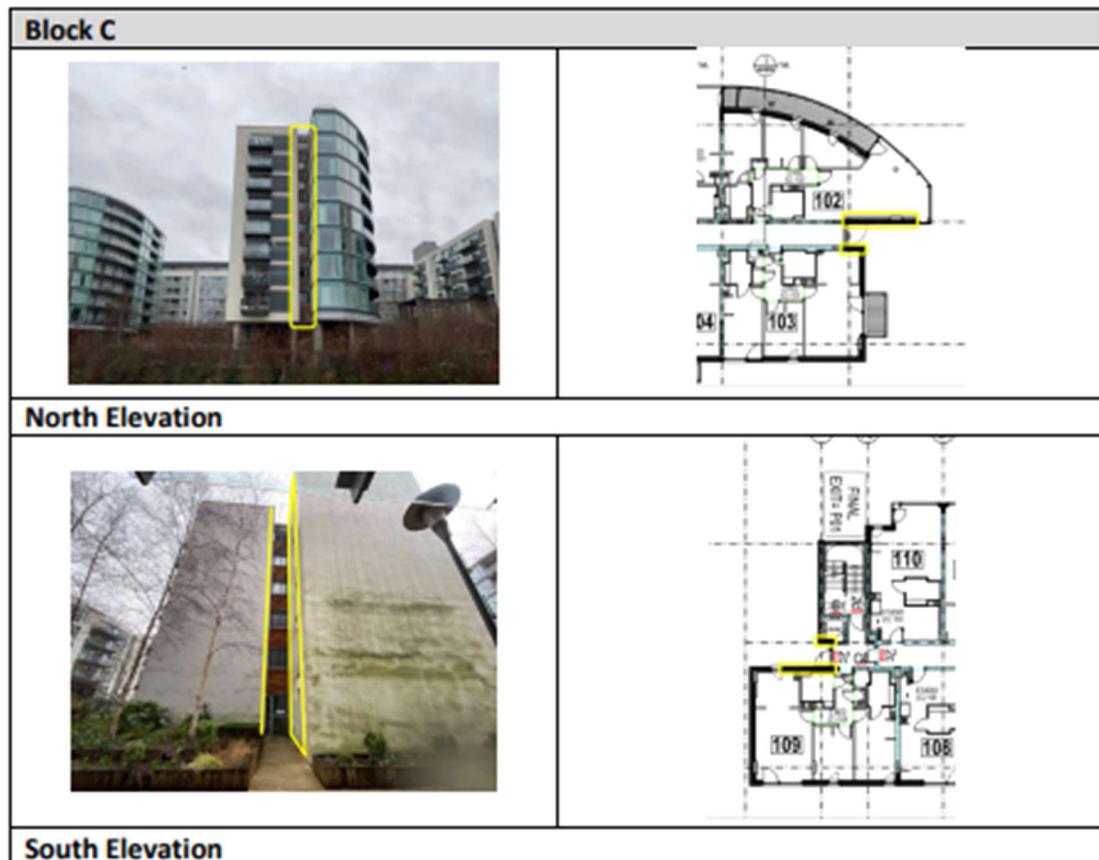
Fig. 27 – Excerpt from the FRAEW report for the EWI render system replacement scope to Block C
