# High Point Village, Hayes

## Façade Remediation Design & Access Statement

Date: 4 August 2023

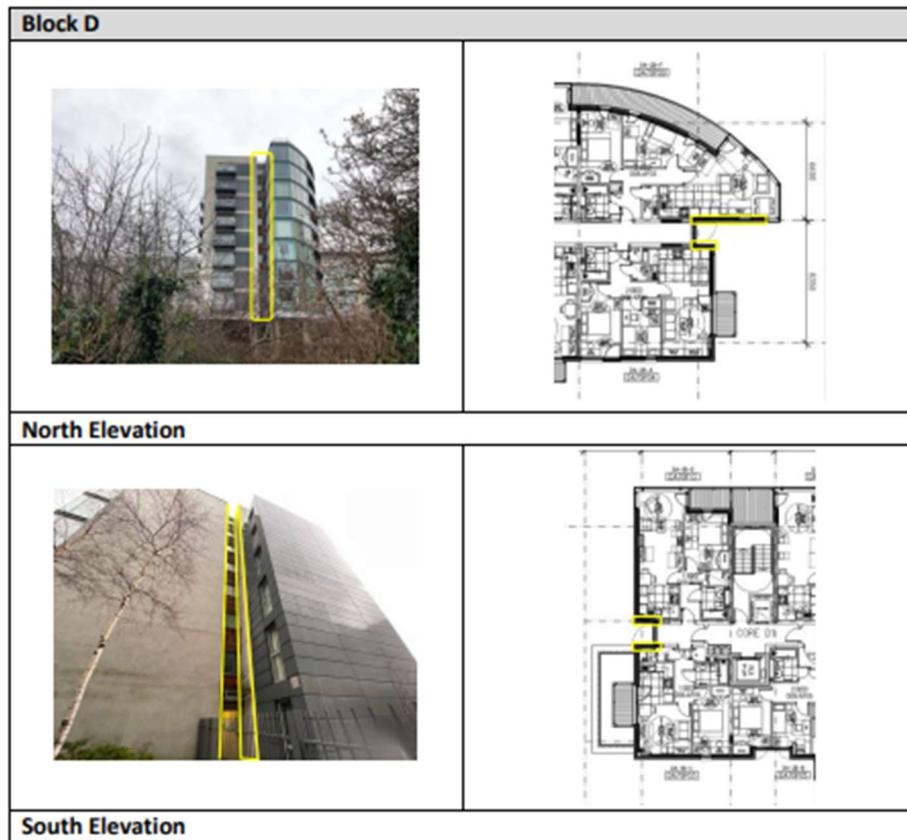
Fig. 28 – Excerpt from the FRAEW report for the EWI render system replacement scope to Block D

The below diagrams indicate the extent of these render remediation works across all 5 blocks; these diagrams have been extracted from the FRAEW report. The yellow lines indicate the areas on the elevations/plans of the render replacement.

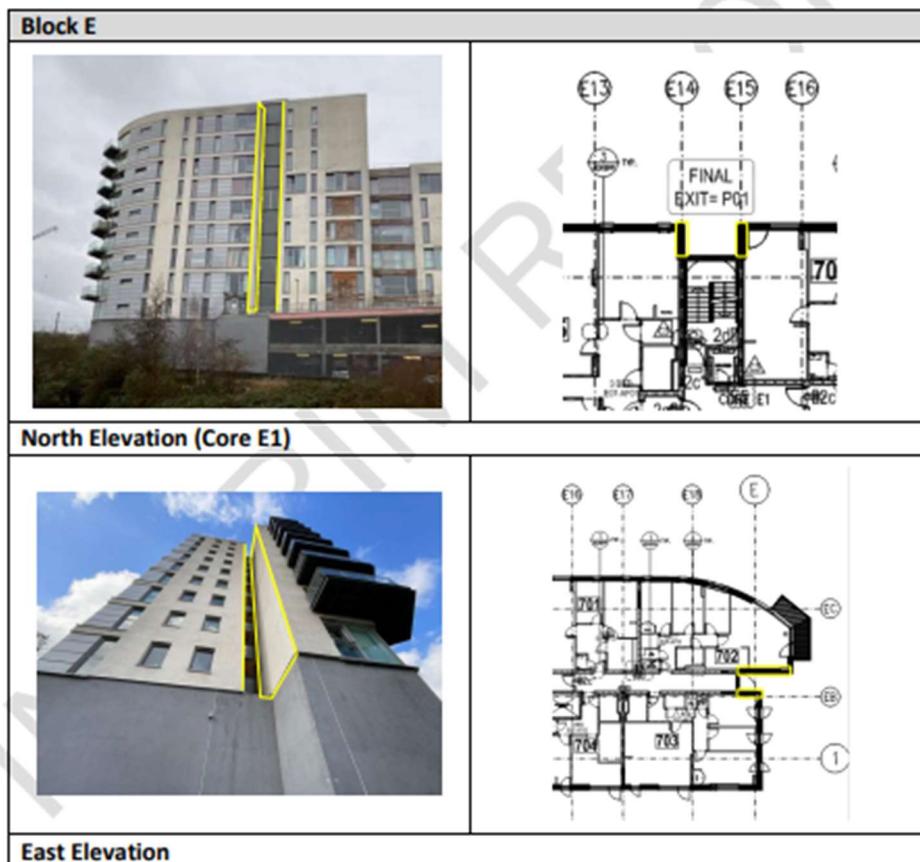
Fig. 29 – Excerpt from the FRAEW report for the EWI render system replacement scope to Block E

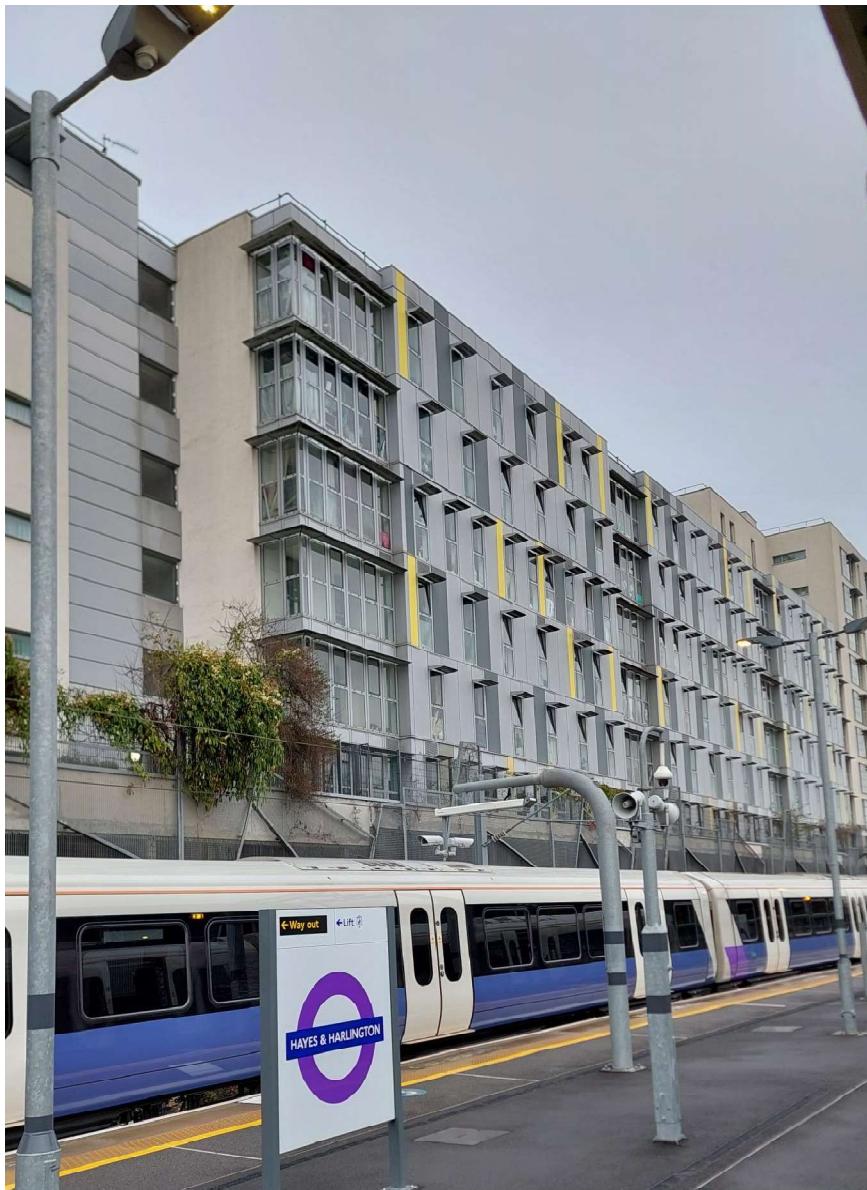
Fig. 30 – Photo above illustrates the South elevation of Block E, visible from the train station at Hayes and Harlington. The light grey and yellow aluminium rainscreen on this elevation correspond to the winter gardens. No remediation is required to the aluminium rainscreen on this elevation

The remediation scope for this wall type only affects the insulation behind the aluminium rainscreen (dark and light grey and yellow on South elevation of Block E – see photo in Fig. 30 from train station side). The aluminium rainscreen is removed to allow the combustible insulation behind to be replaced with non-combustible mineral wool, and then re-instated. There is no change to the existing aluminium panels as these are being re used and re-instated.

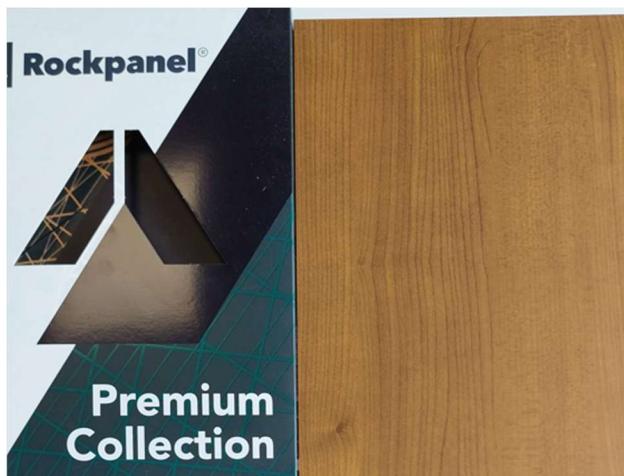
Fig. 31 Rockpanel Premium Woods – Teak (matt finish)

The Rockpanel Premium board we intend to use is 11mm thick, and the wood range is called “Teak”. The PIR insulation behind will be replaced with same thickness mineral wool insulation. In addition, the support framework behind the rainscreen will be replaced with new thermally broken helping hand brackets and rails. The existing grey PPC aluminium profiles and trims, surrounding the window frames and any other architectural features will be retained. It is proposed that the boards will be routed to replicate the plank configuration, with the section having the same width as the current joint between the timber planks. This will take away the necessity for an insect mesh behind the timber plank open joints and will offer a sturdier and more efficient installation option. The board edges and the routed sections will start as light colour (as seen in photo above, left hand side) and which in a short period of time once exposed to the weather (2-4 weeks) will oxidise and turn a dark brown. This process will most likely happen before the boards are installed, as material will be delivered to site. The visual impact will therefore be minimal.

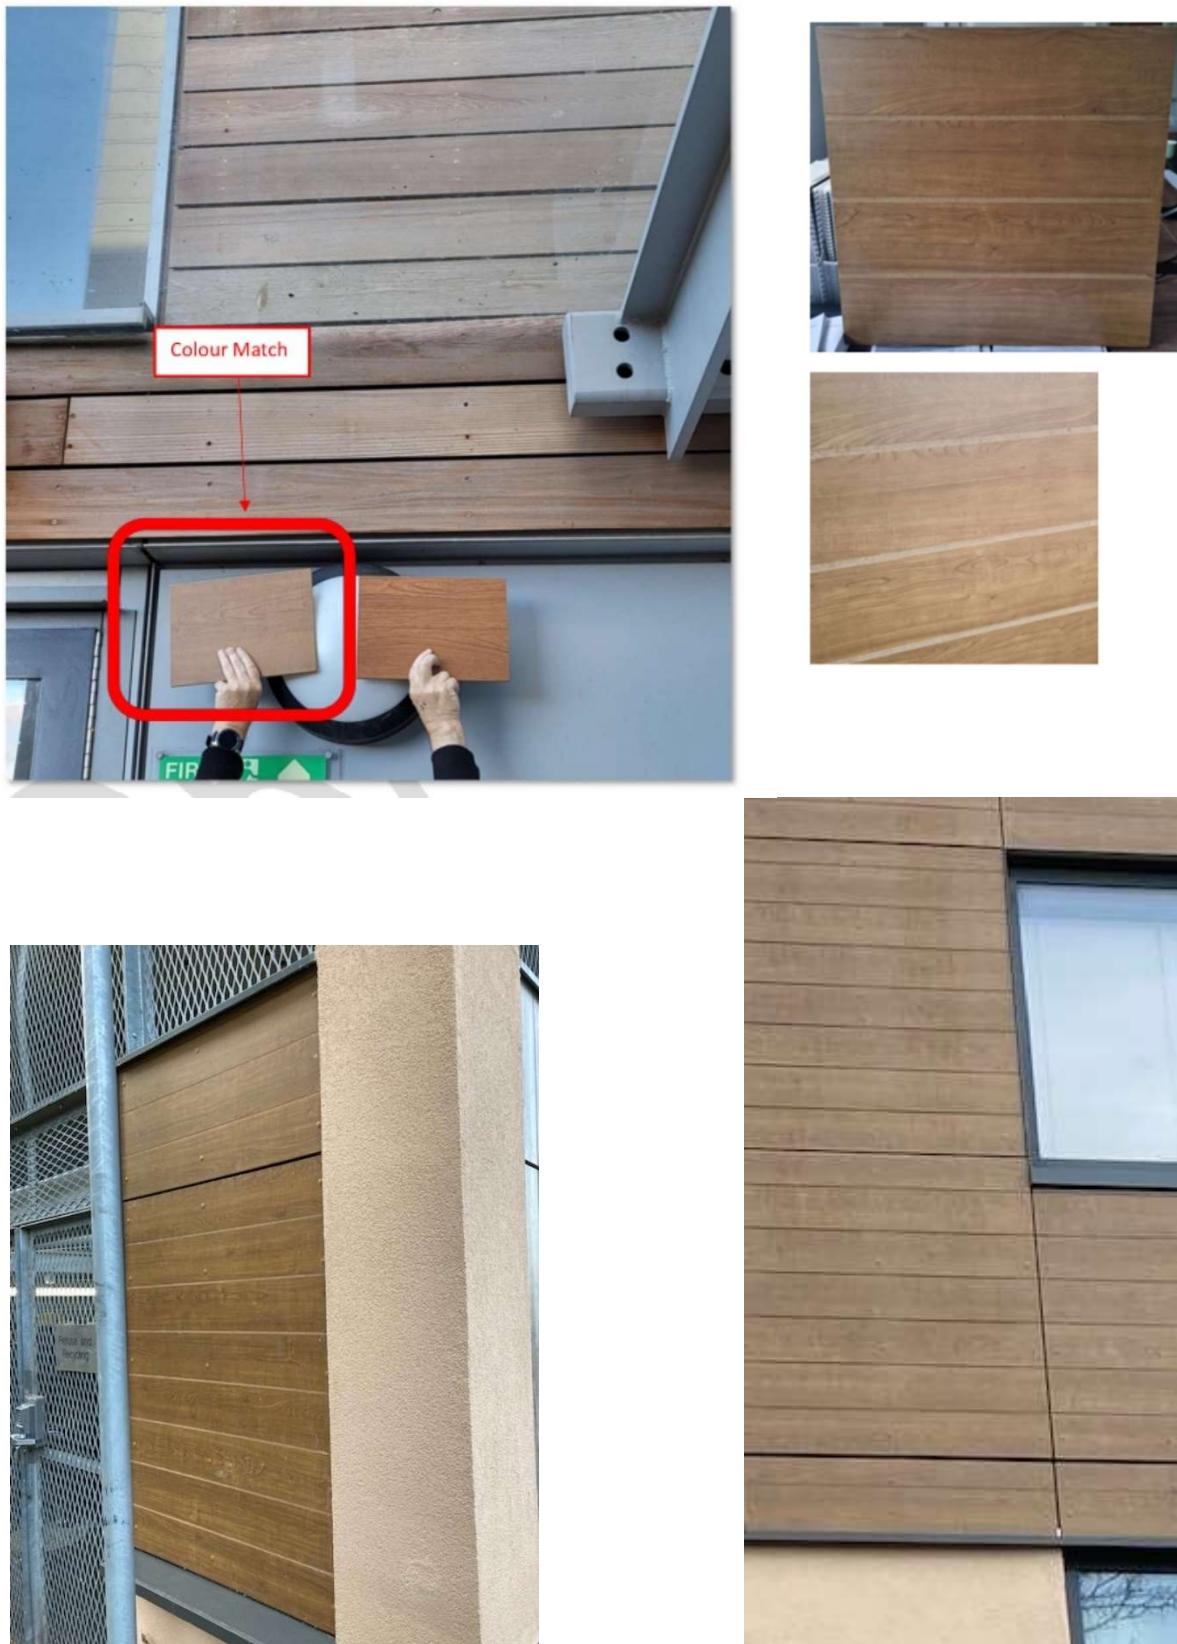
Fig. 32 - Photos above illustrate examples of the routered Rockpanel boards replicating the joint arrangement with the weathered edges. Top left hand side photo shows the "Teak" Rockpanel sample selected as the best match to the existing timber.
