Building Recording (Level 2)

Photographic Record (Volume 2)

Former Nestlé Factory Canteen Building, Nestles Avenue,
Hayes

March 2026

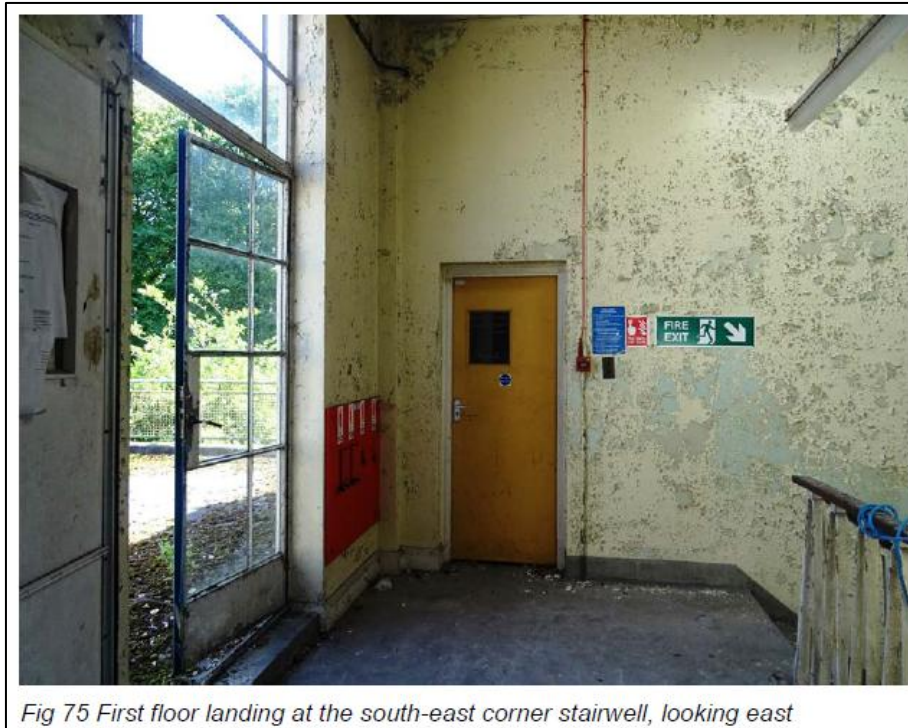
Fig 75 First floor landing at the south-east corner stairwell, looking east

- 3.3.16 Three corners of the building contain stairwells; among these, the south-west corner stairwell contains the main staircase. Two lesser staircases are located in the north-west and south-east corner of the building. All three staircases are reinforced concrete structures cantilevered from the walls. Among these, the south-eastern and north-western staircase each have three flights with two mezzanine landings, whereas the main staircase has five flights with three mezzanine landings. All staircases have uniform bannisters formed of steel spindles supporting wooden handrails (Fig 72, Fig 75, Fig 78).

- 3.3.19 On first floor level, the south-east stairwell provided access into the rooms at the east end of the south wing, the rooftop patio above the colonnade and into the main office areas in the south wing to the west. The door to the east was not accessible during the survey. As a result of the two south-east corner rooms. The roof patio is accessible through a large crittall style metal glazed patio door (Fig 75).

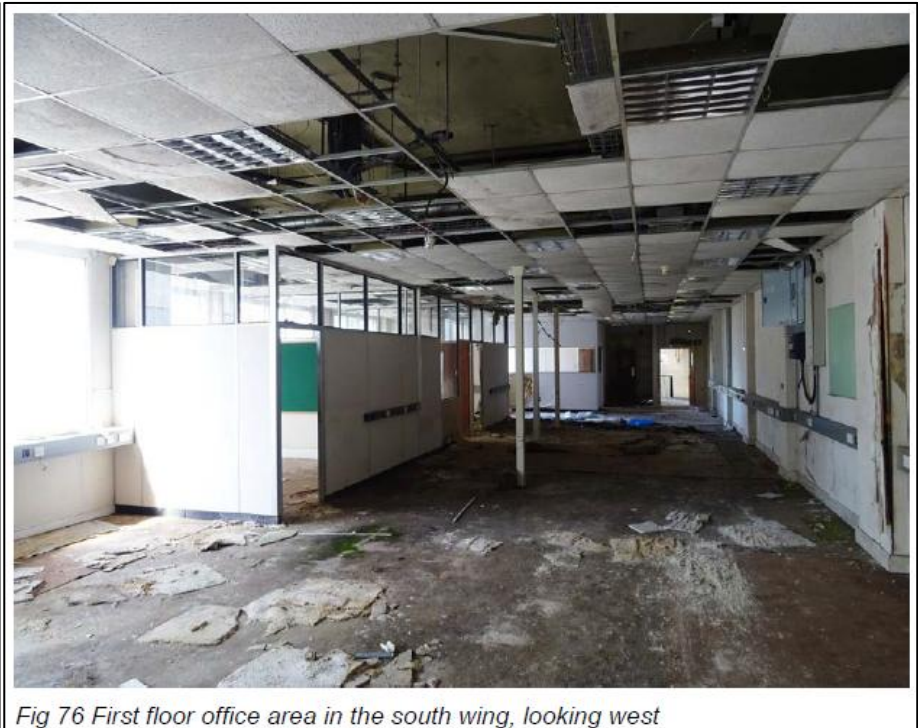
Fig 76 First floor office area in the south wing, looking west

- 3.3.20 The south wing office area has a large interior space mainly open plan with a number of cabins formed of modern partition walls with clerestories. It has a suspended ceiling and carpeted floor. The south wing office had a 1980s interior and was in a very dilapidated condition. The west end of the office area leads into the south-west corner stairwell leaving a computer server room and a WC in the south-west corner. The computer server room has a modern interior with a steel waffle floor (Fig 76, Fig 77).

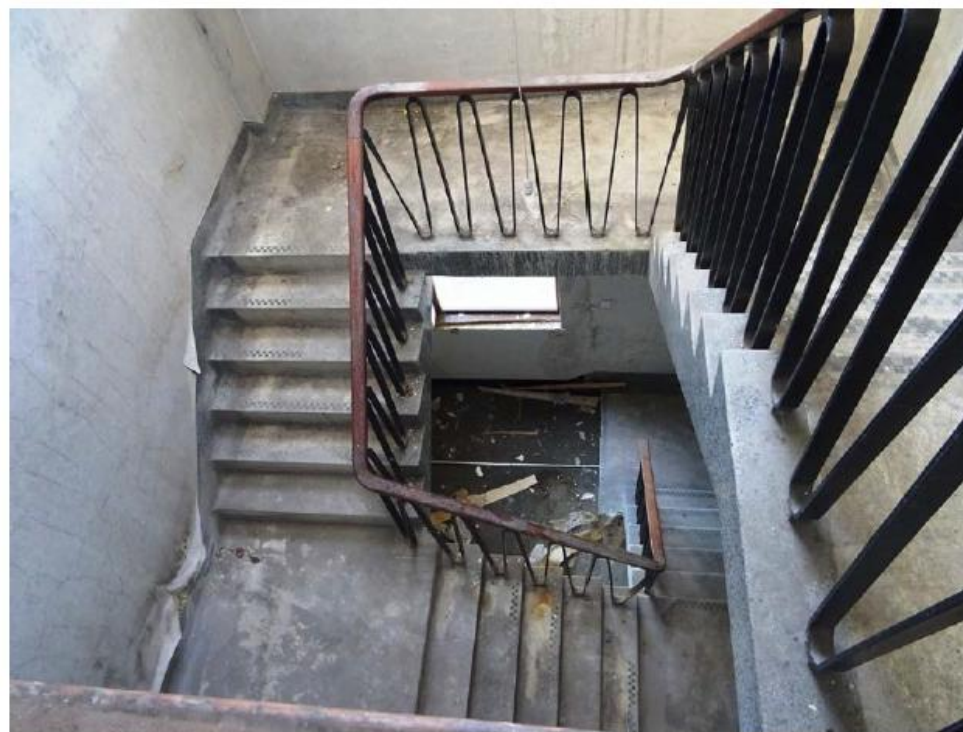
Fig 78 Main staircase at the south-west corner of the building

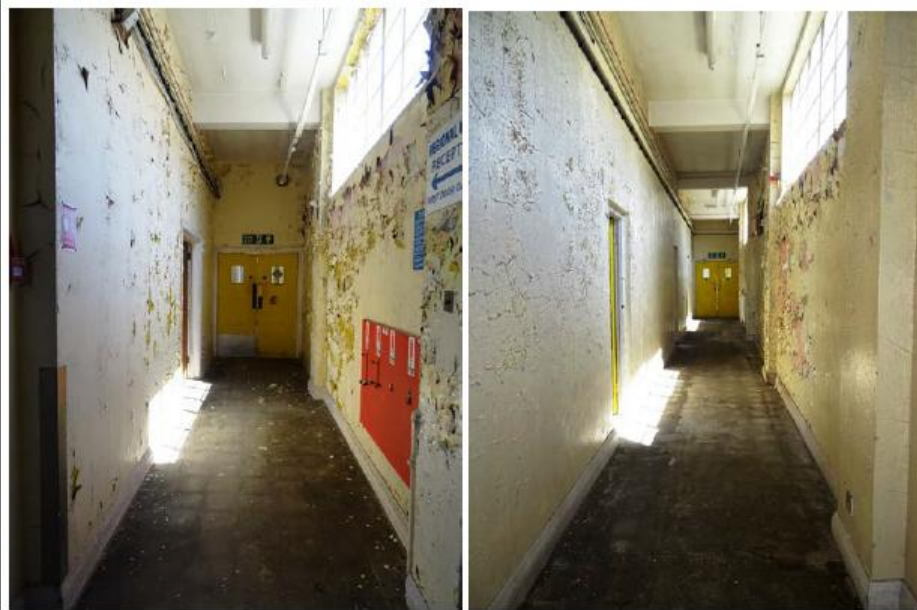
Fig 79 South end (left) and a central portion (right) of the north-south running corridor on the first floor of the west wing.

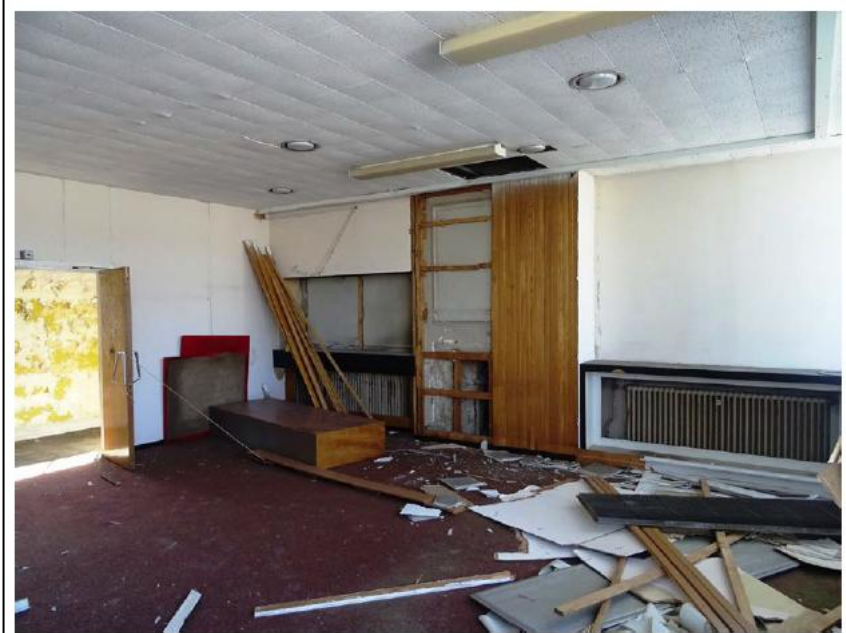
Fig 80 Southern end office room on the first floor of the west wing, looking south-east

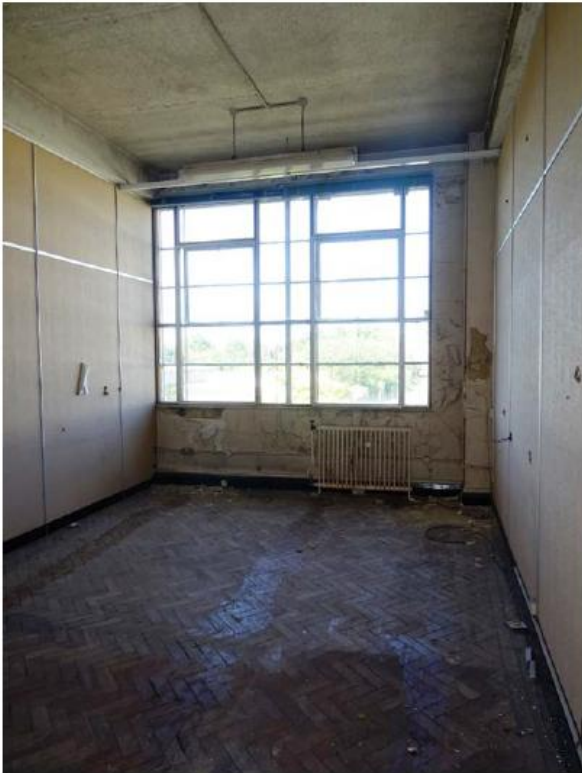
Fig 81 One of the first-floor office rooms in the west wing with herringbone wood parquet flooring

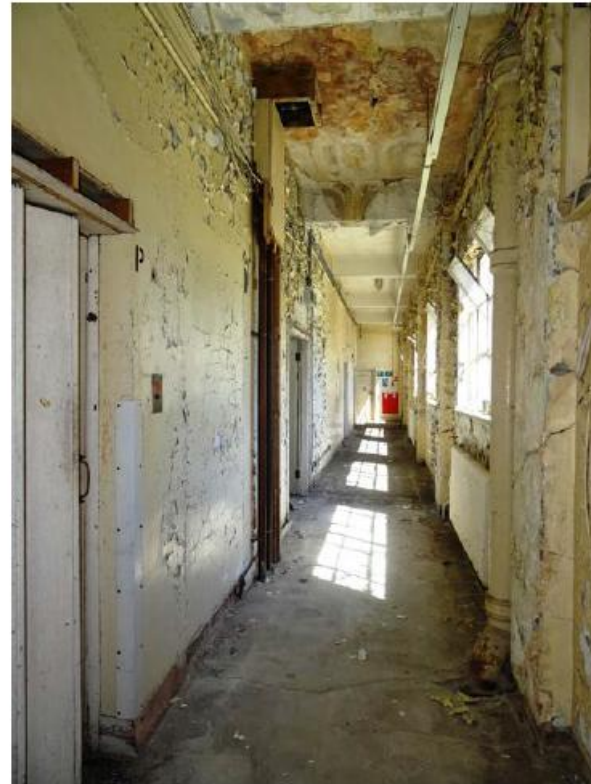
Fig 82 Northern end of the corridor on the first floor, looking north

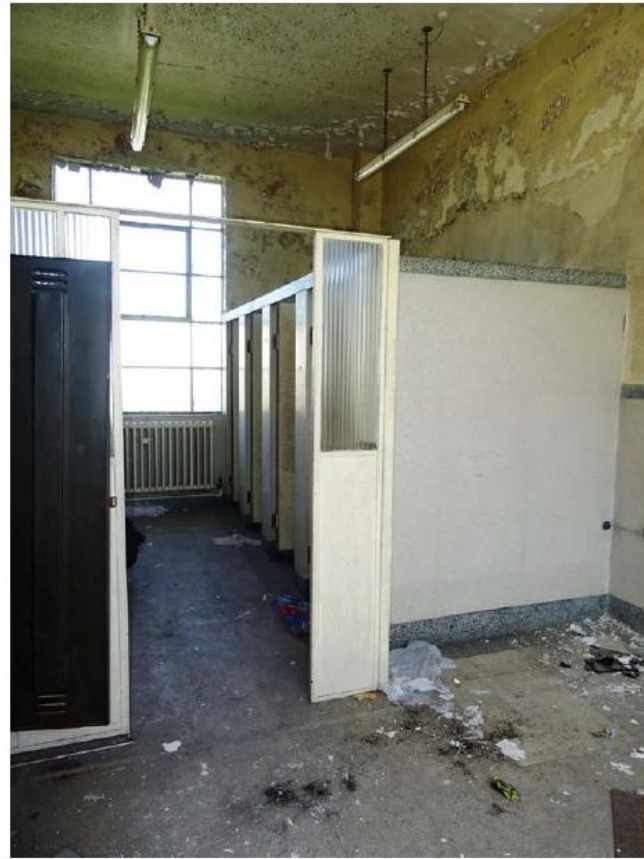
Fig 84 Female WC in the northern end of the west wing on the first floor

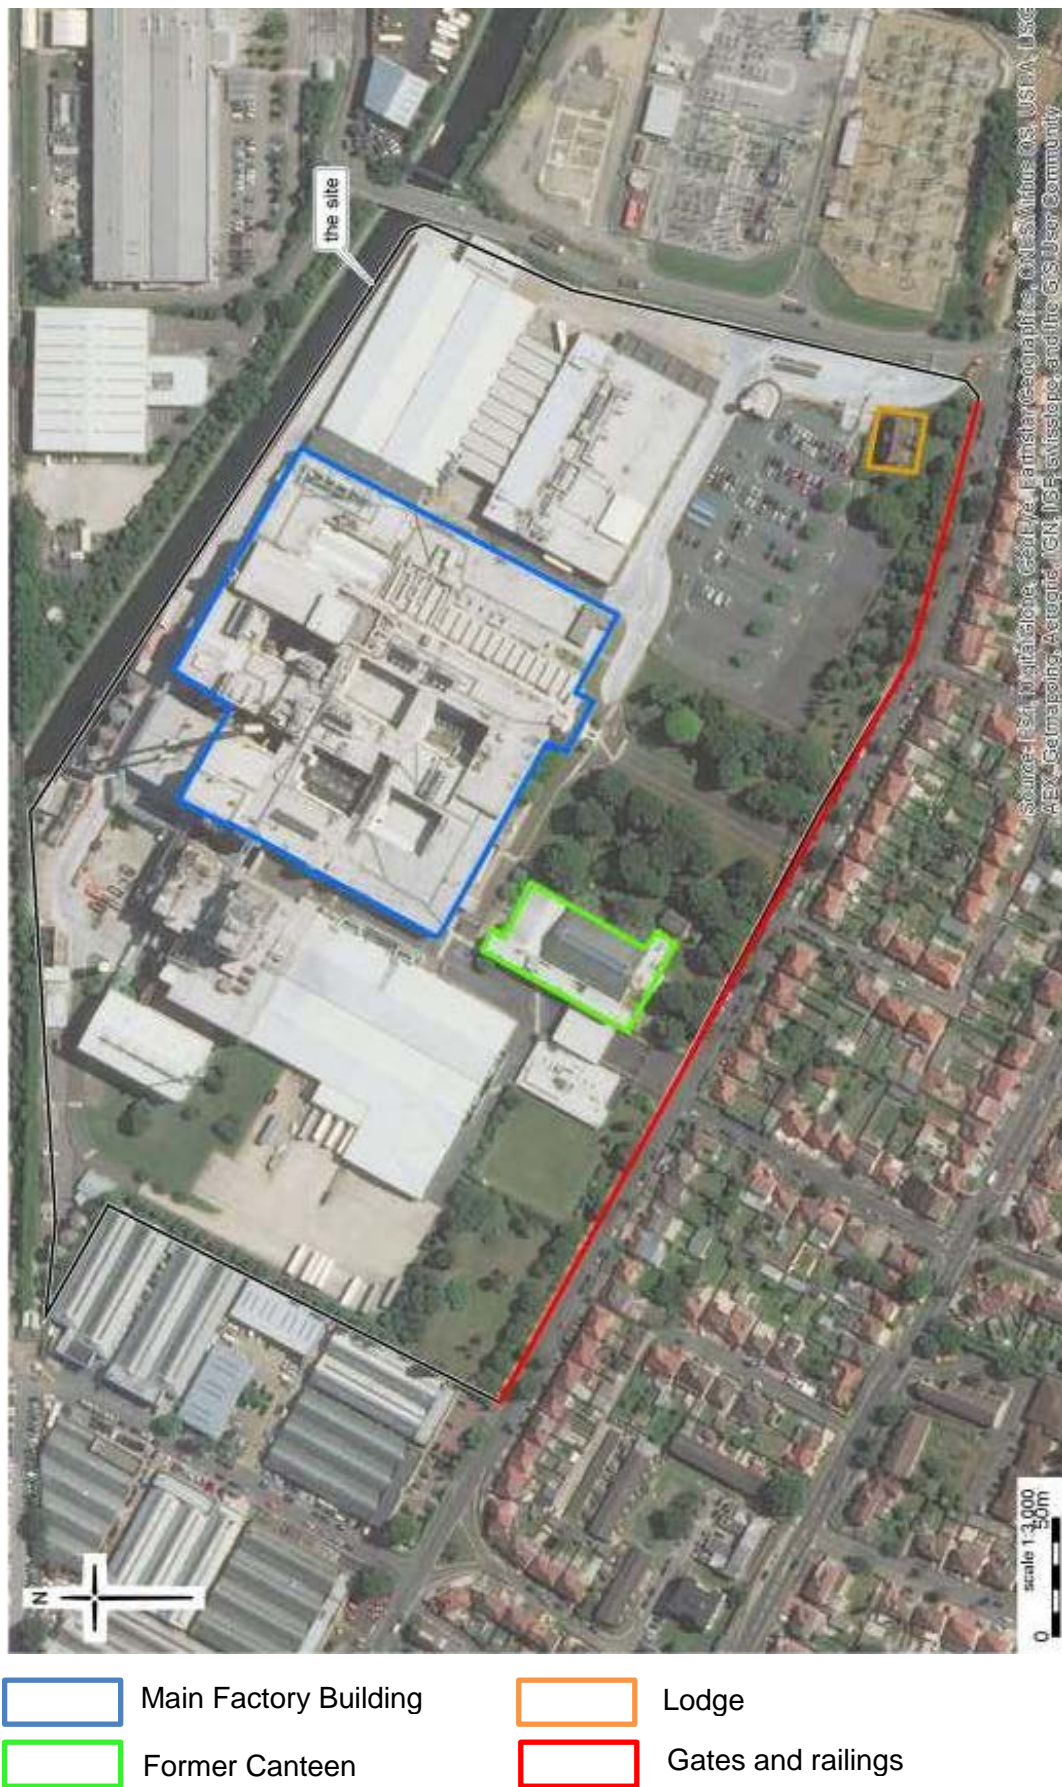
Fig 2 The structures on the site referred to in the text

- 1.1.4 There are four locally listed buildings on the site which form part of the former Nestlé Factory as highlighted in Fig 2. These are as follows (see Fig 2):

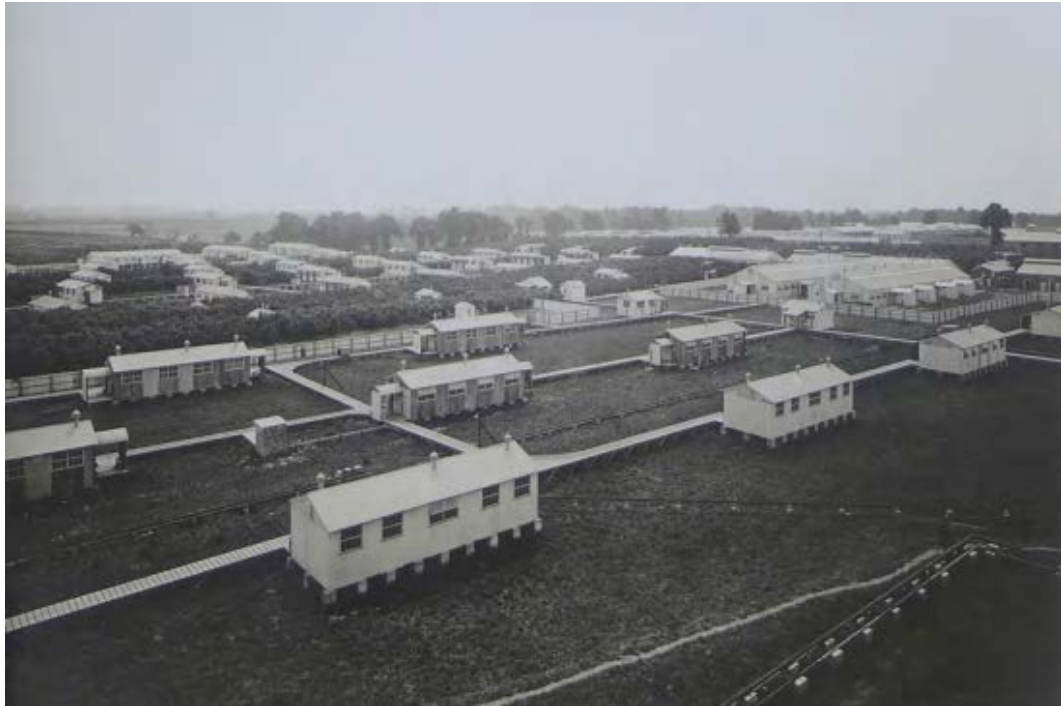
Fig 8 NFF No.7 sheds, cleanways and railway tracks (Collier 2014)

- 2.1.8 Activities which took place at NFF No. 7 were the filling and assembly of quick firing ammunition (QF ammunition) and the filling of larger shells with melted amatol. The amatol filling took place in specialized buildings, but most of the other activities took place in many small timber-framed sheds, huts or shops, usually a standardized 15'x40' allowing for flexibility of use (Fig 8).

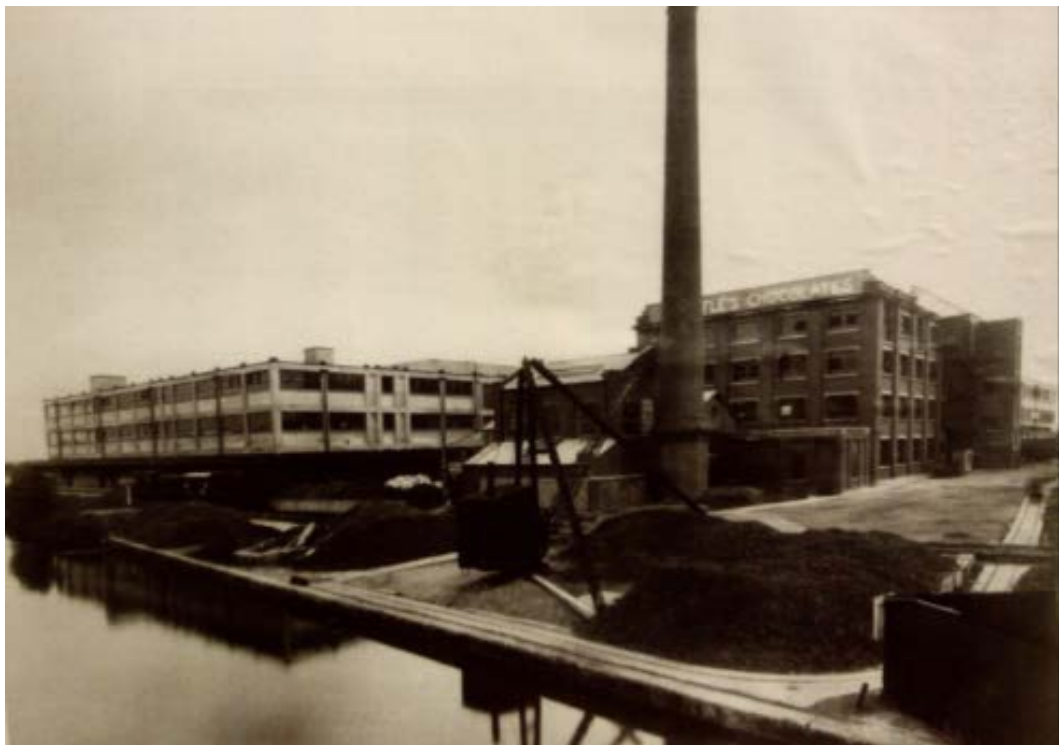
Fig 10 1930s view of the factory from the north-west with the extension (Turley Heritage 2017)

- 2.1.12 The two companies designed a "four storey square-shaped arrangement with four inner courtyards to allow natural light into the factory interiors, set around the existing factory buildings" (Turley Heritage, 2017) (Fig 10). The construction and materials used were the Kahn System of Reinforced Concrete which was groundbreaking technology at the time, invented by American Julius Kahn. In addition, the design of the new extension was part of an overall move toward improving the environment of factories in the US and Europe. The idea of 'Garden Factories' was reflected in both the design of new factory buildings and their surrounding landscapes. In principle, the idea was that 'better grounds make better factories' (Cady, 1947).

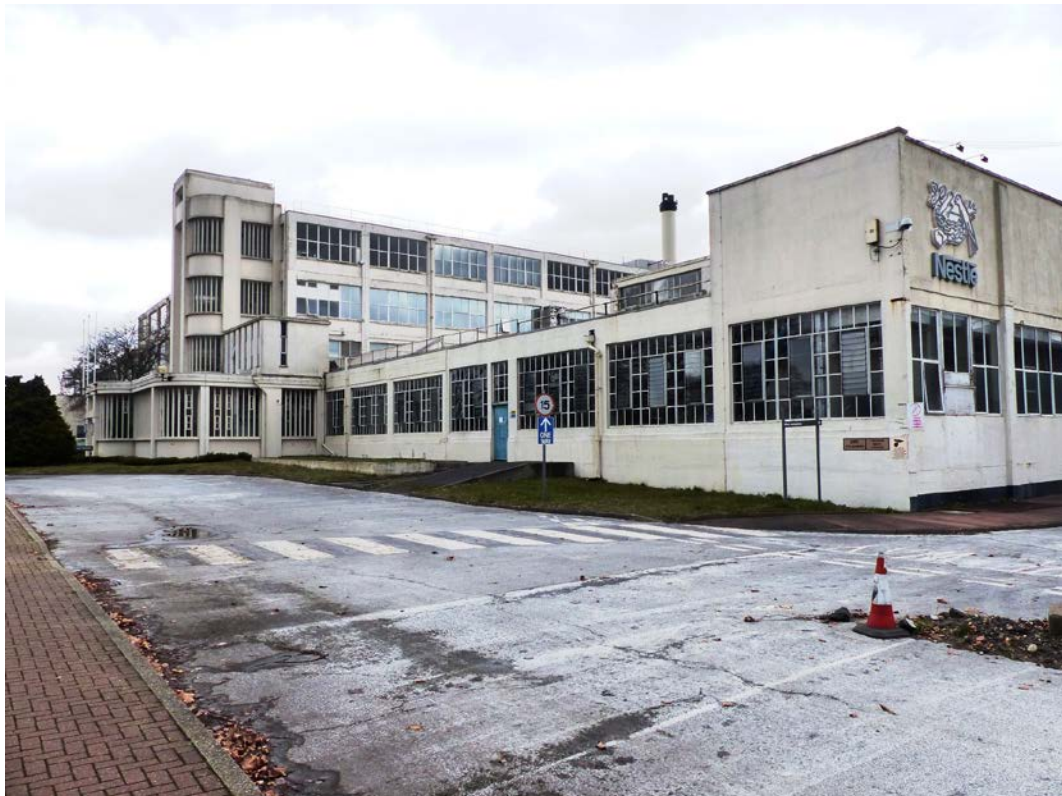
Fig 14 Main factory building, looking north-west

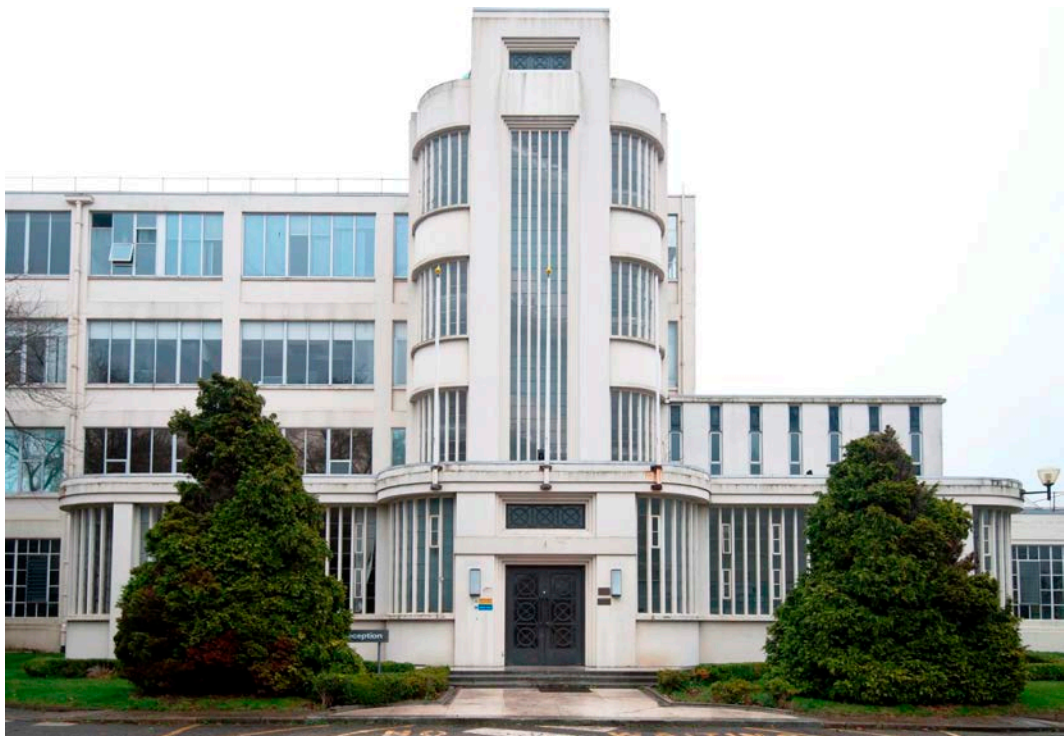
Fig 15 Main entrance tower

- 3.2.6 The main entrance to the building projects out from the south elevation in the form of a tower containing the foyer, the main staircase and a lift shaft. This element of the building was added later but an exact date of its construction is not known. However, according to the heritage statement review of available archival documentation has confirmed that it was likely constructed between 1954 and 1963 (Fig 15).

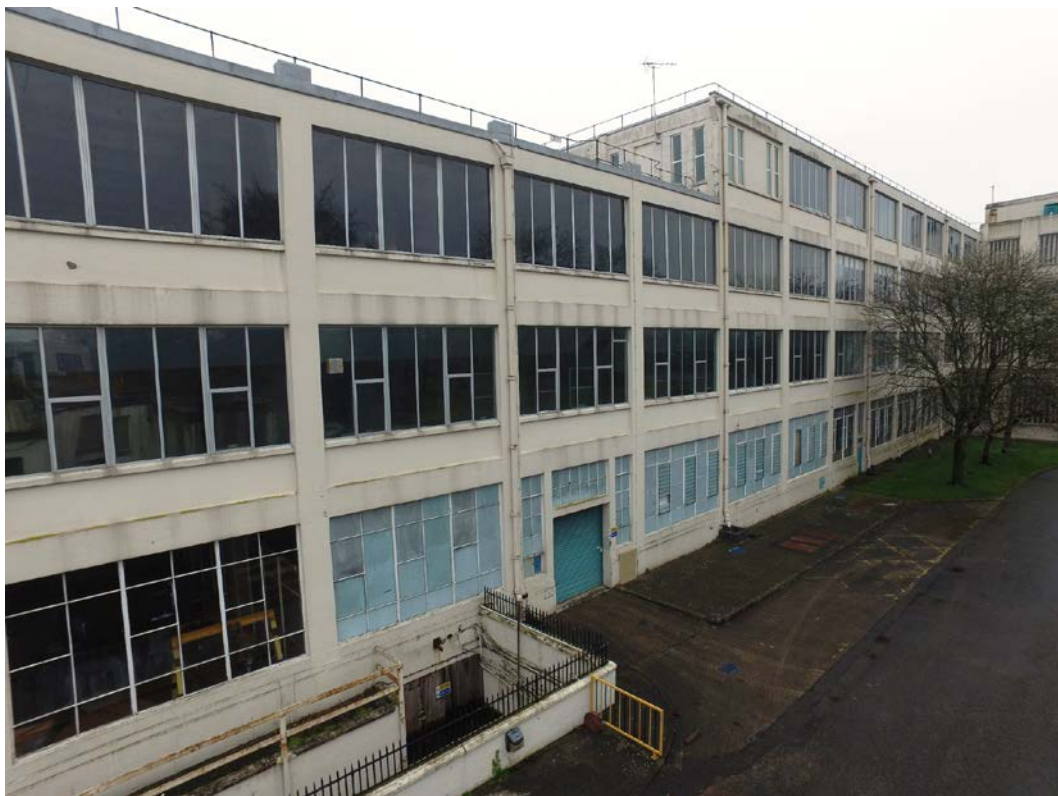
Fig 16 Central section of the south elevation of the main factory building

- 3.2.9 The external elevations of the building have a relatively plain and repetitive appearance. Both south and west elevations of the building are formed of equal bays of multi-pane windows with crittall style metal glazing on all floors.
- 3.2.10 The south facing (front) elevation of the building comprises a three storey section at the west end (Fig 16), while the central section is four storeys high with the entrance tower added in the mid-20th century as described above; the east end of the south elevation is formed of the single storey range that was also added as part of the extension of the factory.

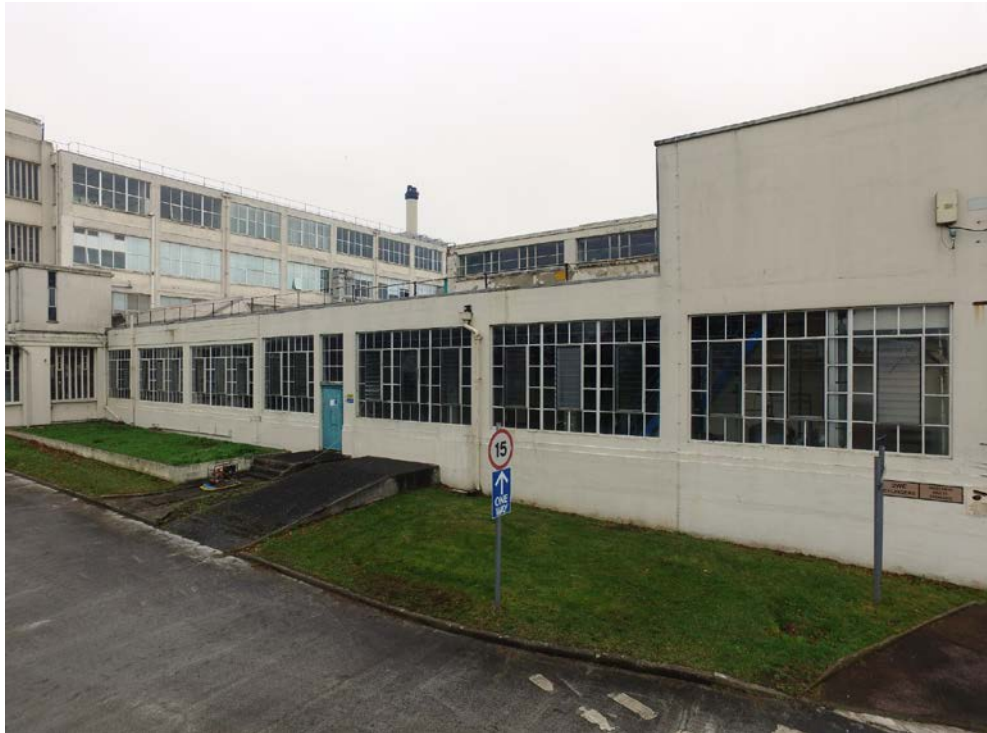
Fig 17 Single storey east section of the south elevation

- 3.2.13 The single storey east end of the elevation is formed of the reinforced concrete extension of the main factory. Its design complemented the existing exterior of the building, having a similar bay formation with each bay having large multi-pane windows. However, the windows in this section have been observed with louvred glass sections. It has a pedestrian entrance doorway approximately in the centre accessed by steps as well as a concrete ramp. The east end of the extension is two storeys high; there are no features in the first-floor level (Fig 17).

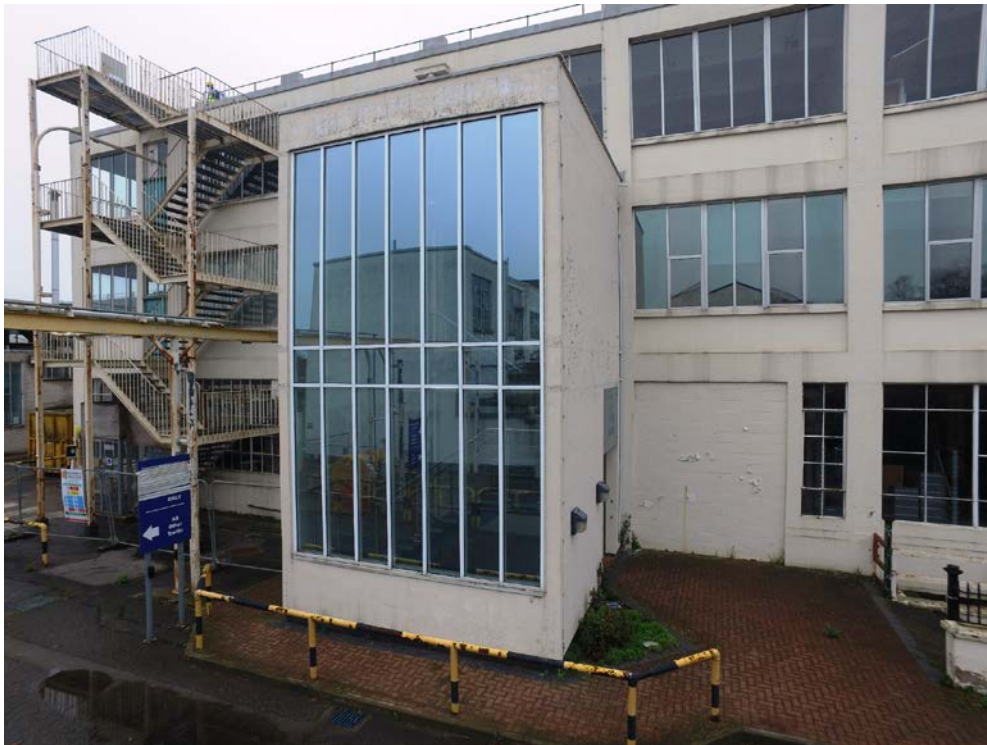
Fig 18 West end of south elevation with a steel fire escape staircase and the modern stair tower

- 3.2.11 The west end of the elevation contains a projected bay housing a staircase that provided access to the first and second floor and is possibly a modern addition to the building. Further west of the south elevation is a steel fire escape staircase that provided access to all three floors and up to the rooftop (Fig 18).

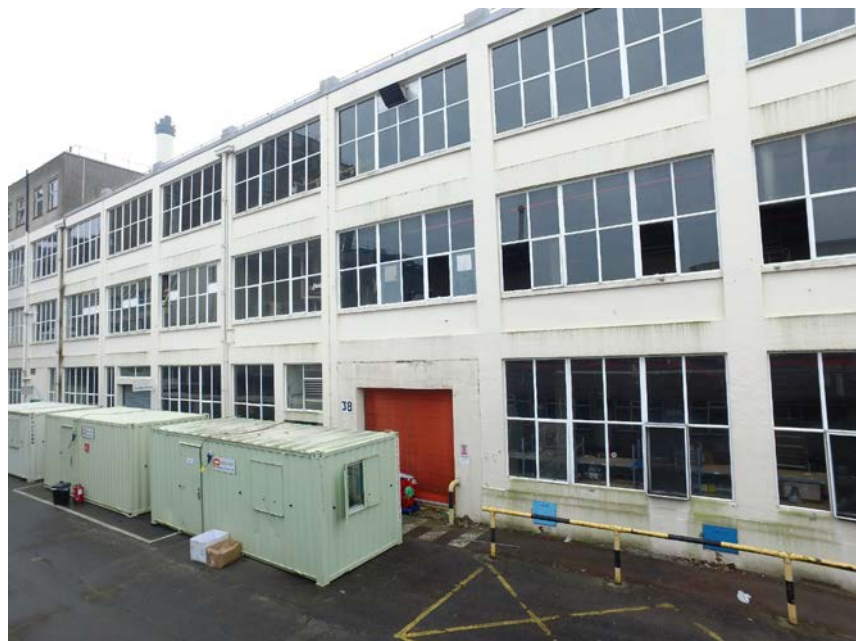
Fig 19 Central section of the west elevation

- 3.2.14 West elevation of the building also has the general bay formation of multi-pane windows with crittall style metal glazing on all floors. The 1920s Truscon building in this elevation is three storeys high with a number of loading bays and pedestrian entrances on the ground level. The north end of the west elevation is formed by the earlier building with distinctive red brick plinth. The openings in the earlier building have concrete mouldings. There is a projecting stairwell at the north end of the 1920s building, and a loading bay has been added to the 1912 further north on the west elevation (Fig 19, Fig 20).

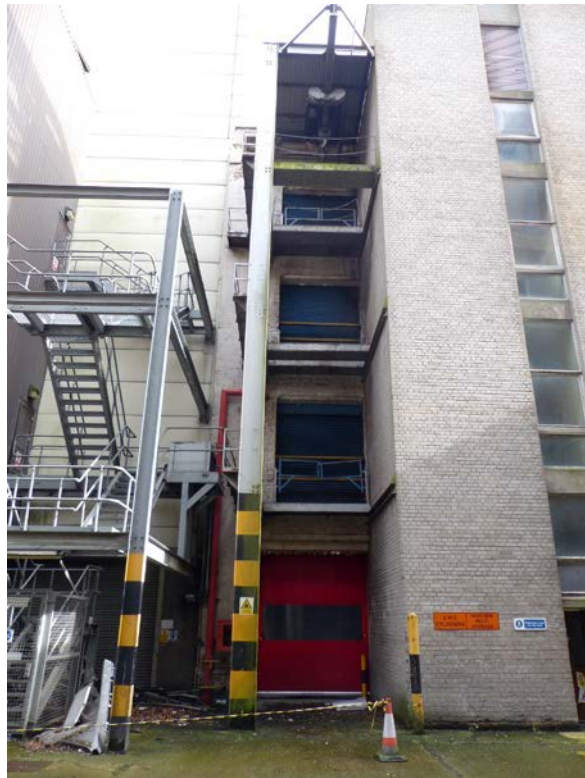
Fig 20 Loading platforms have been added to the north end of the west elevation. Loading bays have been formed by inserting openings in the older part of the factory

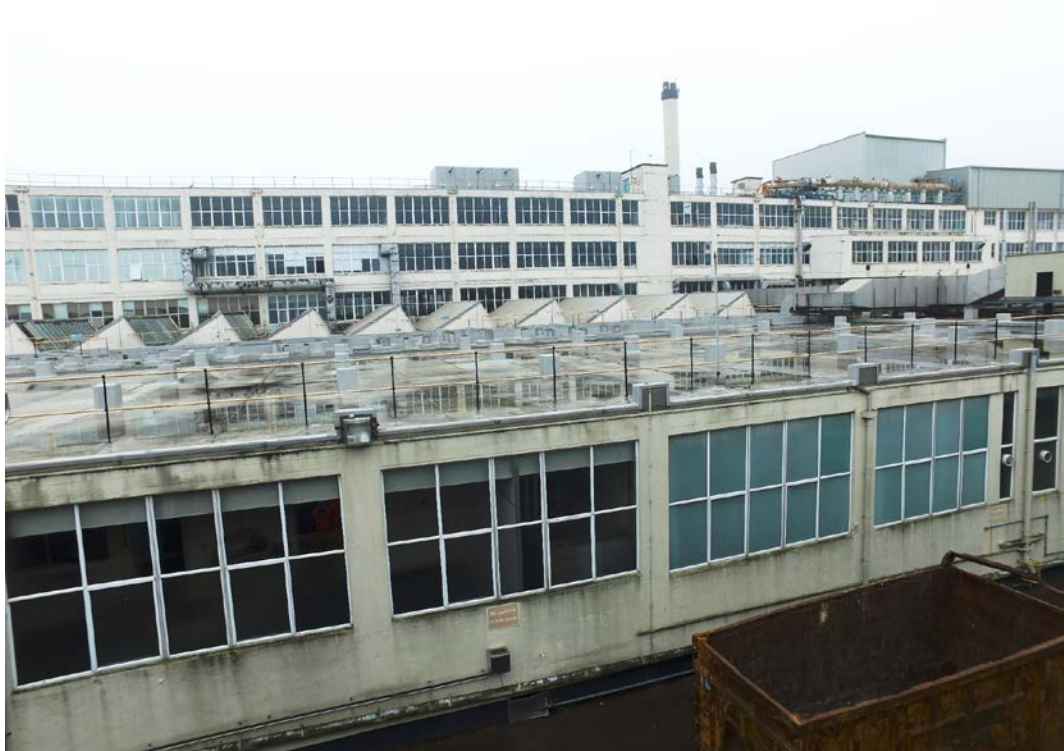
Fig 21 Central section of the east elevation

- 3.2.15 The east elevation of the building is formed of the single storey section of the factory above which the four-storey central building, as well as the industrial M roof, was visible. The two storey section at the south end of the elevation has a large Nestlé insignia on the first-floor level whilst the north end of the east elevation has a large canopy. The canopy is formed of reinforced concrete trusses where the elements are rebate jointed. The canopy is covered in corrugated asbestos sheets with a row of skylights. There are loading doors located within the area covered by the canopy. Presumably, this section functioned as a loading bay (Fig 21, Fig 22, Fig 23, Fig 24).

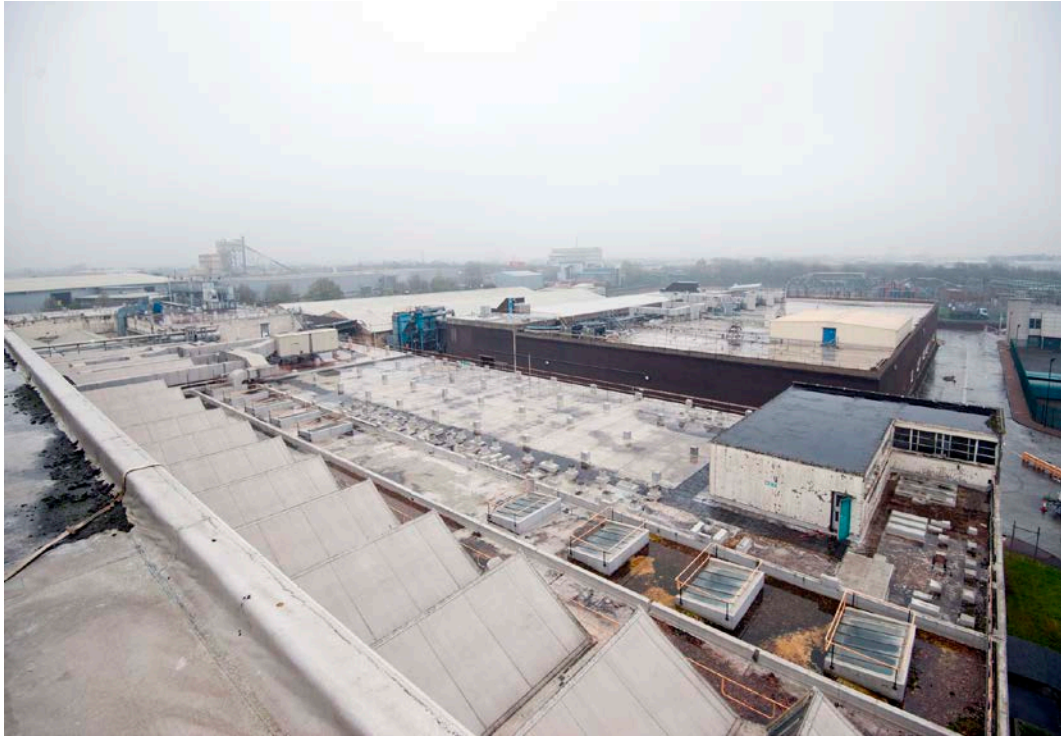
Fig 22 Single storey section of the factory building, view from the roof of the four storey section

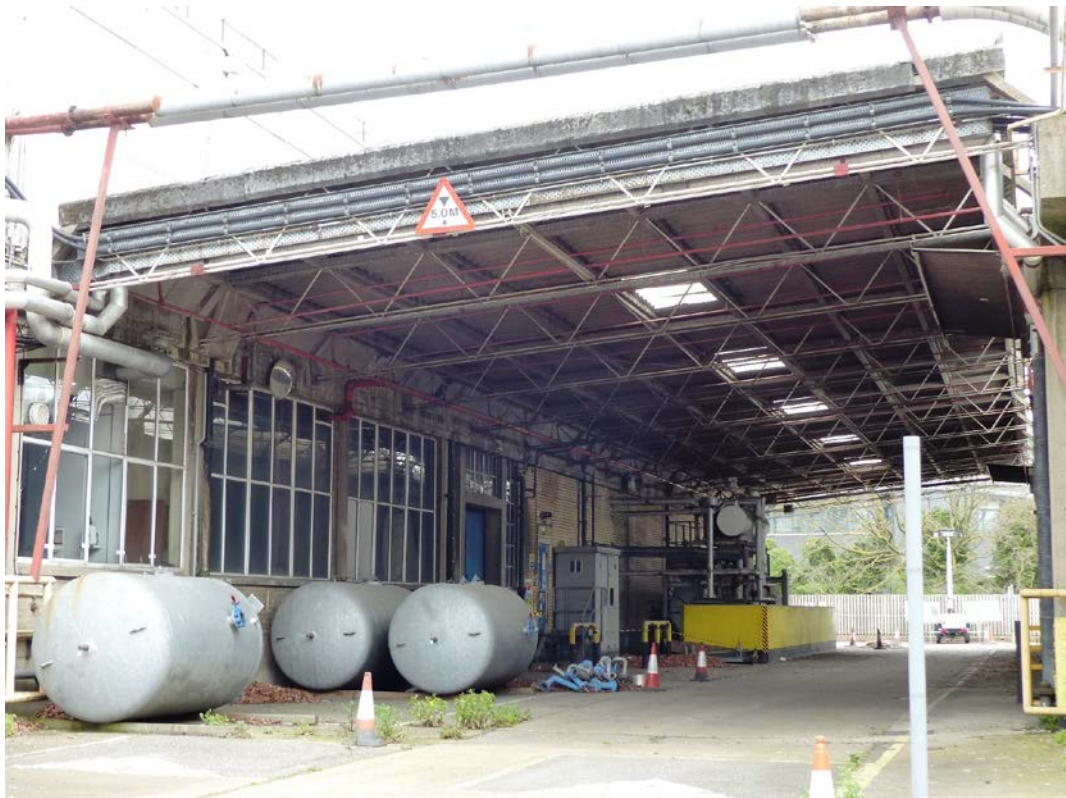
Fig 23 The canopy at the north end of the east elevation, looking north-west

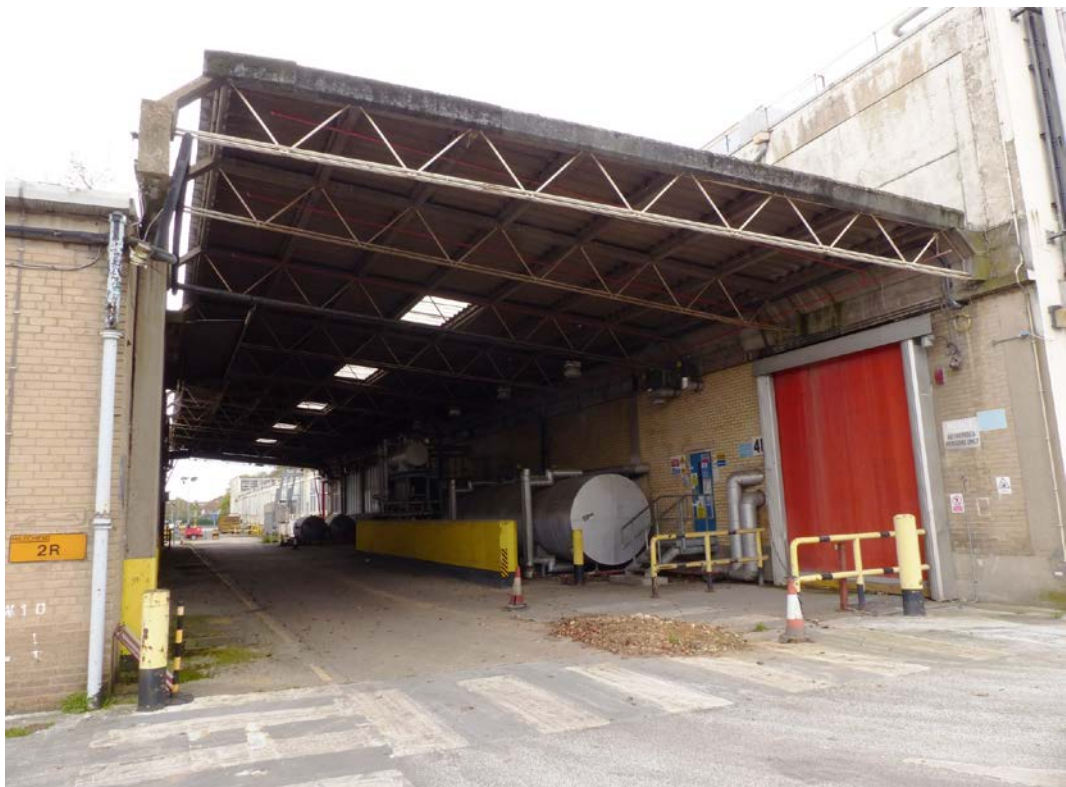
Fig 24 Loading bay covered in a canopy at the northern end of the east elevation

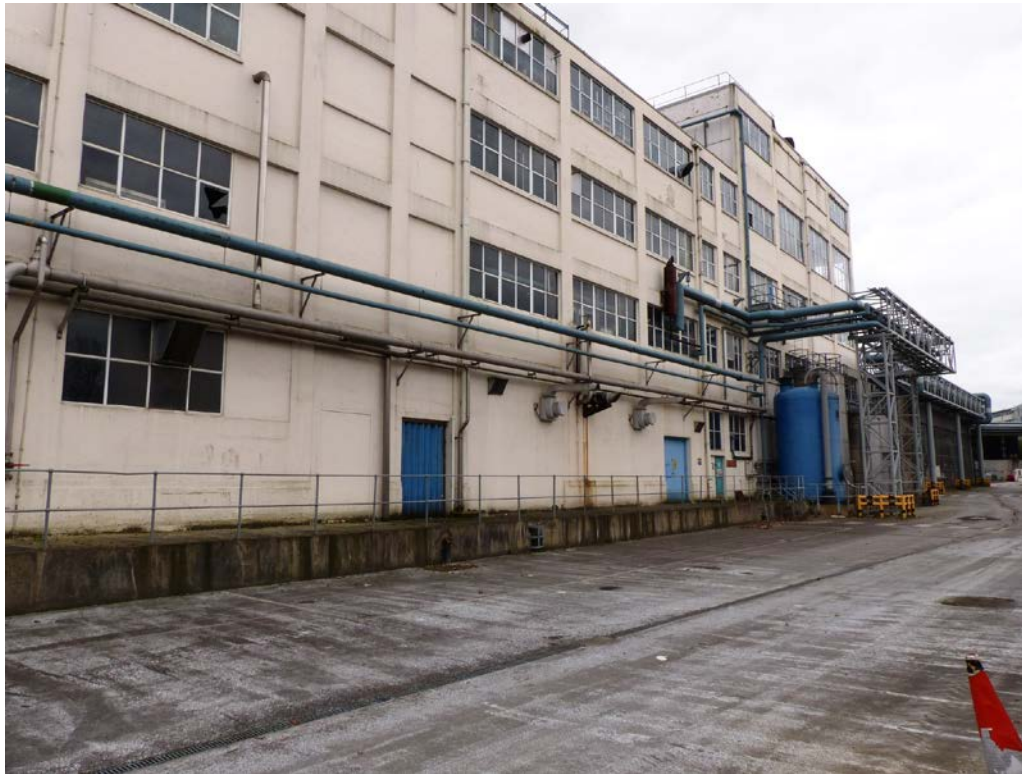
Fig 25 West end of the north facing rear elevation of the factory building

3.2.16 The north facing rear elevation of the building comprises a two-storey section to the east while the rest of the elevation is three to four storeys high. Apart from a lift shaft bay the north elevation also formed of bays with multi-pane crittall style windows on all floors. However, windows in this elevation are not as large as those in the other façades. A wide concrete platform with protective handrail

runs along this section of the elevation. A number of double doors and goods lift door are accessed from the platform. Whilst the two storey section of the elevation has no fenestration in the first-floor level and intermittent bays of windows on the ground level. It has a large loading bay located approximately in the centre of the double-storied eastern section of the elevation (Fig 25, Fig 26).

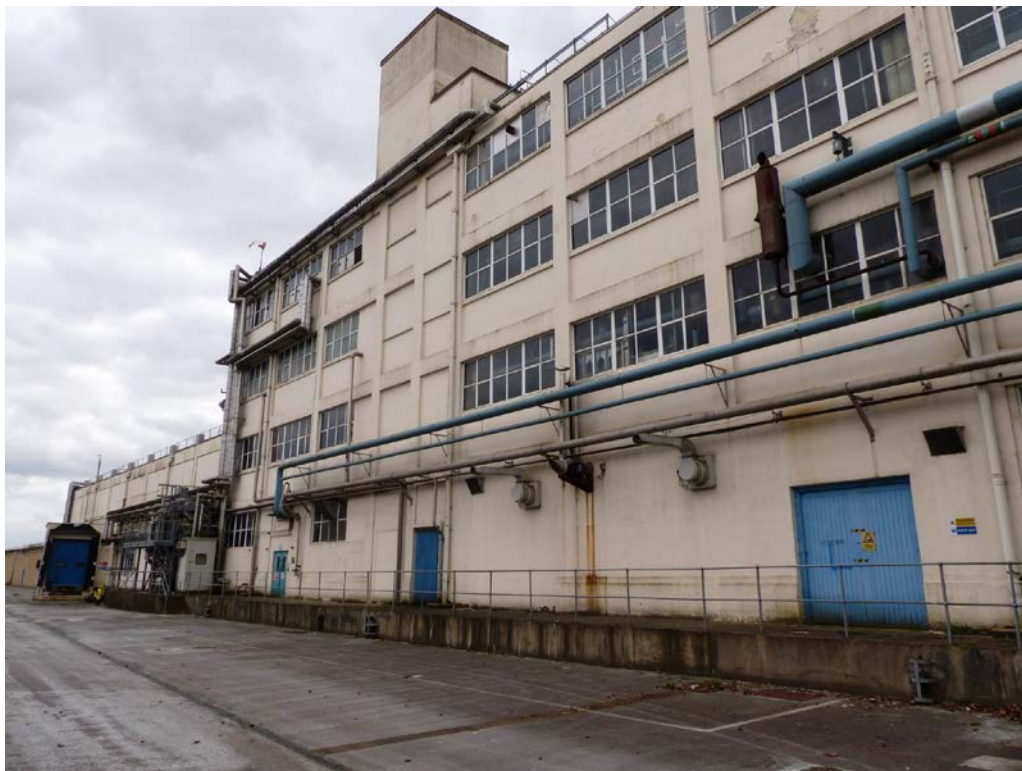
Fig 26 East end of the north elevation of the factory building

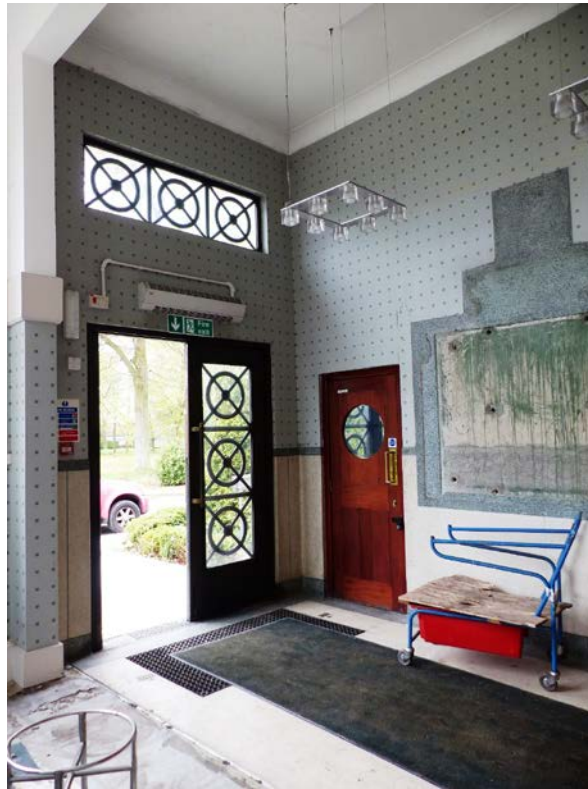
Fig 27 internal view of the main entrance door

- 3.2.17 The main entrance to the factory building is through the entrance tower. It has a large heavy brass double door that swings inward and outwards and leads into a hallway and a lobby area to the east. The hallway and lobby have a terrazzo tiled floor. The stairwell walls on the ground floor originally had a rubbed concrete finish, but it has been covered in plasterboard. The foyer area has fixed glazing above dado height with central pivoting panes. There is a wooden dado rail running below the glazing panes (Fig 27, Fig 28).

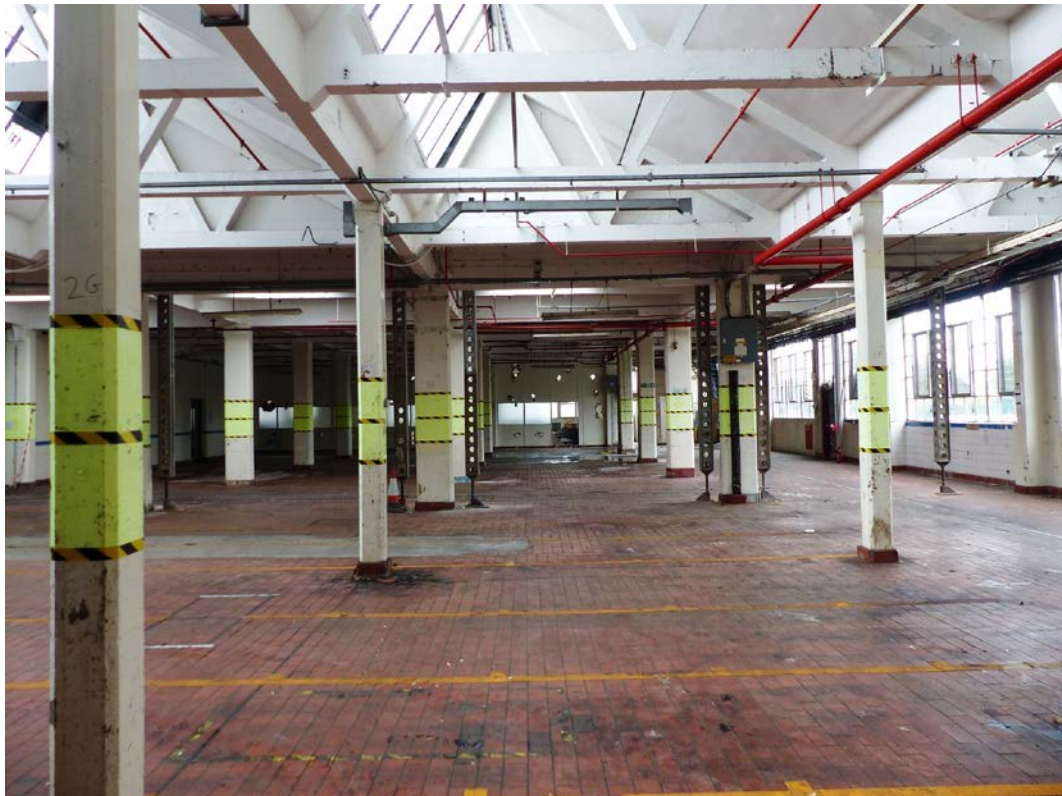
Fig 29 Ground floor storage area within the single storey east section, looking east

- 3.2.20 The south side of the ground floor interior is mainly open with partitioned rooms which appeared to be mostly for storage and in the original layout. Large open space along the south and east side of the building GF17 is also used as storage area. GF1, GF2, GF3 and GF17 has the red tiled floor. The eastern side of the building is single-storied with a reinforced concrete industrial roof with clearstories. Along the east end on the ground floor, there are four small rooms GF4 to GF7 which functioned as laboratories (Fig 29).

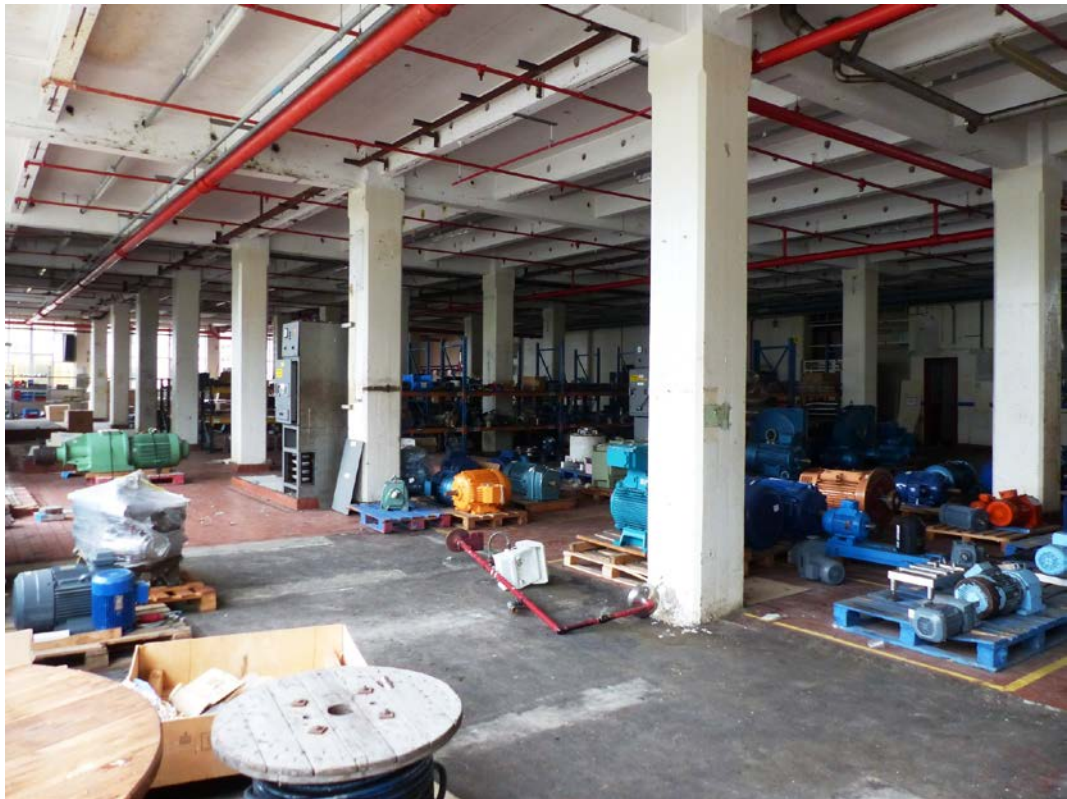
Fig 30 Storage area in the south-west corner of ground floor GF1, looking north-west

- 3.2.21 Area GF2 is accessible from the south through a forklift truck entrance. The red tiled floor of this area was observed with a number of plinths which were presumably installed for the placement of plant and machinery. A double door in the north wall provided access to a storage area that has been inserted into the light well (GF9) (Fig 31). It is constructed of steel framing and corrugated steel sheet walls with a shallow steel roof and has a red tiled floor. The south-west corner area on ground floor, GF1, has a steel mesh-enclosed area which likely functioned as a storage area. Currently, there are hundreds of used motors stored in this area (Fig 30). A staircase raised from GF1 provided access on to the first floor while it has a pedestrian entrance from the south and a loading bay at the north-west corner (Fig 32).
