Building Recording (Level 2)

Photographic Record (Volume 2)

Former Nestlé Factory Canteen Building, Nestles Avenue,
Hayes

March 2026

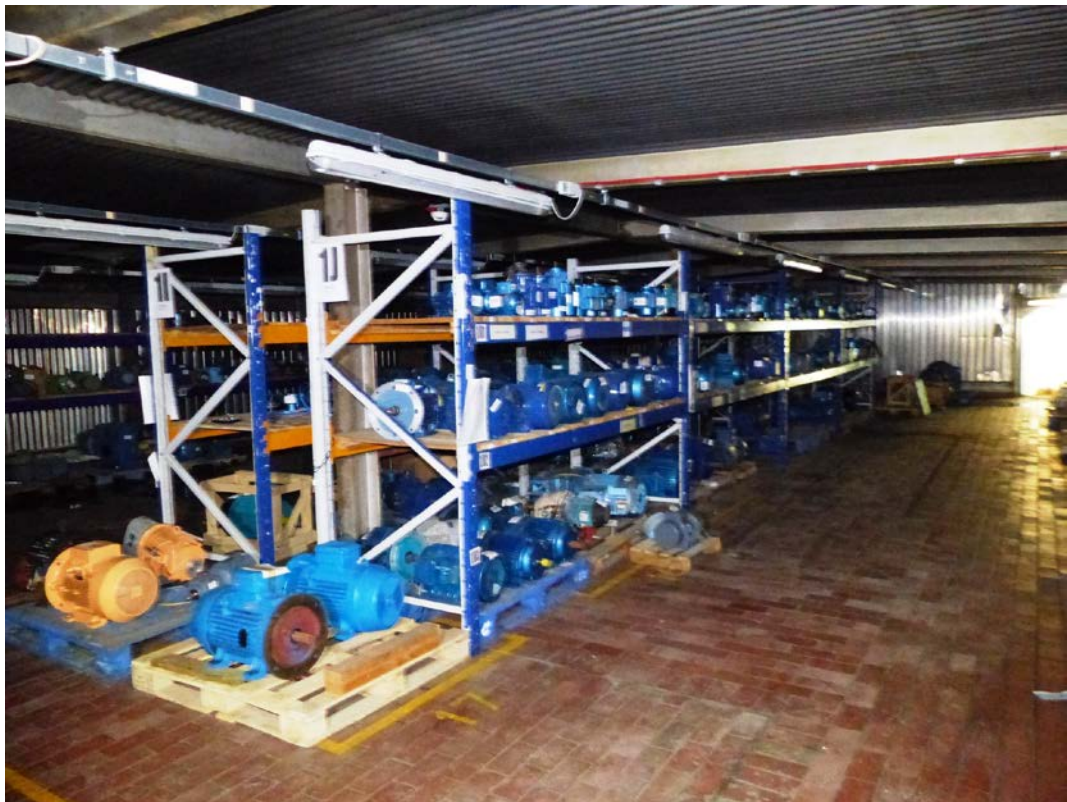
Fig 31 Inserted steel storage area with tiled floor accessed from GF1

- 3.2.21 Area GF2 is accessible from the south through a forklift truck entrance. The red tiled floor of this area was observed with a number of plinths which were presumably installed for the placement of plant and machinery. A double door in the north wall provided access to a storage area that has been inserted into the light well (GF9) (Fig 31). It is constructed of steel framing and corrugated steel sheet walls with a shallow steel roof and has a red tiled floor. The south-west corner area on ground floor, GF1, has a steel mesh-enclosed area which likely functioned as a storage area. Currently, there are hundreds of used motors stored in this area (Fig 30). A staircase raised from GF1 provided access on to the first floor while it has a pedestrian entrance from the south and a loading bay at the north-west corner (Fig 32).

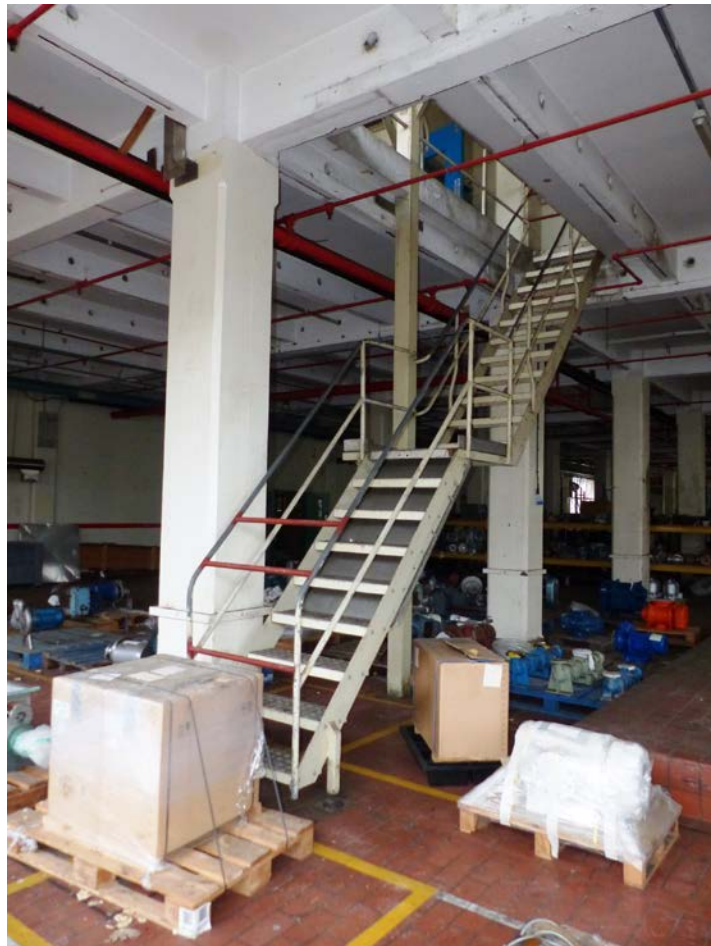
Fig 32 A staircase from GF1 provided access up to the first floor, looking north-

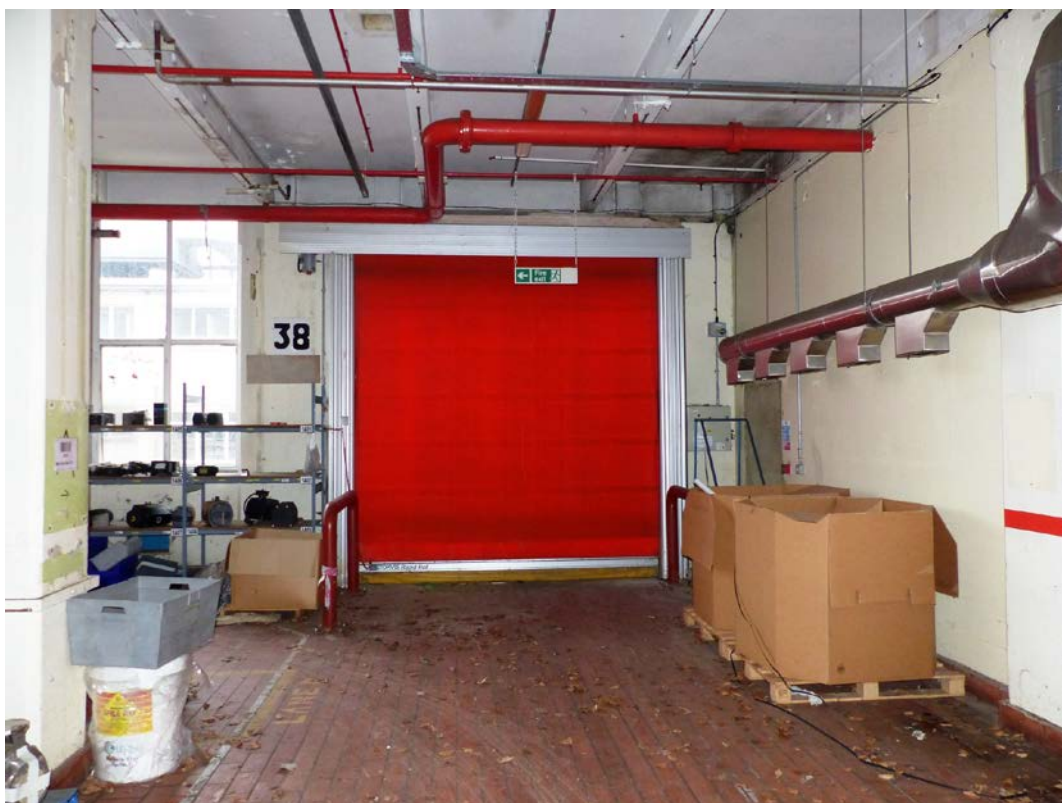
Fig 33 Loading bay at the south-west corner of GF1

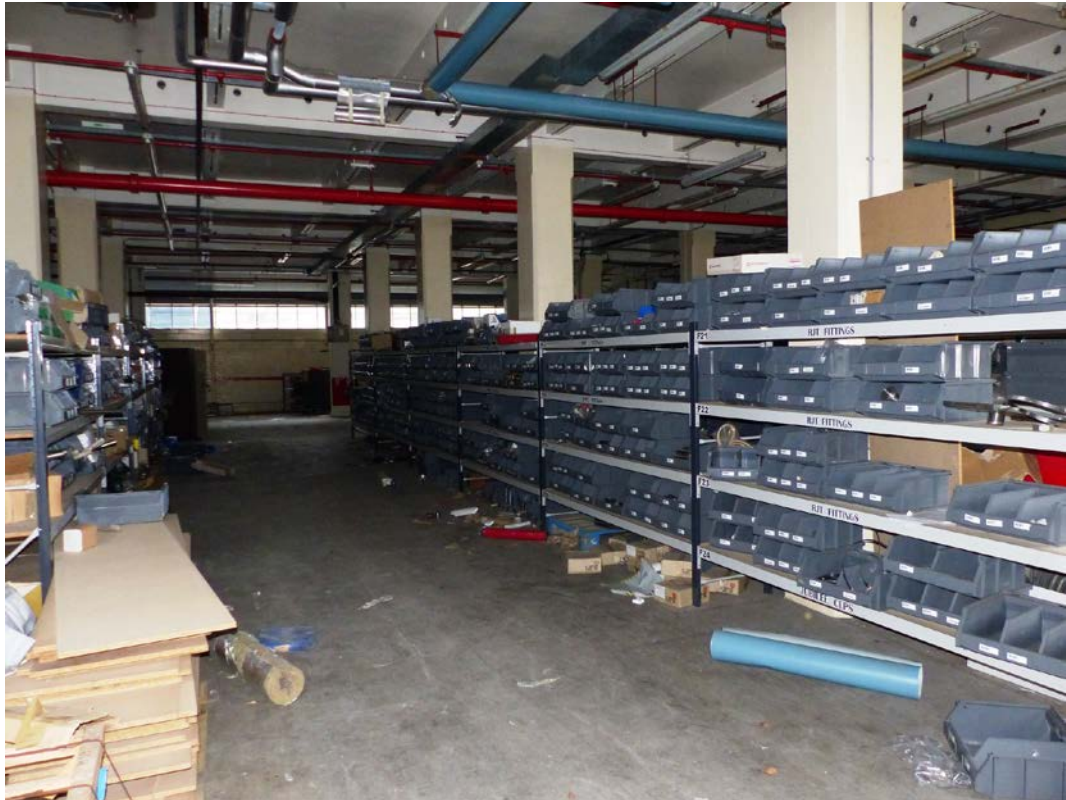
Fig 34 Interior of GF8, looking west

- 3.2.22 Area GF8 along the west side of the ground floor is a large storage area with steel shelves. This area is accessible through a vehicle entrance as well as a pedestrian entrance from the west. The shelving has been used to store workshop tools and parts. It has a painted concrete floor. The east end of the area has been extended into the original light well (GF9) with a steel corrugated lean-to roof and large multi-pane windows to the east. The original external wall to the light-well has been removed however scarring from the walls are evident on the floor (Fig 34).

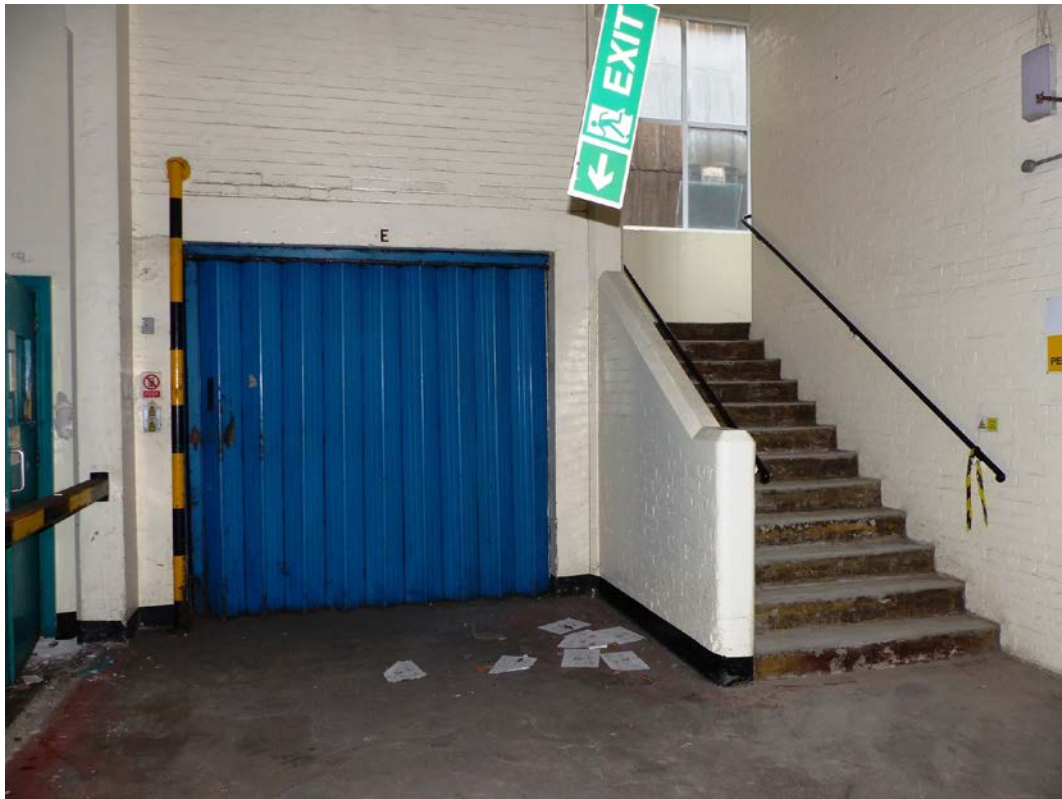
Fig 35 Staircase and goods lift next to GF18

- 3.2.23 From GF8 a double door leads on to a small hallway from where the light well is accessible through a small door. The hallway also faces a small counter opening. The hallway also leads onto a long westward running corridor that has external access from west of the building. It is possible that in the original layout GF8 and GF18 was a single volume of space before the corridor was formed by inserting two side walls of modern breeze blocks. Further north a double door leads onto the east-west running corridor and fork-lift route. The hallway provides access to a lift shaft and a staircase (Fig 35).

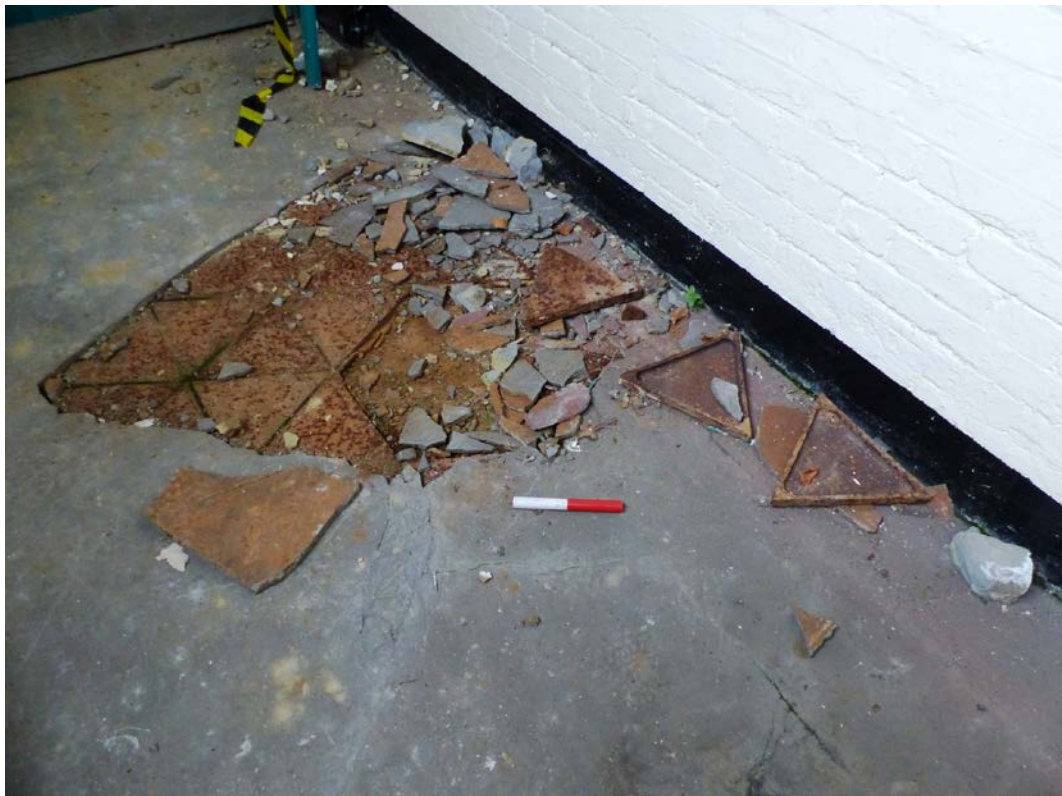
Fig 36 Steel triangular blocks formed the forklift route

roof with skylights (Fig 39). GF27 is a large wide area containing fork-lift route with an external entrance from the west. The floor of this area was also formed of triangular steel plates.

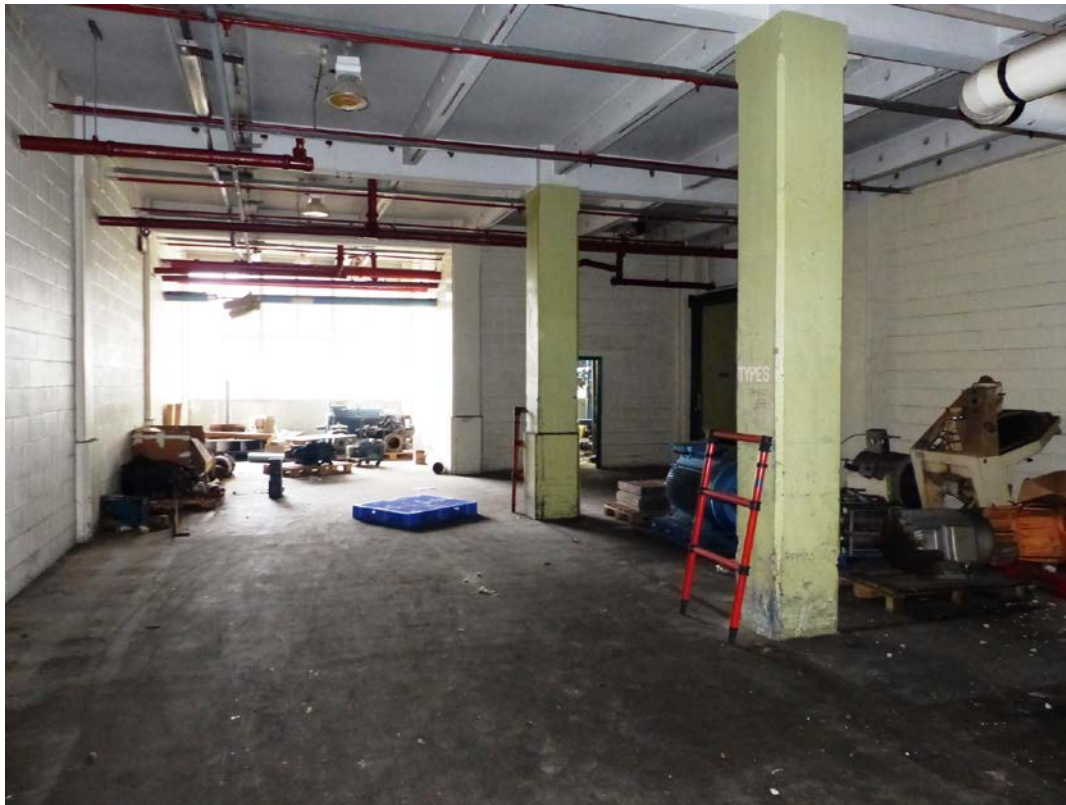
Fig 37 Southern part of GF18, looking west

- 3.2.24 Room GF18 is a large area and functioned as the entrance of a fork-lift route. The northern part of GF18 is located within the original 1912 construction with a large fork-lift entrance from the west (Fig 37). The room also contains a plant room along the west side and a switch room at the east end. This room, as well as the fork-lift route to the east, currently has a concrete rendered floor however through some damaged areas the original floor was observed. The original floor surface was formed of triangular steel plates (Fig 36). Further east is room GF20, also located within the earlier building. It has a jack-arched brick ceiling. Room GF20 to GF23 are all large volume spaces which functioned as Tote Bin Storage areas (Fig 38, Fig 40).

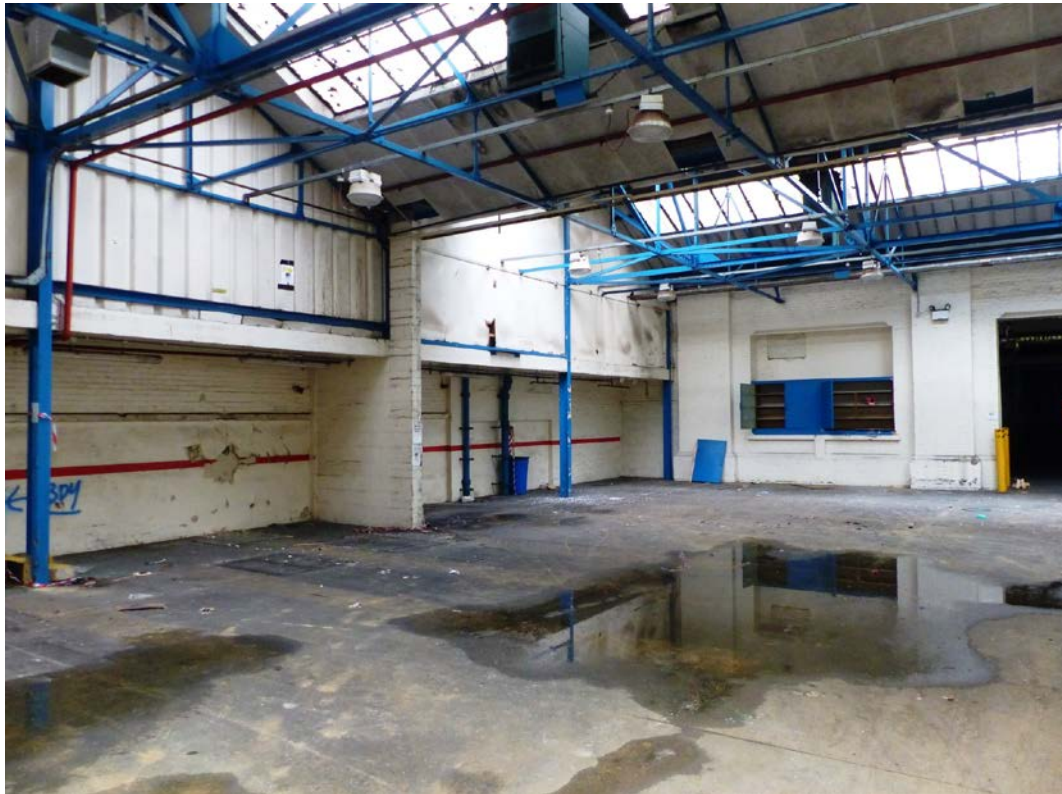
Fig 39 Interior of GF25

- 3.2.25 GF21 is located within a single story section with an industrial M roof, possibly constructed within an original light as well. A double door from GF21 provided access into GF25 which has been used as a workshop and located within the light well of the original building. It has a concrete floor and steel framed industrial

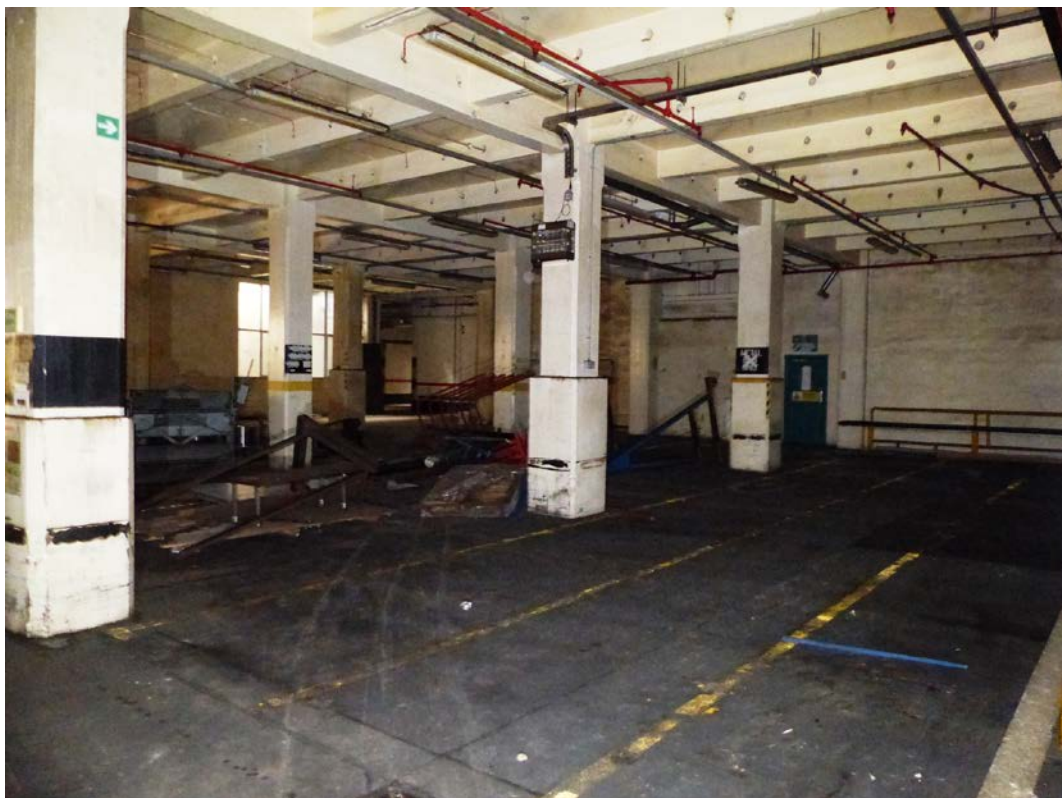
Fig 40 Tote Bin Store, GF22, looking north-west

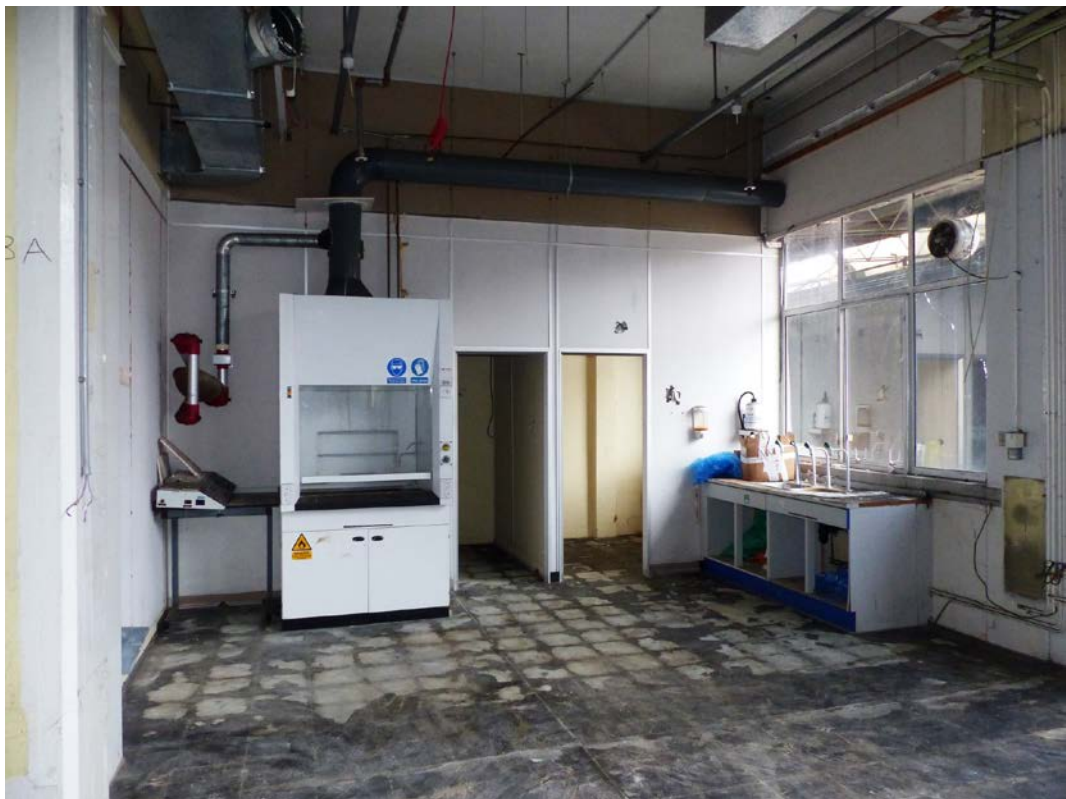
Fig 43 Laboratory area in the north-east corner of GF34

3.2.26 Room G34 is mainly a large open room possibly for storage. It has asbestos tiled flooring and windows to the east (Fig 42). The north end of the area contains a laboratory section with two small chambers (Fig 43). G35 is a large storage area with brick wall to the north separating it from two plant rooms in the north-east corner on the ground floor (Fig 44). This area was not accessible due to hazardous toxic chemicals. A westward running corridor from G35 leads onto a wider fork lift route inside the factory which runs all the way to the north.

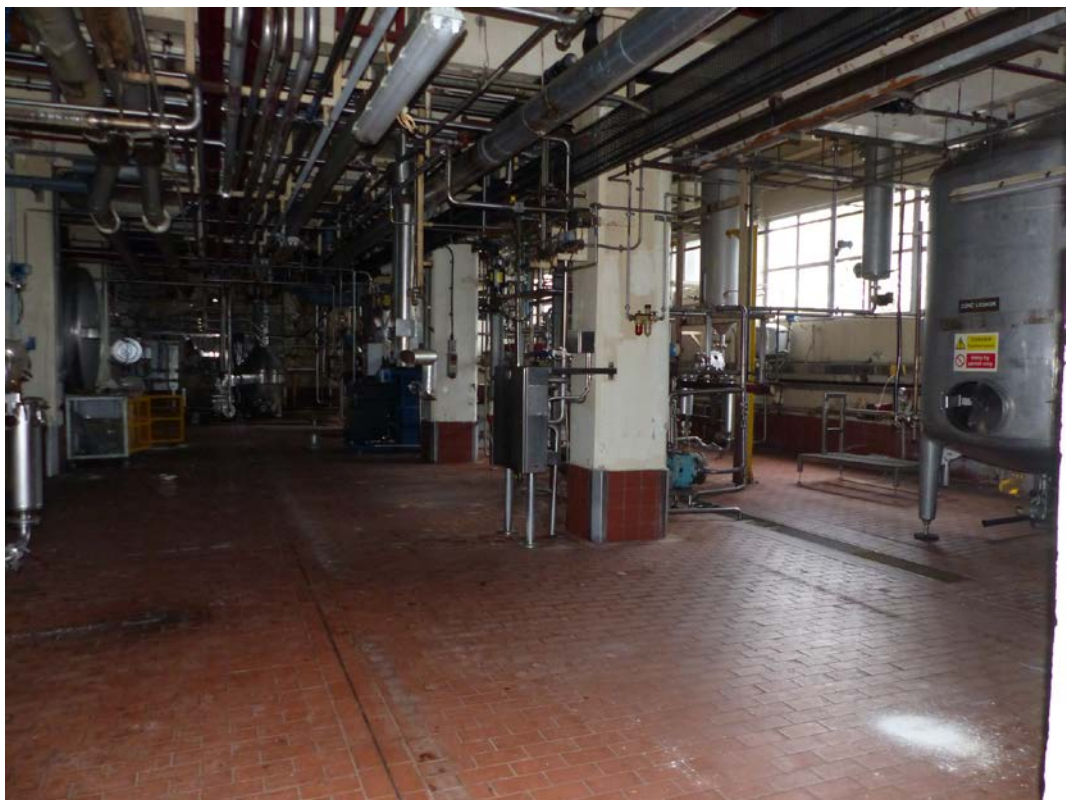
Fig 45 Room GF39

- 3.2.27 The north-west corner of the ground floor, GF39, contains a processing area with the red tiled floor. The reinforced concrete columns in the area have similar red tiled dressed plinths. Steel machinery are fixed onto both the columns and the floor. A number of drainage channels have also been observed running through the floor (Fig 45).

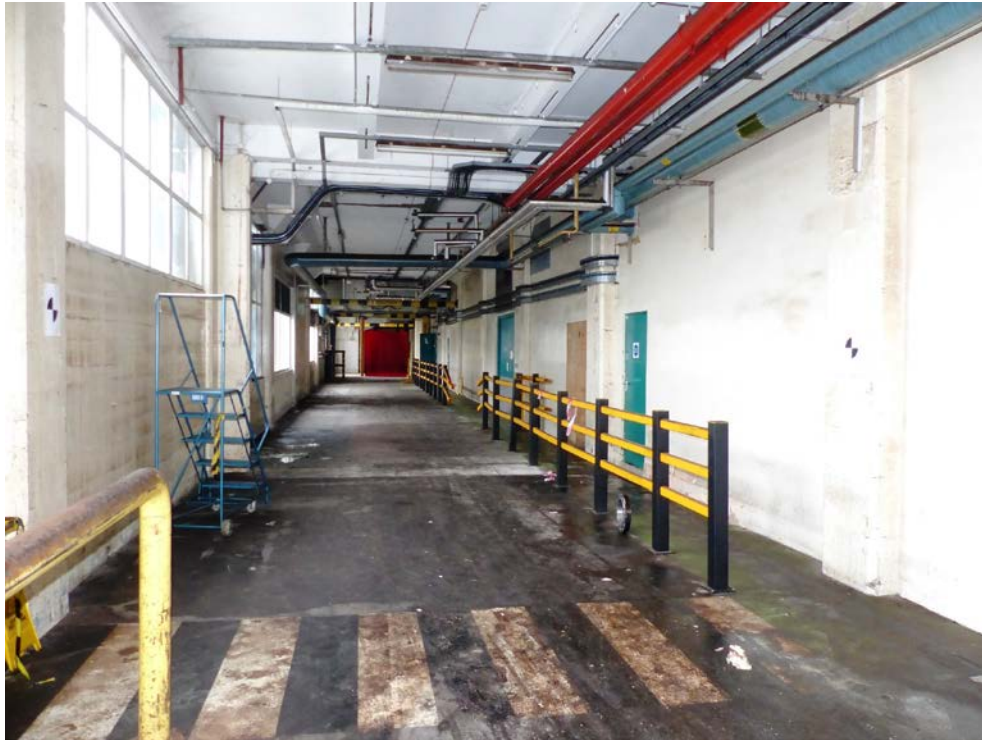
Fig 46 Fork-lift route along the north end of the ground floor, looking east

3.2.28 Along the north side of the ground floor runs a forklift circulation route that provides access to the loading bays at the rear of the building. This area has multi-pane clerestory windows to the north. On the south side of the fork-lift route there is a protected pedestrian route that provided access to a number of large plant rooms (GF44, GF45). Another central forklift route runs south from it which provides access to the large storage rooms GF32, GF33 and ends in GF17. This route also has a protected pedestrian route running along its path up to GF17 (Fig 46, Fig 47).

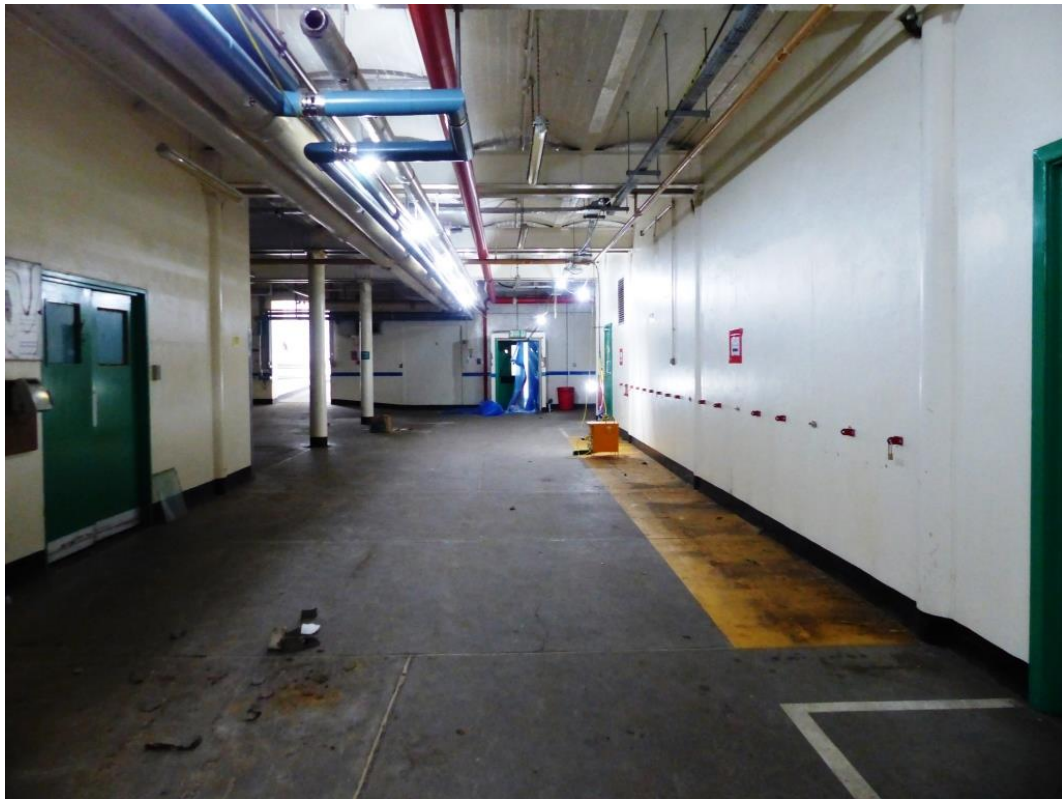
Fig 49 Evidence of the original 1914 Sandow building looking west; the doors to room 1F32 can be seen in the left of the photograph.

- 3.2.32 The rooms along the west elevation include 1F18-1F30. Rooms 1F18-1F20, inclusive, were the male and female locker rooms, showers and toilets. These rooms were accessed through separate entrances at both the north and south ends. Directly north of this area, evidence of the original 1914 Sandow factory building can be seen in the change to vaulted ceilings, brick walls and rounded support pillars. In addition, this part of the building received less natural light due to the nature of its construction (Fig 49).

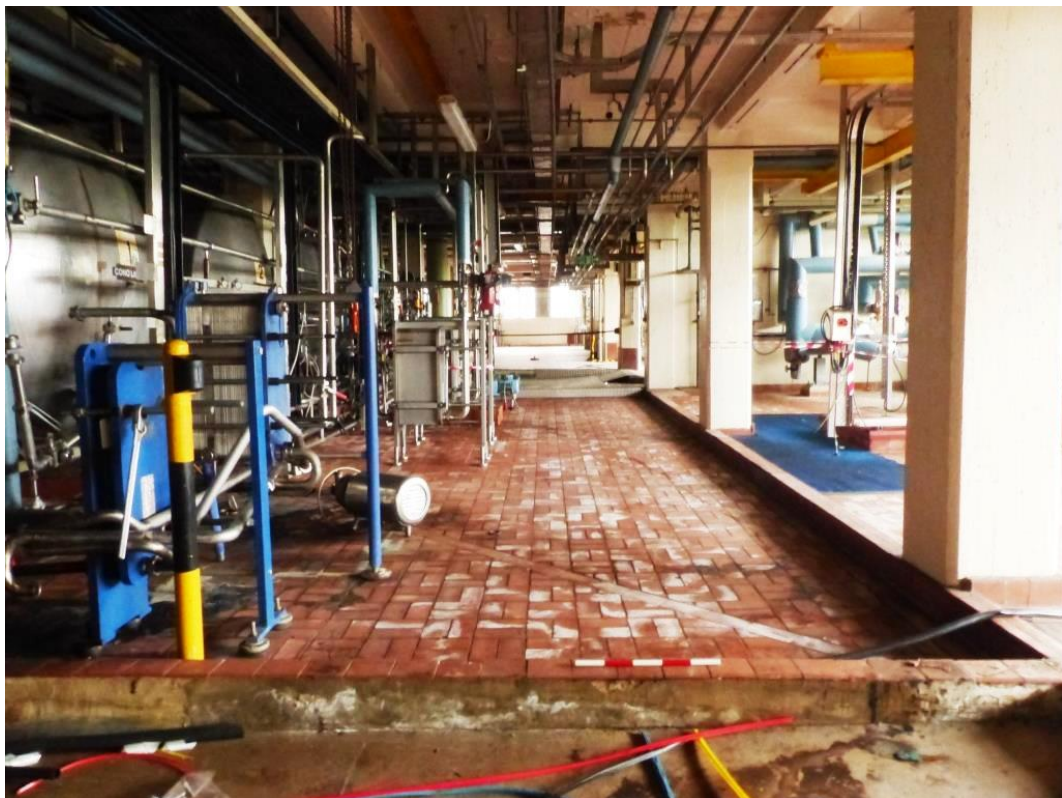
Fig 50 Room 1F49 looking west

series of very large rooms, containing coffee roasting and drying equipment, are located along the north end of the building (1F45 – 1F52) (Fig 50). These large rooms have red tiled floors and variable levels. Heading east through these rooms are large storage rooms 1F51-1F52 which were used for storing green coffee beans.

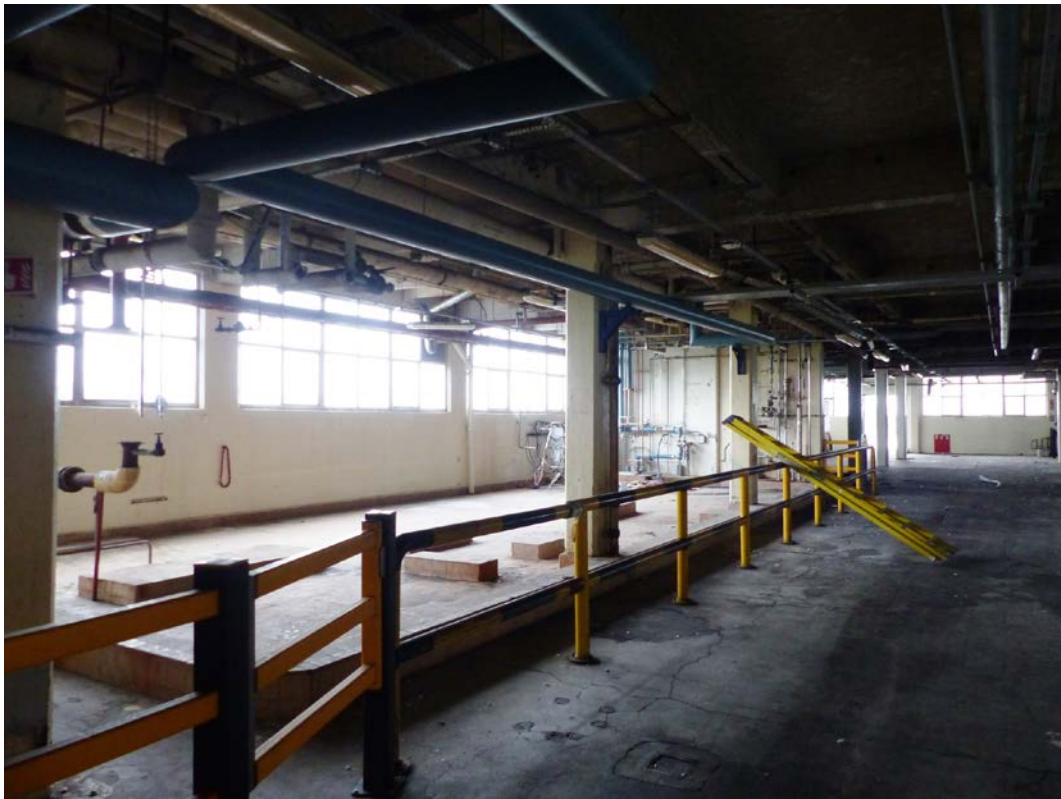
Fig 55 Processing areas along the fork-lift route on the second floor at the north end of the building

- 3.2.40 The north end of the second floor contains a number of chocolate and coffee processing areas as well as a large open space for storage and a fork-lift route (Fig 55). Room 2F25 along the east side of the second floor contains a number of coffee and chocolate processing chambers (Fig 56).

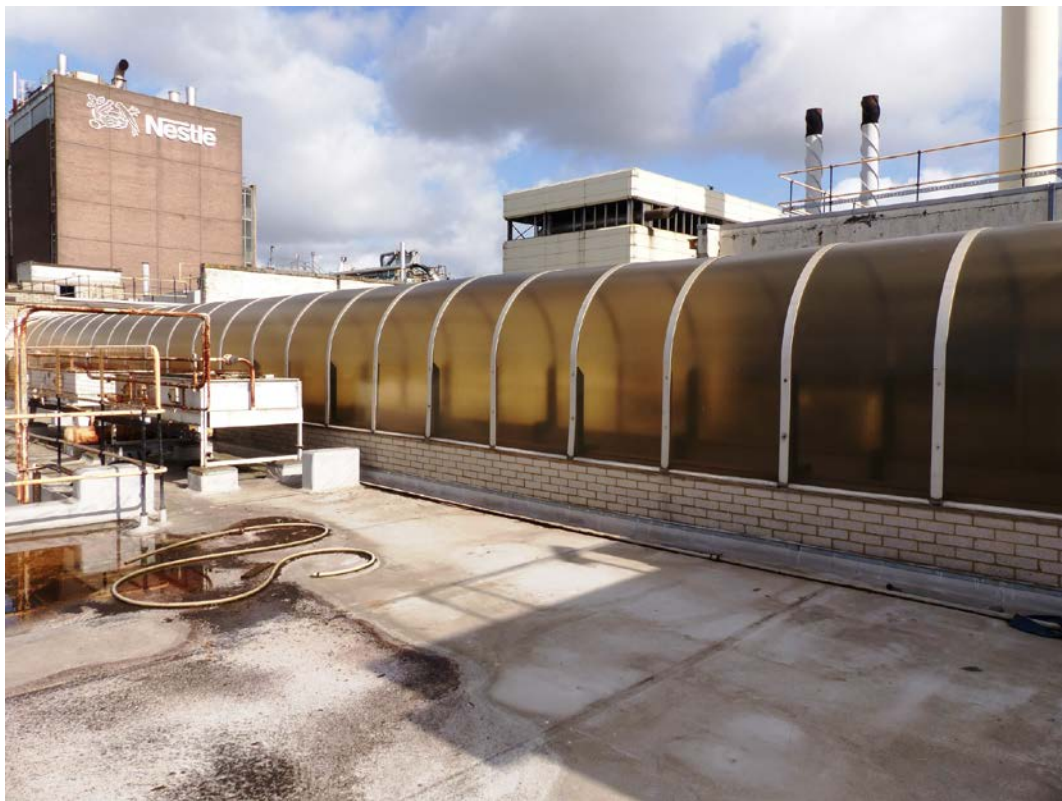
Fig 58 Covered walkway providing access to the older part of the building on the third floor

- 3.2.41 The third floor of the factory building covers a smaller extent than the second floor, as the south-west corner of the building does not have a third-floor level. The north-east section on the third floor contains some processing areas while the central section contains small office areas. The south-east section contained office and storage areas (Fig 57). The third floor of the earlier building in the north-west corner contained a museum, a library and some other services.
- 3.2.42 The office rooms in the central section are connected by a north-south corridor providing access to all areas in this section of the building. The corridor also connects to the north-west side via a covered walkway at its south end. The covered walkway from the central section leads into the third floor of the earlier building in the north-west corner (Fig 58, Fig 59, Fig 60).

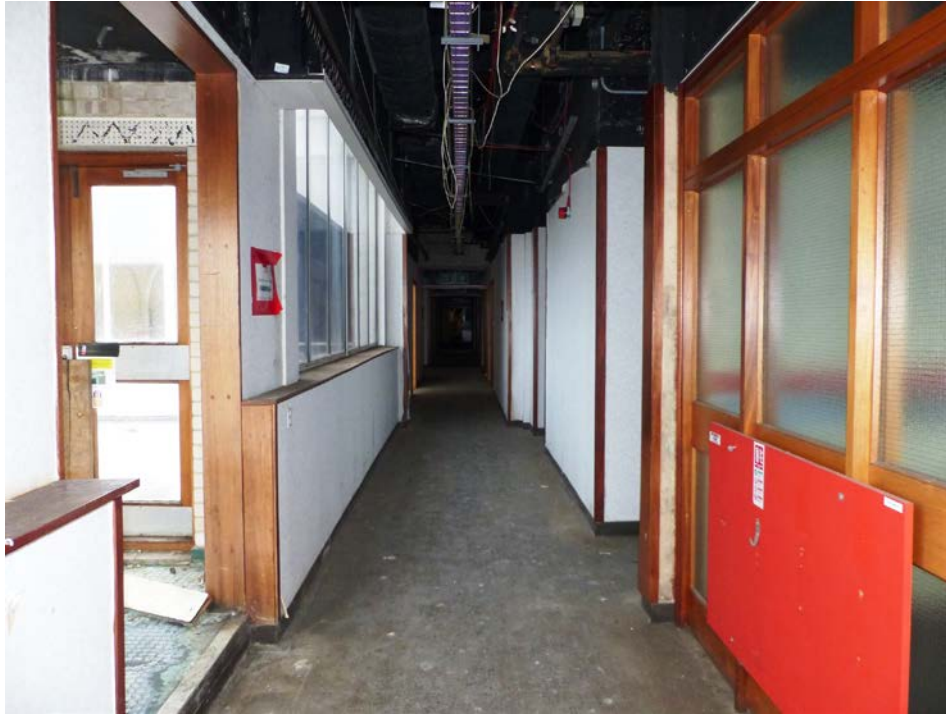
Fig 60 A north-south running corridor through the central section of third floor containing small office rooms

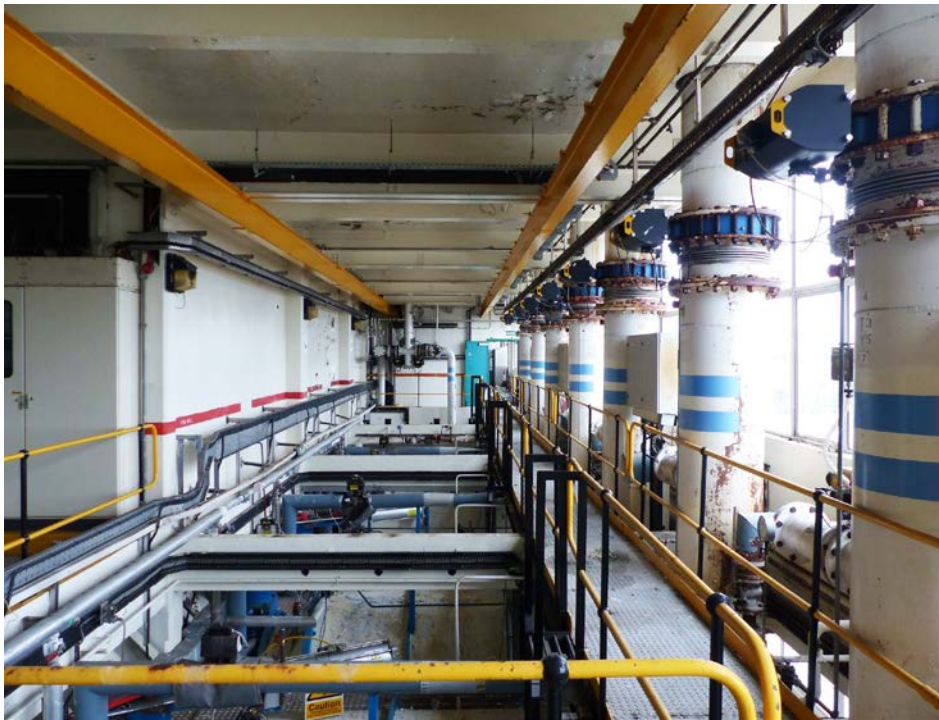
Fig 61 Food production area in the north-east corner of the third floor, looking north

- 3.2.44 The north and north-east section of the building was not accessible from the south-east and west side, but from a staircase from second-floor level. The north-east section contains food production areas (Fig 61). Large plant and processing units were observed in this section of the third floor. There is a small office area plus control room in this section, from which the plant and processing units were controlled and monitored (Fig 62). Further north, along the north end of the third floor, there is a large open area containing plant and machinery, installed on slightly raised plinths (Fig 63).

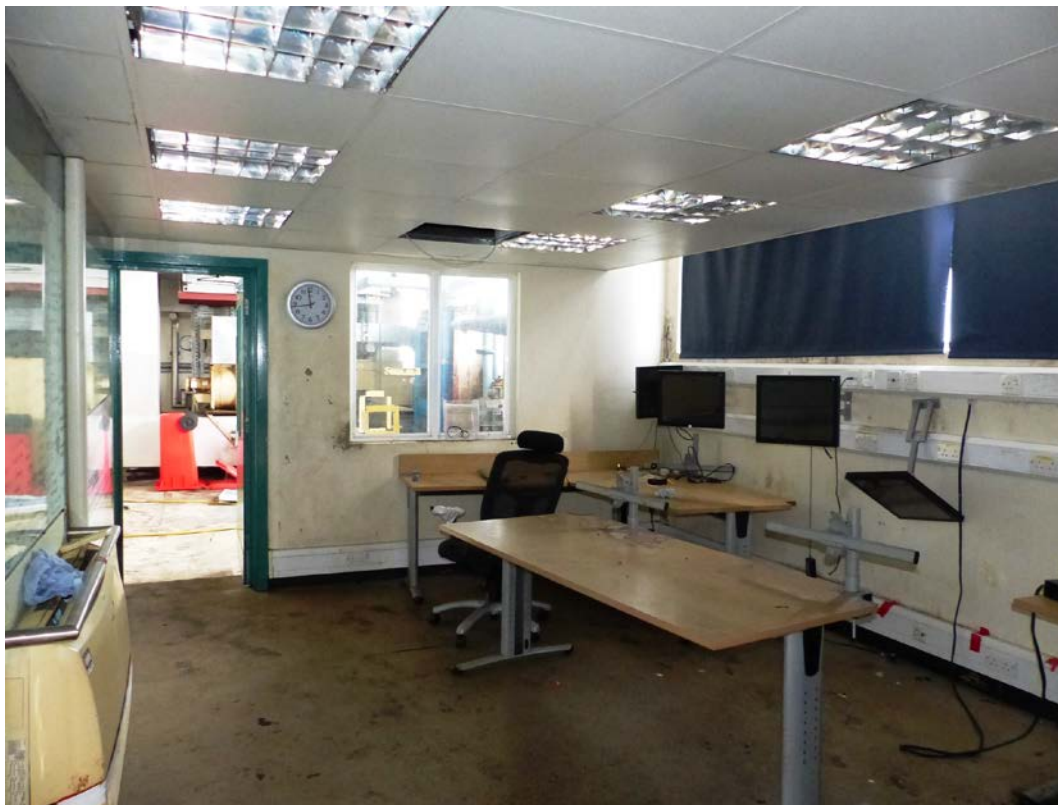
Fig 62 Food production control room and office in the north-west section of the third floor.

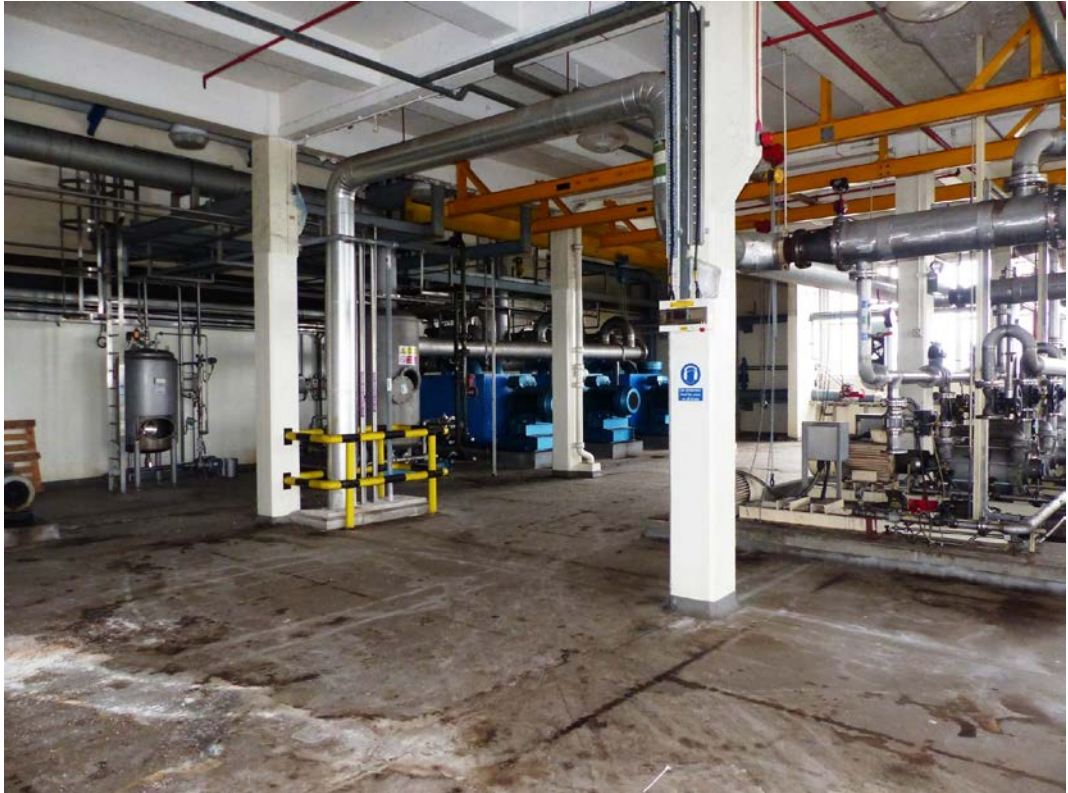
Fig 63 Plant and machinery along the north end of the third floor

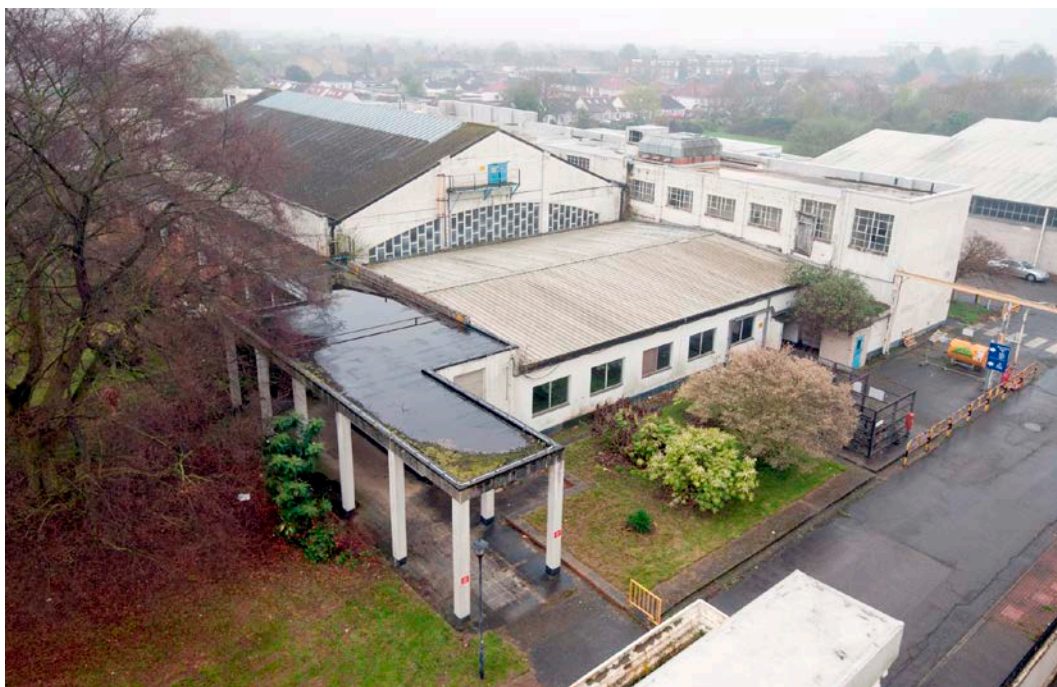
Fig 64 Former canteen building, view from the Main Factory roof, looking south-west

- 3.3.1 The Former Canteen building at the Nestlé Works is a one to two storey reinforced concrete structure, located along the former main entrance way from Nestlé's Avenue. The building was constructed in 1954 following the establishment of the Hayes site as the Nestlé UK headquarters (Fig 64).
- 3.3.2 The Former Canteen is a large amenity building containing an open double storey hall with two-storey office areas along the south and west sides and a single storey colonnade along the east side of the building. Compared to its construction date, the building presents a Streamline Modern style of office canteen which is late Art Deco architecture that complements the 1920s factory building. In recent times the building was used as a warehouse with very slight modifications to its original fabric.

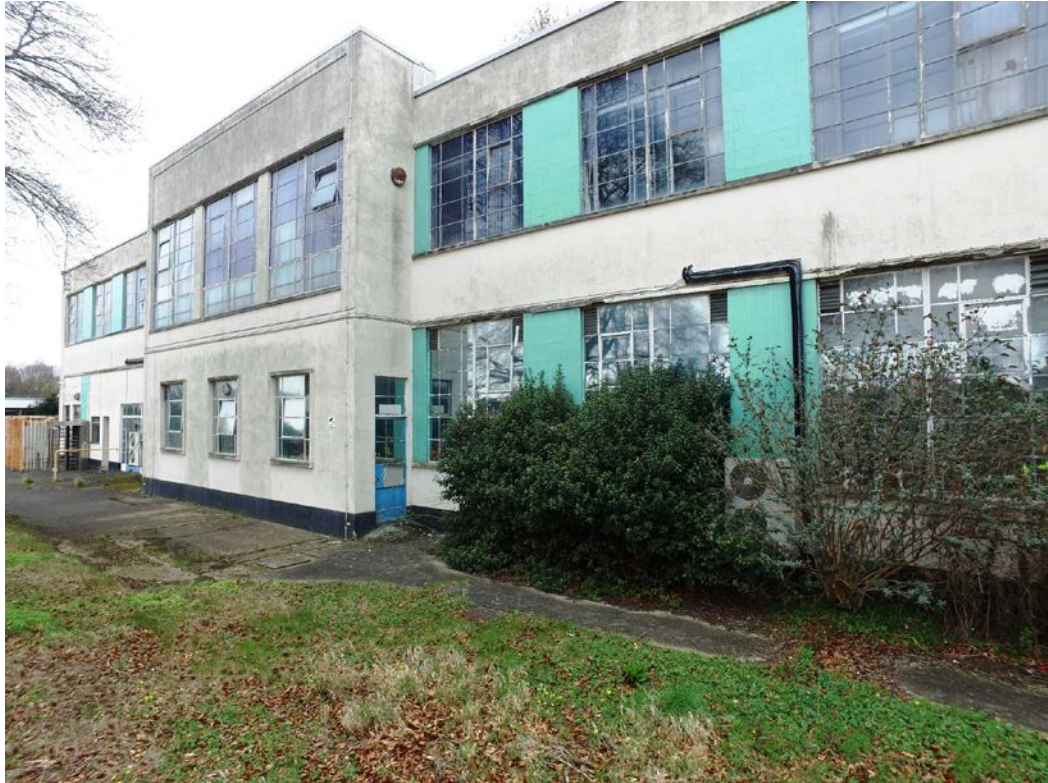
Fig 65 South facing elevation of the former canteen, looking north-west

- 3.3.3 The building has two principal façades, the south and west elevations. Both of these elevations are visible from Nestlé's Avenue and west elevation fronts onto the former main entrance to the south. These two main façades present good detailing in the late Art Deco style, complementing the exterior of the already existing main factory building (Fig 65, Fig 66).

- 3.3.6 The south elevation of the building has three sections, formed of four bays on either side of a slightly advanced central section. The central section has three bays. Both ground and first floor have large multi-paned windows constructed of crittall style metal glazing. The piers between the window openings are not dressed with light green glazed tiles as seen in the west elevation, but the window openings are taller.

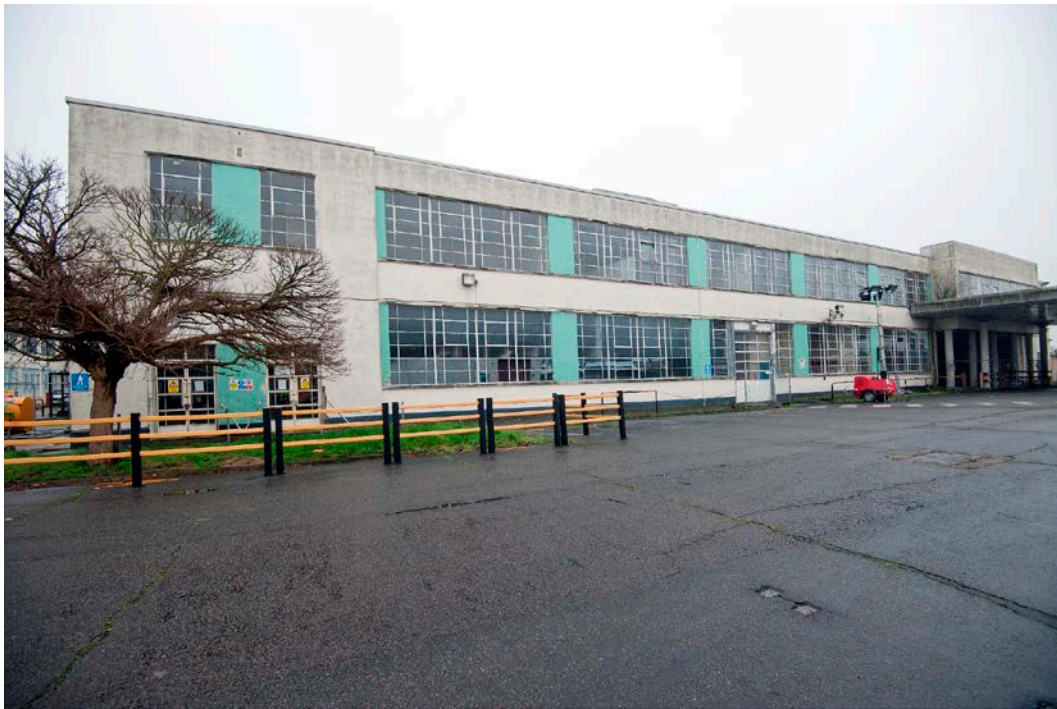
Fig 66 West elevation of the Former Canteen, looking south-east

- 3.3.7 The west elevation of the canteen forms the west wing, and there is a loading bay under a large canopy. The entire elevation features bays of large multi-pane clerestory windows on both levels, separated by sections dressed with mint-green tiles. The windows are made of crittall style metal glazing. On both levels, the windows openings have precast concrete sill bands, slightly projecting with drip-moulds on the soffit of the projection to throw off rainwater. Similarly, the lintel of the windows on both levels have projecting plat bands, also constructed of precast concrete with drip mould. Both plat band and sill bands have a sloping top face (Fig 66, Fig 67).

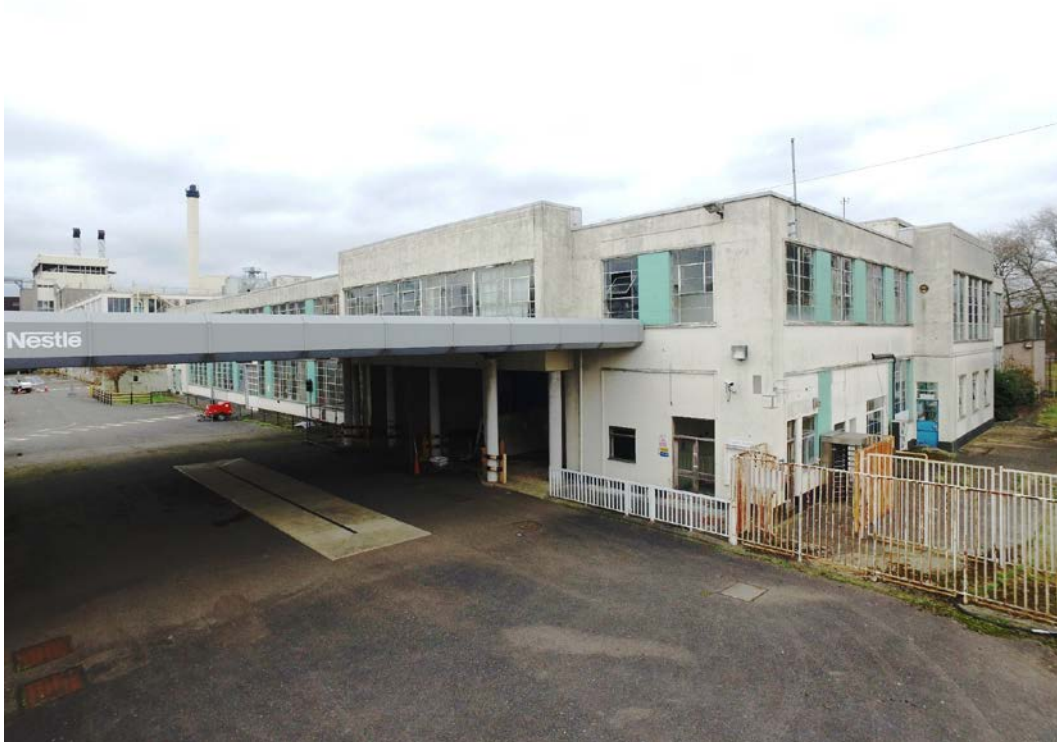
Fig 67 South end of the west elevation with a large steel canopy

- 3.3.9 The south end of the west elevation contains a large canopy above a loading bay. The loading bay and the canopy appeared to be inserted features and were probably added in the 1980s. The loading bay has a double stepped recess containing two large vehicle entrances. There are also two pedestrian entrances either side of the vehicle entrances. Further south the elevation contains a gated office, accessed by a set of timber frame double doors with flanking fixed-light windows. The southern flank window is blocked and has a concrete surround. In front of the bay is a stone and tile paved surface protected with a waist-high steel fence. Along the base of the west elevation, the building has a low concrete plinth, painted in black (Fig 67).
