Building Recording (Level 2)

Photographic Record (Volume 2)

Former Nestlé Factory Canteen Building, Nestles Avenue,
Hayes

March 2026

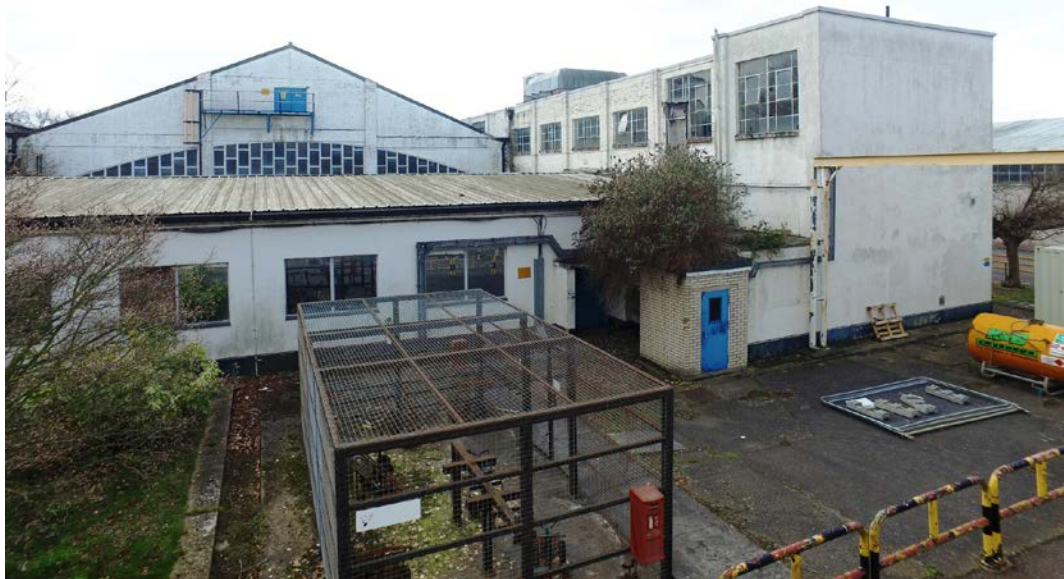
Fig 68 West end of the north elevation, looking south-west

- 3.3.10 The north facing rear elevation of the former canteen building comprises the north end of the two-storey west wing. The upper section of the gable of the main hall, at the north end of the colonnade has a projecting porch. There is also a low single-storey section built against the north elevation of the main hall, which contains plant and utility services. This central section is set back from the colonnade and the west wing, forming a recessed garden area. The north end of the west wing has a plain façade with no fenestration or openings. However at ground level, scars of a former door and a window were observed (Fig 68, Fig 69).

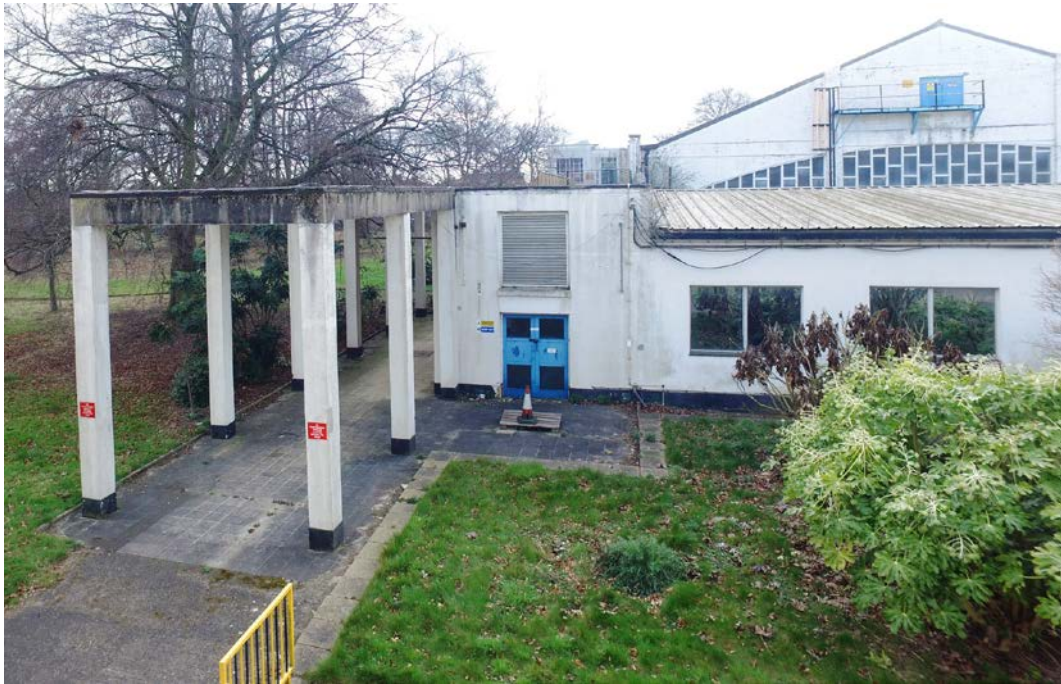
Fig 69 East end of the north elevation, looking south

- 3.3.11 The single storey service area to the north end of the main hall has five sets of windows to the north spaced at regular intervals. These aluminium glazed windows appeared later compared with the age of the building. These also have sloping, externally projecting sills formed of two courses of black tiles. This elevation also contains a number of plant room doors at ground level and a plinth similar to that seen in the west elevation. The plant doors have louvred vents. Further east of the elevation contains the simple entrance porch of the colonnade (Fig 69).

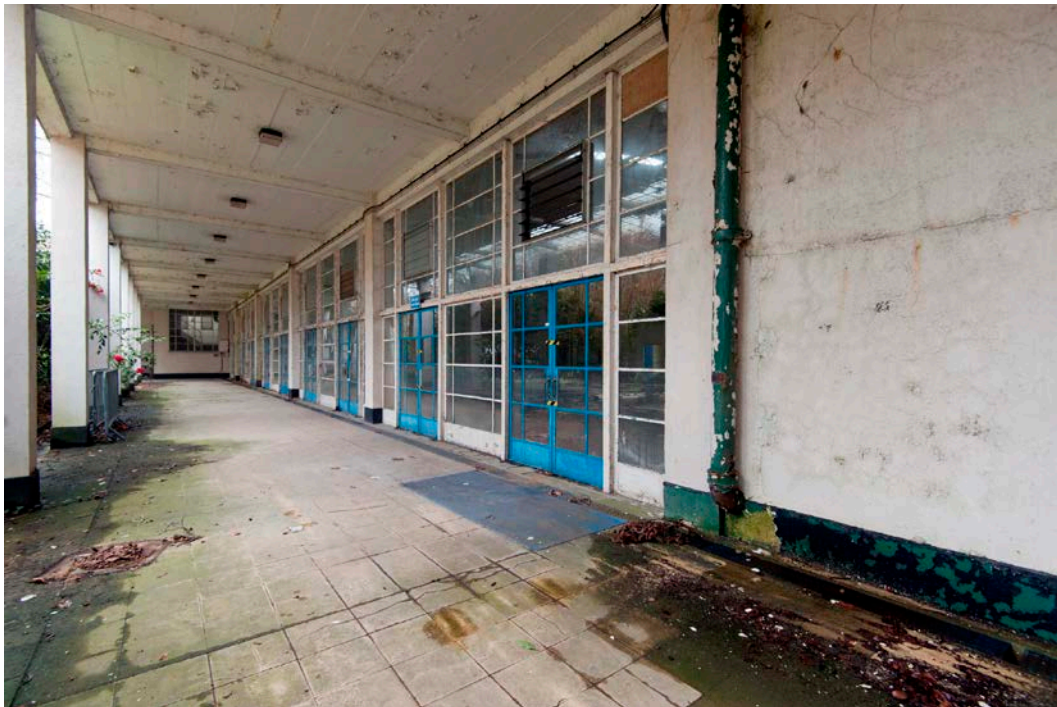
Fig 70 East elevation of the main hall and the interior of the colonnade, looking south-west

- 3.3.12 The east elevation of the building is comprised of the single storey colonnade, east elevation of the two-storey south wing and the east pitch of the main hall roof. The colonnade has a series of reinforced concrete columns along the east side of the building supporting the concrete roof. Within the colonnade, the east elevation of the main hall is articulated in five bays separated with reinforced concrete columns. Each bay has large crittall style metal glazing frames with two sets of double doors with a louvred window above the doors. All bays have a similar span, apart from the southernmost bay which is slightly smaller and contains only one set of doors (Fig 70).

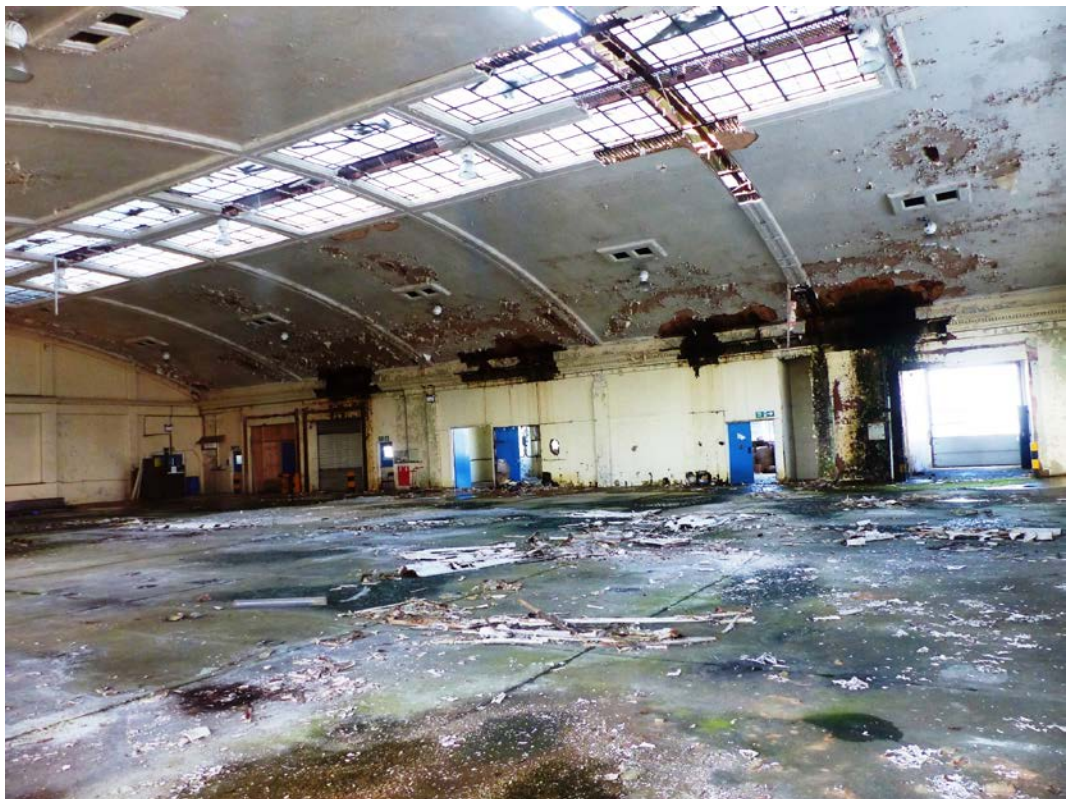
Fig 71 Interior of the main hall of the former canteen, looking south-west

- 3.3.15 The former canteen building has a simple internal layout formed of the two office wings along the south and west side of the main hall, a colonnade along the east and plant and utility blocks at the north end. Due to environmental health and safety hazards, the majority of the ground floor including the main hall was inaccessible during the present survey (Fig 71).

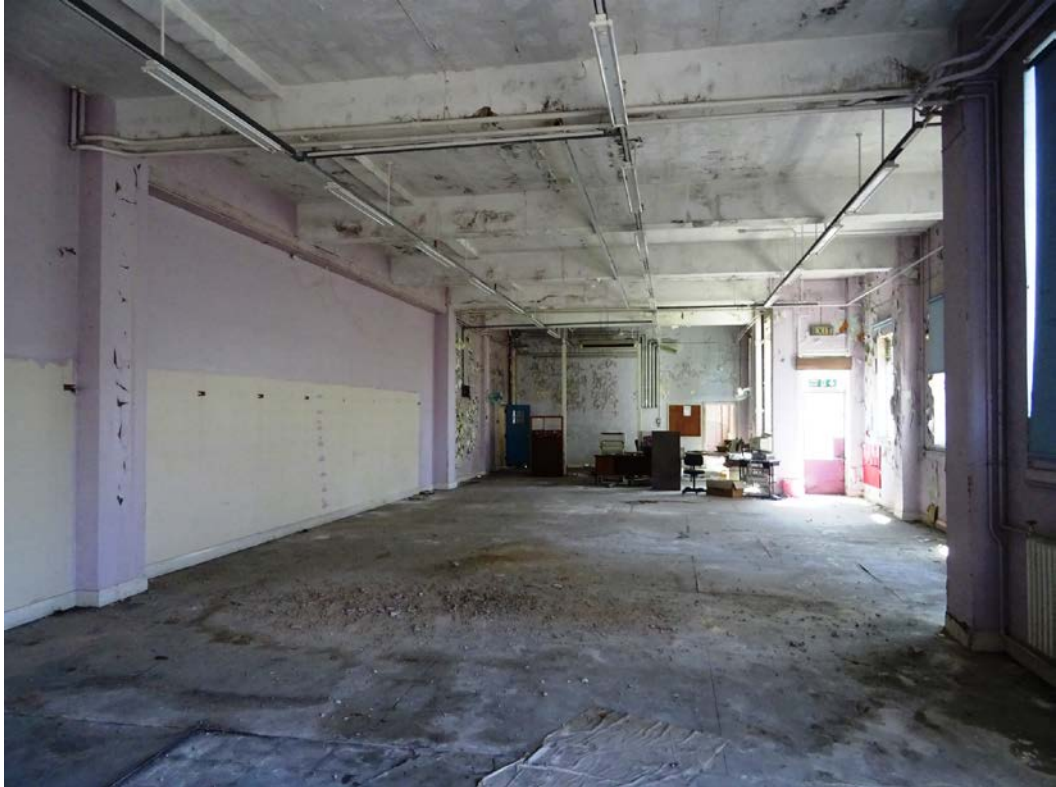
Fig 73 The main office area in the south wing on the ground floor, looking east

and two fire-exits at both ends of the projecting central section of the south wing. The main office area in the south wing on the ground floor has an open plan layout with a kitchen area at the east end (Fig 73, Fig 74). It has a concrete floor and a possible bricked up wide opening to the main hall area in its north wall. The west end of the south wing on the ground floor was inaccessible at the time of the survey. A pedestrian entrance from the south, at the west end, provides access into the main stairwell through a narrow corridor whilst the north-west stairwell is accessible through a double metal glazing crittall door from the west.

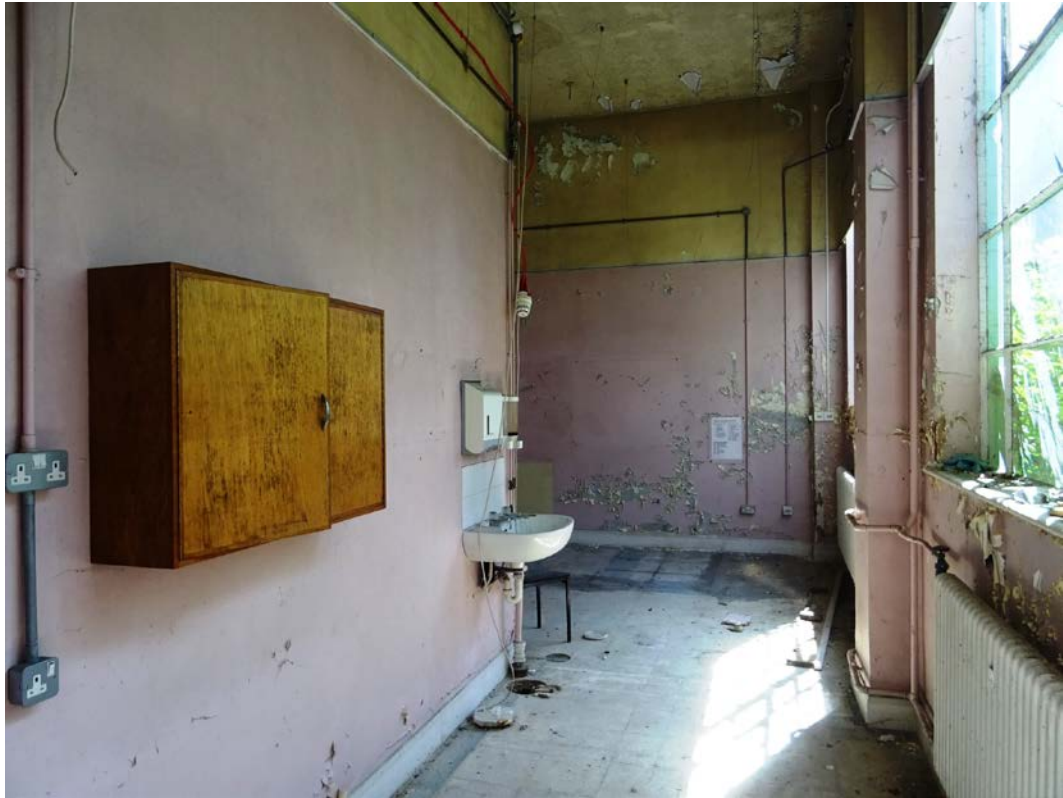
Fig 74 Kitchen area at the east end of the south wing, looking east

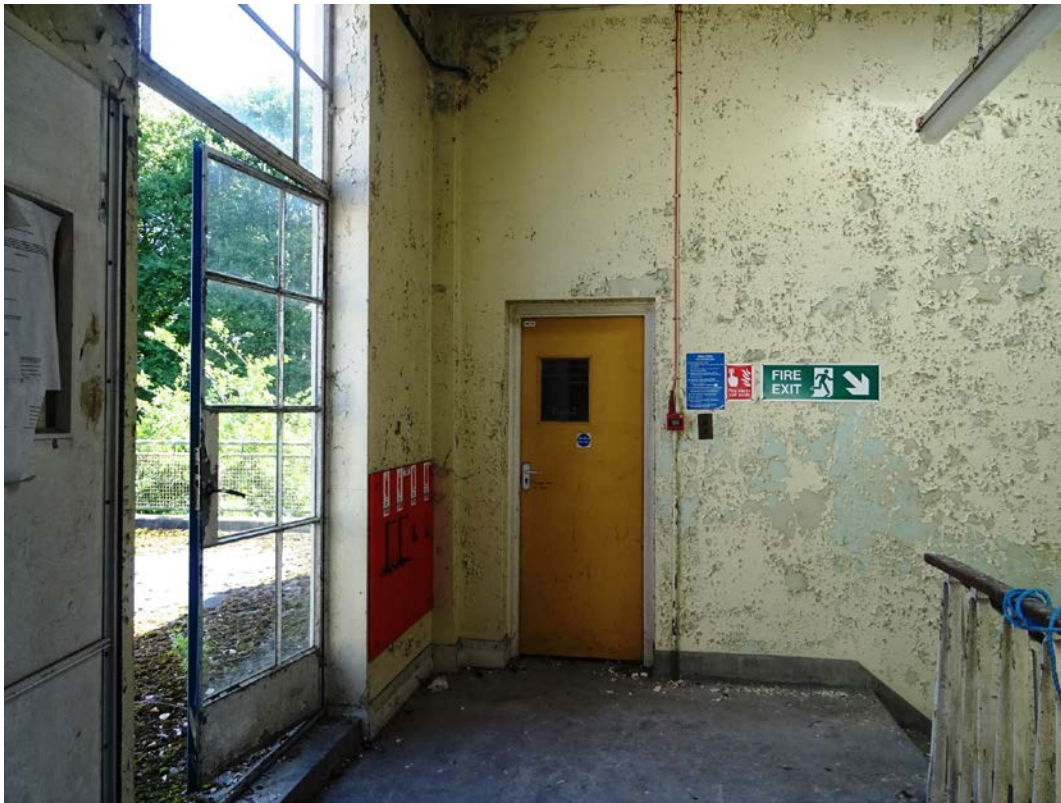
Fig 75 First floor landing at the south-east corner stairwell, looking east

- 3.3.16 Three corners of the building contain stairwells; among these, the south-west corner stairwell contains the main staircase. Two lesser staircases are located in the north-west and south-east corner of the building. All three staircases are reinforced concrete structures cantilevered from the walls. Among these, the south-eastern and north-western staircase each have three flights with two mezzanine landings, whereas the main staircase has five flights with three mezzanine landings. All staircases have uniform bannisters formed of steel spindles supporting wooden handrails (Fig 72, Fig 75, Fig 78).

- 3.3.19 On first floor level, the south-east stairwell provided access into the rooms at the east end of the south wing, the rooftop patio above the colonnade and into the main office areas in the south wing to the west. The door to the east was not accessible during the survey. As a result of the two south-east corner rooms. The roof patio is accessible through a large crittall style metal glazed patio door (Fig 75).

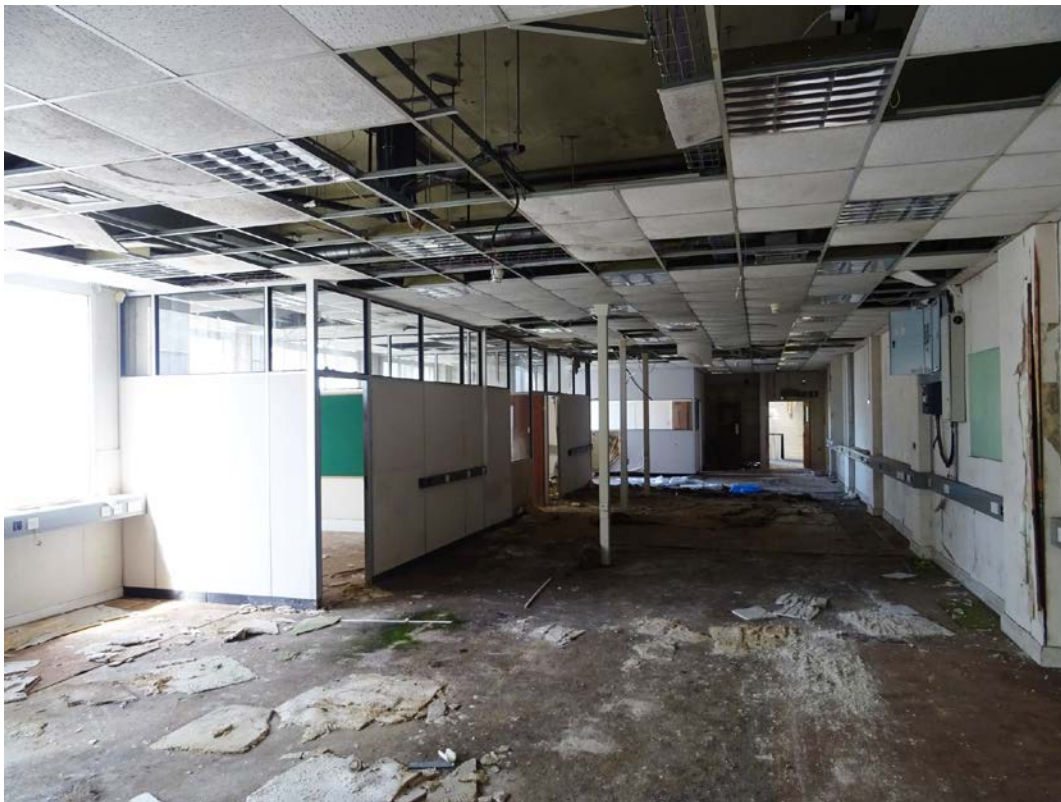
Fig 76 First floor office area in the south wing, looking west

- 3.3.20 The south wing office area has a large interior space mainly open plan with a number of cabins formed of modern partition walls with clerestories. It has a suspended ceiling and carpeted floor. The south wing office had a 1980s interior and was in a very dilapidated condition. The west end of the office area leads into the south-west corner stairwell leaving a computer server room and a WC in the south-west corner. The computer server room has a modern interior with a steel waffle floor (Fig 76, Fig 77).

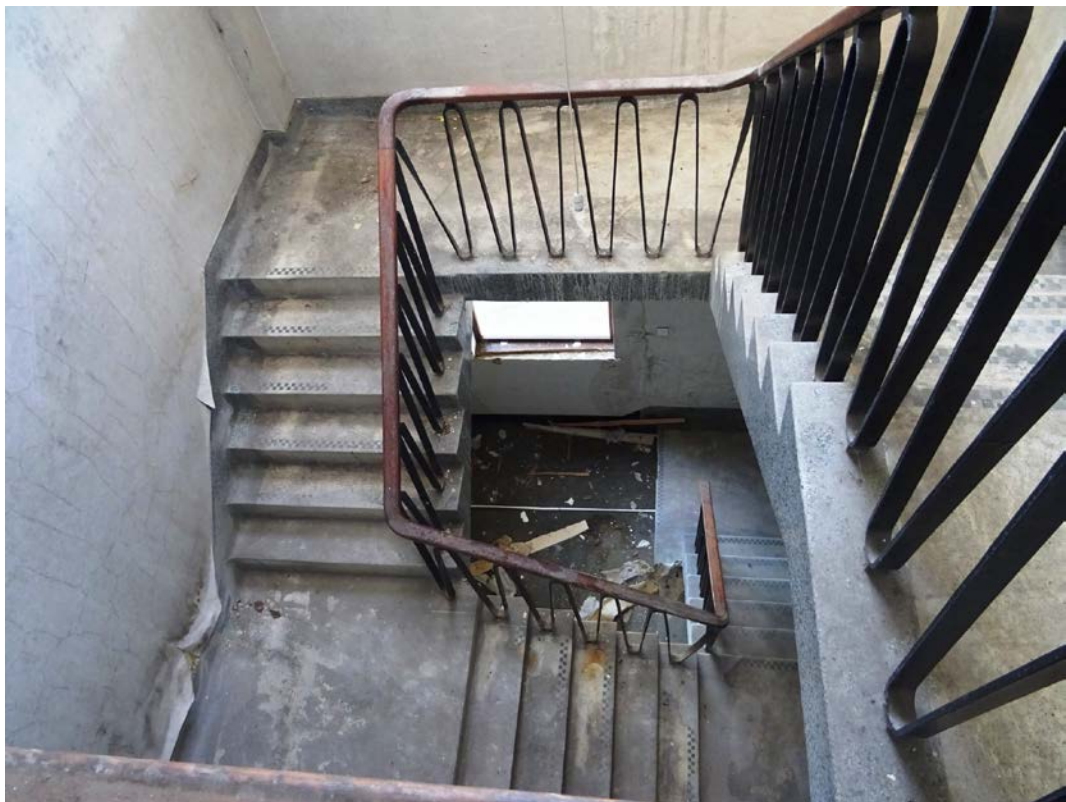
Fig 78 Main staircase at the south-west corner of the building

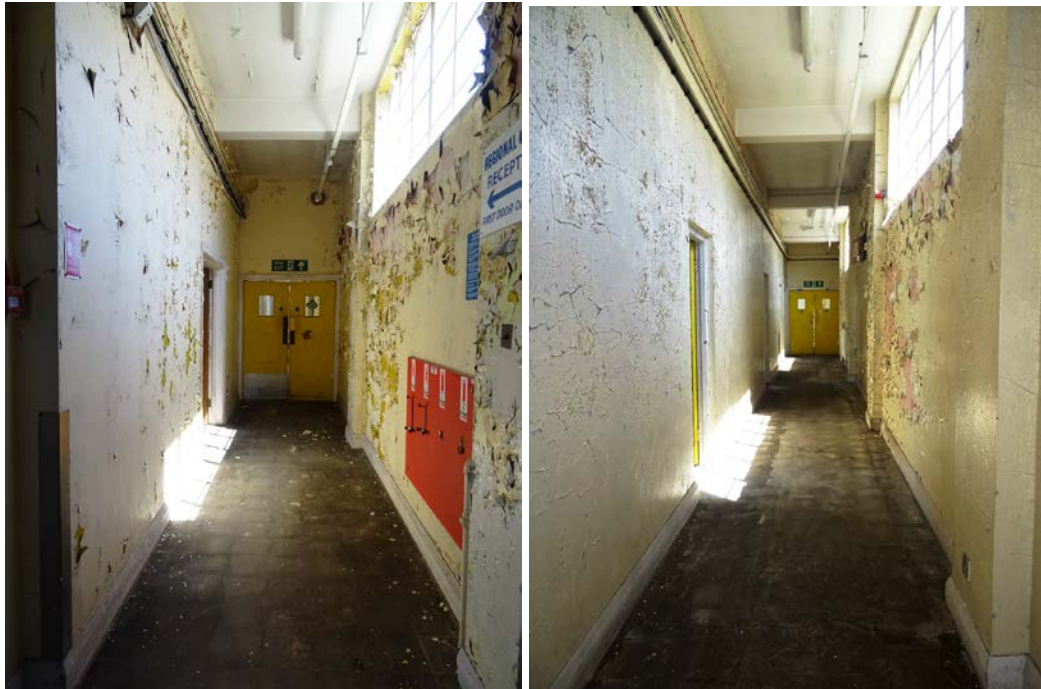
Fig 79 South end (left) and a central portion (right) of the north-south running corridor on the first floor of the west wing.

- 3.3.21 From the south-west corner stairwell, a long northward running corridor provided access to the offices in the west wing. The west wing has a series of offices with windows to the west and all accessed from the long corridor. The corridor is well lit with clerestory windows to the east. These are smaller than those in the west and south elevations of the building. The clerestory windows in the southern half of the corridor are at a higher level clearing the Main Hall. The northernmost two windows are large. Of these the northern one provides light in a female WC. The second window from the north in the corridor accommodated a later inserted door possibly to access a service gantry that has since been removed (Fig 79).

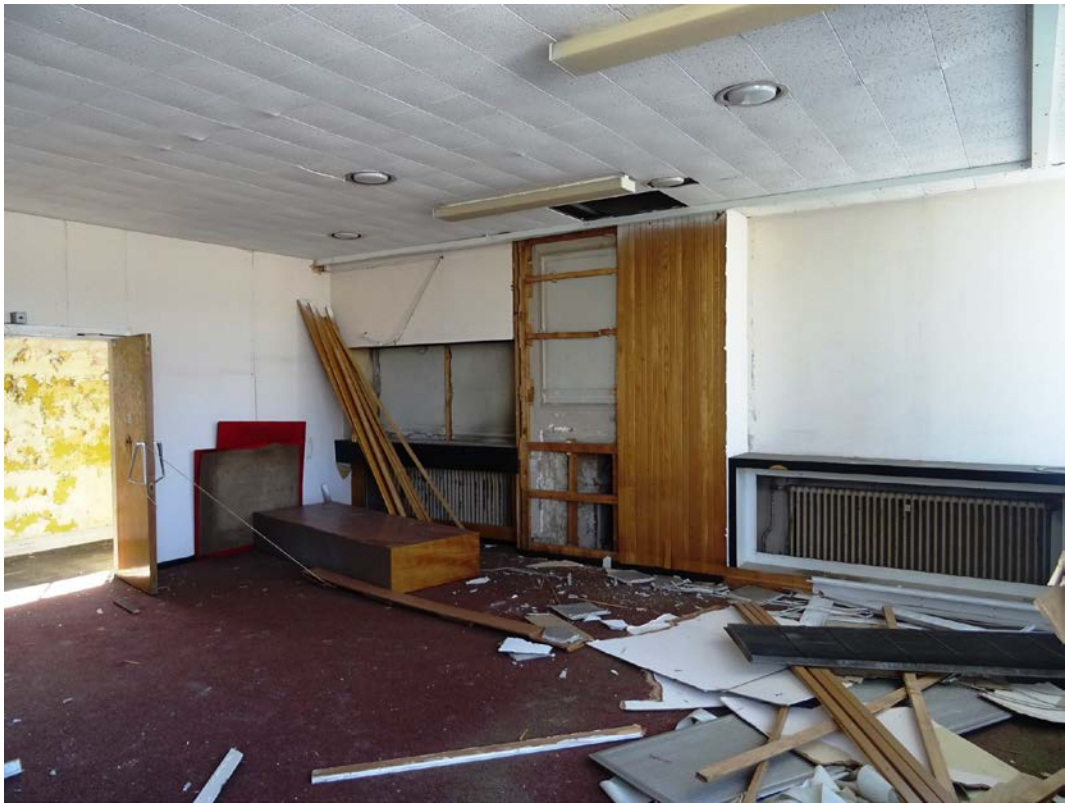
Fig 80 Southern end office room on the first floor of the west wing, looking south-east

- 3.3.22 The office rooms within the west wing have been modified. Originally these rooms had wooden parquet flooring in a herringbone pattern. These were all covered in carpets. Herringbone parquet flooring was observed in a number of rooms where the carpet has been removed (Fig 80, Fig 81).

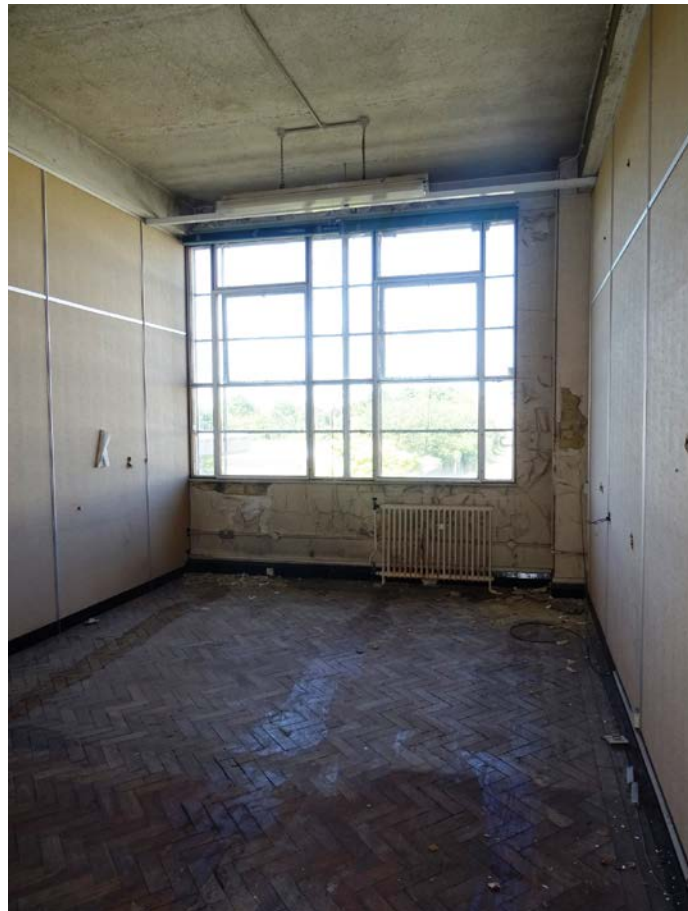
Fig 81 One of the first-floor office rooms in the west wing with herringbone wood parquet flooring

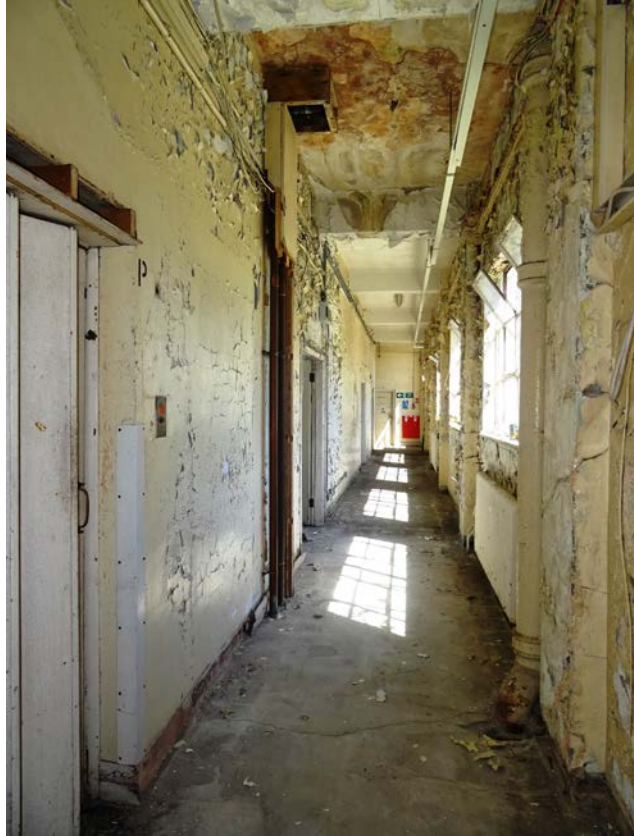
Fig 82 Northern end of the corridor on the first floor, looking north

- 3.3.23 At the northern end of the first floor, there is a large female WC with the original interior. The door into the WC leads into a common area with a hand basin; the remainder of the toilet area, with cubicles and the mirrored washing area, are separated by a glazed metal screen. The interior of the WC including the cubicles have a terrazzo tile floor and wall dressing as seen in the south-west staircase (Fig 82, Fig 84).

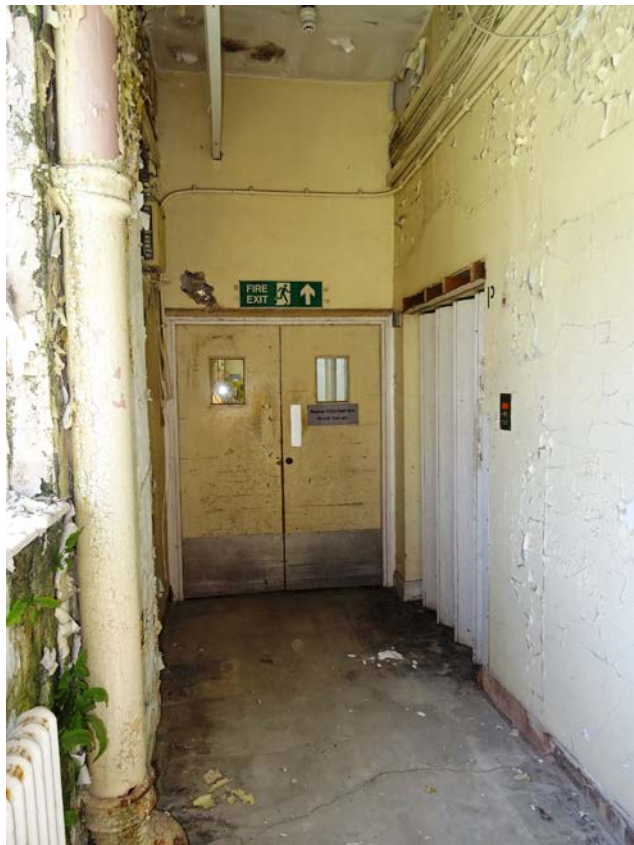
Fig 83 Goods lift accessed from the corridor on the first floor

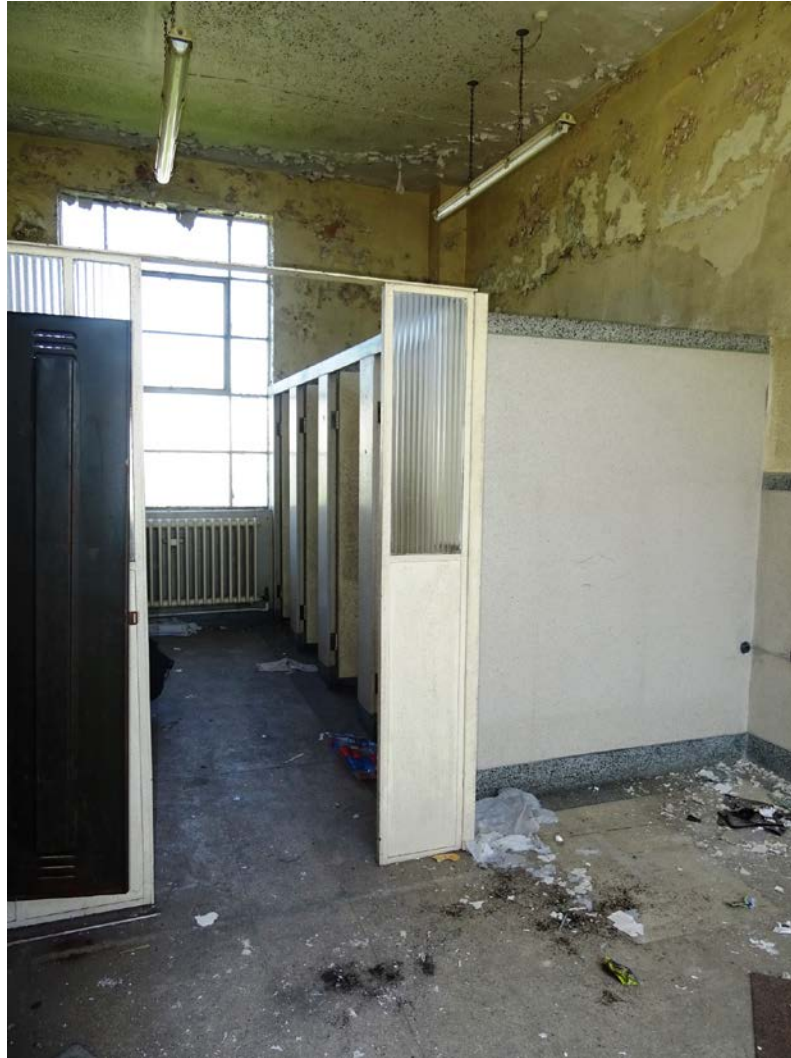
Fig 84 Female WC in the northern end of the west wing on the first floor

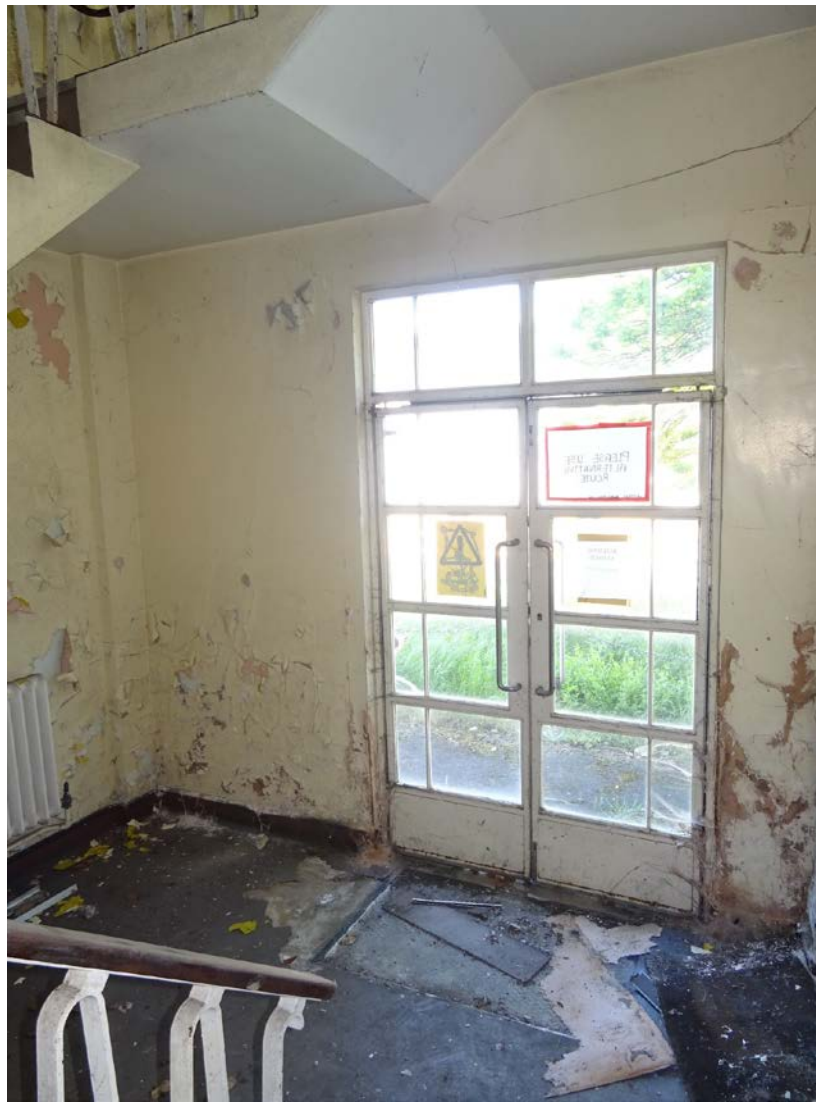
Fig 85 External door from the north-west stairwell

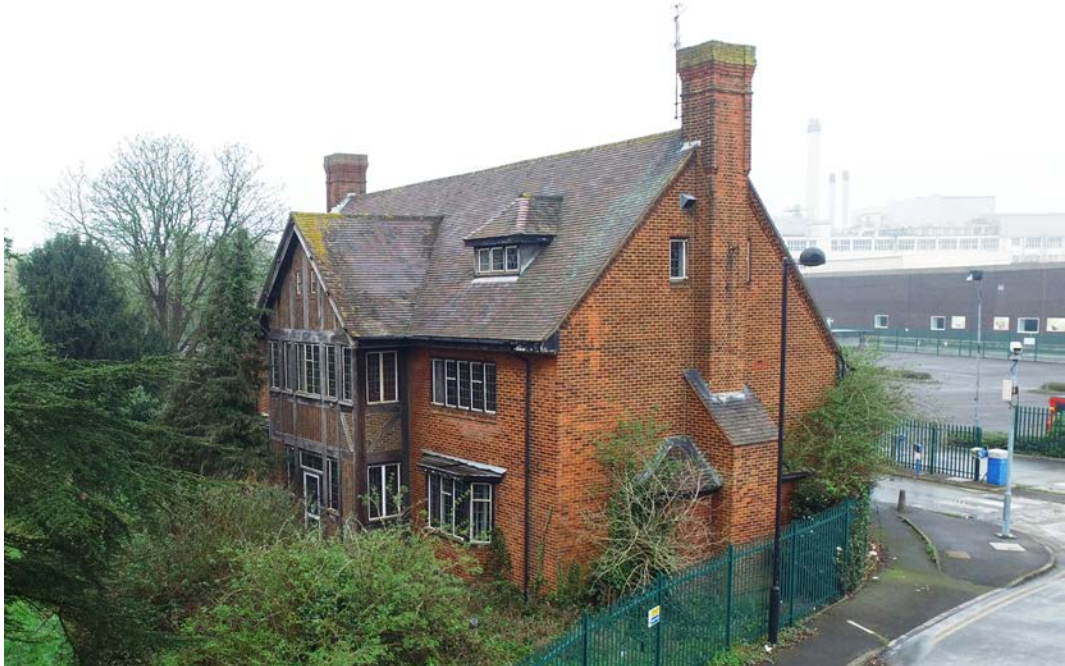
Fig 86 The lodge, looking north-west

- 3.4.1 The lodge building is located at the south-east corner of the site visually separated from the main factory buildings by the wooded area running along the southern verge of the site. Much of the wooded area, however, has been replaced with a large car park presumably during the mid-20th-century expansion of the site. It is believed that the lodge building was constructed in 1919 as part of an initial extension of the site. There is no concrete evidence to confirm the date of its construction though its design and form appears synonymous with this period.

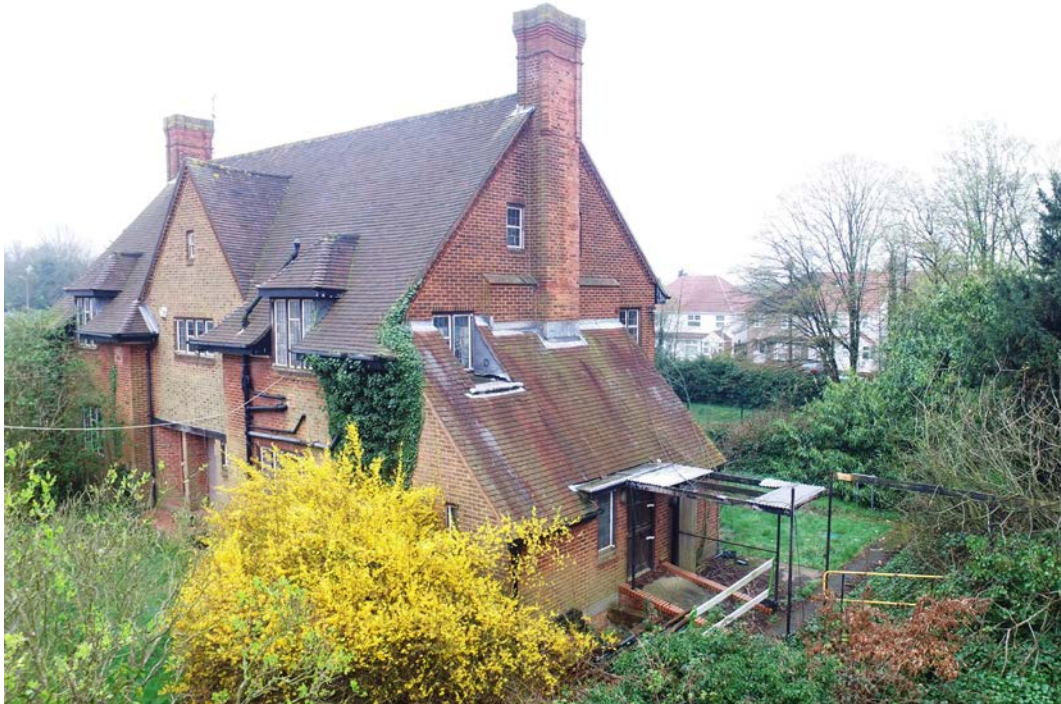
Fig 87 North and west facing elevation of the Lodge, looking south-east

- 3.4.7 The west elevation also has an exterior projecting brick chimney identical to that seen in the east elevation (Fig 87). Also seen in the east elevation are two small window openings in the brick gable, at either side of the chimney, providing natural light into the attic level. At first floor level, there is slight projecting brickwork observed with slate capping presumably containing flues from the first-floor fireplaces. There are two windows to the west at first-floor level.

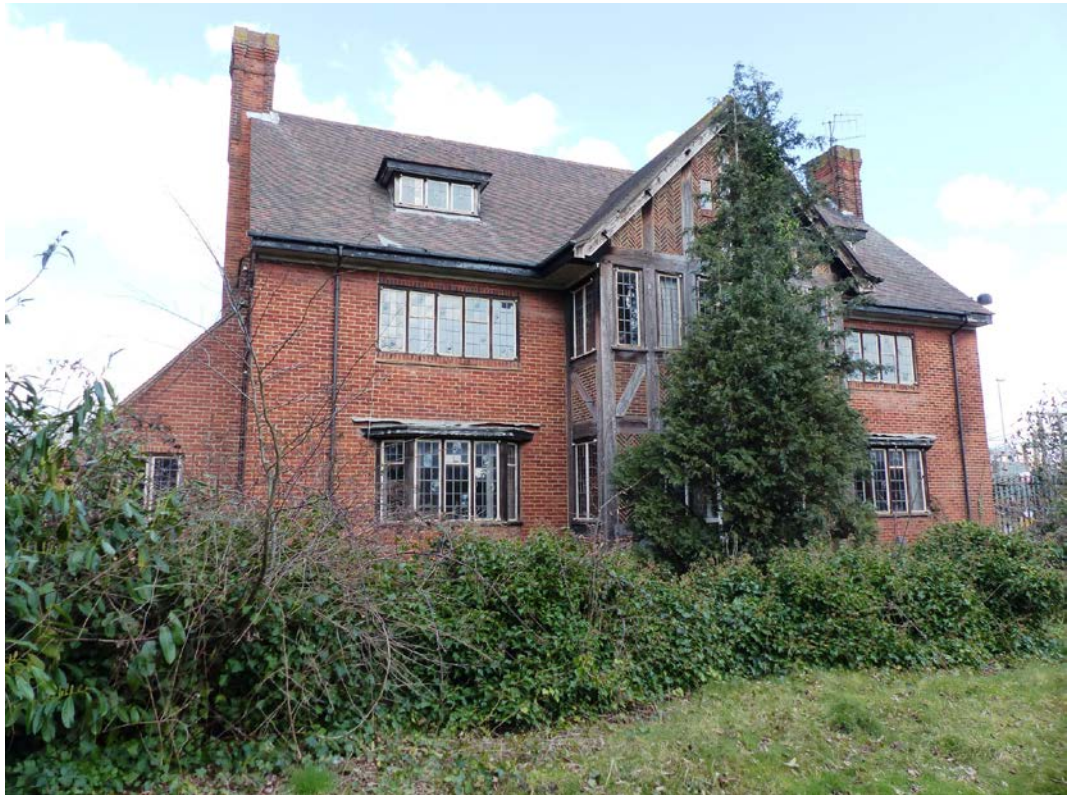
Fig 88 South elevation of the lodge, looking north-east

- 3.4.10 South elevation of the building forms its main façade fronting on to Nestlé Avenue though the building is quite set back from the street and only partly visible due to trees and vegetation (Fig 88).

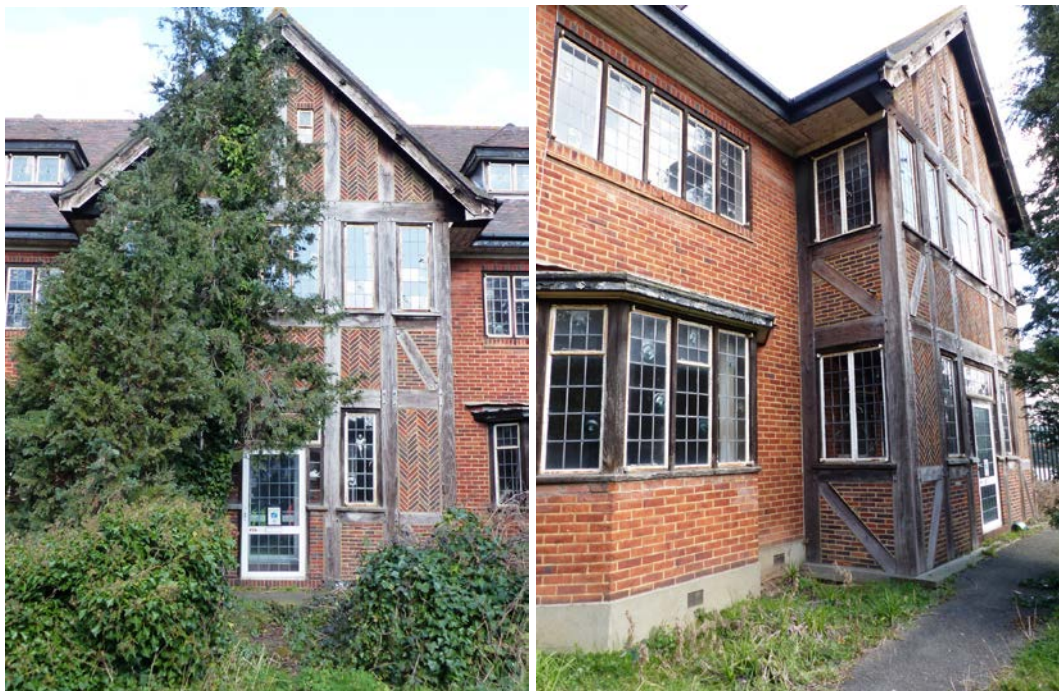
Fig 89 The main entrance bay in the south elevation of the lodge, front (left) and side (right) views

- 3.4.11 The original façade, prior to the ground level extension to the west, has a symmetric appearance with a projecting entrance bay at the middle. Both bays have one large bay window at the ground floor level with independent tiled bay-roofs, one four-light window on the first floor and a dormer in the attic with hipped-roofs.

- 3.4.12 The projecting entrance bay was constructed as structurally independent of the building, although internally integrated, and its gable roof is integral to the main roof structure. It is effectively a timber-framed structure with brick-infilled external walls; all timber elements of the framing are visible externally as well as internally (Fig 89, Fig 89). The south façade of the entrance bay has a herringbone pattern brick-infill with a mix of red and dark bricks.

- 3.4.13 The entrance bay contains an external doorway to the south with a wide top-pivoting transom and flanking windows at ground floor level, while on the first floor it has five sets of windows facing south. There are two miniature windows in the gable of the bay. Both the ground and first floors of the entrance bay have identical side windows to the east and west. The central bay does not have a plinth along its base as seen in the rest of the exterior of the building

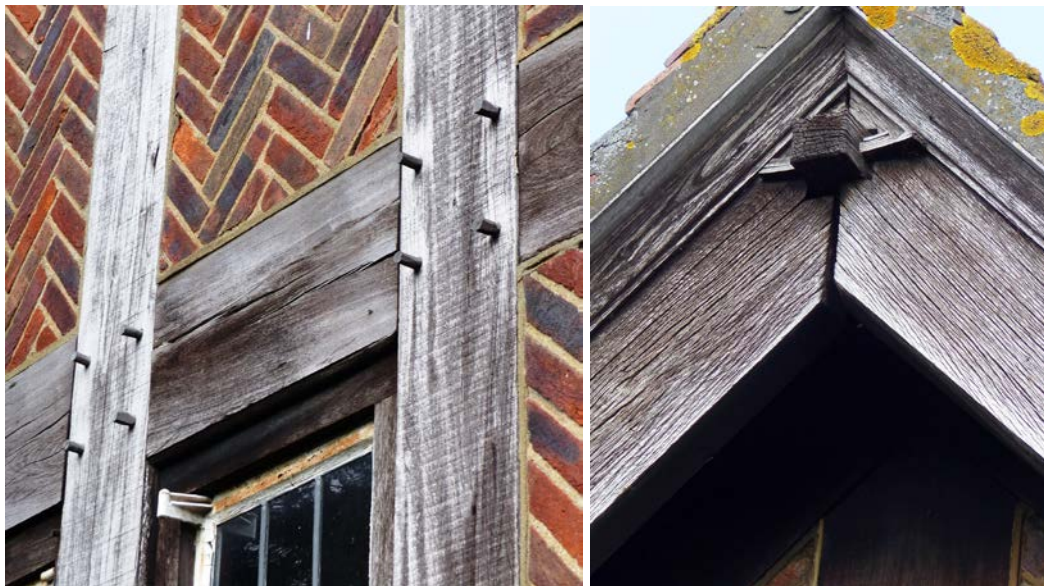
Fig 90 Projecting out wooden pegs and wedge lock

- 3.4.14 An interesting feature of the timber-framed bay is that all timber elements of the frame have traditional mortise and tenon joints with double wooden pegs. The pegs have square profile ends thicker than the inserted rounded portion, and the ends are projecting out of the joint prominently. Similar fashion has been noticed in the roof bargeboard joint. The bargeboards in the gable are wedge locked to the roof structure, and the wedge lock elements stick out quite prominently (Fig 90).

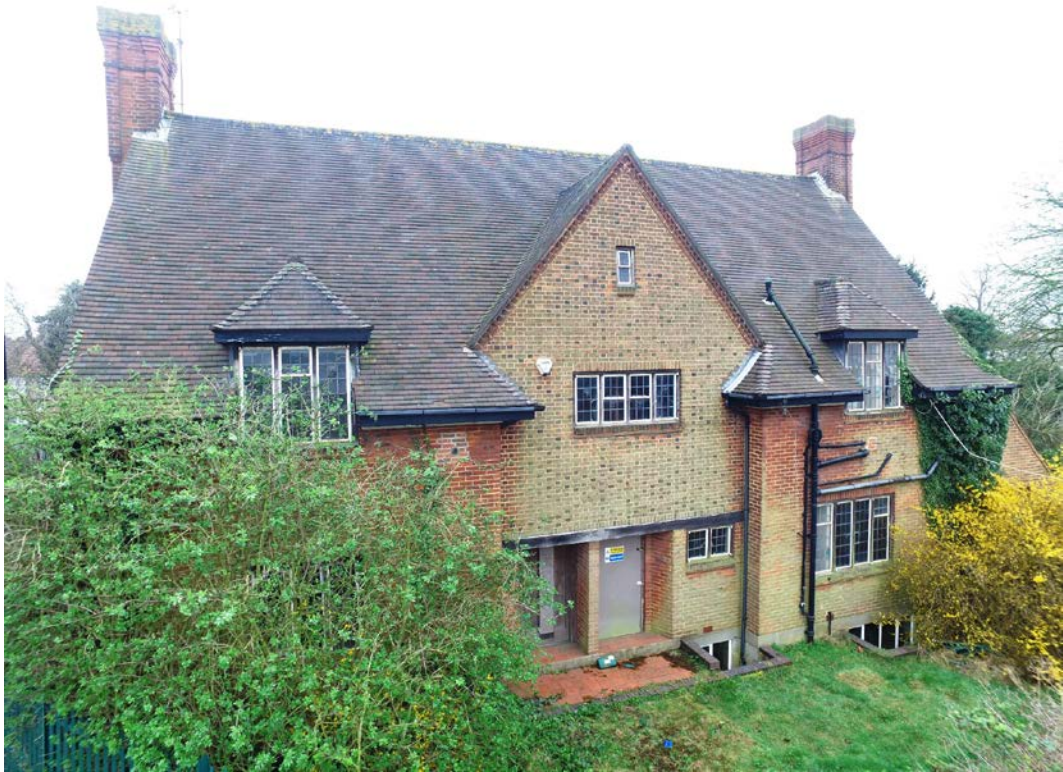
- 3.4.15 The north elevation has a near symmetric appearance formed of a central bay with a gable and two slightly advanced side bays. The central bay contains two separate external entrance doorways within a recessed porch. Presumably, these two doorways provided access into two separate units in the original layout. The doors were also observed with two different property addresses. However, as the internal layout has been modified to convert it into a single unit, one of the doors has been blocked (Fig 91).

Fig 91 North elevation of the Lodge, looking south-west

- 3.4.17 The central bay has a four-part window on the first floor and a small light within the gable providing light for the attic level. The gable has a red brick-dentilled frieze (Fig 91).
- 3.4.18 Above both side, bays are timber-framed dormer windows projecting from the main roof. These allow light into the first-floor level; there are windows at ground level too. The ground floor window in the west bay is larger than that in the east bay. The entire north elevation features the general concrete rendered plinth. Along the base of the west and the central bay, there are two basements light-well areas with very low edge protection.

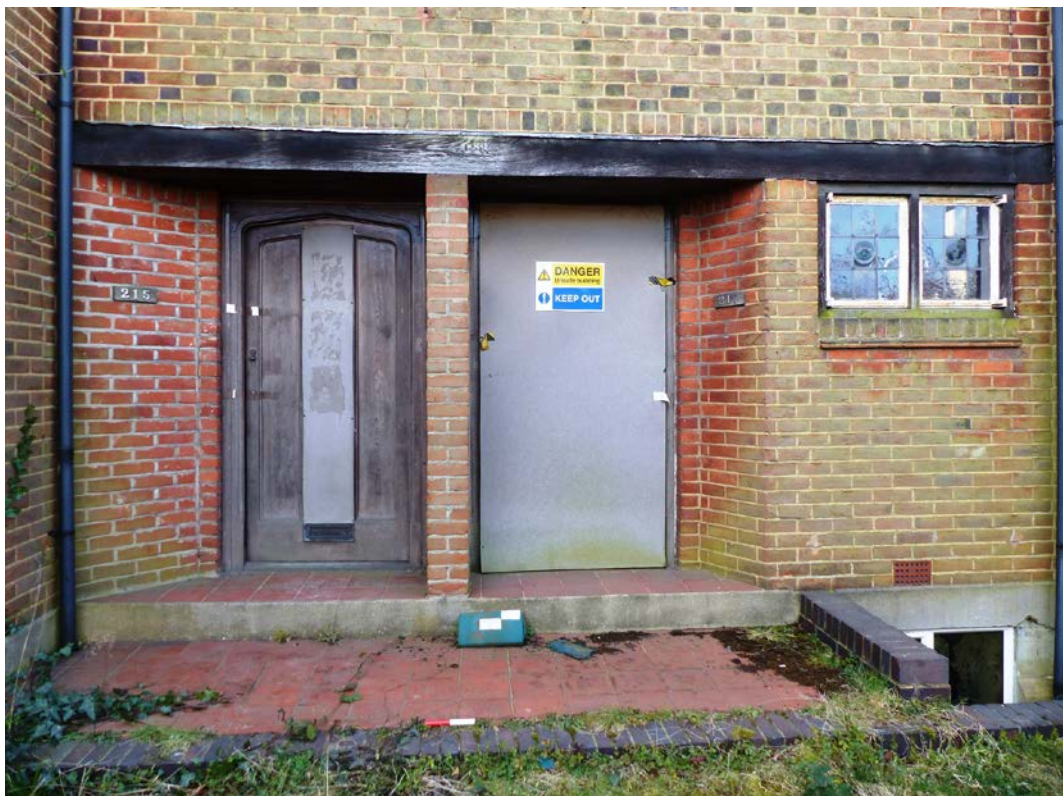
- 3.4.16 The entrance recess is formed by the support of a large timber beam, but it is not located in the centre of the bay. It has chamfered openings and a 9-inch square red tiled floor, with blue engineering brick edging. To the west of the porch, there are two small clerestory windows (Fig 92).

Fig 92 Entrance doorways from north

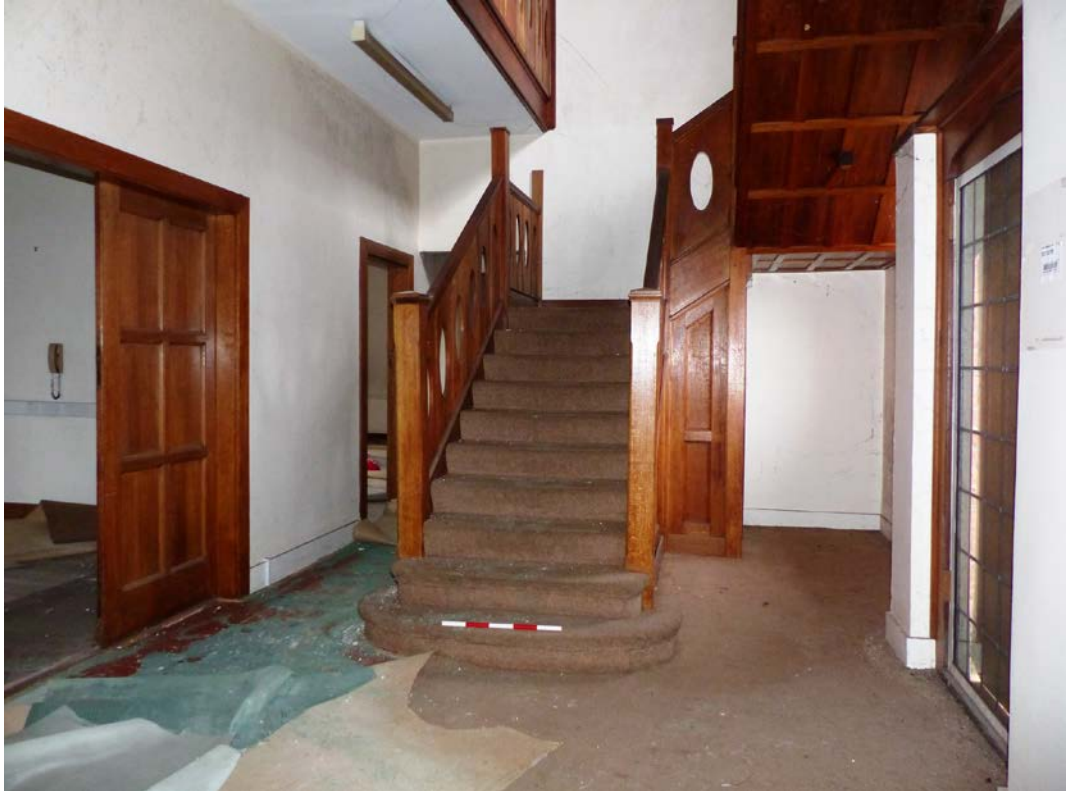
- 3.4.23 The staircase has square profile oak newel posts and a wood panelled bannister with ellipses and moulded handrail. Balcony protection and caps also have same panelling. The soffit of the stair flights is also timber panelled. The banisters end on the second to last tread which has rounded ends and bullnose capping. The starting step is wider and also has bullnose capping.

Fig 93 The entrance hall and staircase on the ground floor, looking south-west

- 3.4.22 The interior of the Lodge building was accessed from the north through the entrance door within a recessed porch. It leads into an entrance hall containing the impressive oak staircase. The existing timber wooden staircase is designed in late Arts and Crafts style and is probably the most significant internal feature of the building (Fig 93). The staircase and entrance area has a tiled floor formed of 9-inch square red floor tiles. The western of the two doors has a fully glazed patio style door but timber boarded from outside (Fig 94).
