Building Recording (Level 2)

Photographic Record (Volume 2)

Former Nestlé Factory Canteen Building, Nestles Avenue,
Hayes

March 2026

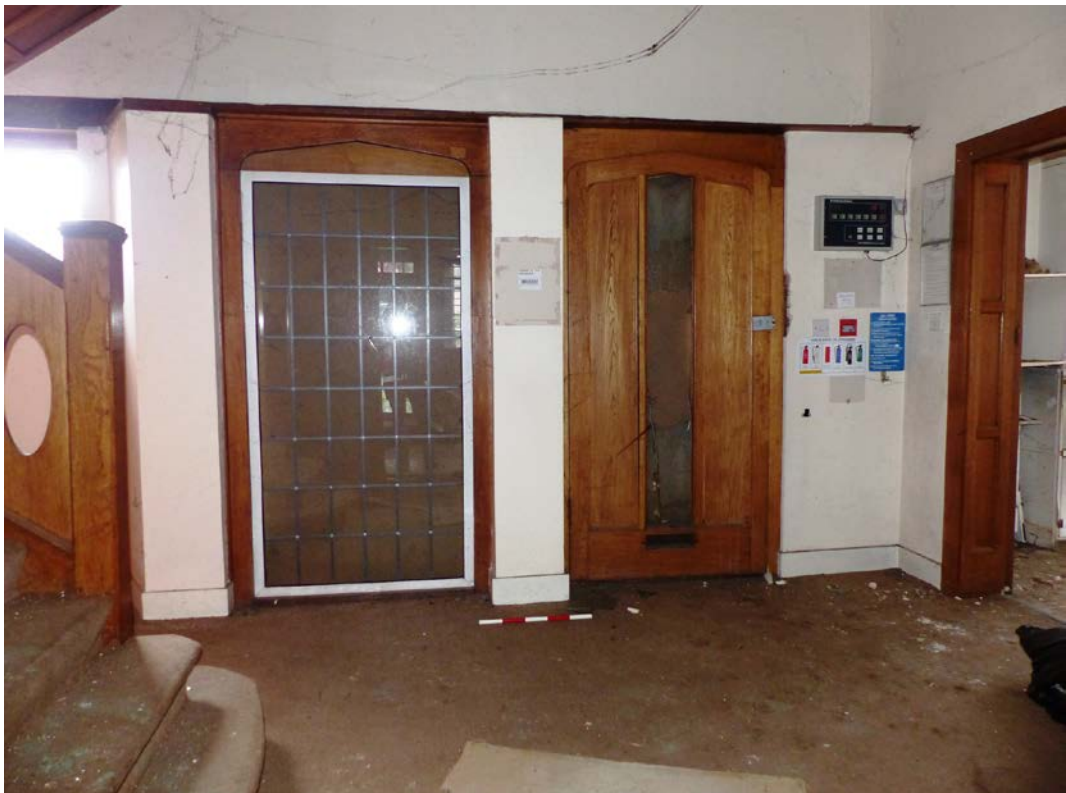
Fig 94 Internal view of the entrance doorways looking north

- 3.4.22 The interior of the Lodge building was accessed from the north through the entrance door within a recessed porch. It leads into an entrance hall containing the impressive oak staircase. The existing timber wooden staircase is designed in late Arts and Crafts style and is probably the most significant internal feature of the building (Fig 93). The staircase and entrance area has a tiled floor formed of 9-inch square red floor tiles. The western of the two doors has a fully glazed patio style door but timber boarded from outside (Fig 94).

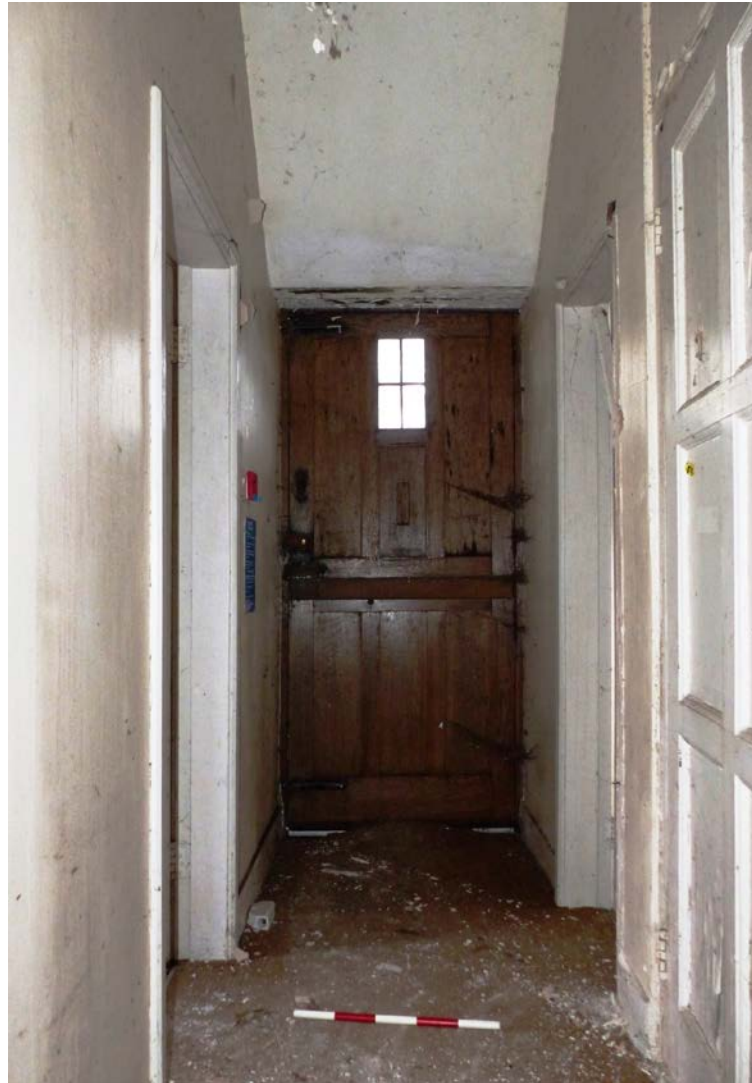
- 3.4.24 The ground floor of the lodge contains three large rooms to the south, a kitchen, lobby, services and utility rooms along the north side. The main internal circulation of the building is provided from the lobby. It provides access to a kitchen (G4) located in the north-east corner, two large rooms G9 and G2. A hallway runs westward from the lobby provided access into a small WC (G7), G6- which was possibly originally a kitchen, and the extension further to the west containing a laundry/ironing room, staircase to the basement, and a toilet. The hallway also leads up to an external doorway to the west (Fig 95).

Fig 95 External door to the west from the ground floor hallway, looking west

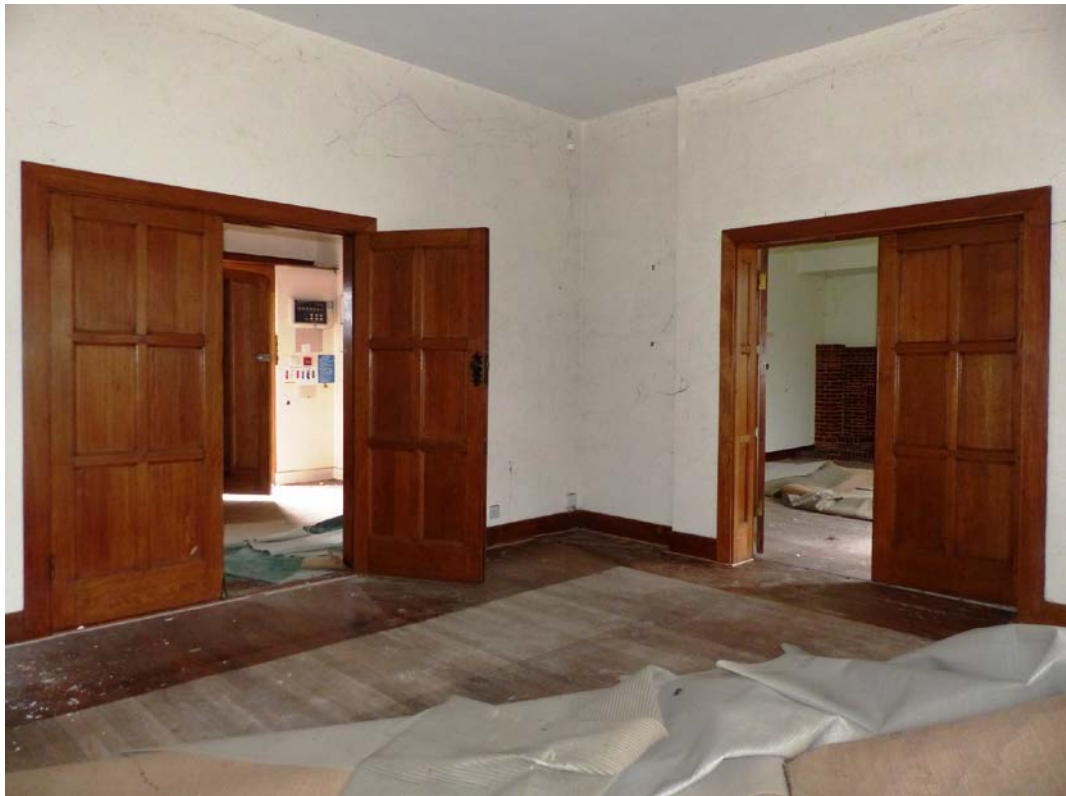
- 3.4.25 The front entrance of the building from the south leads into a small lobby (G1). This area was not accessible during the survey because of loose asbestos floor tiles. Room G2 is accessed from G1 and functioned as a reception area. It has a door to a small balcony area, into the projecting bay to the south. Two windows are flanking the glazed door to the south providing natural light into G2. It had oak floor boards covered in thick carpet. Room G2 has large double oak panelled doors to the east and north leading in to G3 and G5 (Fig 96).

Fig 96 Room G2. Note double timber doors to the stairwell and to room G5, looking north-east

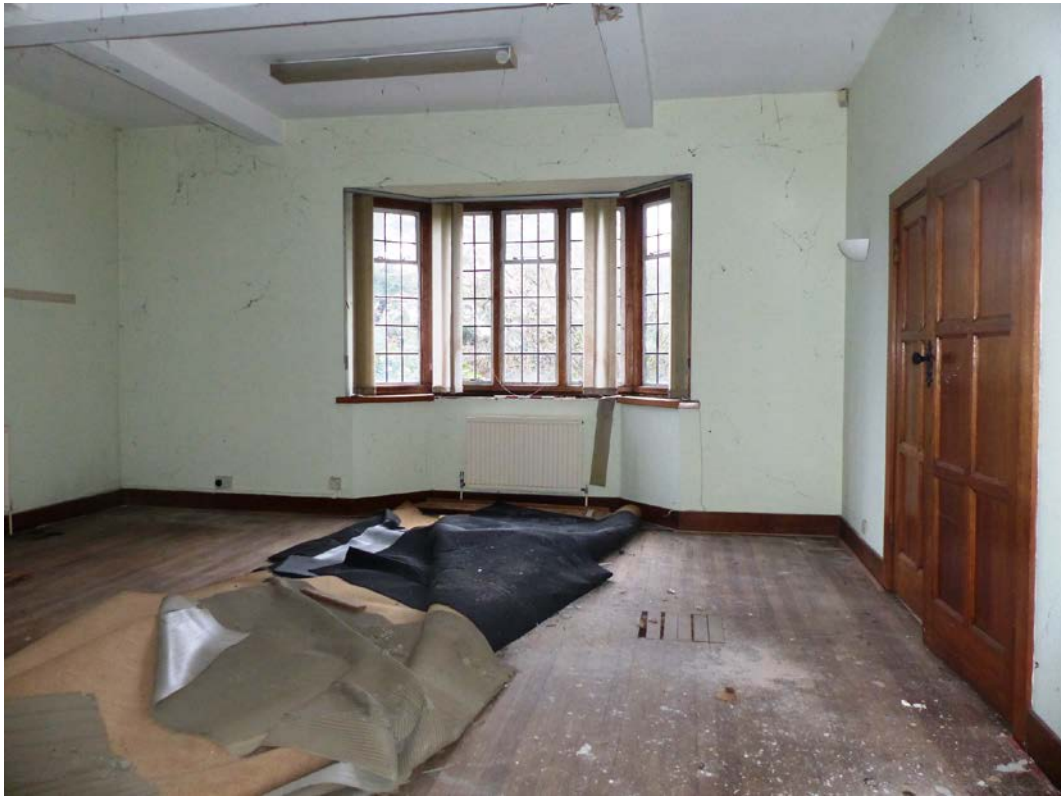
3.4.26 Room G5 is located in the south-east corner of the building. It has a large bay window containing steel 5-part casements within a timber frame. The window has an internal laminate wood sill. The north-east corner of the room has a large Arts and Crafts style fireplace, and next to it there is a blocked window to the south.

G5 also has a timber boarded floor with a thick carpet. The north wall of this room is a thin stud wall that formed the kitchen, G4, which appeared to be a later insertion. Perhaps G5 and G4 were originally one large room with the fireplace in the middle of the east wall (Fig 98, Fig 99).

Fig 98 Room G5, looking south

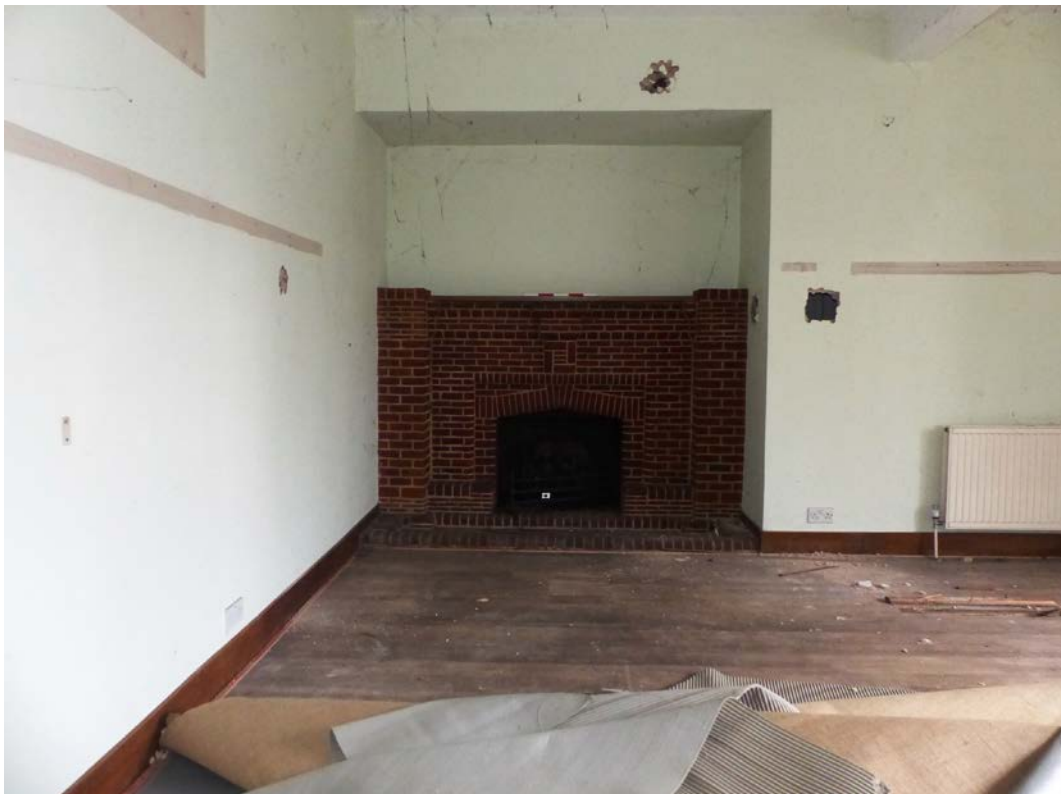
Fig 99 Fireplace in G5, looking east

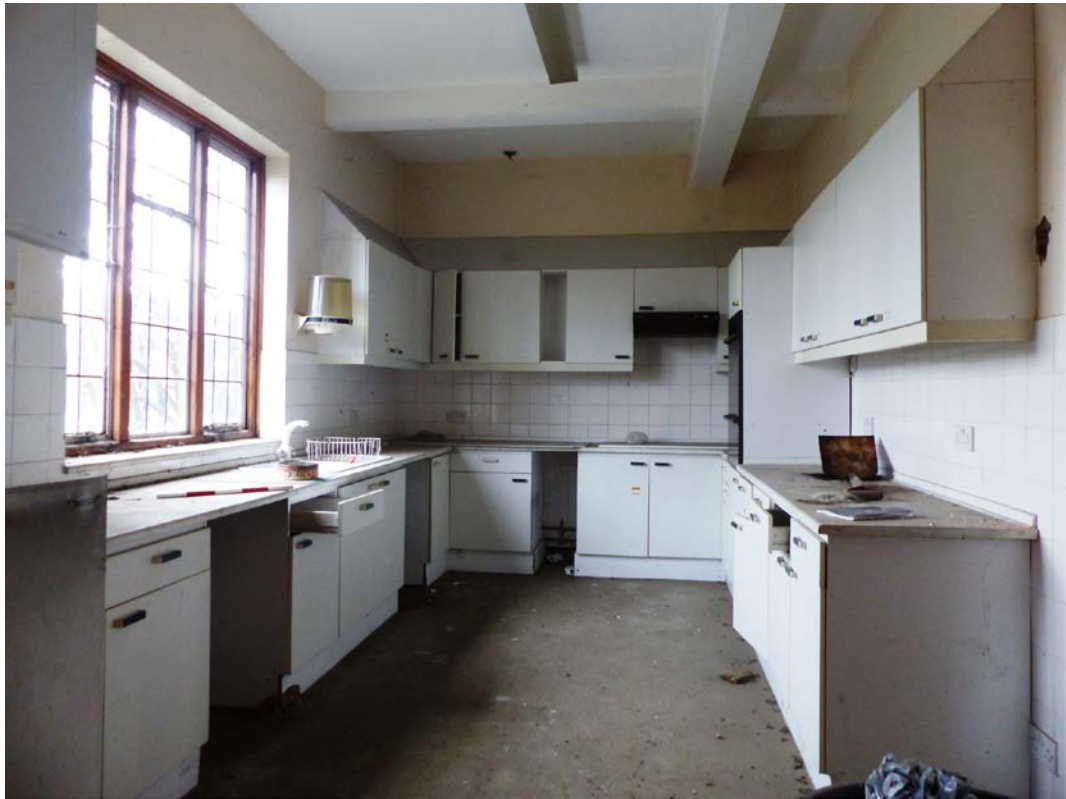
- 3.4.27 The kitchen has a 1980s interior with laminate MDF kitchen cabinets. It has a large window to the north bringing ample natural light. The kitchen has a linoleum covered floor, white laminated worktops and the walls are dressed in white glazed tiles. The north-west corner of the kitchen also has a boiler cabinet (Fig 100).

Fig 100 Interior of the kitchen (G4), looking east

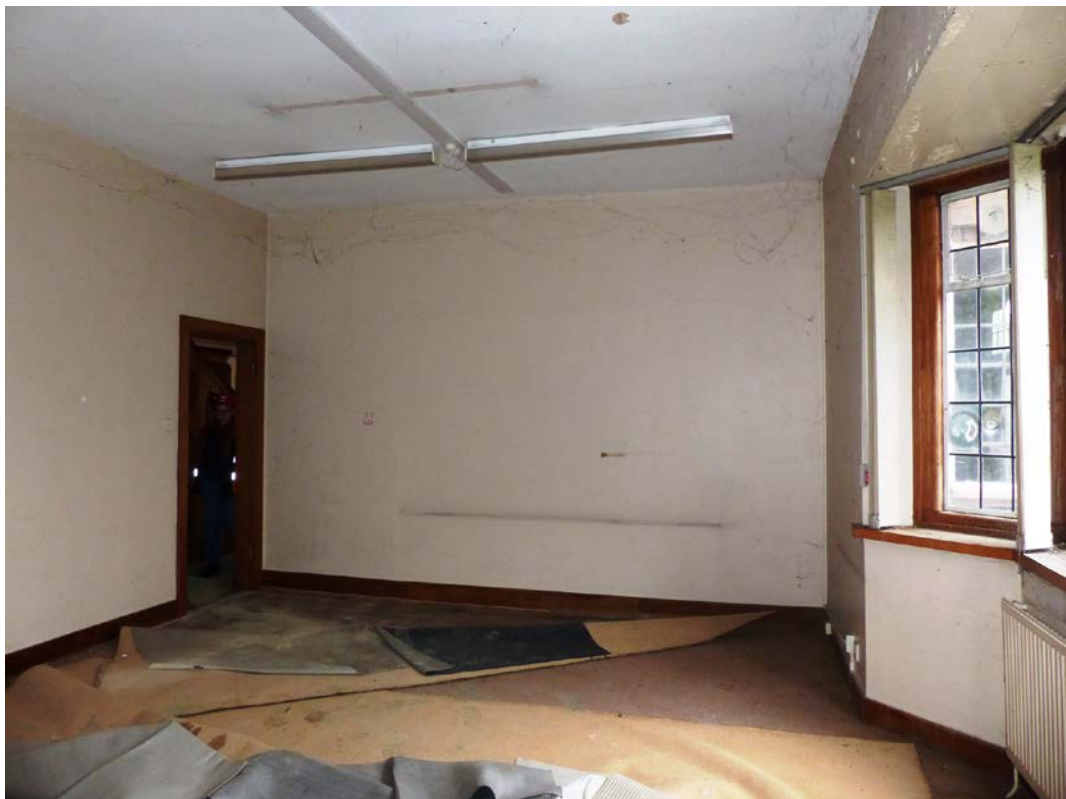
Fig 101 Room G9, looking north-east

3.4.28 Room G9 (Fig 101) is located in the south-west corner of the ground floor. It is accessed from the stairwell lobby (G3). The interior is well lit by a large bay window to the south, identical to that seen in room G5. It has a timber boarded floor covered with carpet.

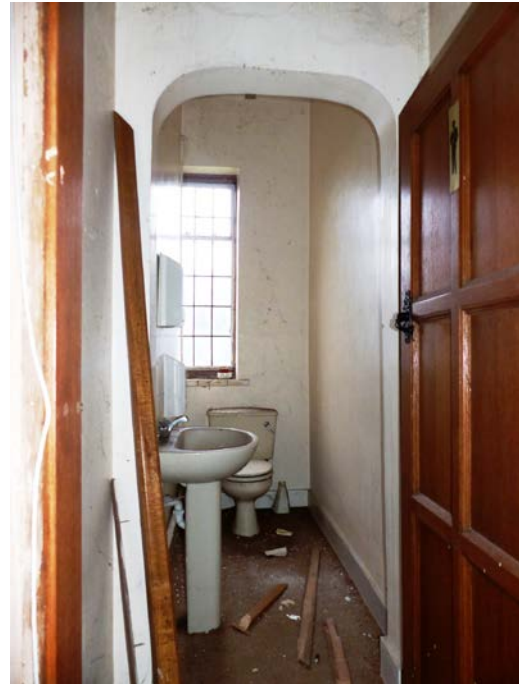
Fig 103 male WC on the ground floor (G7)

- 3.4.29 Room G7 is accessed from the ground floor hallway through a semi-circular arch way (Fig 103). It contains a small male WC and shares a part of a four-part window to the north. Another portion of the window provides natural light into room G6 which is also accessible from the westward running hallway. G6 has a red tiled floor like G3 and the hallway. It is possible that this was originally a kitchen with a pantry in the north-west corner.
- 3.4.30 Further west is the staircase leading to the basement through a door from the hallway (Fig 102). To the south within the ground floor extension is a laundry/ironing room with a double casement window to the south. It has asbestos tiled flooring. An old iron was also noticed in the room. In the north-west corner of the building within the ground floor extension is a small WC (G10) (Fig 106) with windows to north and west.

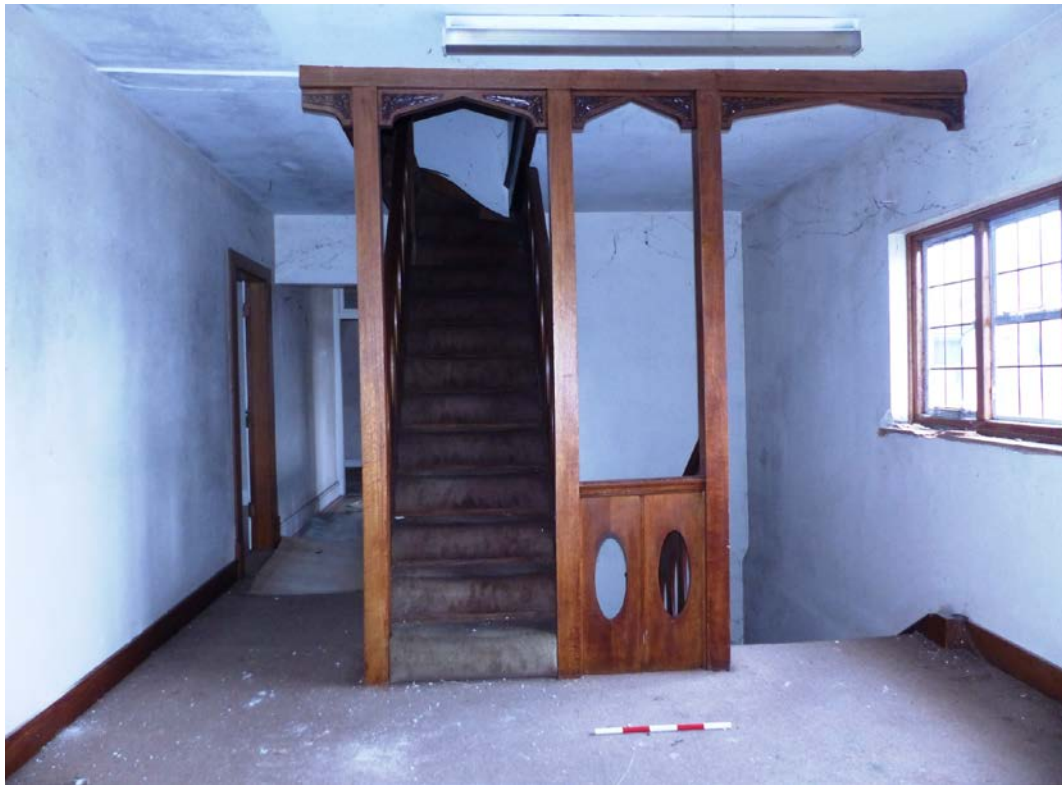
Fig 107 First floor landing, looking west

- 3.4.31 The first floor of the lodge has five bedrooms, two toilets and a storage room all accessed from the stairwell landing and the hallway running west. The Staircase has a much wider fascia with four shallow ogee arches with decorative carvings. However, the southern arch has been removed (Fig 107).
- 3.4.32 All rooms on the first floor apart from the south-east corner room (1F3) are accessible from the landing and hallway. Room 1F3 has doorways room 1F2 and 1F4. The internal partitions are formed of wooden stud walls and plaster boards. All rooms on the first floor have timber boarded floor with later added carpets and wooden skirting throughout.

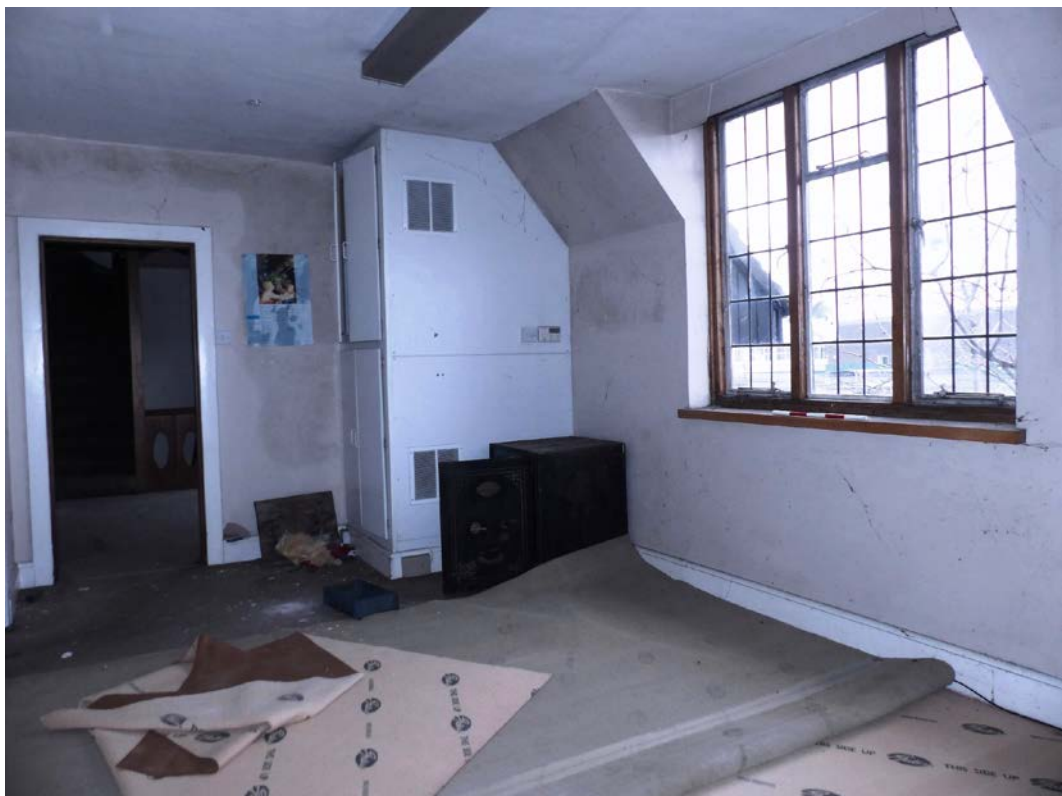
Fig 108 North-east corner bedroom on the first floor (1F2), looking north-west

- 3.4.33 The first-floor landing (1F1) has a four-part window to the north and a carpeted floor. All the doors and the skirting visible from the landing have clear varnished oak trim conforming to the appearance of the staircase. Room 1F2 to the north-east corner has triple casement window in a dormer. This room also has an inserted boiler cupboard with vents in the north-west corner. A heavy metal safe was also seen in the room (Fig 108).

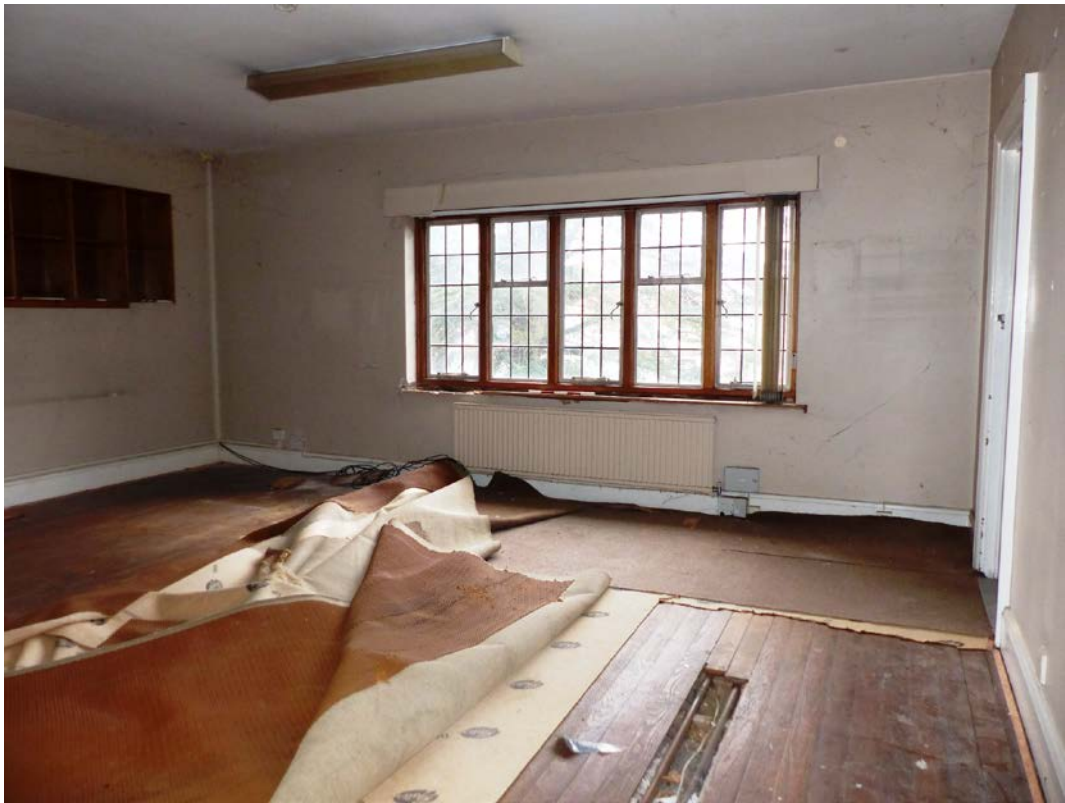
Fig 109 South-east corner bedroom on the first floor of the lodge, looking south-east

- 3.4.34 The south-east corner room on the first floor (1F3, Fig 109) has a five-part combination window of casements and awnings. A similar five-part window to the south at the west end, however, internally shared by room 1F7 and 1F6 (Fig 111). The partition wall between 1F6 and 1F7 did not appear to be inserted. The small area in the projecting entrance bay on the first floor, room 1F5 is very well lit by five windows to the south and one at each side. It is accessed from room 1F4 through a folding door. As well as the glazed door, two fixed light windows, either side of the door bring natural light into room 1F4 (Fig 110).

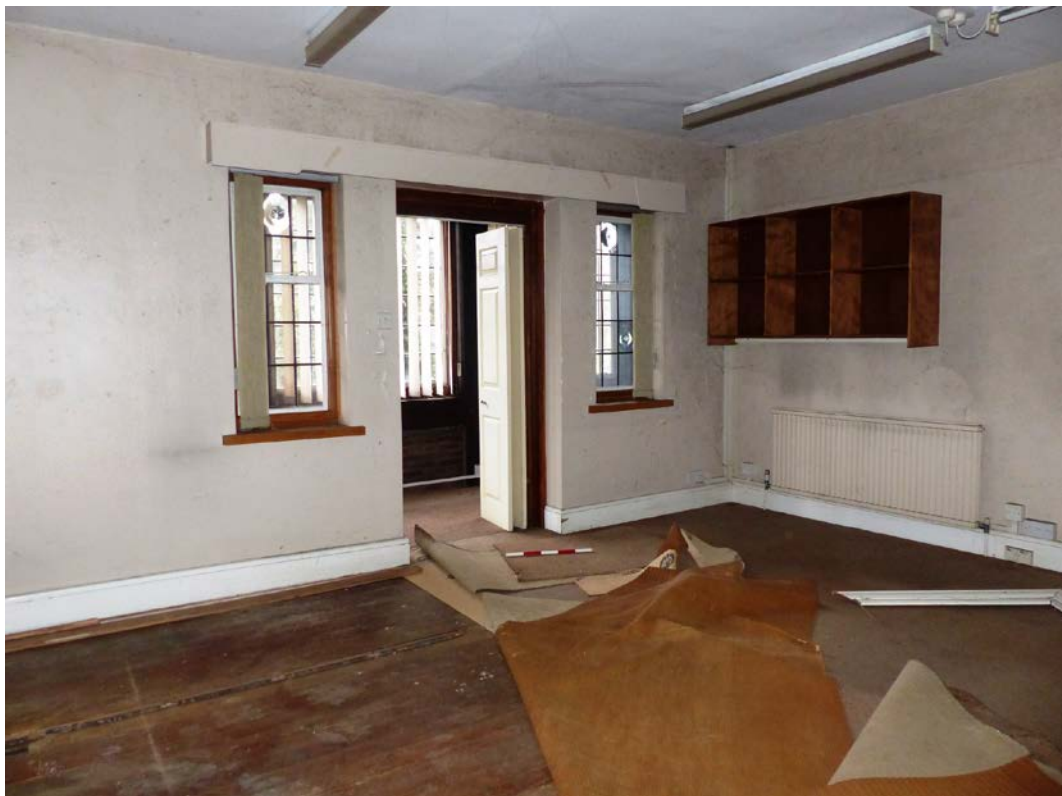
Fig 110 Room 1F4, looking south-west

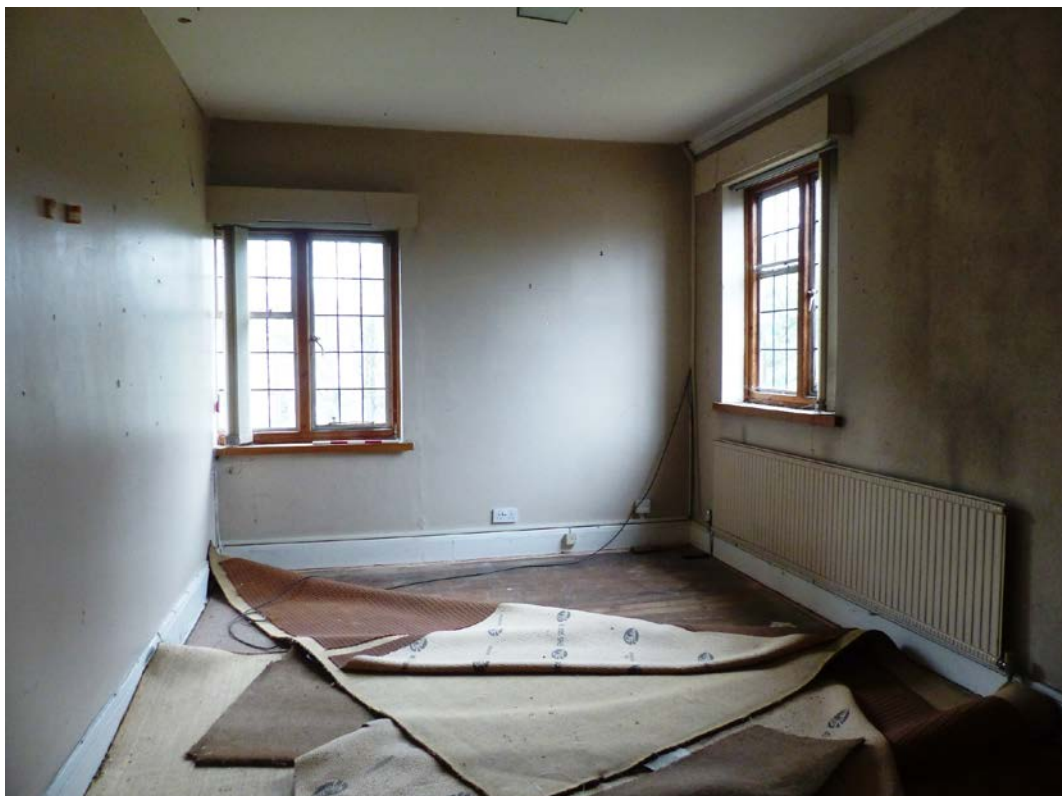
Fig 111 South-west corner room on the first floor (1F7), looking south. Note east wall abuts window to the south

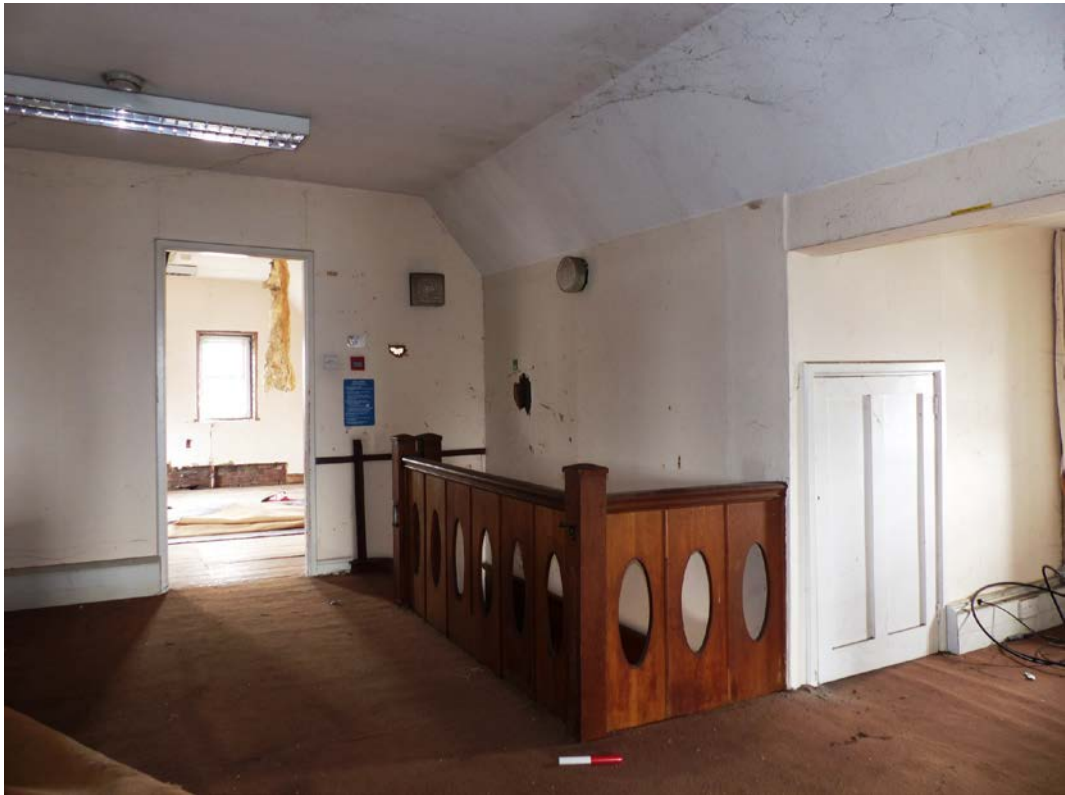
- 3.4.36 The attic level of the building formed the second floor, accessed by a single flight of the wooden staircase. The staircase leads into a large room and has a panelled timber protection to the staircase (Fig 112).

Fig 112 Second floor landing of the staircase, protected with timber panelled railing

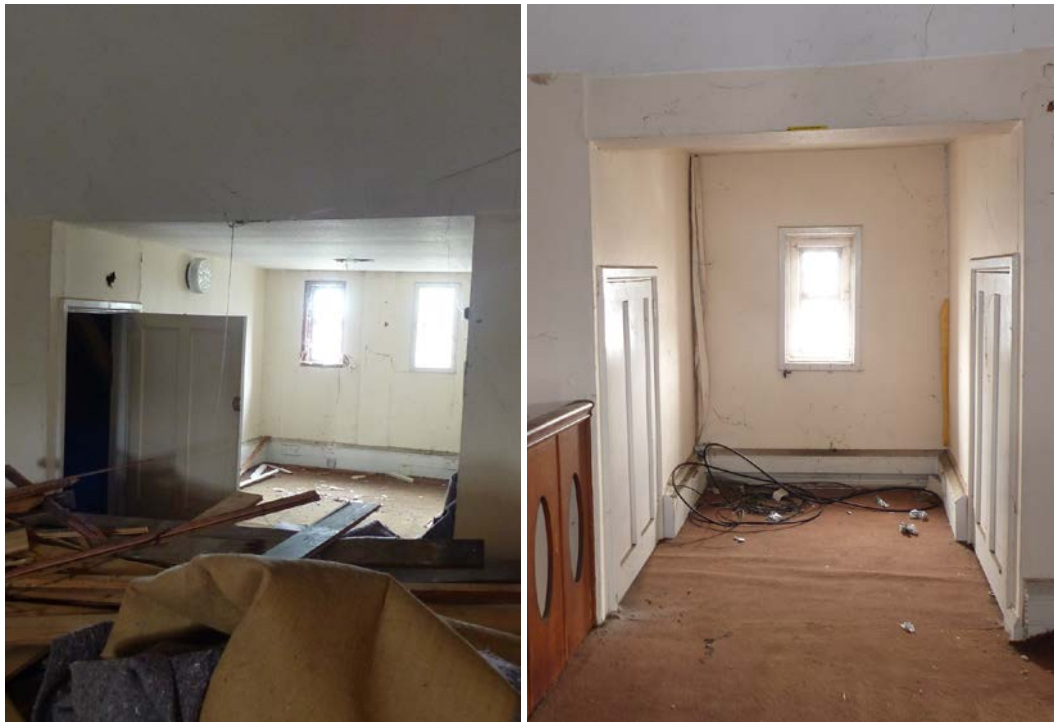
- 3.4.37 The second floor contains three large rooms along the centre of the building with eave storages on both north and south sides of the rooms. The staircase providing access to the second floor leads into the central room (2F1). It has chamfered ceilings on north and south sides of the room reflecting the slope of the roof pitches. It has a carpeted softwood timber board floor with the floorboards running north to south. Both the east and west end rooms on the second-floor level are accessed through this room. There are two alcoves to the north and south projecting from room 2F1 with low headroom. The south alcove is located within the projecting main entrance bay and has two small windows to bring natural light in whilst to the north a small window in the north gable provide natural light into this small space. Both alcoves have access doors into the eave storage spaces (Fig 113).

Fig 113 South (left) and northern (right) alcoves in 2F1

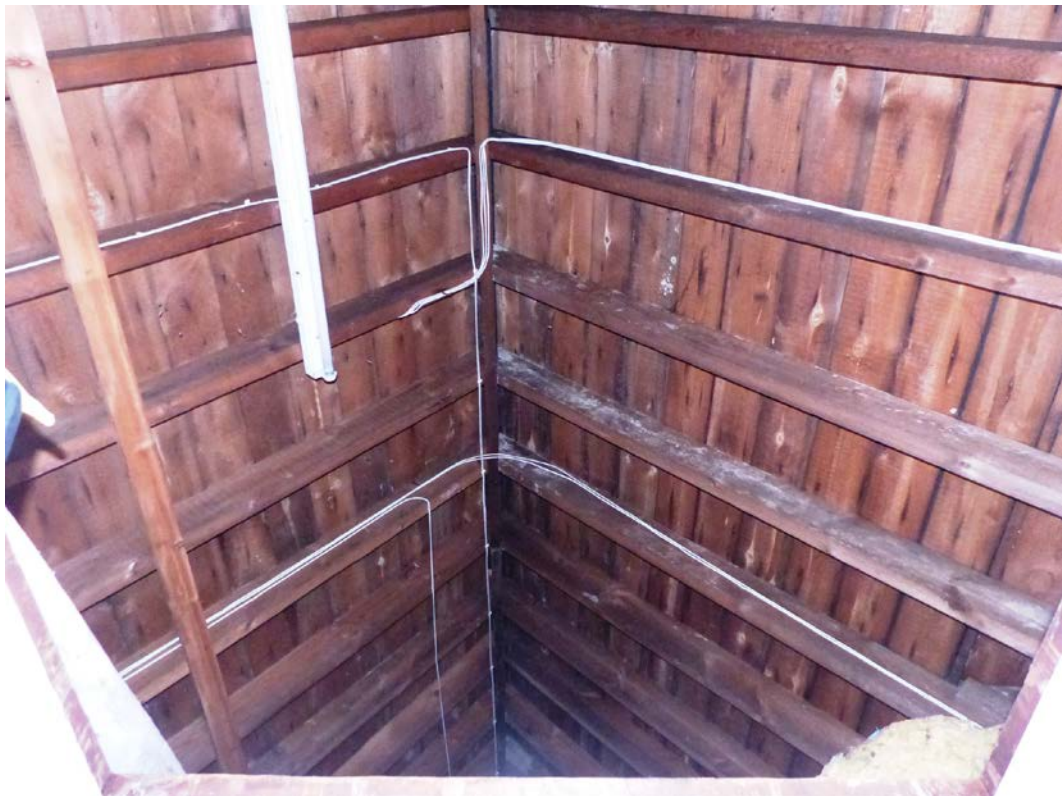
Fig 114 Common rafter timber boarded roof construction was visible through a hatch in the ceiling of room 2F2

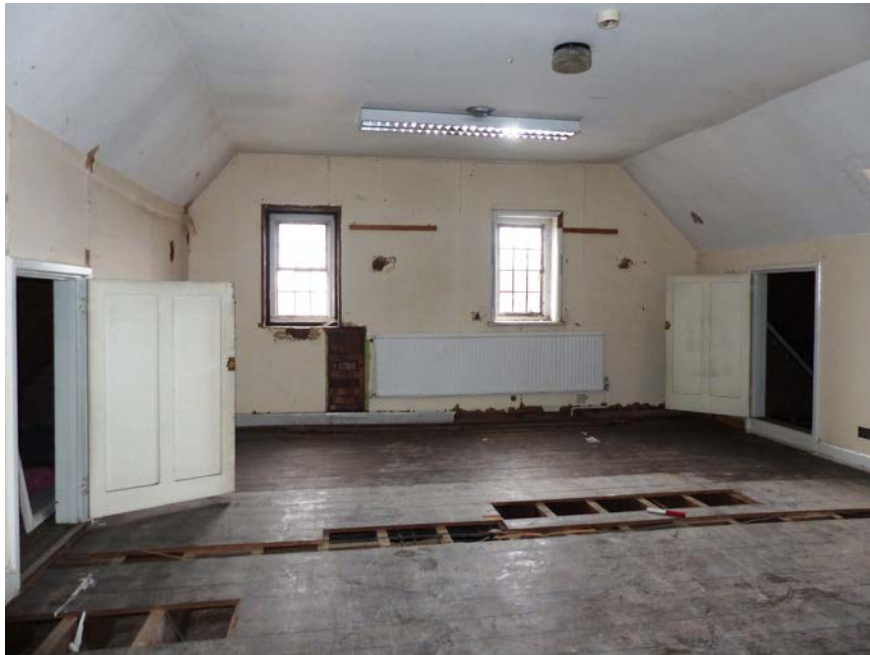
Fig 115 Interior of the east end room (2F3) on the second floor of the lodge, looking east

- 3.4.39 Both rooms have identical dormer windows to the south, with pairs of windows to the sides, providing natural light (Fig 115, Fig 116). They both have access doors into the eaves storage spaces along the north and south sides of the rooms. Room 2F2 also has a hatch to access the roof space. The timber boarded roof construction was visible through it (Fig 114). A number of floorboards were loose in the east end room, 2F3, through which the floor construction was observed. The floorboards are 1-inch thick and 6-inch wide throughout the second-floor rooms. These are nailed onto east-west running floor joists, which had a general scantling of 11-inch thickness and 2-inch width. Floor joists are spaced 10-inch apart on average. The eaves spaces, however, have been observed with similar but separate floor structures. In both end rooms, the dormer window recesses to the south have 6-inch higher floor levels (Fig 116).

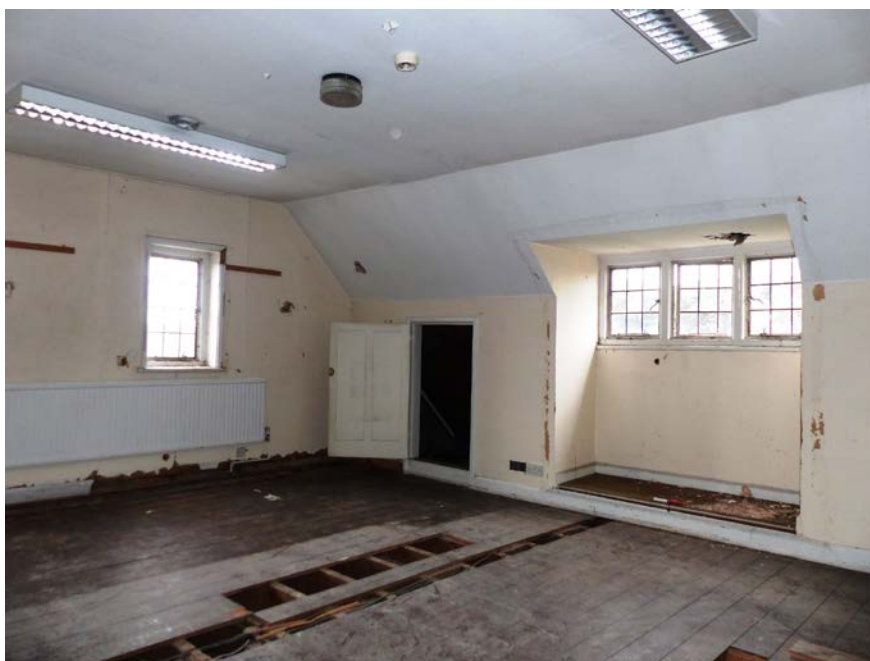
Fig 116 Dormer window recess to the south in room 2F3, looking south-east

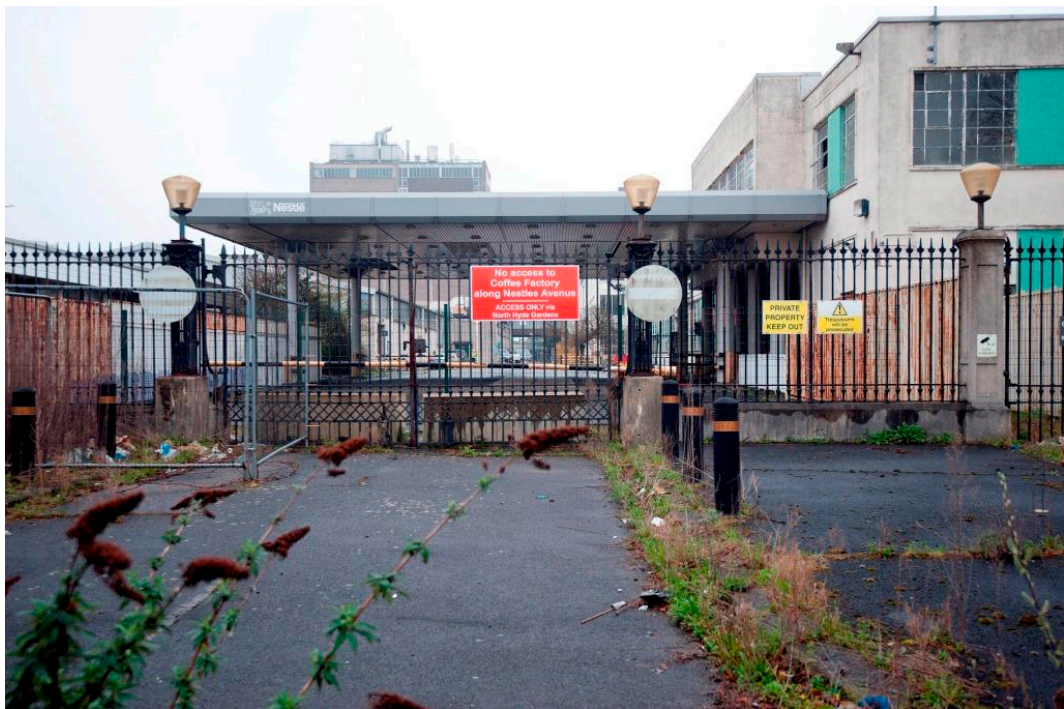
- 3.5.2 The Beverage Division gate assemblage (Fig 118) consists of a central vehicle entrance with two pedestrian gates located on either side oriented in a straight east-west line across the entrance. Between the vehicle gate and the pedestrian gates, there are areas measuring approximately 4.125m of fixed type 'A' railings (see railing description below). The pedestrian gates are approximately 1.5m wide not including a 0.75m section of type 'A' railing to the side of each gate, one 0.75m section at the east end and the other at the west end. The gate posts or piers of the pedestrian gates are concrete post type 'A' as described below in the Railings section. The vehicle gate is approximately 5.70m wide, and its characteristics are the same as railing type 'A', with two additional lower rails, between which there is iron lattice-work with straight pickets in the bottom horizontal section (Fig 118).

Fig 118 the Beverage Division Gate as seen from the south (Photo Maggie Cox, MOLA)

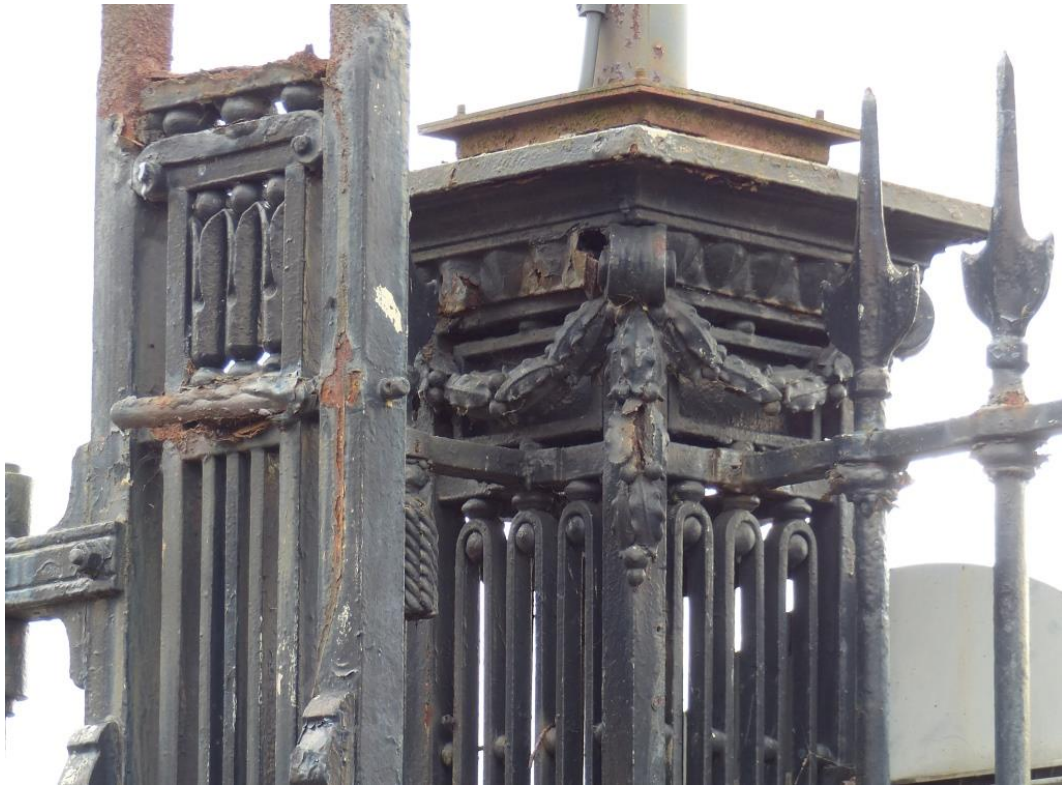
- 3.5.3 All of the gate piers at the Beverage gate have lamps extending from the tops. The vehicle gate piers are formed of very ornate hollow ironwork which can be

said to resemble an Ionic style column. The capitals begin with an abacus and volute, below which are both egg and bead motifs, followed by a leaf and rope festoon or garland (Fig 119). The shaft of the piers is decorated hollow flute and fillet style with beading which repeats down to the bottom of the pier. The main piers are supported by concrete plinths and behind the main piers to the vehicle gate are flat support piers or pilasters with iron outriggers, also anchored into a concrete plinth. The support piers retain many of the same ornamental features of the main piers with the addition of some skeuomorphic ribbon ornamentation.

Fig 119 Beverage Gate pier detail seen from the northwest

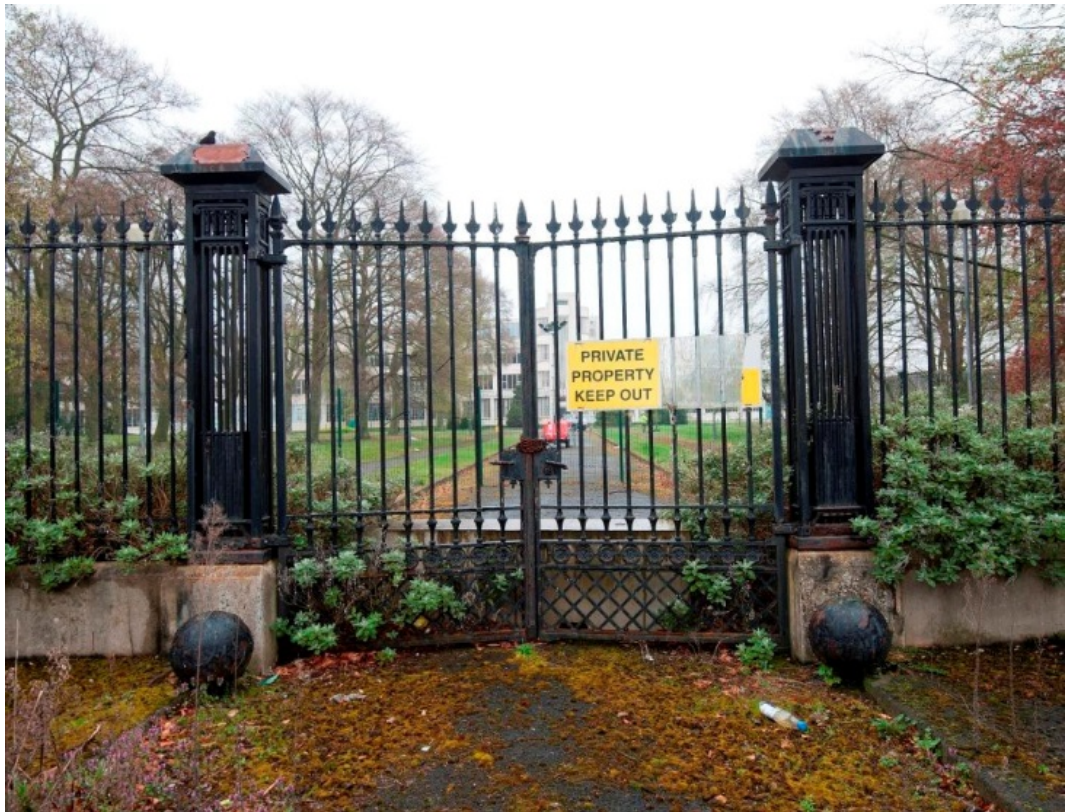
- 3.5.4 The Main Gate assemblage gives a more formal impression and consists of a central section for vehicle entry (Fig 120) measuring approximately 3m east-west which, like the Beverage Gate, is flanked by two pedestrian entrances. There is curved fixed type 'A' fence sections between the vehicle gates and the pedestrian gates (Fig 121). The central section of the gate has type 'A' characteristics apart from the lower sections which have decorative rosettes (Fig 122) and below the rosettes, iron latticework. Starting from the south (street) side there two sets of pilasters on the east and west sides which are less ornate and consist of hipped capitals below which beading and simple scroll detail can be seen followed by hollow flutes and fillets with bead detail at the bottom. Following on, there are two ornate piers before the inward curving plinth leading to the central vehicle gates and then piers on the east and west sides of the central gate. The two ornate piers have the same detail as described in the Beverage Gate piers in Fig 119 (see above) with the addition of hipped capitals and acorn finials in place of lamps (Fig 123). Atop the curved plinths are fixed sections of fence type 'A' as described in the Railings section below (Fig 121). The piers directly flanking the vehicle gate are hollow ironwork comprised of four pilasters (as described above) welded together and topped with hipped capitals (Fig 120 Fig 121).

Fig 120 The Main Gate central section from the south (Photo Maggie Cox, MOLA)

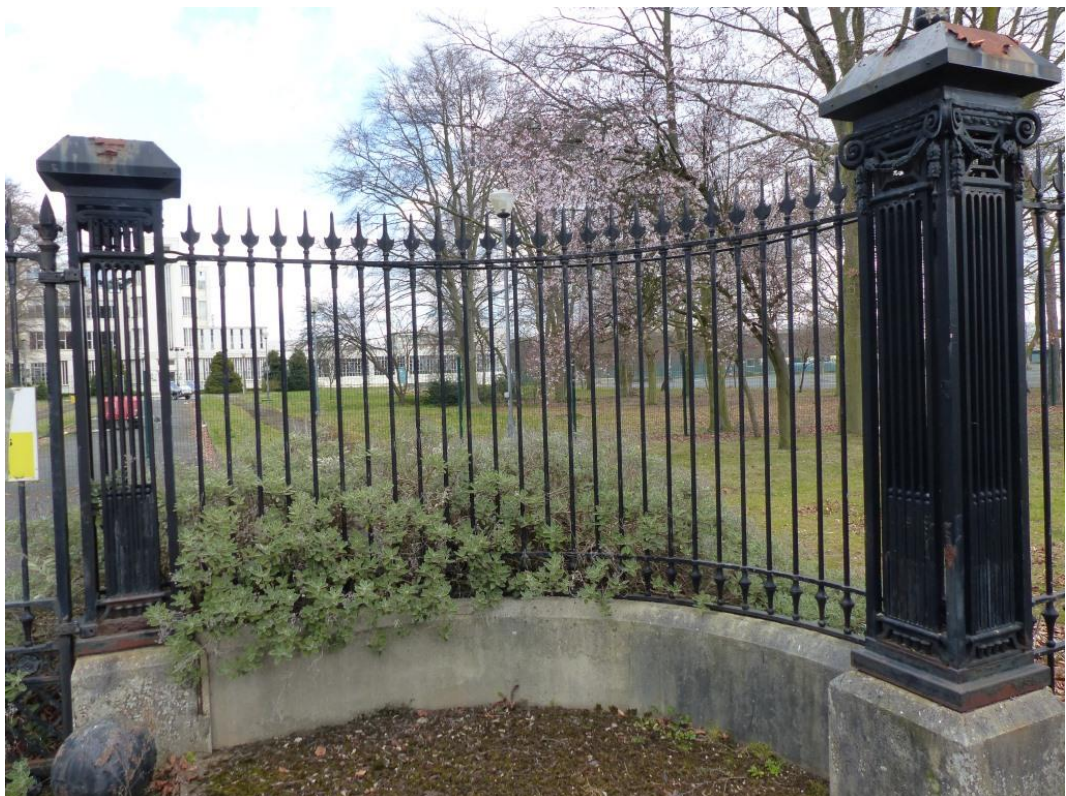
Fig 121 Curved section of Main Gate, east side, showing pier types 1 and 2, from the south.

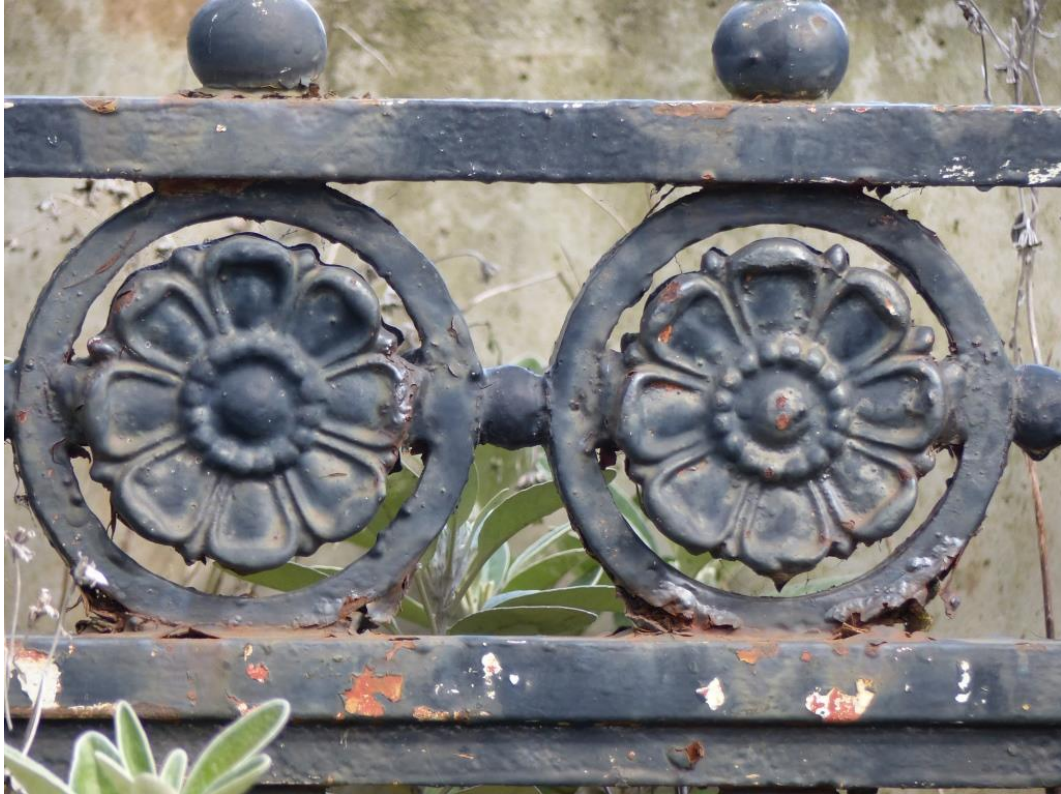
Fig 122 Main Gate rosette detail from the south

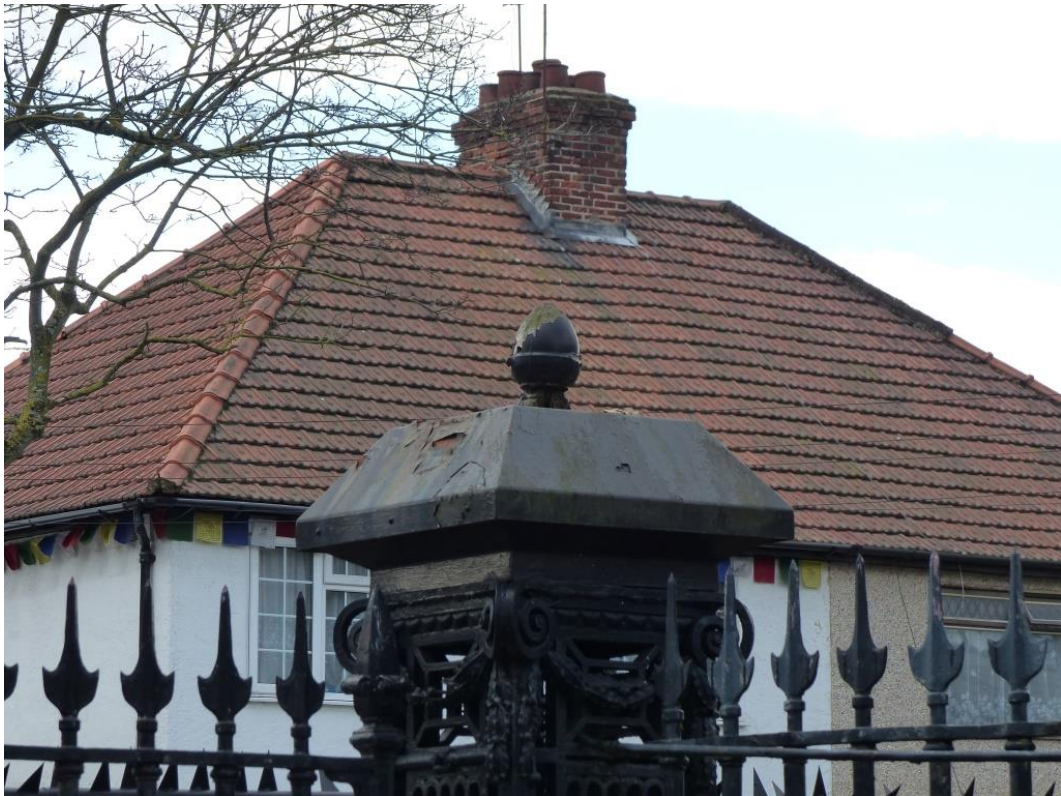
Fig 123 Acorn finial detail in Main Gate seen from the north-east.
