Building Recording (Level 2)

Photographic Record (Volume 2)

Former Nestlé Factory Canteen Building, Nestles Avenue,
Hayes

March 2026

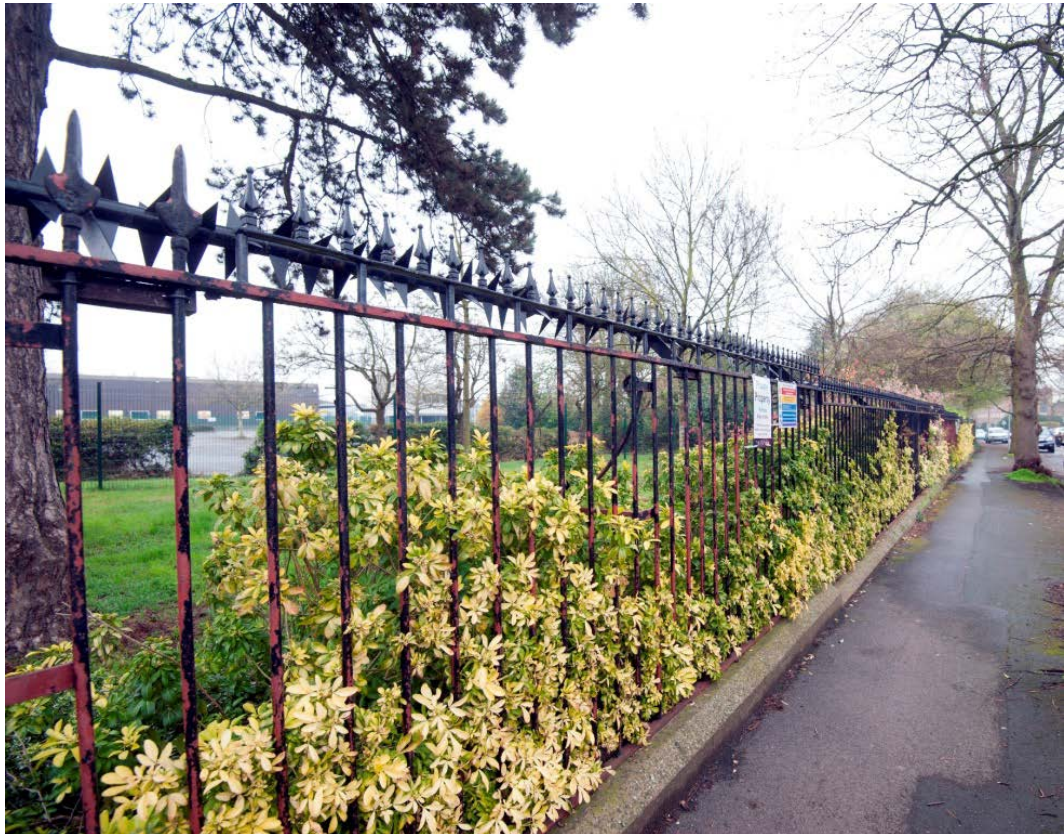
Fig 124 A section of the fence/railing, looking east (Photo Maggie Cox, MOLA)

- 3.5.5 For the purposes of the MOLA Standing Building Survey, the fencing was divided into sections 1 through 8, with section 1 starting from the west. The section number changed as physical elements of the fence changed. Examples of elements which constituted changes were the existence of a base plinth, changes to the type of finial, changes in the rails of the fencing and the height of the fence (Fig 124). There were four types of railings recorded: A, B, C and D.

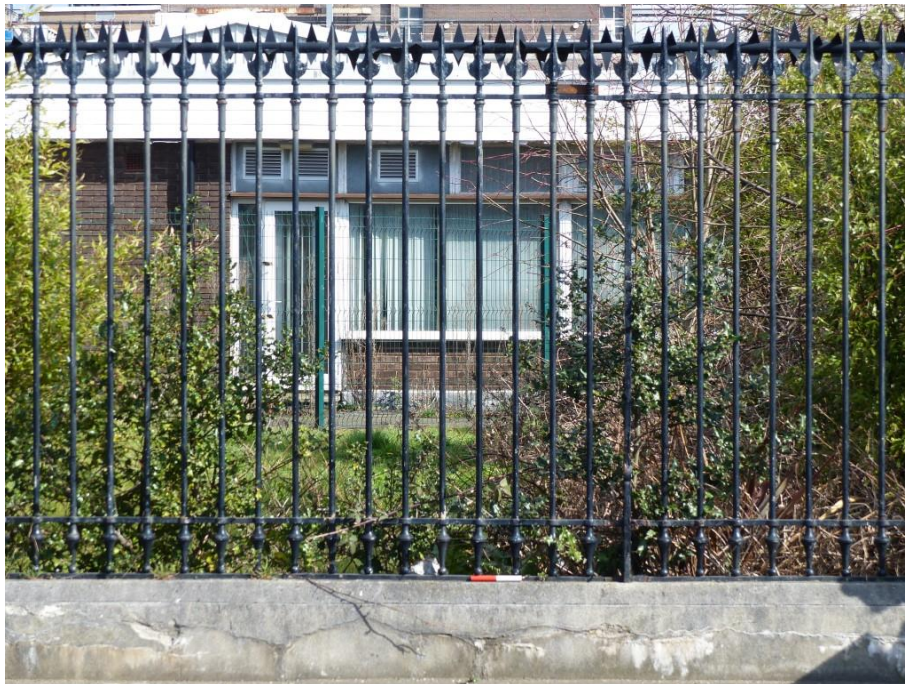
- 3.5.6 The elements of **Type A** are, from top to bottom: an unusual variation of triad spear style finials, top and bottom rails which have projecting rounded parts with collars below, where the vertical pickets pass through them. The bottom of the pickets has a rounded, tapered element below which there is a frame rail which is bolted directly to the concrete plinth. These elements stabilise the pickets and fence sections along with iron outriggers which run at approximately every 1.84m on the north side of the railings (Fig 125, Fig 126).

Fig 125 Railing Type A, looking north

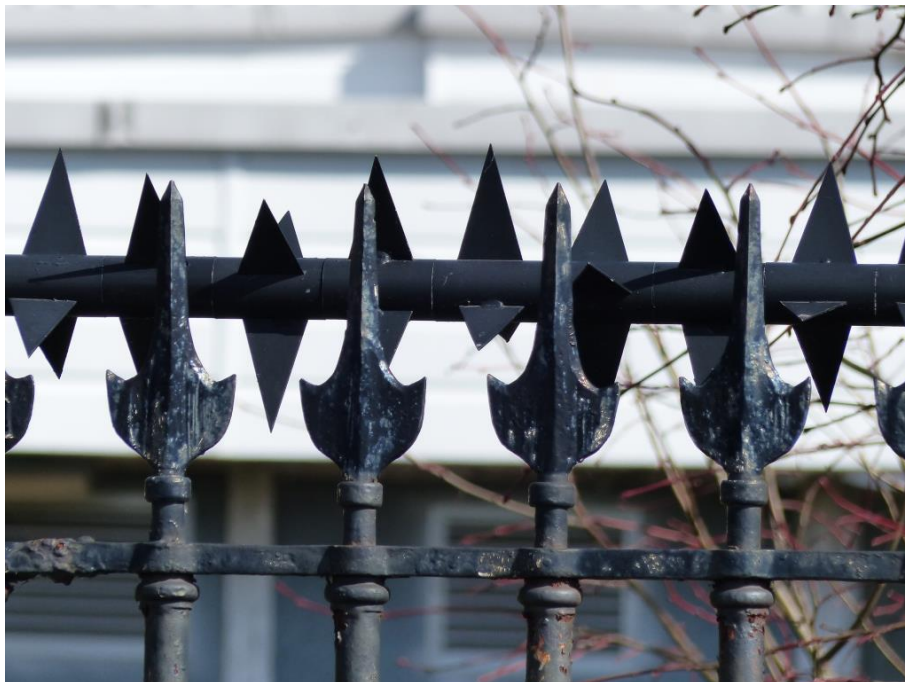
Fig 126 Railing Type, A finial detail, looking north

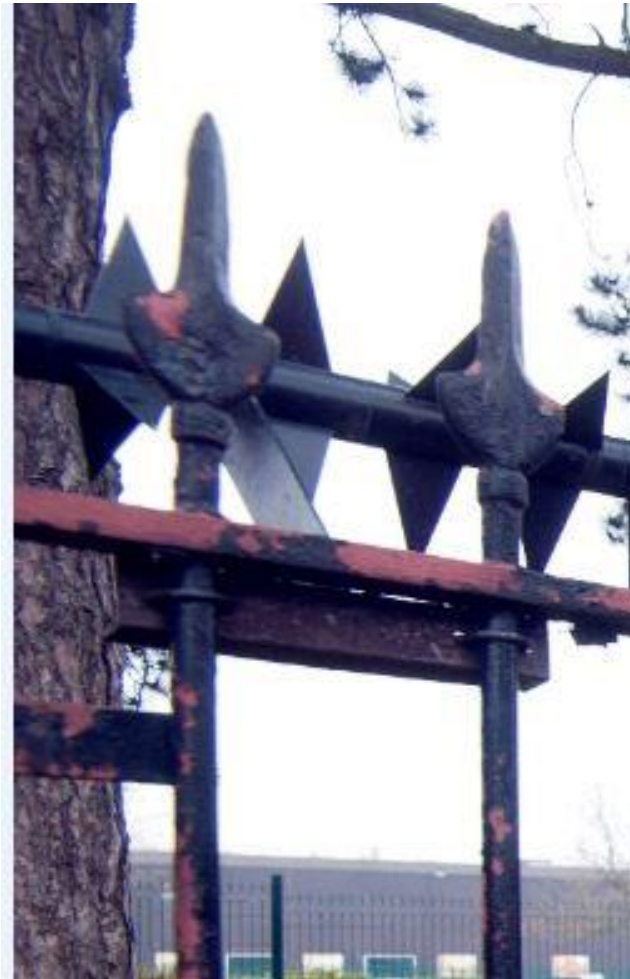
Fig 131 Railing Type C detail, looking north-east

3.5.8 Railing **Type C** has the same triad style finials as A and B. However the top rail does not have the rounded projecting detail or the collar under the top rail (Fig 131), which can be seen on Type A. This may be due to it being later repair or replacement or that it is some distance from the main entrance and so not necessarily as decorative.

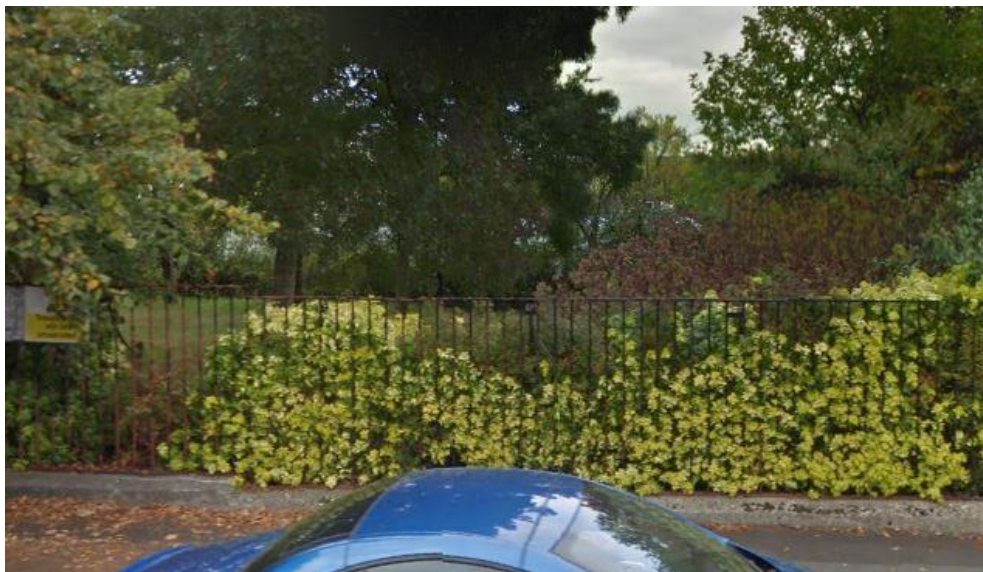
Fig 135 2014 Google Street View, railing Type D from the south showing absent finials

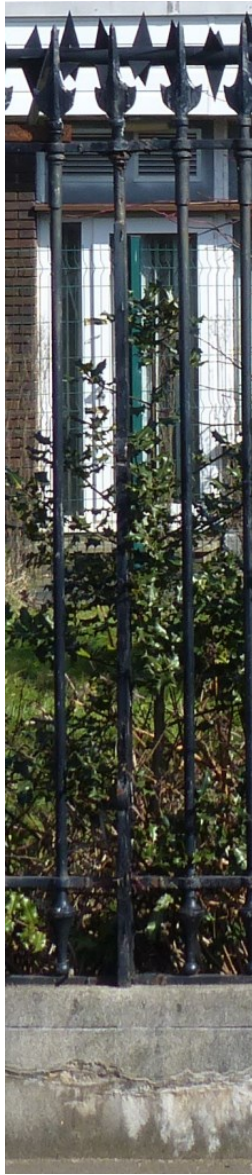
Fig 138 Post Type C, the central vertical member seen from the south

- 3.5.10 Post types A, B and C were recorded along with the railings and in addition to the posts recorded at the Gates. Post type A is a large concrete pillar approximately 2.28 meters tall with shallow recessed 'panels' on all sides. It is bevelled or chamfered at the top and above the base which measures 570mm (Fig 136). The post type B pillar is formed of solid cast iron elements which include an acorn finial and a plain post capital with fluting detail on the square vertical shaft (Fig 137). Post type C can be found only on the west end of the railings and the Beverage Gate and in railing type A. It is topped with the triad finial and is a flat baluster (flat with shaped sides). Although difficult to discern an example can be seen in (Fig 138).

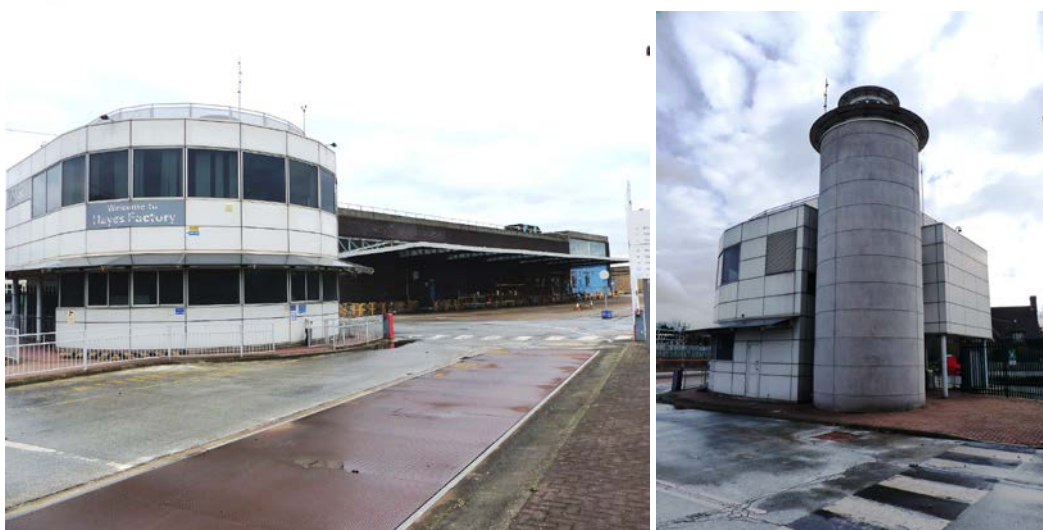
Fig 140 Entrance gatehouse and security office building. Note weighbridge installed in the road (left), view from the north (right)

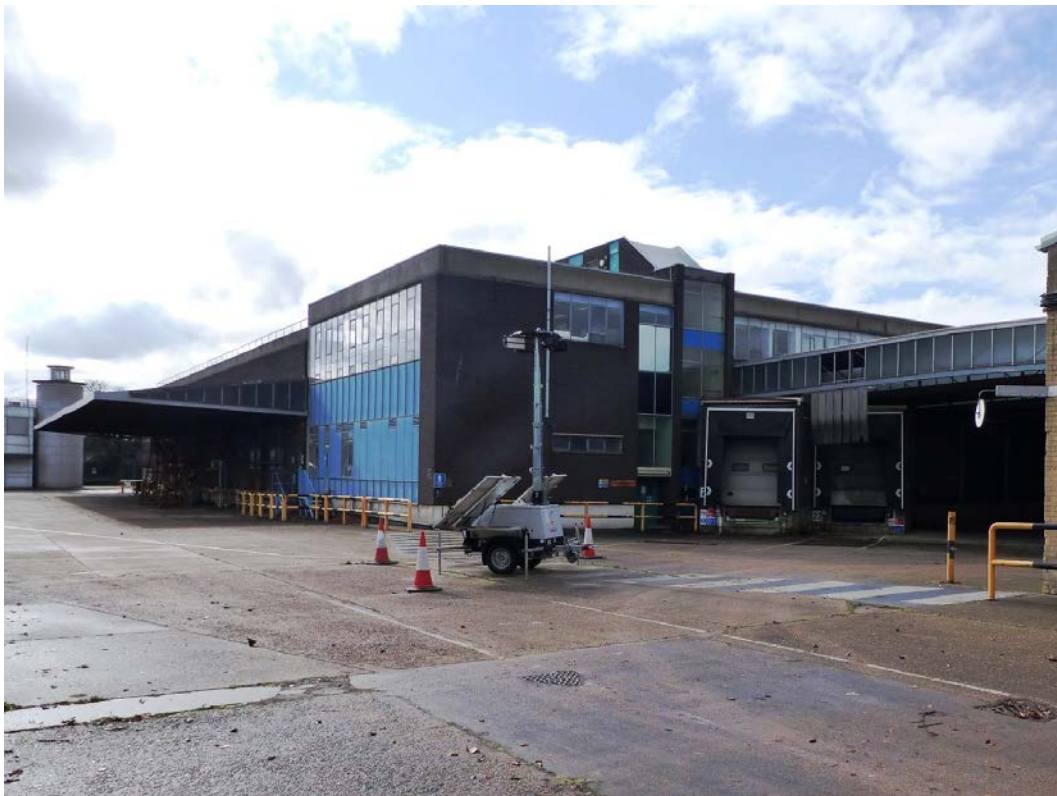
Fig 144 Later added factory building located on the east side of the site with a cantilevered canopy, looking south

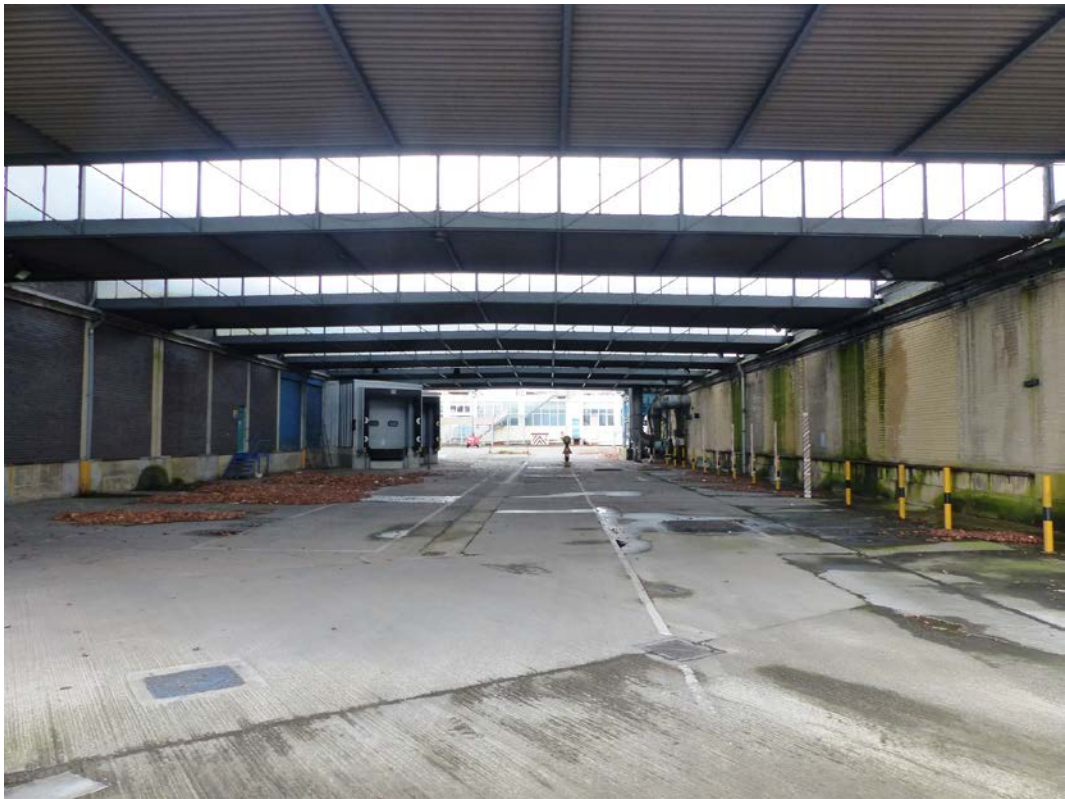
Fig 145 Loading bay with modern steel canopy between the two large factory buildings in the north-east corner of the site.

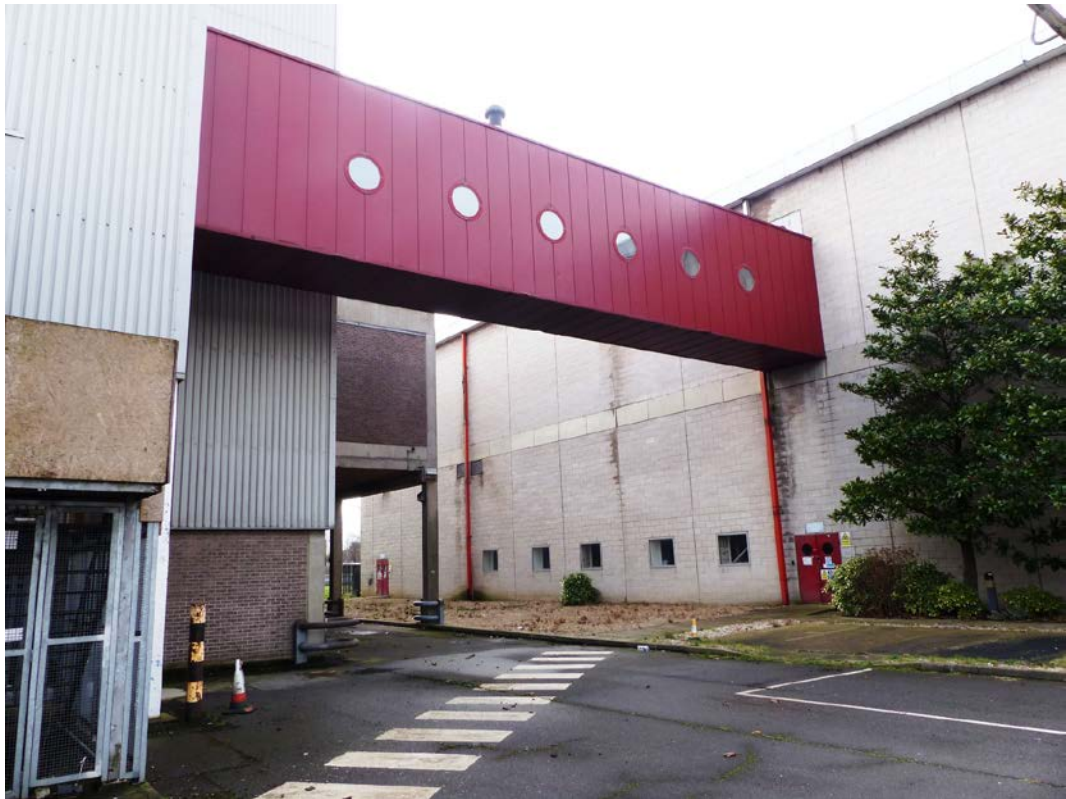
Fig 149 A modern high-level steel framed walkway connecting the two late 20th-century factory buildings at the north-west corner of the site.

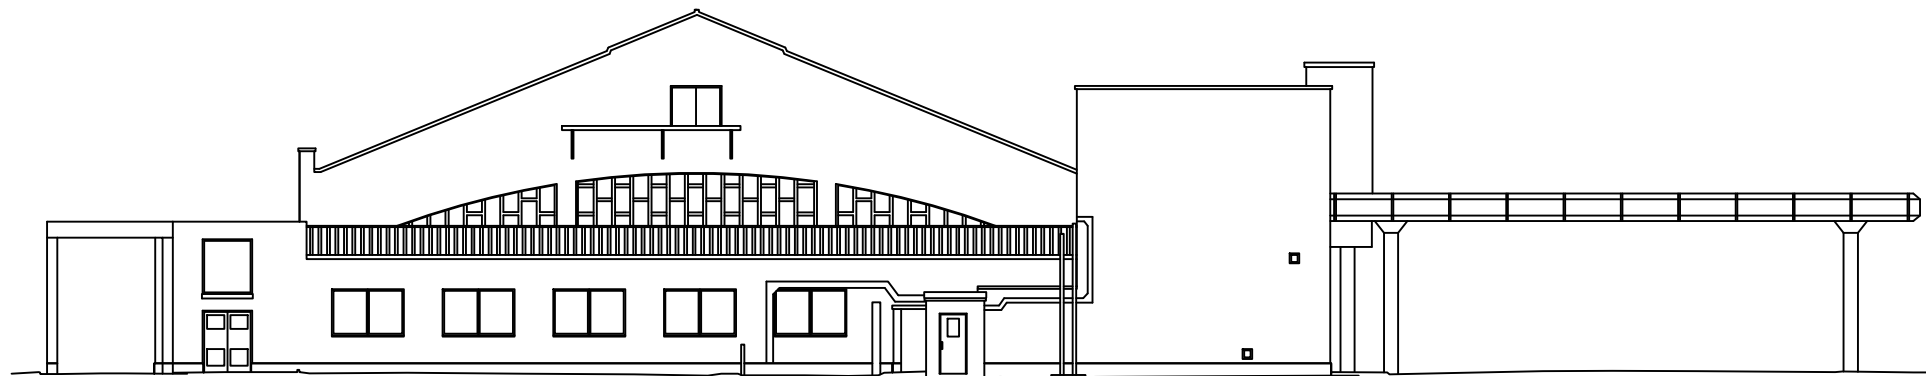
DRAWING TITLE:
North elevation of the Former Canteen

Datum: 25.00m.

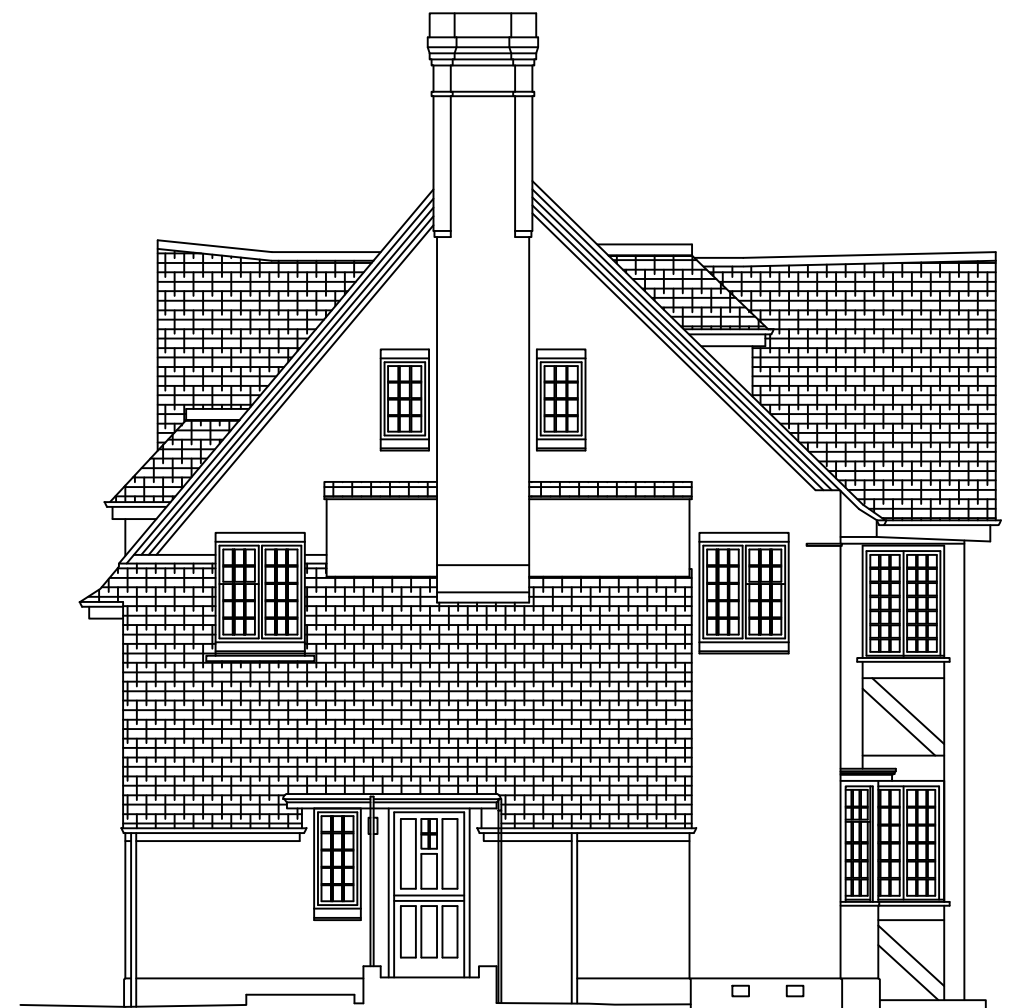
West Elevation

Datum: 25.00m.

- 3.4.7 The west elevation also has an exterior projecting brick chimney identical to that seen in the east elevation (Fig 87). Also seen in the east elevation are two small window openings in the brick gable, at either side of the chimney, providing natural light into the attic level. At first floor level, there is slight projecting brickwork observed with slate capping presumably containing flues from the first-floor fireplaces. There are two windows to the west at first-floor level.

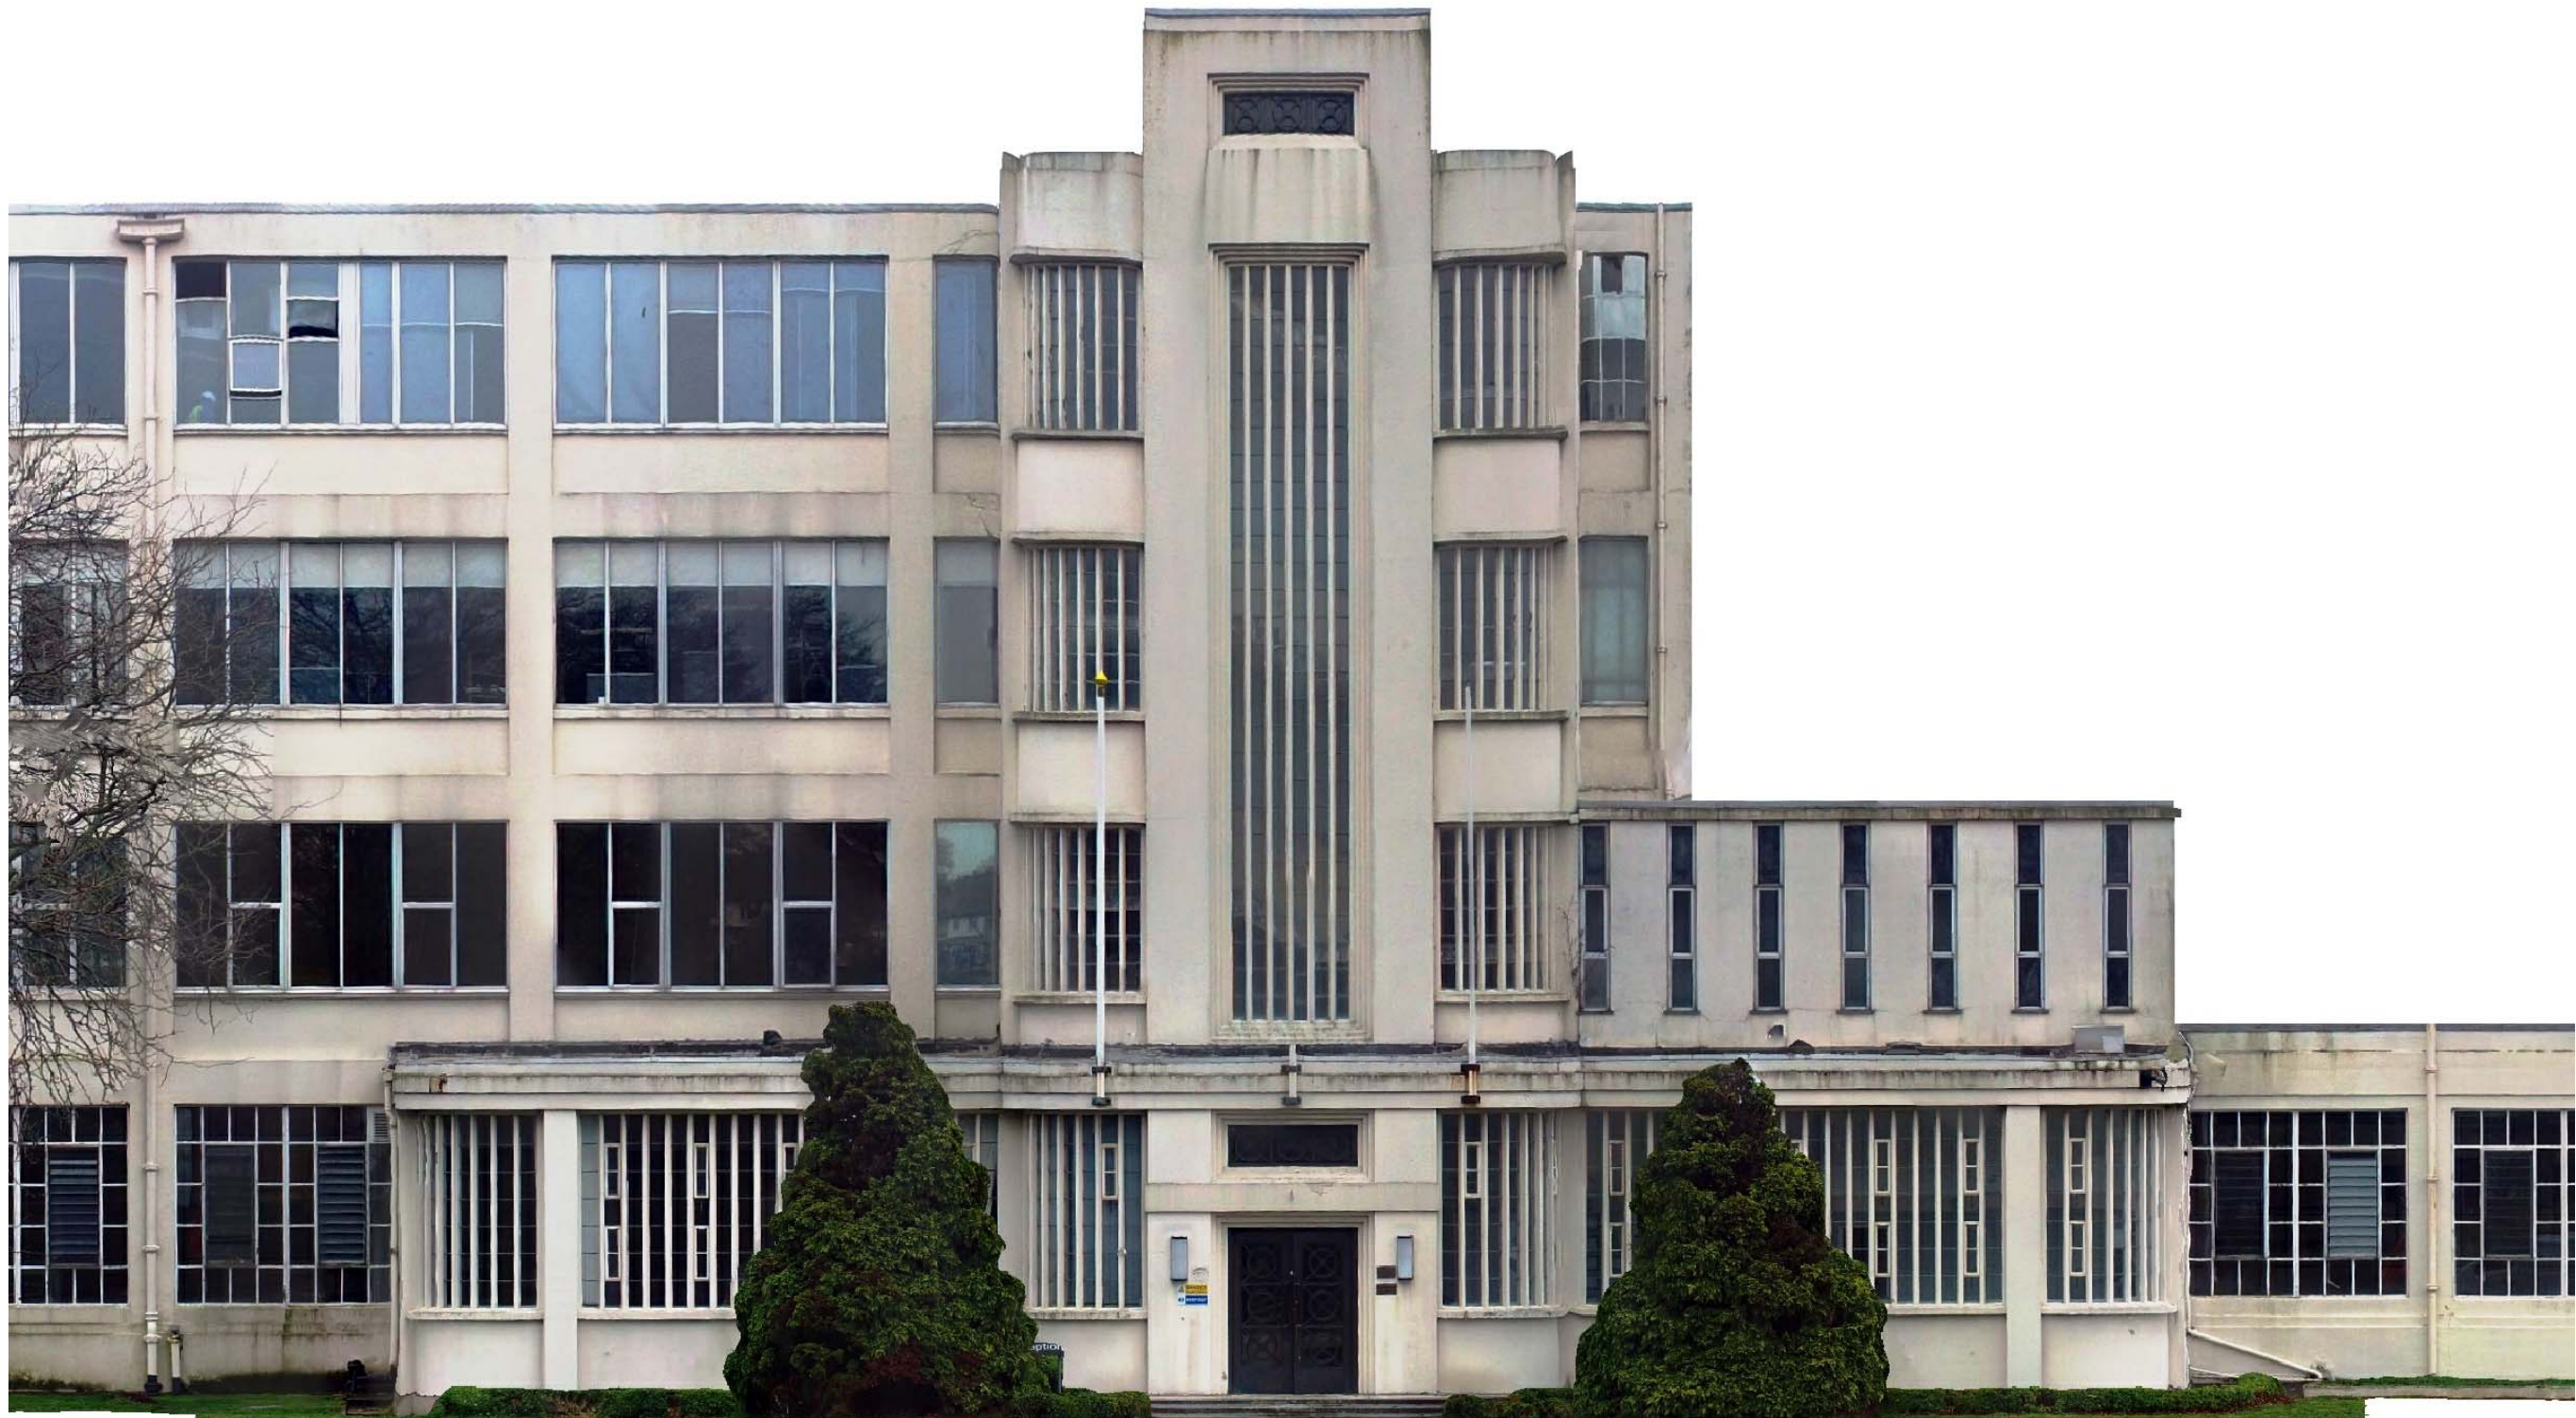
South Elevation (central section) of the Main Factory Building

1:100 on A3

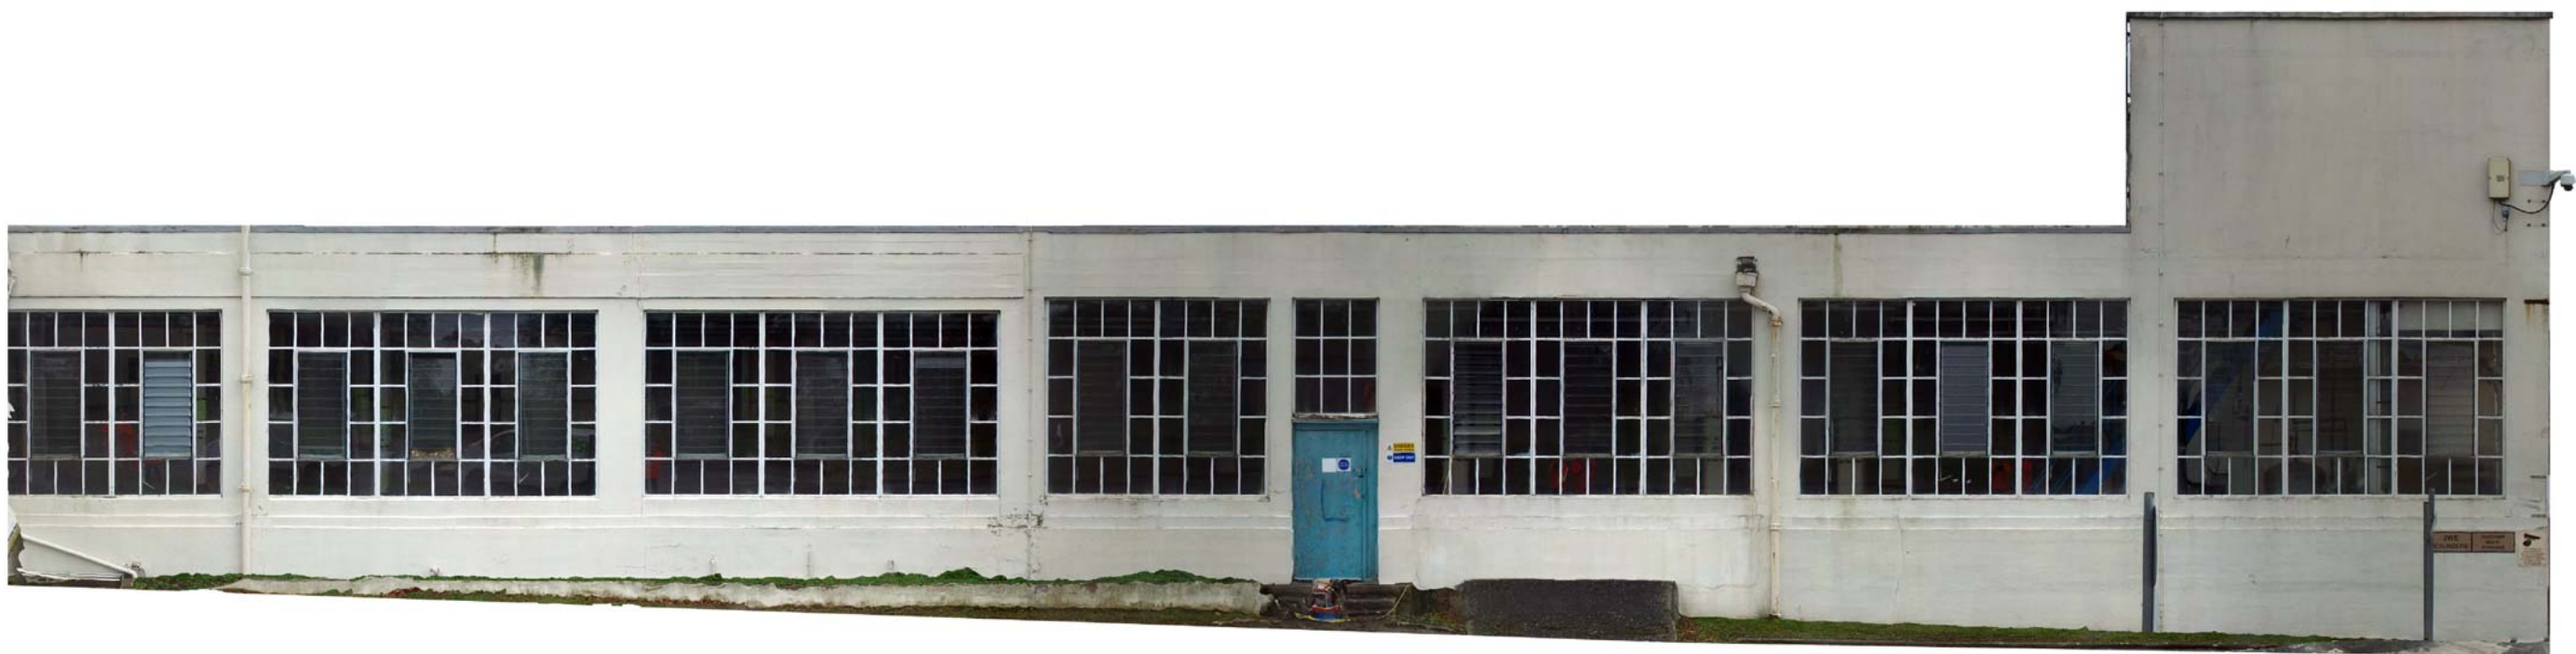
South elevation (east end section) of the Main Factory Building

0 10 m
1:100 on A3

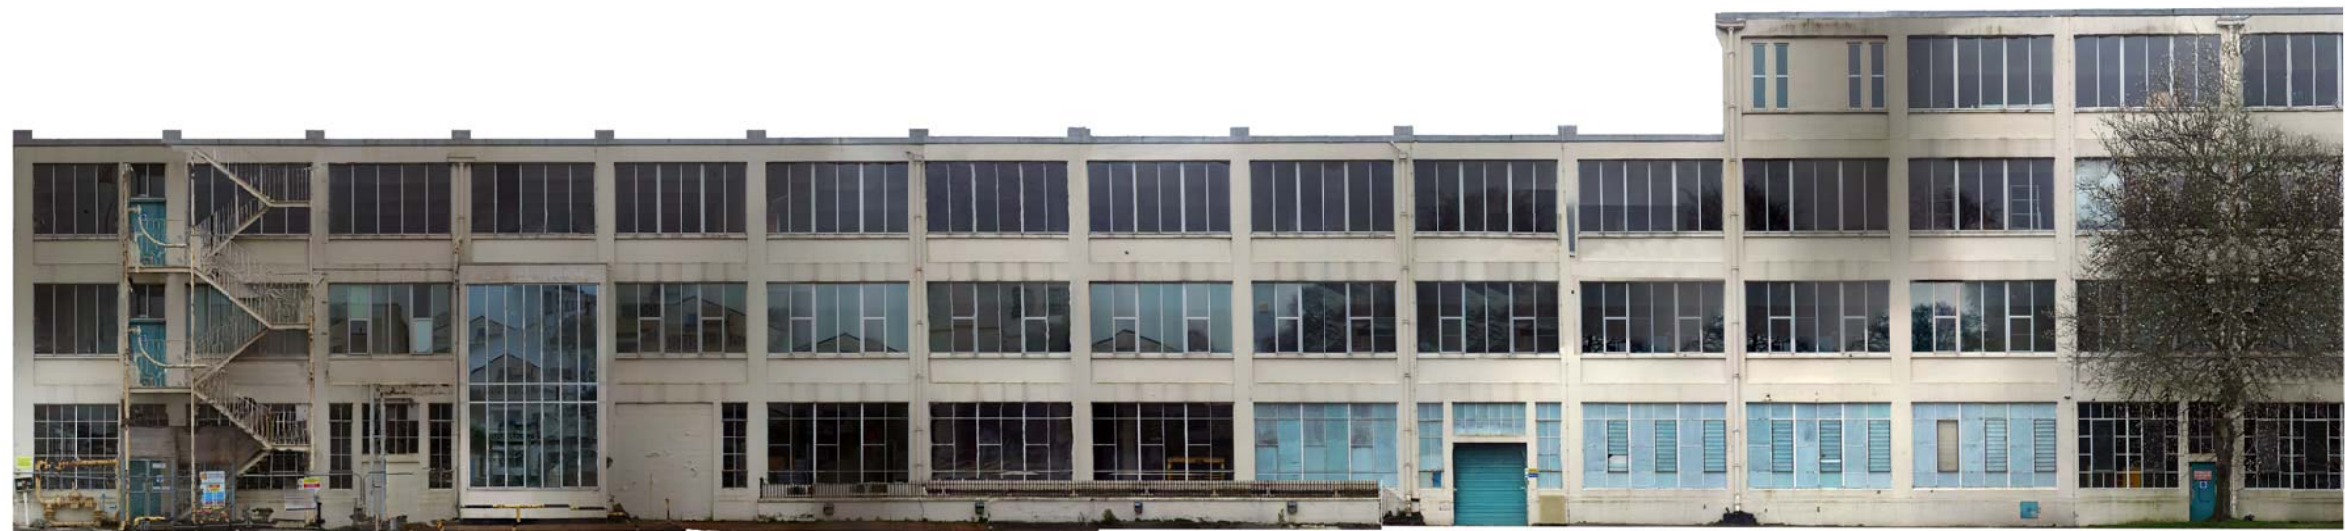
South elevation (west end section) of the Main Factory Building

1:250 on A3

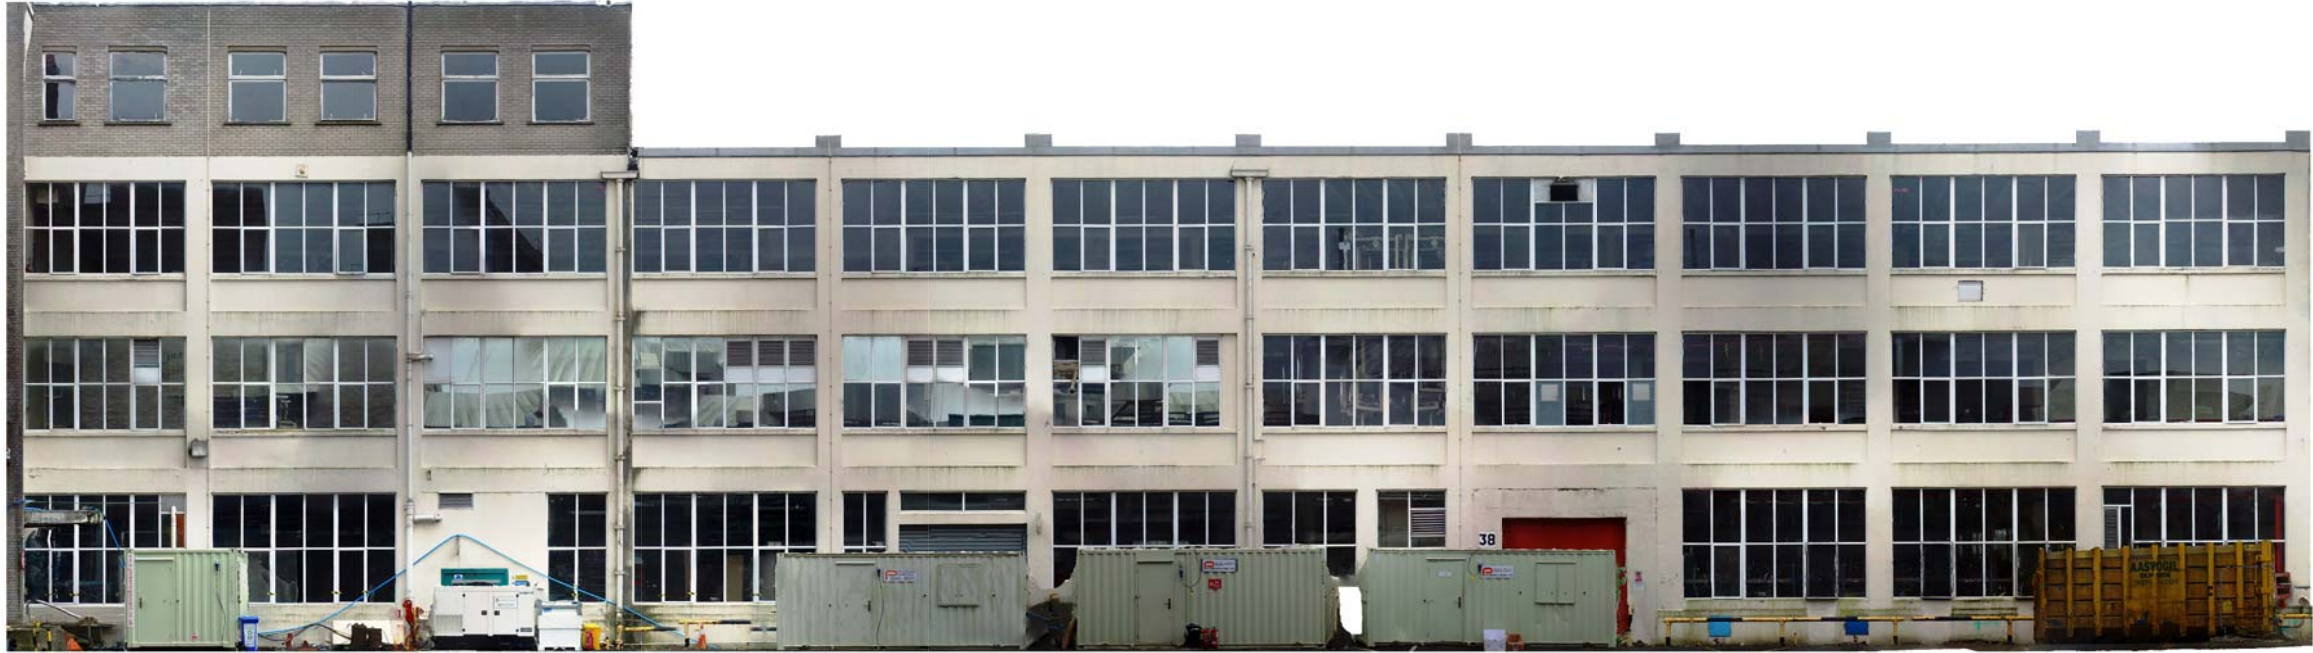
West elevation of the Main Factory Building (Southern section 1920s Truscon construction)

1:200 on A3

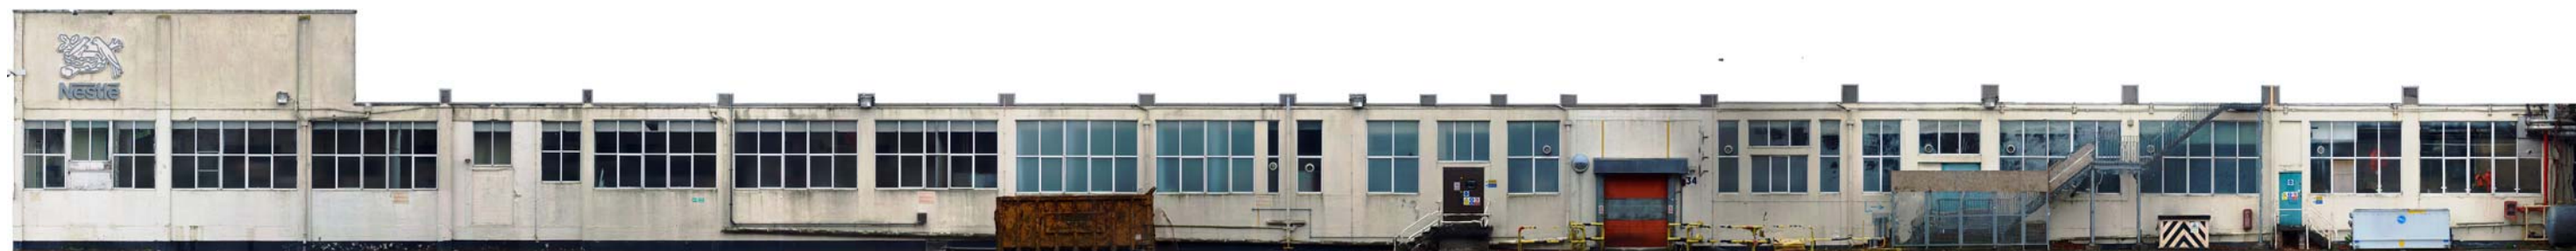
East elevation of the Main Factory Building (Southern section)

1:250 on A3

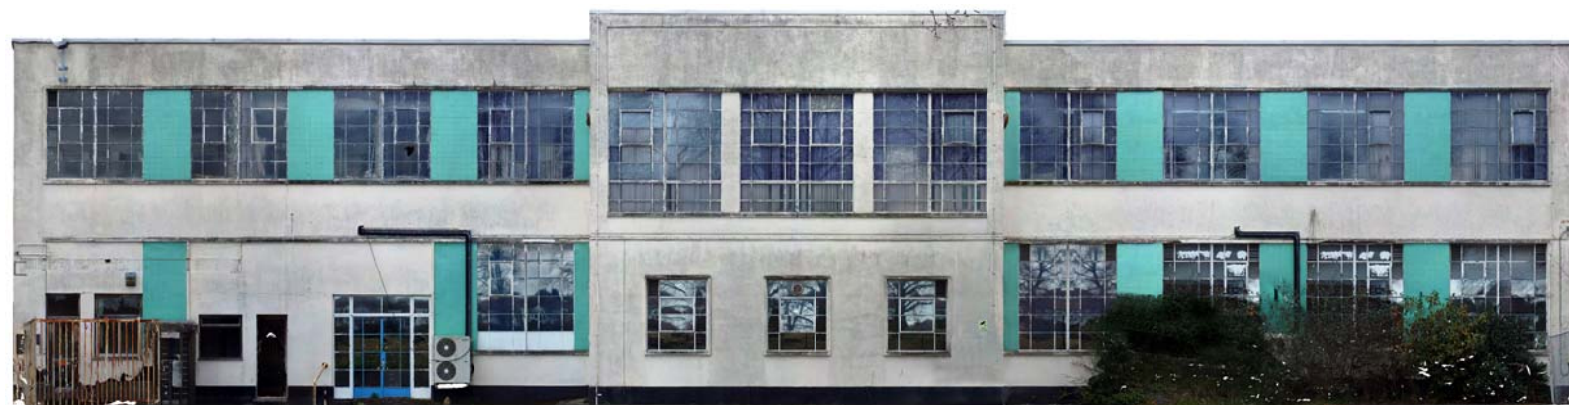
South elevation of the Former Canteen Building

1:200 on A3

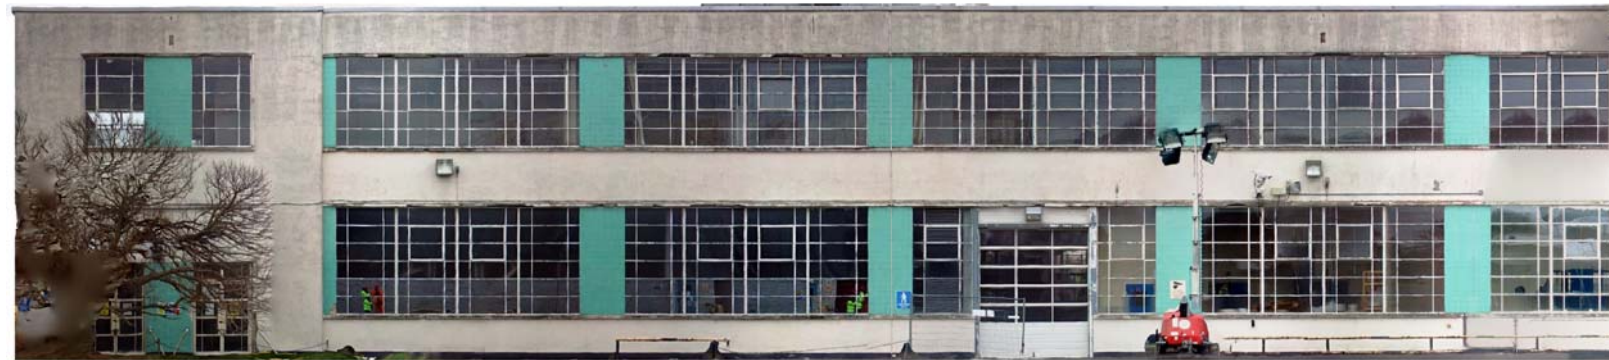
West elevation (north of canopy) of the Former Canteen Building

1:200 on A3
