Bouygues UK
Beckett House
1 Lambeth palace Road
London
SE1 7EU

5 December 2023
MES/2312/TER284

Ref: Rosedale College, Hayes – Addendum Flood Risk Assessment (Groundwater)

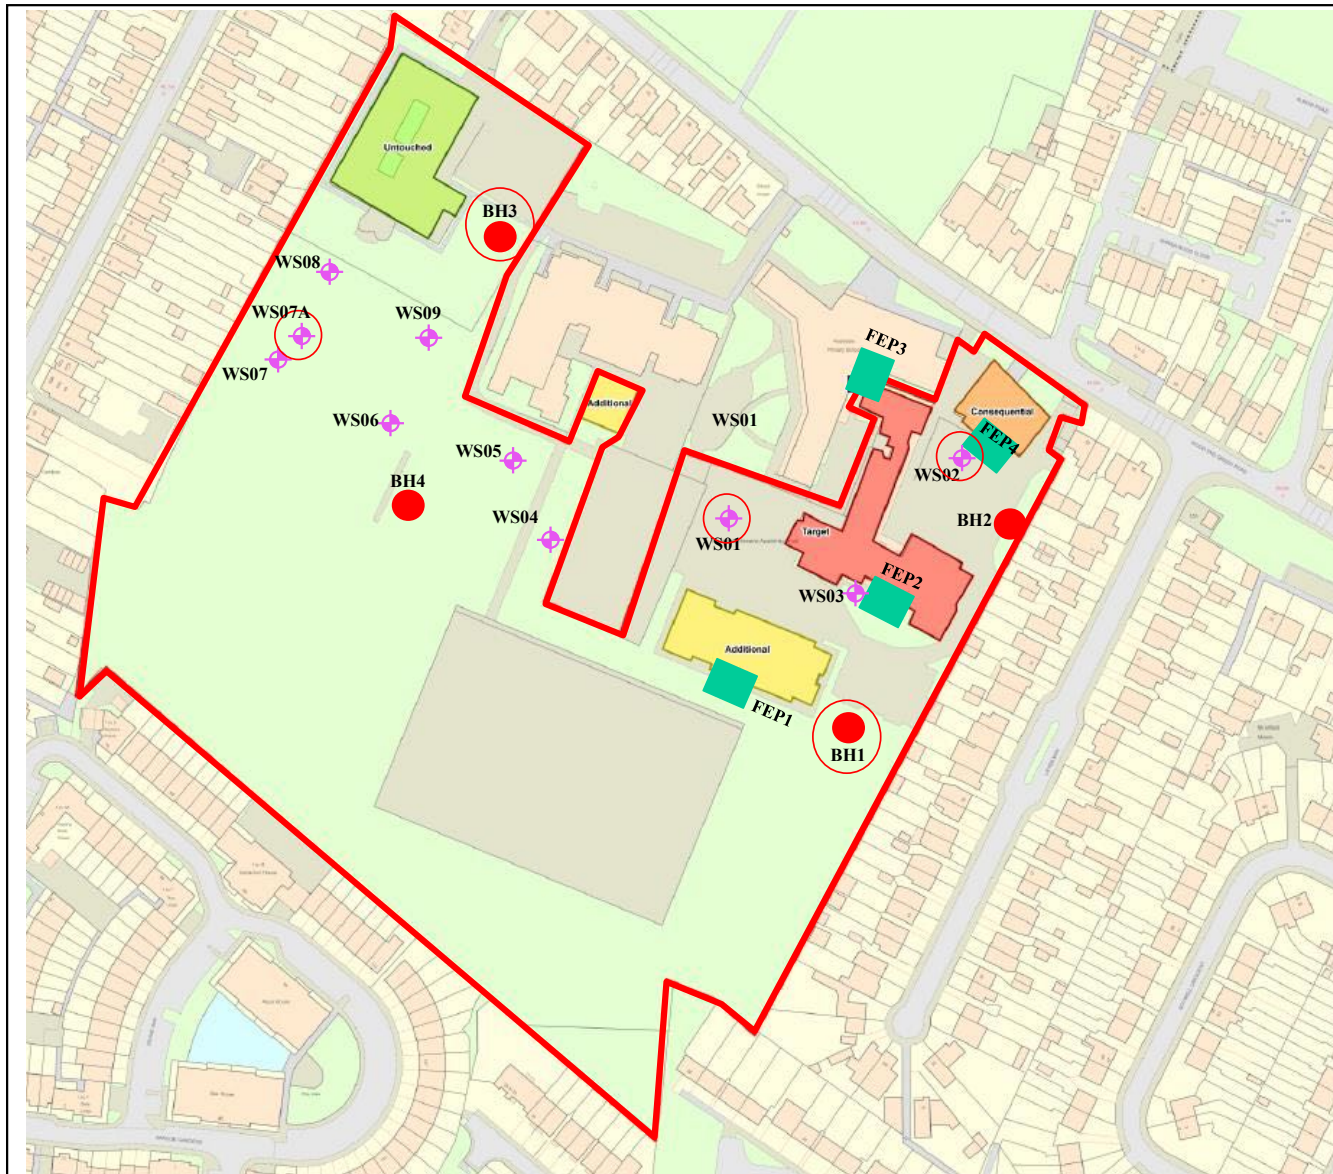
DO NOT SCALE	
NOTES:	
  - Approximate Red Line Boundary	
  - Foundation Exploratory Pit Location	
  - Cable Percussive Borehole Location	
  - Windowless Sample Borehole Location	
  <p>Lawrence House, Meadowbank Way, Eastwood, Nottingham, NG16 3SB Tel: 01773 535 555 Fax: 0870 600 6091 www.hspconsulting.com</p>	
CLIENT:	
MACE Group	
PROJECT:	
Rosedale College, Hayes, London	
TITLE:	
Exploratory Hole Location Plan	
SCALE@SIZE :	ISSUE:
NTS	FINAL
DESIGN/DRAWN :	DATE:
DRS/JB	March 2022
PROJECT No:	DRAWING No:
C3886	502
© HSP Consulting Engineer Ltd © Crown Copyright.

Encs: HSP Site Investigation – Layout Plan and Borehole Logs
Milvum Site Investigation – Layout Plan

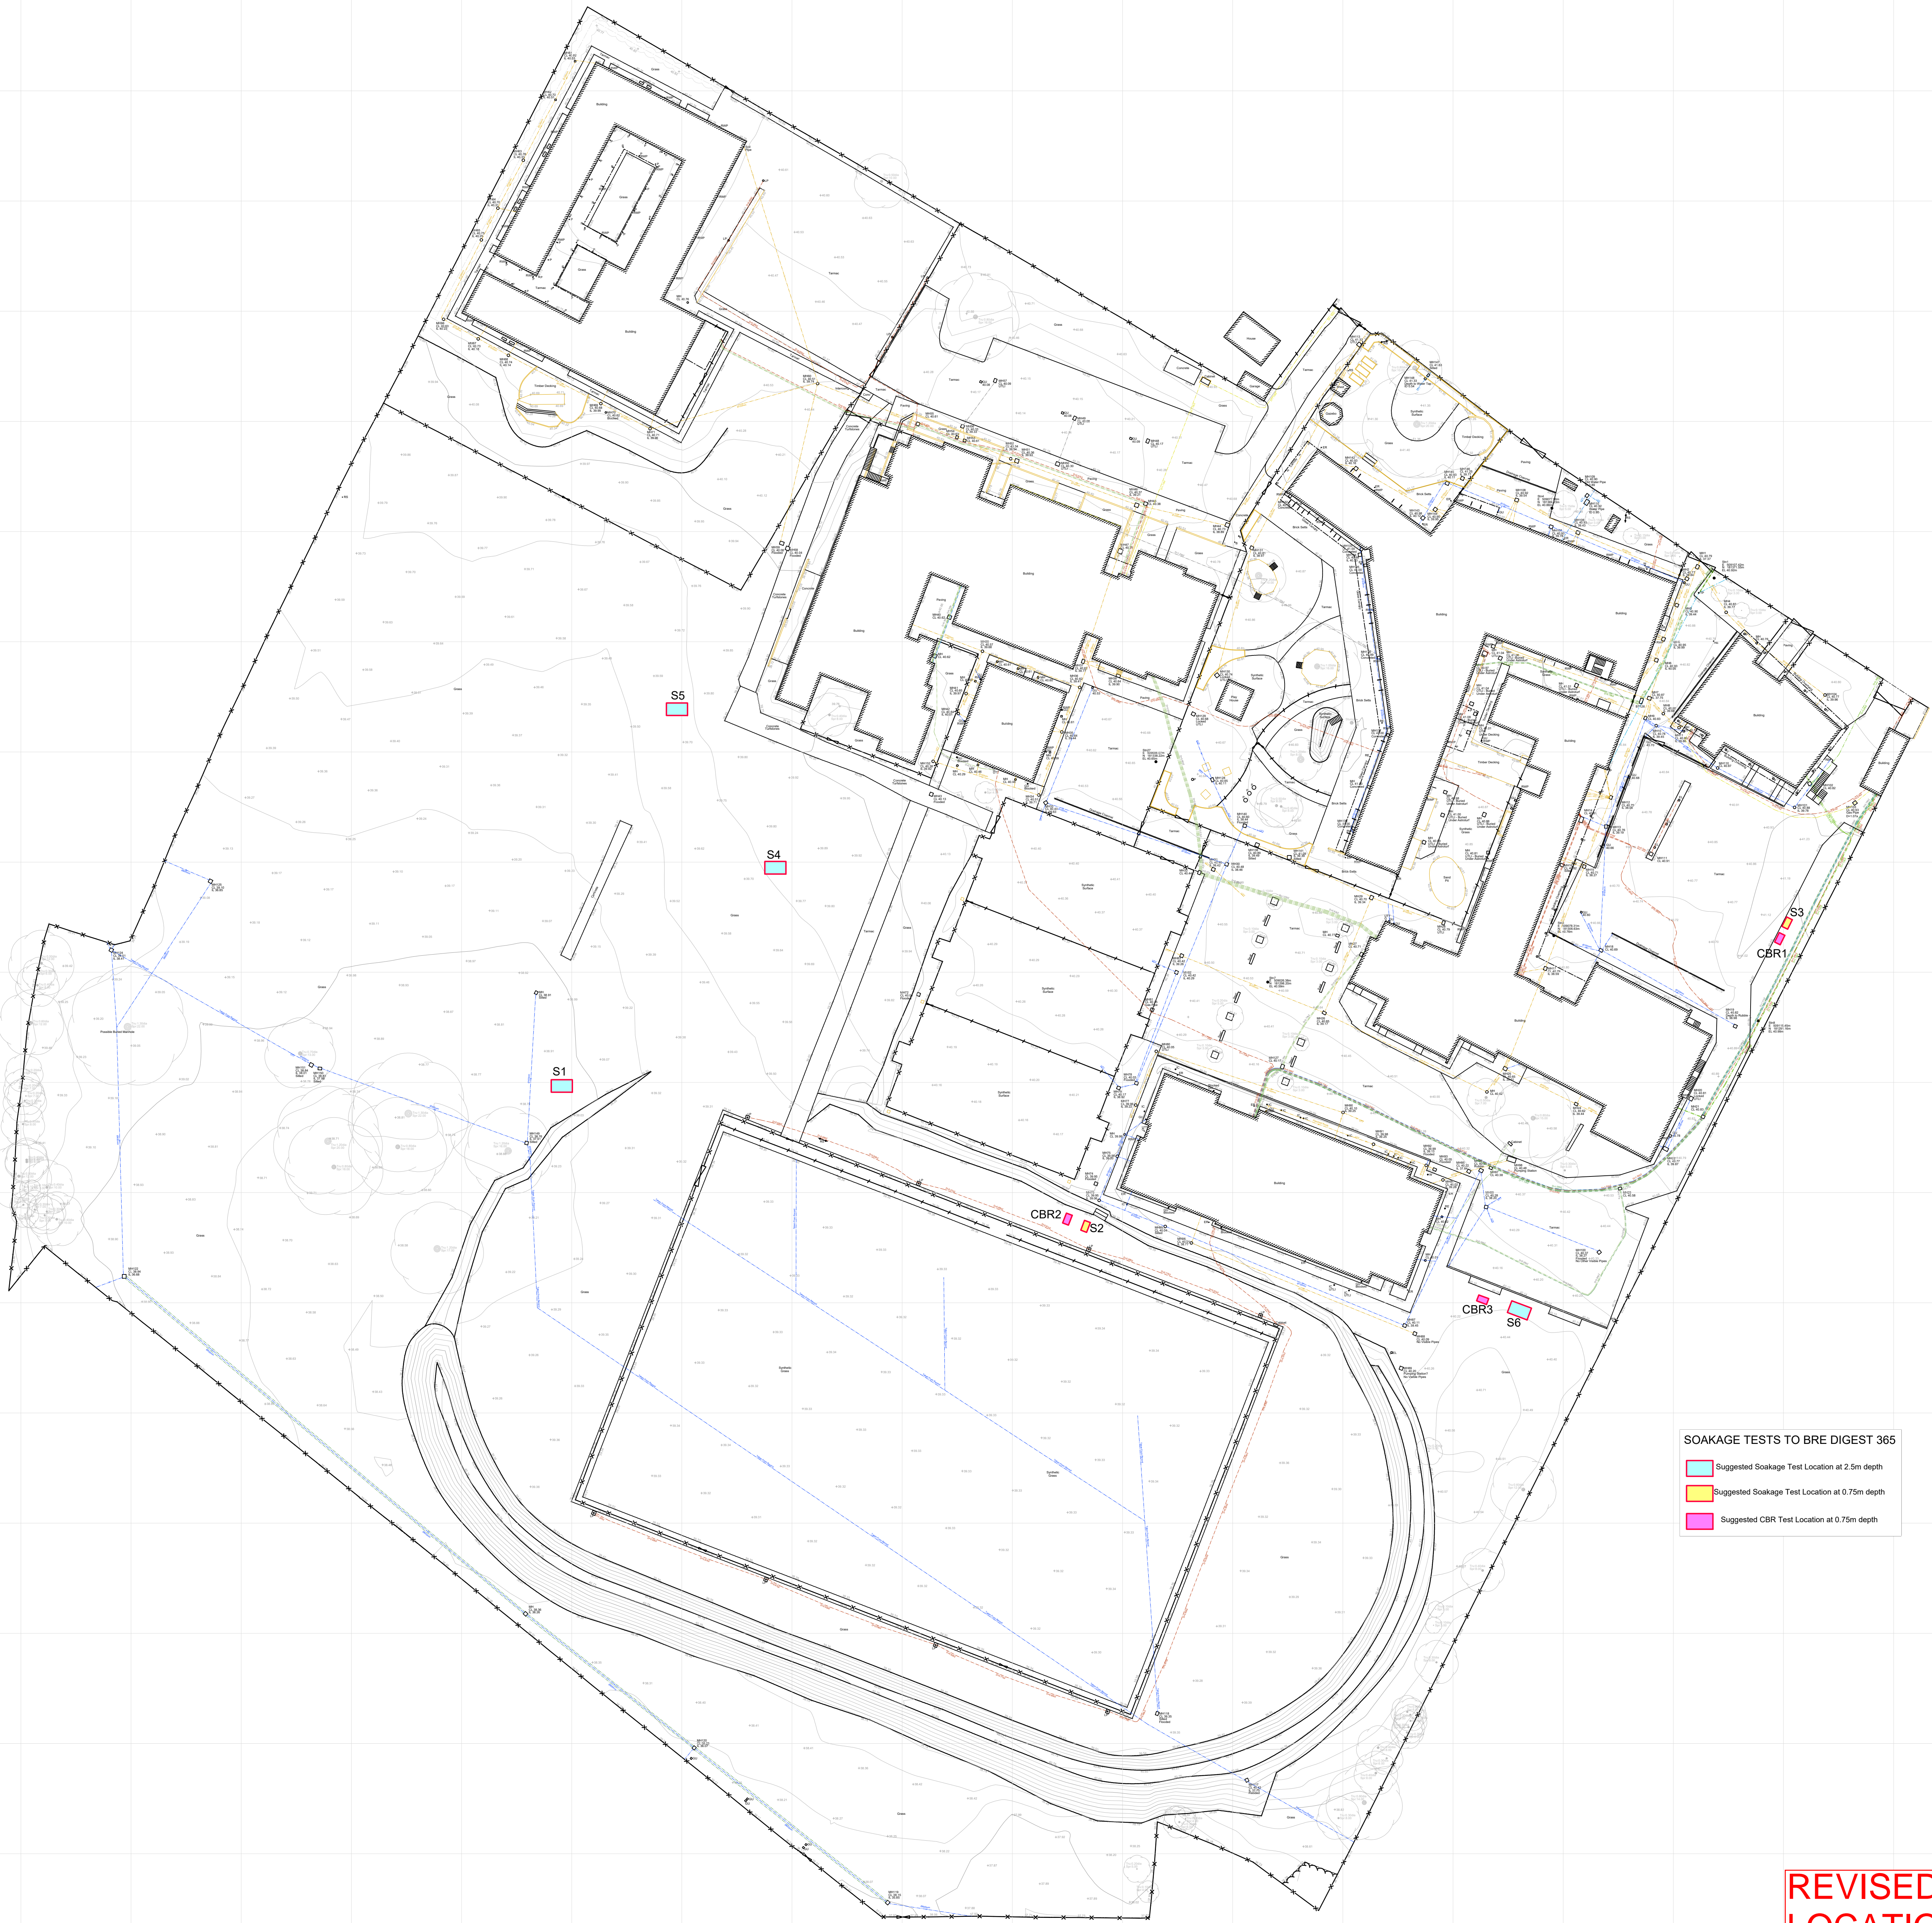
SOAKAGE TESTS TO BRE DIGEST 365

- Suggested Soakage Test Location at 2.0m depth
- Suggested Soakage Test Location at 0.75m depth
- Suggested CBR Test Location at 0.75m depth
