Optera Structural Solutions

SOW 7962 Scheme proposal for the installation of a root barrier to front of property suffering subsidence on behalf of Questgates

POLICY HOLDER:	Mr Nikesh Damanai
POLICY HOLDER ADDRESS:	31 Copse Wood Way, Northwood, Harrow. HA6 2TZ
CLIENT REFERENCE:	QG1S1210326
OUR REFERENCE:	7962
PROJECT MANAGER:	Paul Milliam
ROOT BARRIER PROJECT FEE:	£33,766.92 + VAT.

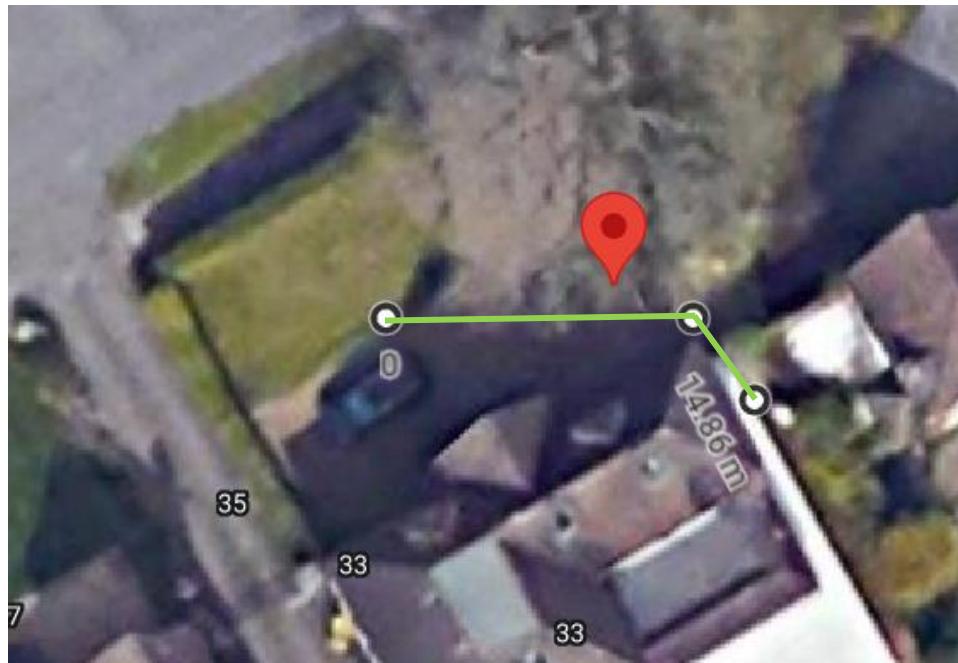
Aerial plan indicating proposed 8m length and alignment of barrier.

The barrier has been designed based on the technical information provided and advice that that damage has been caused by root induced clay shrinkage and T1 is the main cause of movement. The barrier proposed is to be 15m long and 3.7m deep running across the front and down the side. Whilst roots were only found to 1.3m Oak tree roots can extends to a significant depth and therefore the barrier design takes this into consideration.

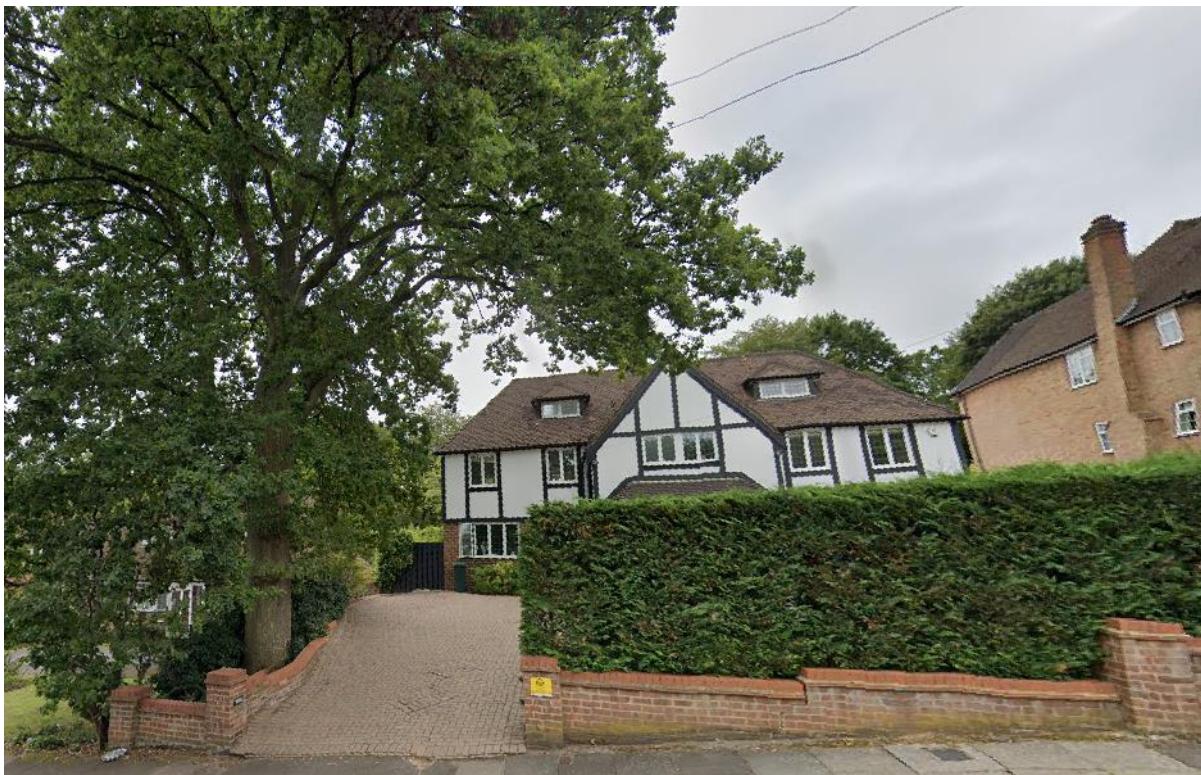
Road side view of the property, note Oak tree to front left.

The property is a large two storey plus attic conversion, 5 bedroom detached property, with cavity brick external walls under a pitched tiled roof. The property has been extended to the rear. The house sits within a residential street slightly elevated from the road.

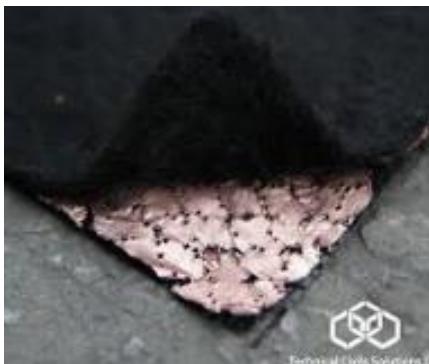
The Copper signal barrier details a copper foil securely bonded between porous geotextile, releasing copper ions and forming copper carbonate (verdigris) that signals an adverse reaction to roots deflecting them away from the barrier. The presence of copper does not constitute an eco-system burden or impact on groundwater.

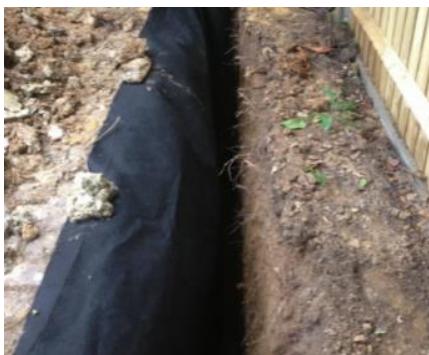
This solution is multipurpose and ideally suited to the current application. Traditional impervious barriers divert rather stop roots and may block moisture movement. Also, roots getting under such barriers can grow back to the surface. Therefore, the use of this permeable barrier stops roots either by engaging and constricting them or by chemically inhibiting them.

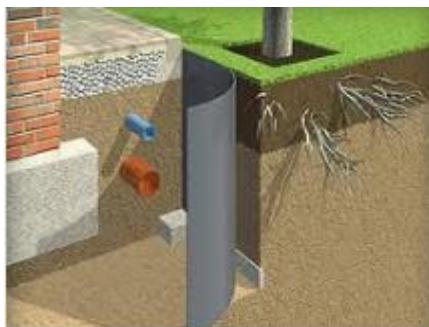
Following the installation of the shield the trench will be backfilled and compacted mechanically with 20mm single sized stone. Alternatively, dependent upon site conditions backfill using lean mix concrete will be utilised on the structure side of the shield. On occasions some natural settlement is anticipated following completion. In all instances the project envisages a return visit to the property to affect any required maintenance of the surface of the reinstatement routinely programmed within 6 months following completion of the installation.
