## **Method Statements for works at 21 Barnhill, Pinner, HA5 2SY**

## 2. Task Description carried out for the Outhouse

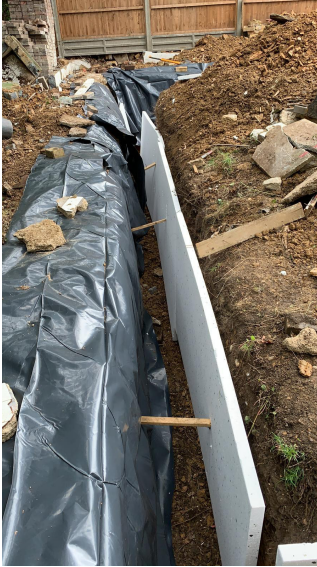
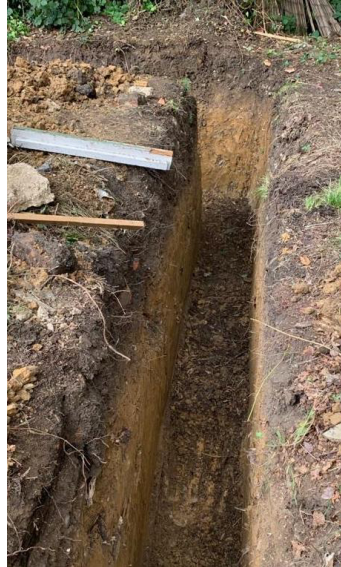
Rear foundations existing overgrowth to the rear boundary.

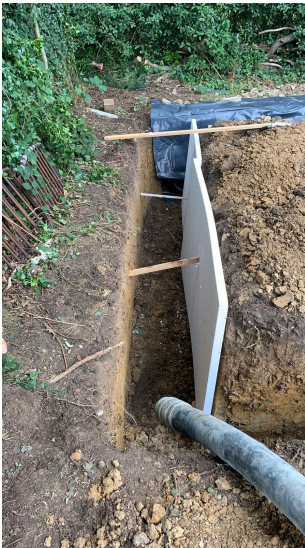
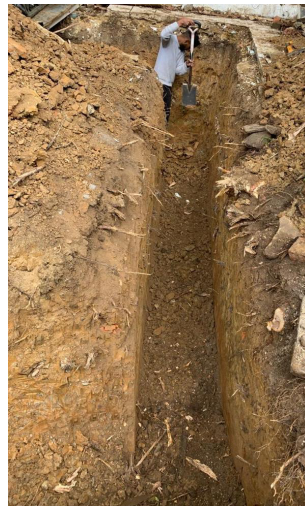
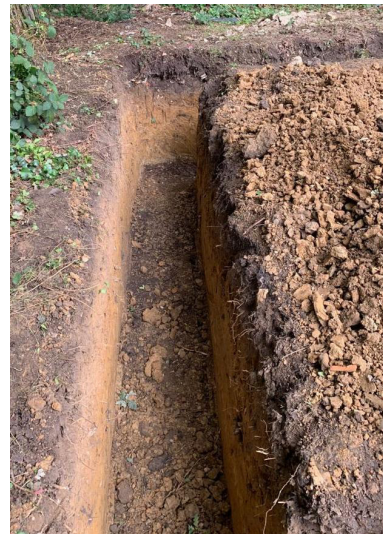
Trench dug out by hand tools. During the dig no large tree roots were encountered.

Pouring of concrete with 'Clayboard' lining to the inside face of foundations to prevent ground heave.

All the foundations were dug out carefully by hand and very small threads of roots were noticed through the trench. The internal sides to the foundation were lined with 'Clayborad' to prevent any future ground heave as well as a DPM layer to the full depth of the rear foundations to stop an future tree roots encroaching and pushing against the foundations.

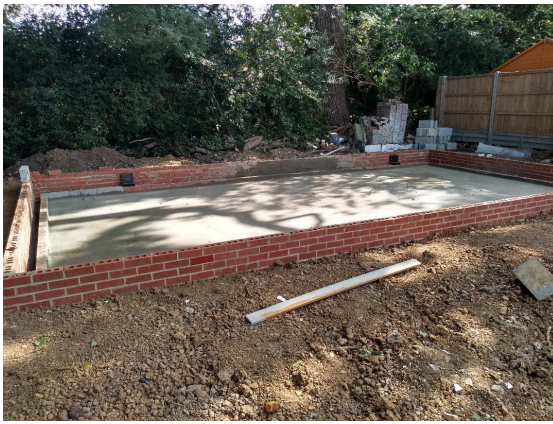
Oversite concrete poured over DPM

- 4) **Brickwork and beam and block-** An oversite concrete was poured of DPM and brick coursing laid with DPC. Beam and block was installed. Brick work wall taken up to 2m. All work were ceased on Friday 2<sup>nd</sup> October 2020 upon the requested of the Planner.

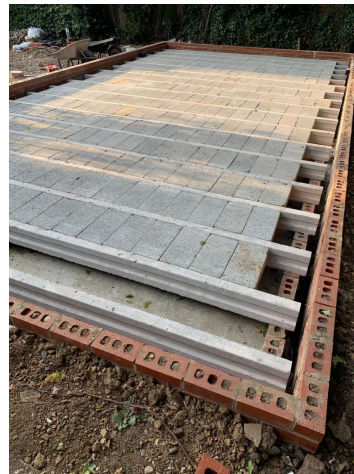
Laying of Beam & Block floor

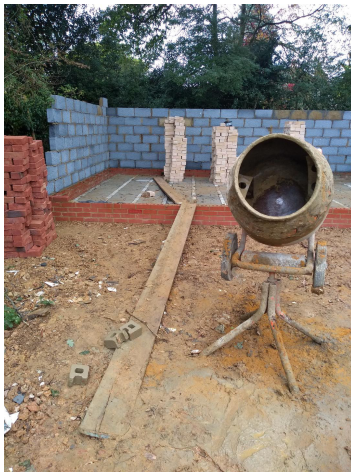
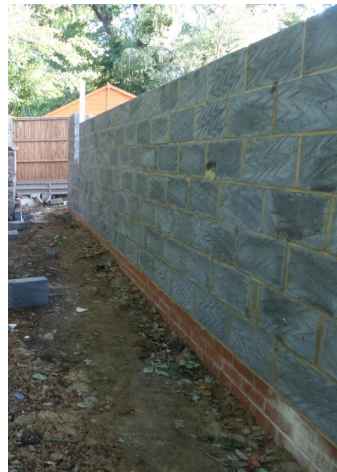
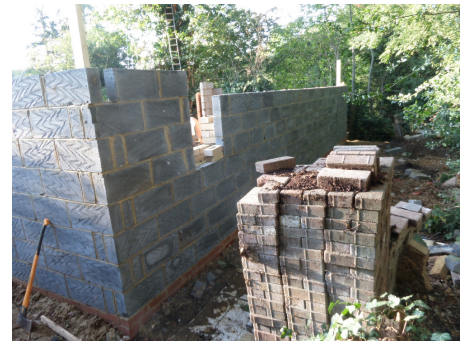
Rear & side walls substantially built up.

As noted on the day the site visit by the Planning Officer, the walls to the Outhouse have reached almost roof level ( 2m height )and all the foundations, oversite concrete, beam and block have been laid. Photographs provided at the end to show the progress of the works as well as lack of large tree roots through the foundations.

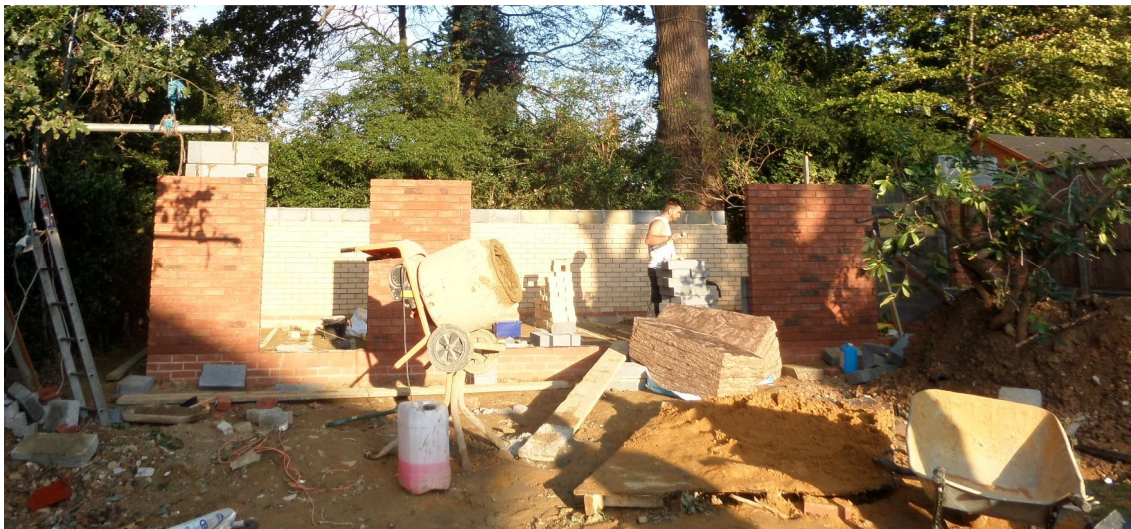
Work stopped on Friday 2<sup>nd</sup> October 2020 after intervention of Planning Department.
