Document:	Flood Risk Assessment and Drainage Strategy		
Project Name:	Mixed Use Retail and Residential Development, Morrisons, High Street, Yiewsley		
Client:	Harbourside Investments Ltd		
Project Reference:	10/4897		
Date of Issue:	December 2022	Rev:	A
Engineer:	D. Mutepfa	Checking Engineer:	W. E. Hansard

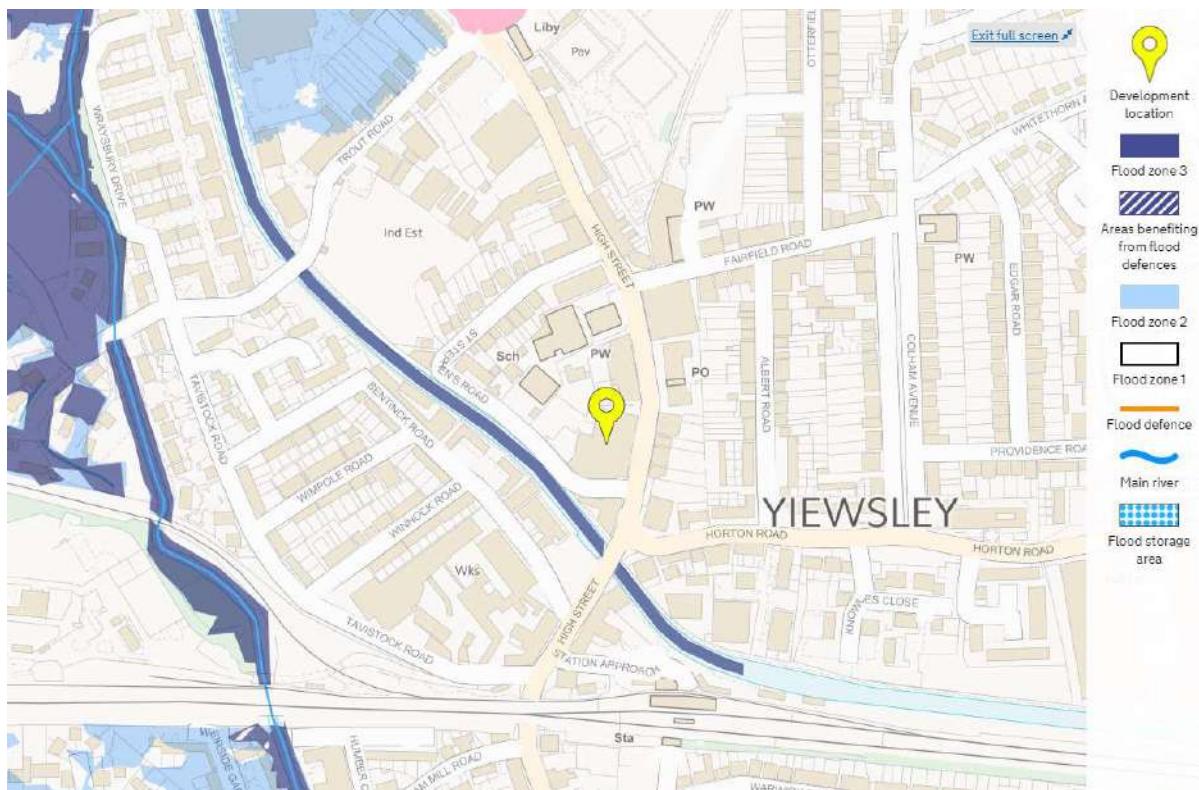
Designated main rivers closest to the site are Fray's River approximately 340m to the west and the River Colne a little further west. These rivers are considered too remote to pose fluvial flood risk to the project site. Closer to the site is the Grand Union Canal and this too is not a source of flood risk as it is constrained within its banks. This can be seen in the EA flood map below.

Fig. 1 : EA Flood Map – River and Tidal Flooding

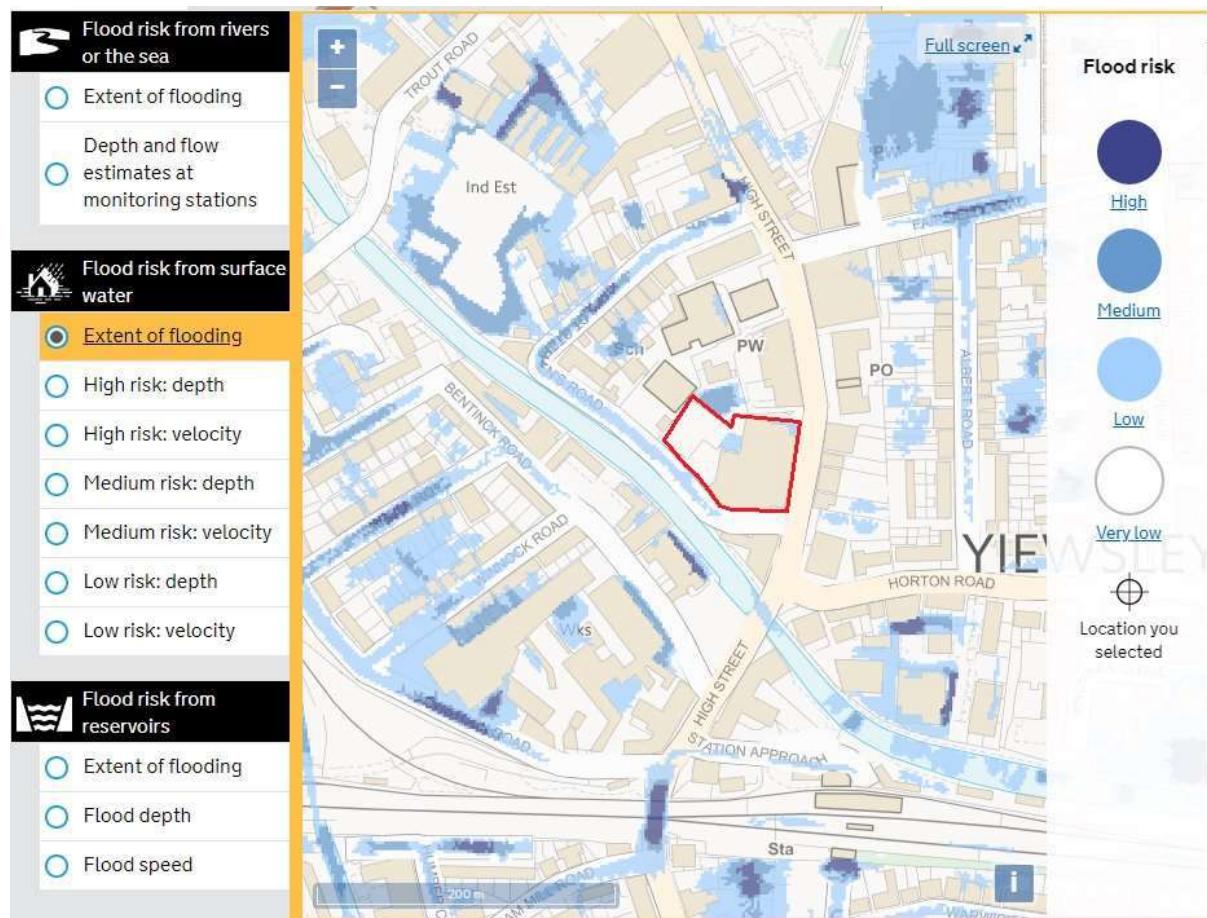
Pluvial or surface water flooding arises out of the inability of surface water runoff to infiltrate into the ground during intense or prolonged rainfall. Urban development adds to the problem by replacing natural open spaces with hard paved impermeable surfaces. Surface water flooding is exacerbated when natural drainage channels or artificial drainage systems have insufficient capacity to absorb the additional runoff. The EA's online flood risk map indicates that the risk of flooding from surface water runoff on the site is very low (see Fig. 2 below).

Fig. 2: EA Flood Map – Surface Water Flooding

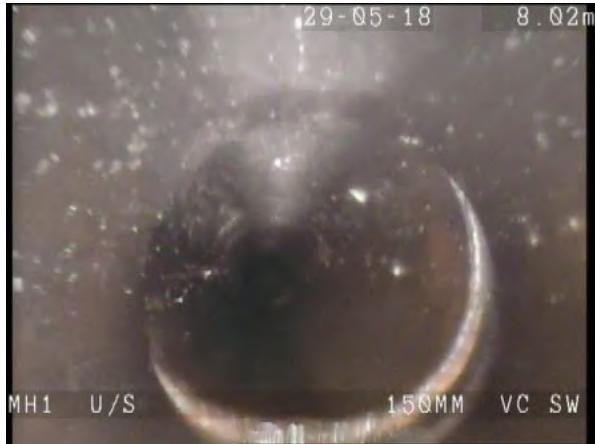
MH3X_a3ddf67a-6157-40fe-801c-e0e08bedef87_20180604_105126_505.jpg, 00:00:36, 8.10m
Joint displaced, medium

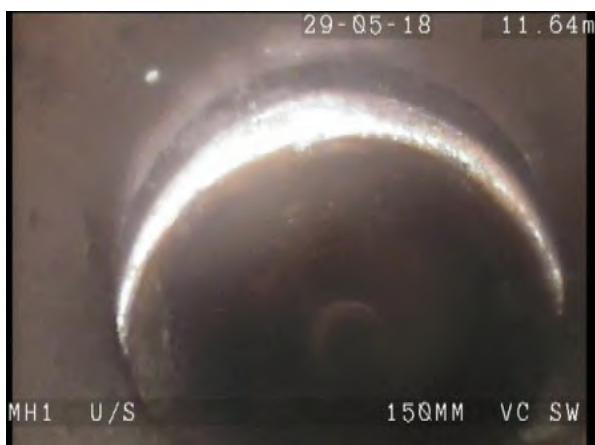
MH3X_d36944c7-39db-467e-8472-70c44a59c664_20180604_105151_525.jpg, 00:00:48, 11.60m
Joint displaced, medium

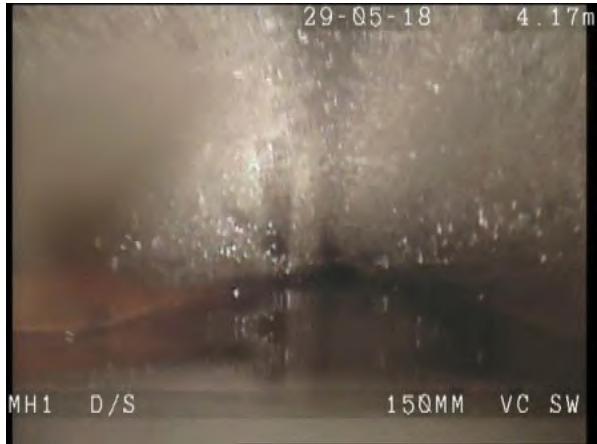
Water level, 40% of the vertical dimension

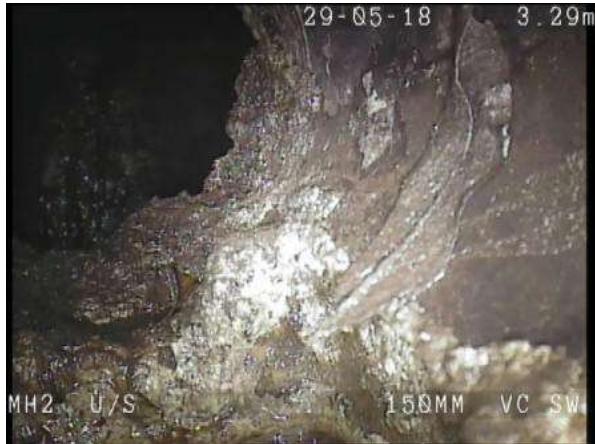
U_S
MH2X_11a977aa-52f8-4ecc-9658-b7c98e4b651a_20180604_1
10848_924.jpg, 00:00:45, 3.30m
Settled deposits, fine, 5% cross-sectional area loss

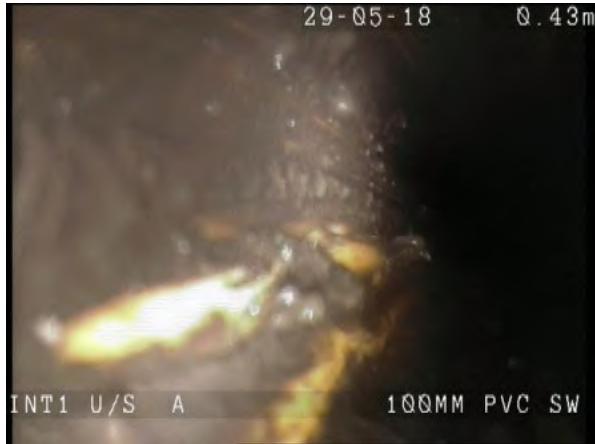
A_INT1X_d93bc85b-68b5-4cbd-a036-2f44e01cce6d_20180604_112539_134.jpg, 00:00:08, 0.30m
Settled deposits, fine, 5% cross-sectional area loss

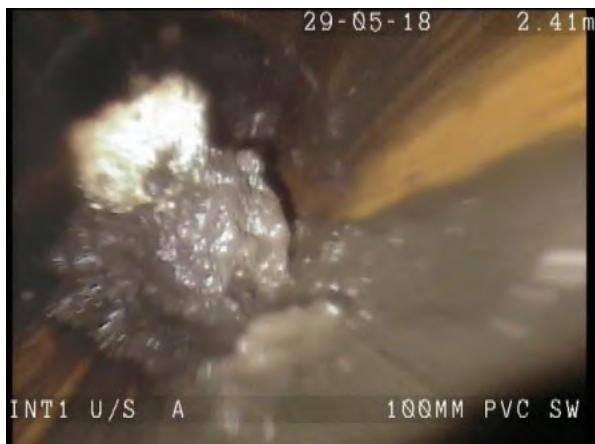
A_INT1X_e7e7ead-7a53-40b7-88a5-a5bca6dd5703_20180604_112635_734.jpg, 00:00:23, 2.50m
Settled deposits, fine, 40% cross-sectional area loss

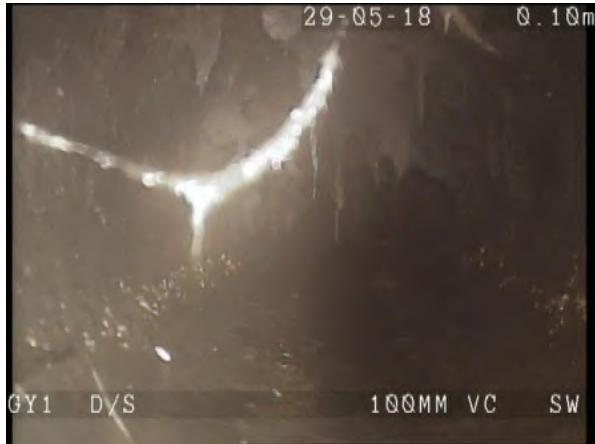
GY1X_4ae48c69-bb7e-4f0a-8a19-bf8cd0d8e4c5_20180604_11
3150_073.jpg, 00:00:06, 0.10m
Settled deposits, fine, 5% cross-sectional area loss, start

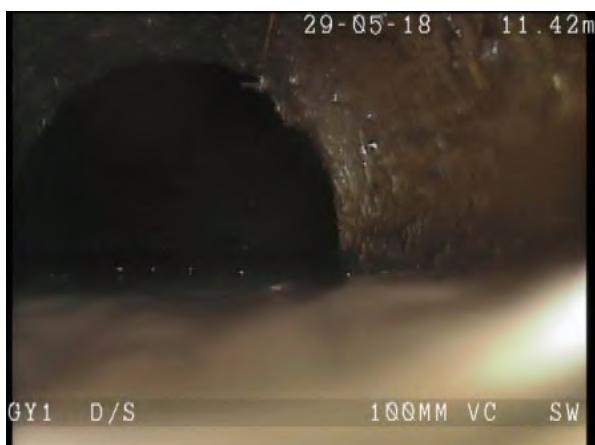
GY1X_62b55fb9-55af-4203-8062-cc2fc1078ddd_20180604_11
3822_372.jpg, 00:01:17, 12.10m
Finish node type, catchpit, reference number: MH4

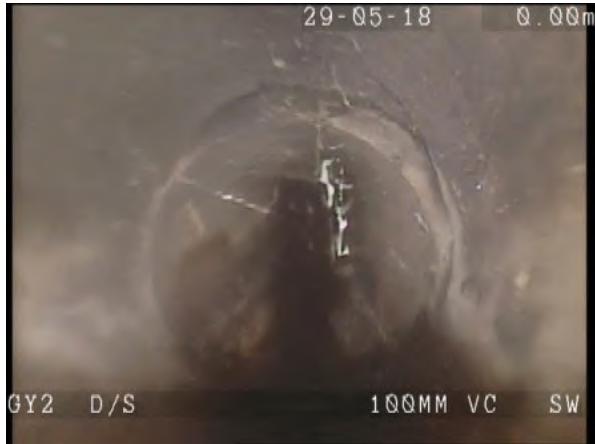
GY2X_dd061343-718e-4456-898a-1fea845b377_20180604_1
14119_072.jpg, 00:00:07, 0.20m
Hole in drain or sewer at a joint from 11 o'clock to 3 o'clock

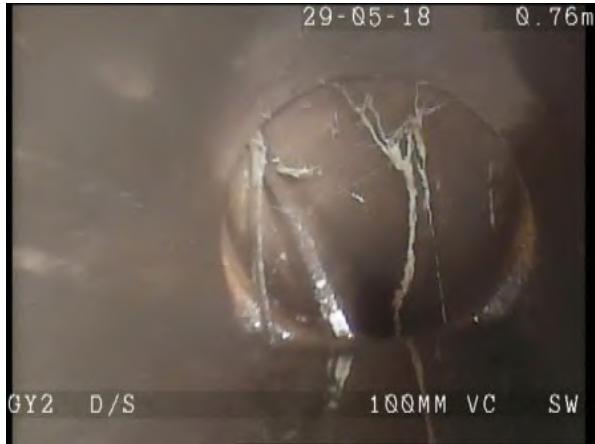
GY2X_33c5c1ea-f169-4d8f-ada0-a495ecdef433_20180604_11
4148_482.jpg, 00:00:12, 0.80m
Joint displaced, medium

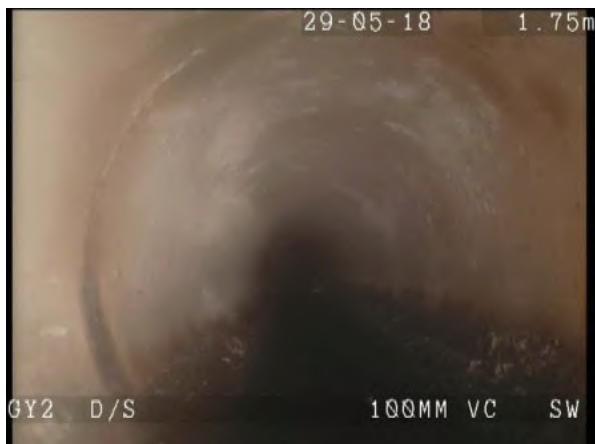
GY2X_d3e3e17c-9730-48b7-b2a5-2de544580fdd_20180604_1
14259_842.jpg, 00:00:19, 1.80m
Crack, circumferential from 12 o'clock to 12 o'clock

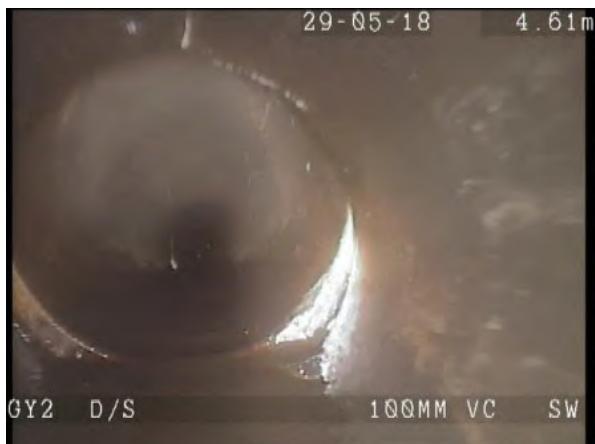
GY2X_a79ea17b-9a1f-4af5-83d4-555353067472_20180604_11
4230_449.jpg, 00:00:34, 4.70m
Joint displaced, medium

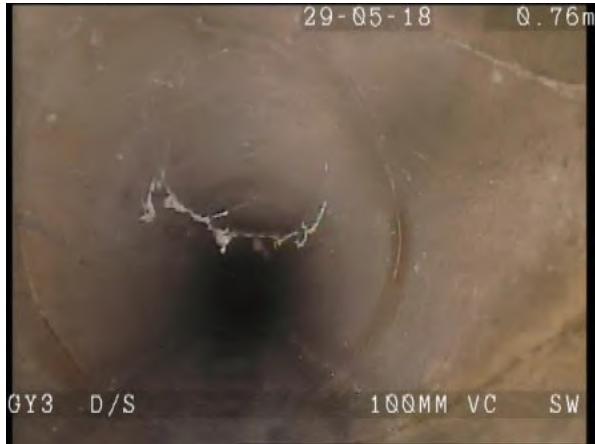
GY3X_dd9d2f66-7a16-4d3e-a03f-82c0c425fc5c_20180604_115332_276.jpg, 00:00:10, 0.80m
Crack, circumferential from 12 o'clock to 12 o'clock

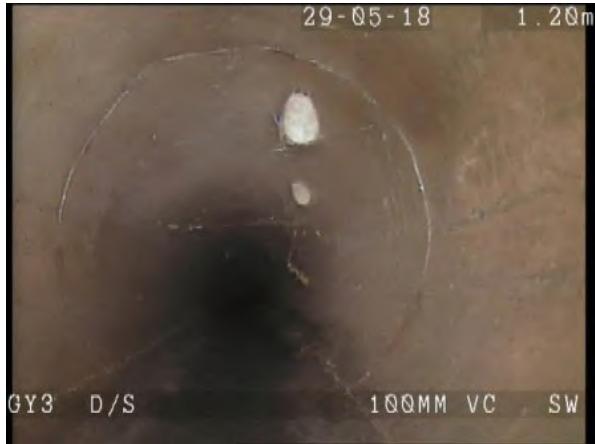
GY3X_50057357-3fb3-43e8-84e6-5fc63ff7c92e_20180604_115348_849.jpg, 00:00:13, 1.30m
Crack, circumferential from 12 o'clock to 12 o'clock

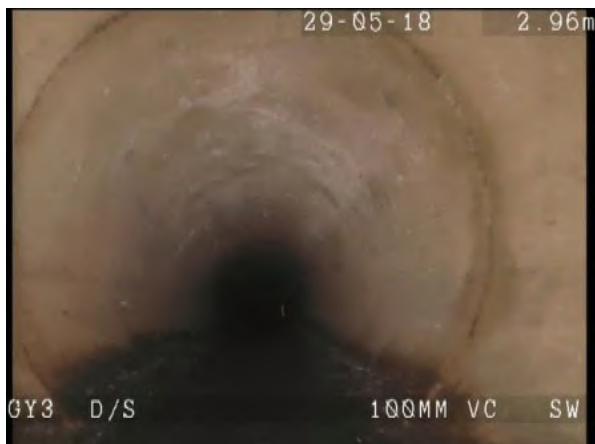
GY3X_f5782e97-a6ba-4fec-a11c-89e9b0a02103_20180604_115415_309.jpg, 00:00:23, 3.00m
Crack, circumferential from 7 o'clock to 5 o'clock

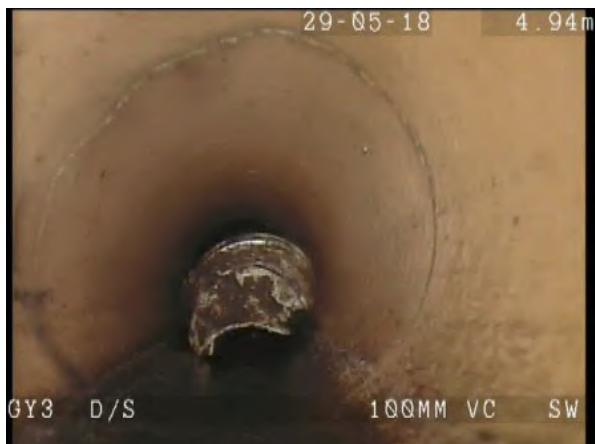
GY3X_b9039a48-1108-4694-bd18-1360eff10592_20180604_115439_085.jpg, 00:00:31, 5.00m
Crack, circumferential from 7 o'clock to 5 o'clock

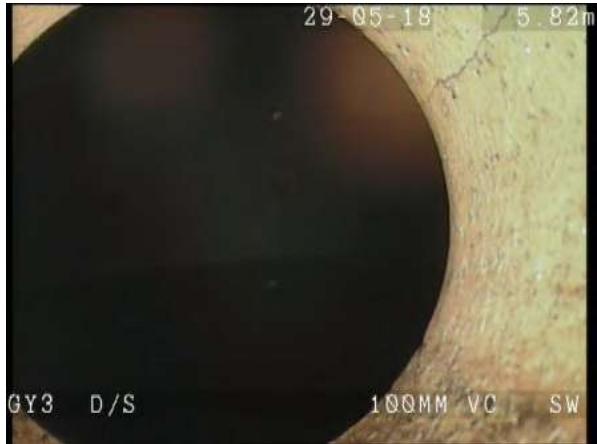
GY3X_323402f6-742c-4e3a-aa89-da4814f1e971_20180604_11
5520_333.jpg, 00:00:37, 5.80m
Crack, longitudinal at 2 o'clock

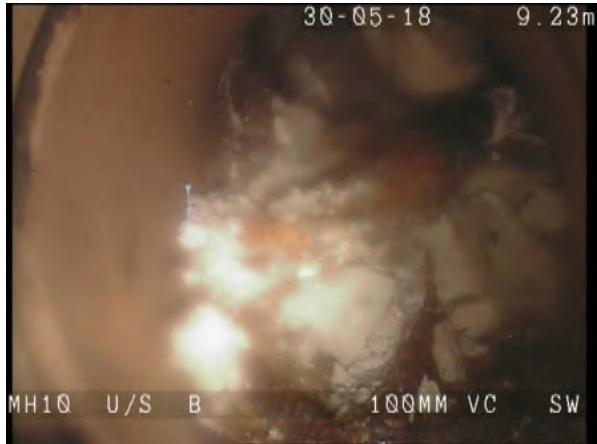
B_MH10X_4d6fb09f-78bf-47cb-b3e9-59aa1e942ddd_20180604
_122311_591.jpg, 00:00:54, 9.30m
Settled deposits, coarse, 90% cross-sectional area loss

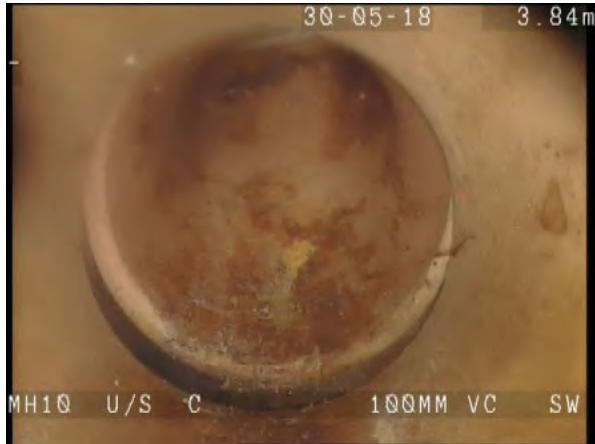
C_MH10X_194d6610-d4d8-461b-be4e-2840784a06d6_20180604_122550_959.jpg, 00:00:27, 3.90m

Joint displaced, medium

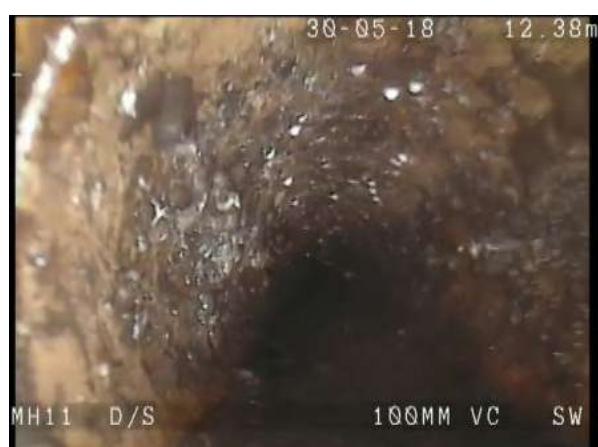
MH11X_c36e24ac-677f-42e1-8109-ac41a0b01cfb_20180604_1
30344_193.jpg, 00:01:23, 12.40m

Settled deposits, fine, 5% cross-sectional area loss, start

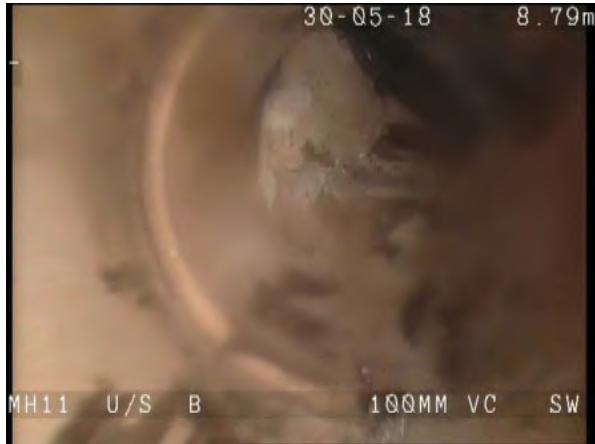
B_MH11X_ece2156b-2a64-47e8-81b9-f28b627ce6dd_20180604_131600_646.jpg, 00:01:07, 8.80m
Settled deposits, coarse, 50% cross-sectional area loss

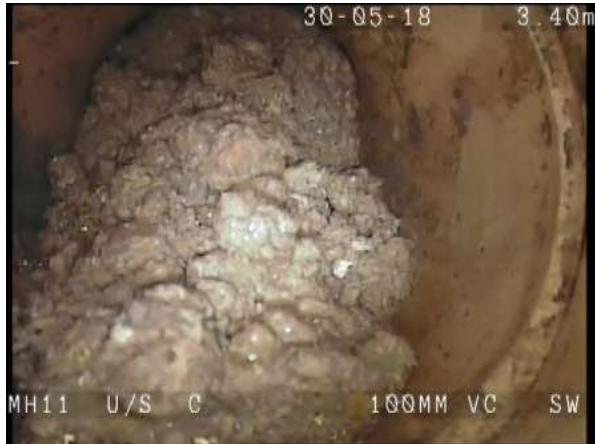
C_MH11X_2567db29-1375-41da-92e6-dec86a3494df_20180604_131952_395.jpg, 00:00:29, 3.40m
Settled deposits, coarse, 95% cross-sectional area loss

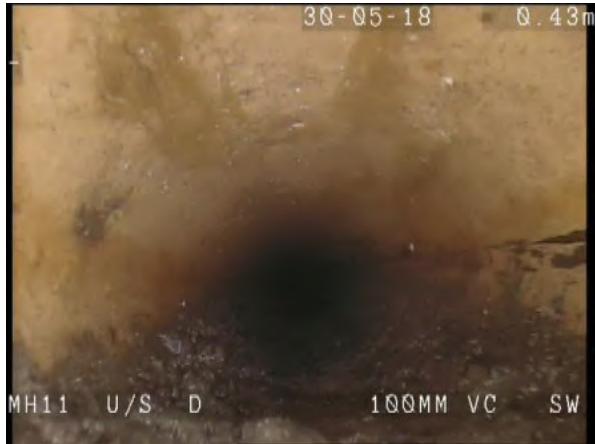
D_MH11X_836448f8-7026-4146-97aa-9682418fdd29_20180604_132208_441.jpg, 00:00:10, 0.40m
Settled deposits, fine, 10% cross-sectional area loss, start

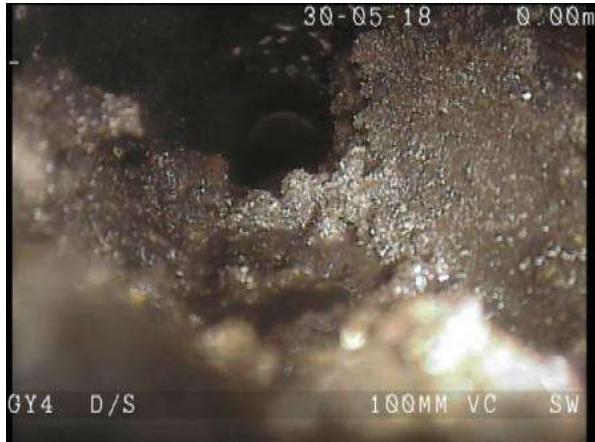
GY4X_89492c26-b0de-426a-9dc6-f6b212b91f96_20180604_132822_598.jpg, 00:00:00, 0.10m
Settled deposits, fine, 10% cross-sectional area loss

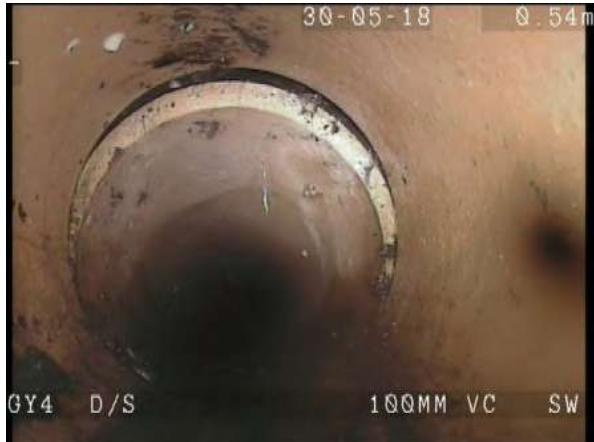
GY4X_fb7ebc75-bacb-4bc7-9aa2-9c46b27d4ab2_20180604_132856_232.jpg, 00:00:18, 0.60m
Joint displaced, medium

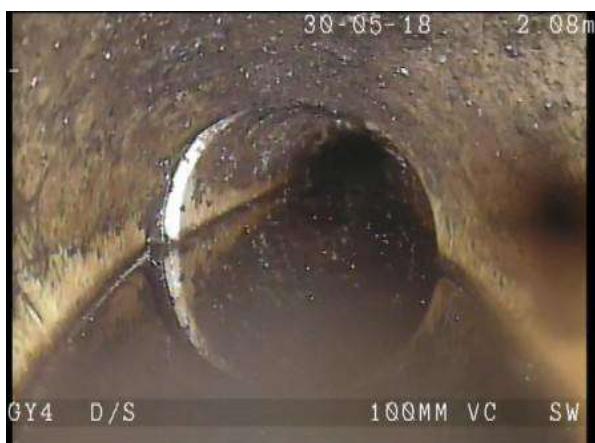
GY4X_f2a9412c-e04b-47e4-a18a-4c80e63c3138_20180604_132918_034.jpg, 00:00:28, 2.10m
Water level, 20% of the vertical dimension

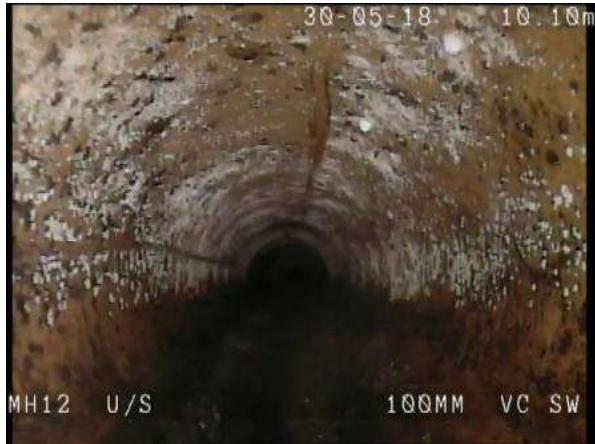
U_S
MH12X_427be56e-b667-4e80-a128-1737d92584ef_20180604_133524_873.jpg, 00:01:11, 10.10m
Settled deposits, fine, 5% cross-sectional area loss, start

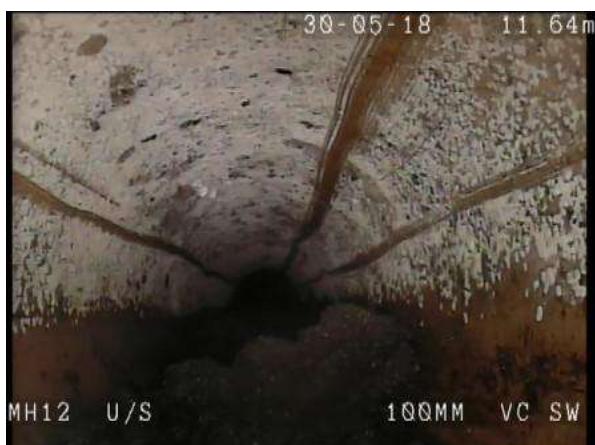
U_S
MH12X_2bbc4dde-a064-4af7-8145-a1a1beeace39_20180604_133947_373.jpg, 00:01:21, 11.70m
Settled deposits, fine, 10% cross-sectional area loss

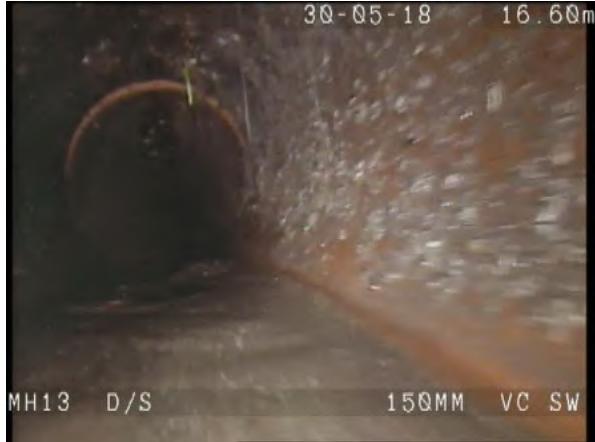
MH13X_3a5ea860-e9c1-4aa8-bd1c-61770eea8ec1_20180604_140213_355.jpg, 00:01:44, 16.60m
Settled deposits, fine, 5% cross-sectional area loss, start

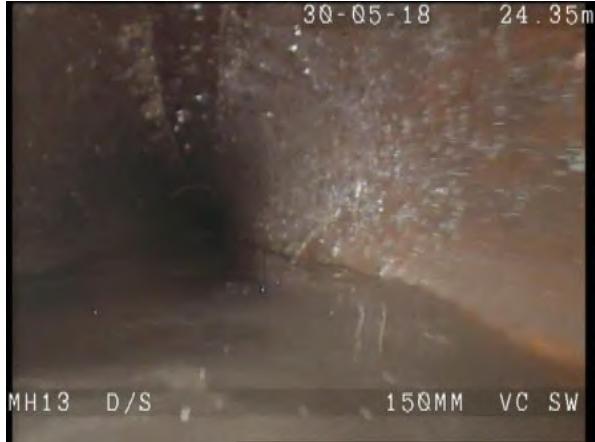
MH13X_7c3a29fa-817e-4c34-b5ab-992eafca8806_20180604_140331_807.jpg, 00:02:23, 24.30m
Water level, 20% of the vertical dimension

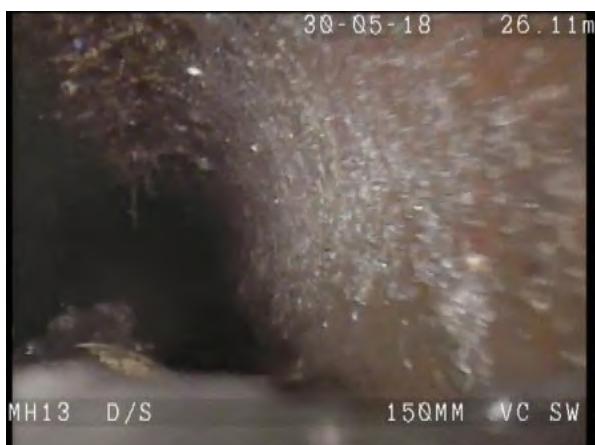
MH13X_5646dd2b-e2fd-4983-bc3b-baadbd282d9a_20180604_140400_848.jpg, 00:02:36, 26.10m
Settled deposits, coarse, 10% cross-sectional area loss

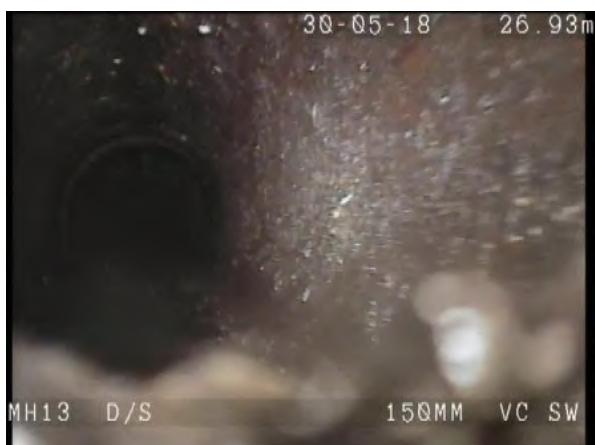
MH13X_1bfd6dfd-bb9d-4c16-adf4-dd01b0b5bb0a_20180604_140445_777.jpg, 00:02:42, 27.00m
Settled deposits, fine, 5% cross-sectional area loss, start

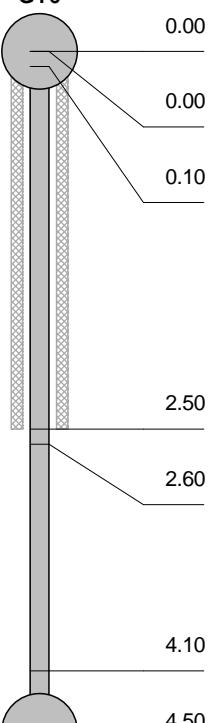
0.00	GY	Start node type, gully, reference number: GY6	00:00:00		
	0.00	WL	Water level, 5% of the vertical dimension	00:00:00		
	0.10	S01	Settled deposits, fine, 20% cross-sectional area loss, start	00:00:05		
	2.50	F01	Settled deposits, fine, 20% cross-sectional area loss, finish	00:00:26		3
	2.60	WL	Water level, 20% of the vertical dimension	00:00:26		
	4.10	LR	Line deviates right	00:00:46		
	4.50	SA	Survey abandoned: JOINS ANOTHER RUN BLIND	00:00:54		
D/S GY6						
Depth:

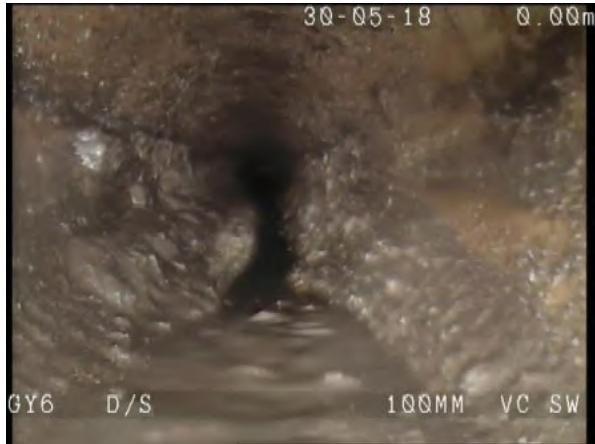
GY6X_4f11b5a9-0457-4edd-8c58-6809d6ef90ec_20180604_14
1001_233.jpg, 00:00:05, 0.10m
Settled deposits, fine, 20% cross-sectional area loss, start

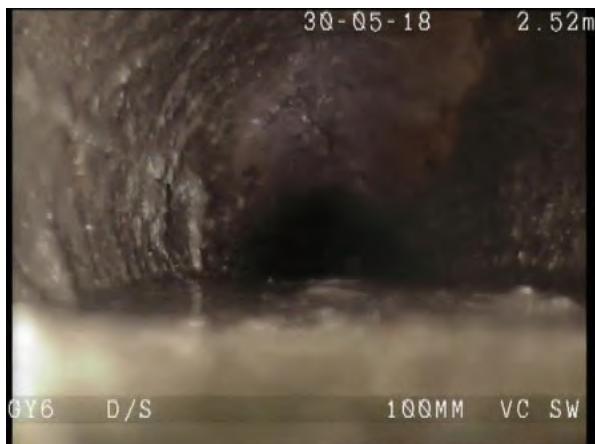
GY6X_b725a713-67d4-4dc1-8d3a-32cf0ec695b7_20180604_1
41144_644.jpg, 00:00:26, 2.60m
Water level, 20% of the vertical dimension

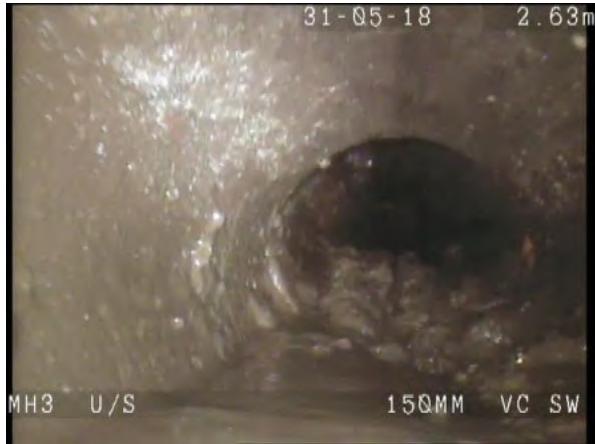
U_S
MH3X_f8612077-ef92-47e7-a340-44c9e82f0511_20180604_14
2336_384.jpg, 00:00:26, 2.60m
Settled deposits, fine, 20% cross-sectional area loss

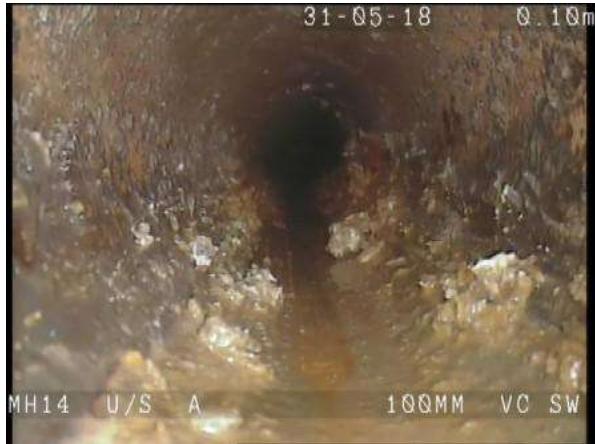
A_MH14X_04528b0a-7455-46eb-b22f-35010d4167e5_20180604_143517_428.jpg, 00:00:05, 0.10m
 Attached deposits, grease from 3 o'clock to 8 o'clock, 5% cross-sectional area loss

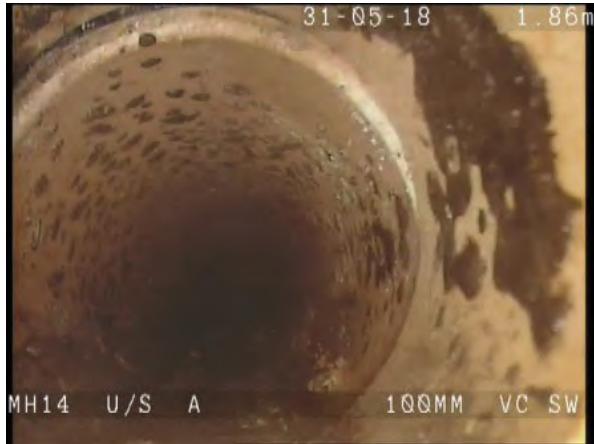
A_MH14X_0ebe5ef9-0fe6-42d8-a01f-5de9df510e83_20180604_143440_621.jpg, 00:00:16, 1.90m
 Joint displaced, medium

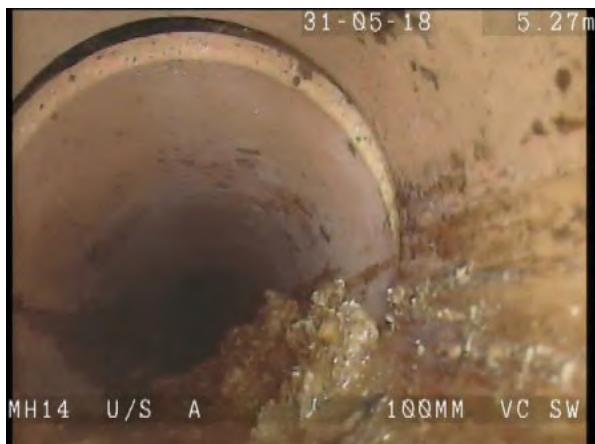
A_MH14X_f734058e-39ba-499b-9f6f-974fac535ce5_20180604_143727_323.jpg, 00:00:38, 5.30m
 Joint displaced, medium

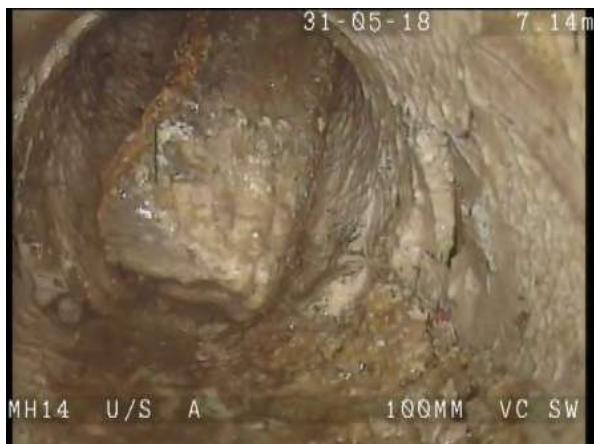
A_MH14X_9e96a233-ed1c-48e5-94ed-759369fd6198_20180604_143909_323.jpg, 00:00:52, 7.20m
 Other obstacles from 5 o'clock to 7 o'clock, 20% cross-sectional arealoss

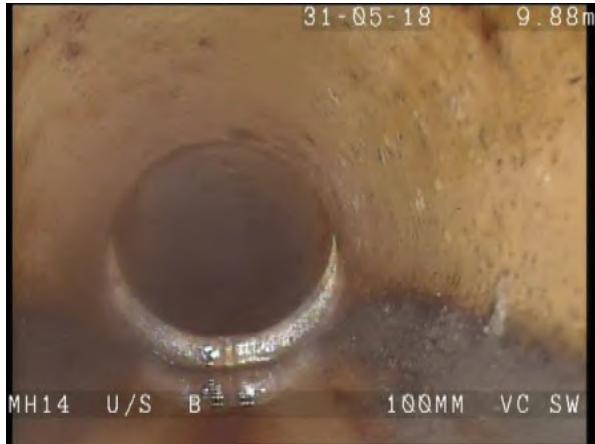
B_MH14X_f80fcc4a-b6ef-4fc9-a41e-e90103d837d1_20180604_145211_035.jpg, 00:01:13, 10.00m
Joint displaced, medium

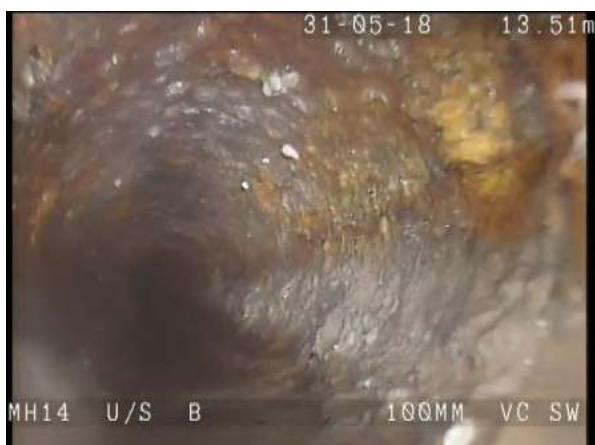
B_MH14X_18d6d96b-3466-4bf2-97b0-6d6743690ace_20180604_150518_290.jpg, 00:01:44, 13.50m
Material changes to cast iron

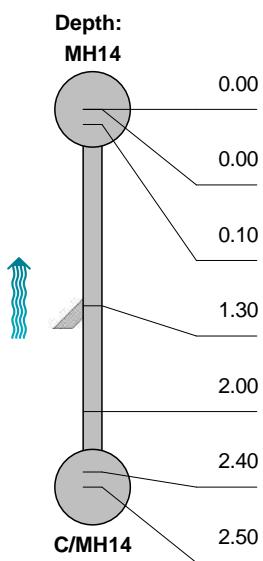
1:50	Position [m]	Code	Observation	MPEG	Photo	Grade
Depth:						
MH14						
	0.00	MH	Start node type, manhole, reference number: MH14	00:00:00		
	0.00	WL	Water level, 5% of the vertical dimension	00:00:00		
	0.10	DES	Settled deposits, fine, 5% cross-sectional area loss	00:00:07		2
	1.30	JN	Junction at 2 o'clock, diameter: 100mm	00:00:19		
	2.00	DES	Settled deposits, fine, 5% cross-sectional area loss	00:00:23		2
	2.40	LU	Line deviates up: 90 BEND	00:00:28		
	2.50	SA	Survey abandoned: DUE TO BEND	00:00:28		
C/MH14

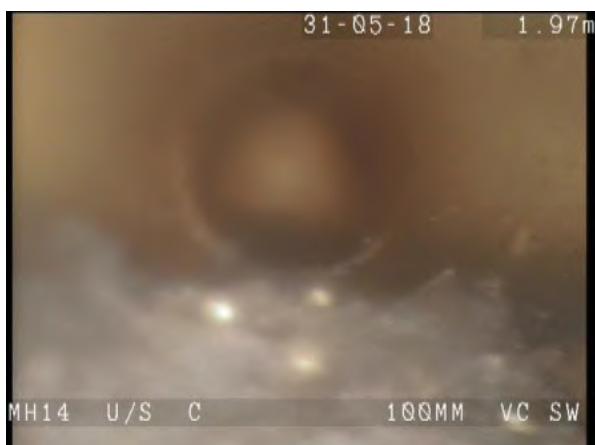
C_MH14X_4ecbaa30-d2c2-4194-8ce2-954695fa2ab7_20180604_151814_784.jpg, 00:00:23, 2.00m
Settled deposits, fine, 5% cross-sectional area loss

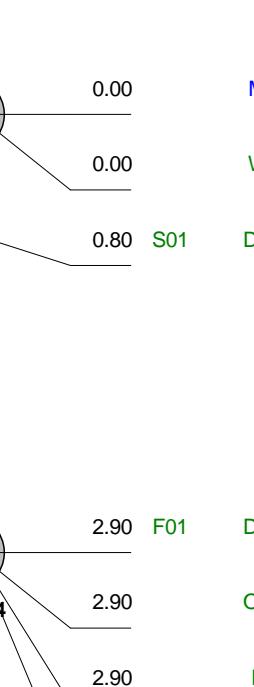
0.00	MH	Start node type, manhole, reference number: MH14	00:00:00		
	0.00	WL	Water level, 5% of the vertical dimension	00:00:00		
	0.80	S01	DES Settled deposits, fine, 10% cross-sectional area loss, start	00:00:11		
	2.90	F01	DES Settled deposits, fine, 10% cross-sectional area loss, finish	00:00:45		3
D/MH14	2.90	OBZ	Other obstacles from 4 o'clock to 8 o'clock, 40% cross-sectional area loss: ON 90 BEND	00:00:45		5
	2.90	LU	Line deviates up: 90 BEND	00:00:45		
	2.90	SA	Survey abandoned: DUE TO BEND/OBSTRUCTION	00:00:45

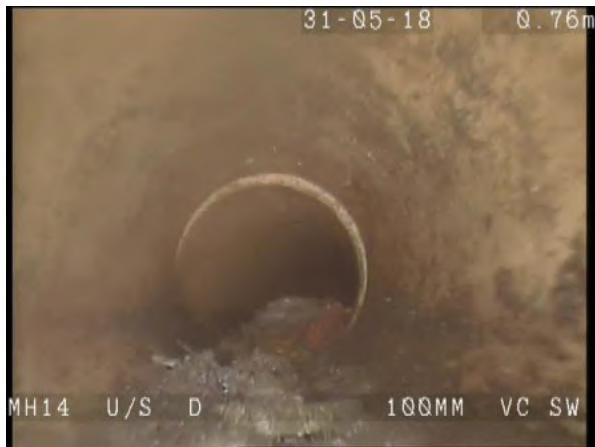
D_MH14X_b1db26ca-8089-47d0-a1ff-45bb5a26b379_20180604_152331_678.jpg, 00:00:11, 0.80m
Settled deposits, fine, 10% cross-sectional area loss, start

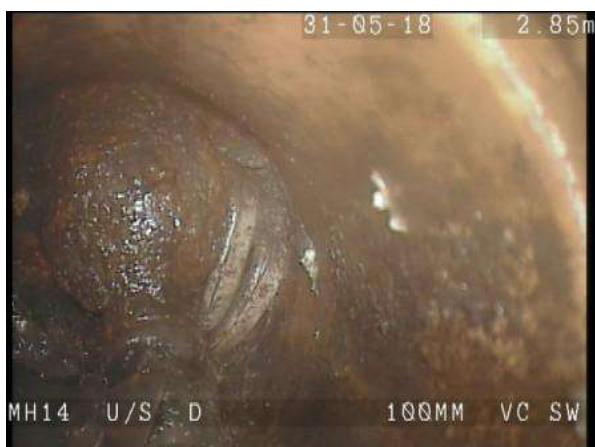
D_MH14X_a3025a4a-48bc-453f-b890-f5ff270501e4_20180604_154048_176.jpg, 00:00:45, 2.90m
Other obstacles from 4 o'clock to 8 o'clock, 40% cross-sectional area loss

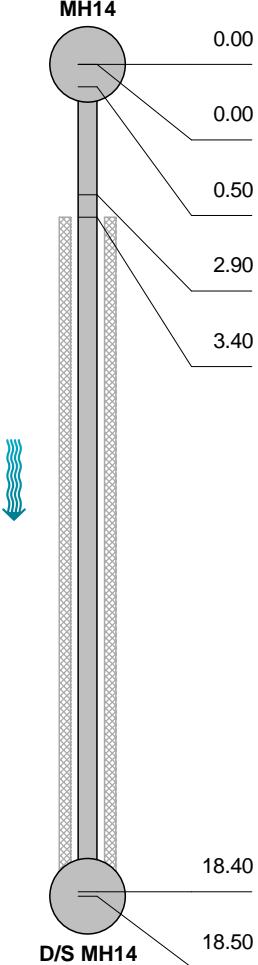
1:168	Position [m]	Code	Observation	MPEG	Photo	Grade
Depth:						
MH14						
	0.00	MH	Start node type, manhole, reference number: MH14	00:00:00		
	0.00	WL	Water level, 5% of the vertical dimension	00:00:00		
	0.50	CLJ	Crack, longitudinal at joint at 2 o'clock	00:00:09		2
	2.90	WL	Water level, 20% of the vertical dimension	00:00:22		
	3.40	S01	CUW Loss of vision, camera under water, start	00:00:27

18.40	F01	CUW Loss of vision, camera under water, finish	00:01:40		
	18.50	SA	Survey abandoned: DUE TO WATER LEVEL / UNKNOWN PIPE LENGTH	00:01:44		
Depth:

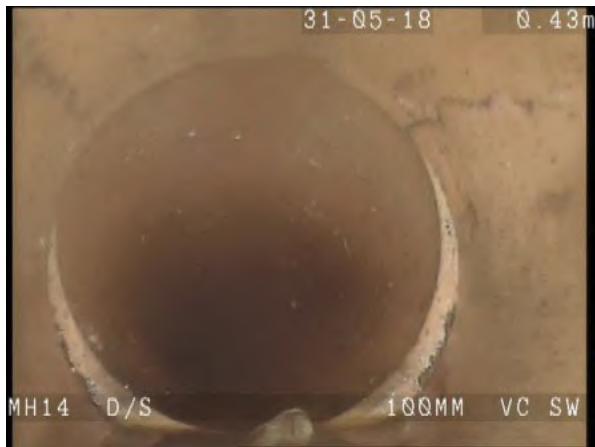
MH14X_168c0c70-77c0-4d60-9b76-dbb6a92cb306_20180604_154812_244.jpg, 00:00:09, 0.50m
Crack, longitudinal at joint at 2 o'clock

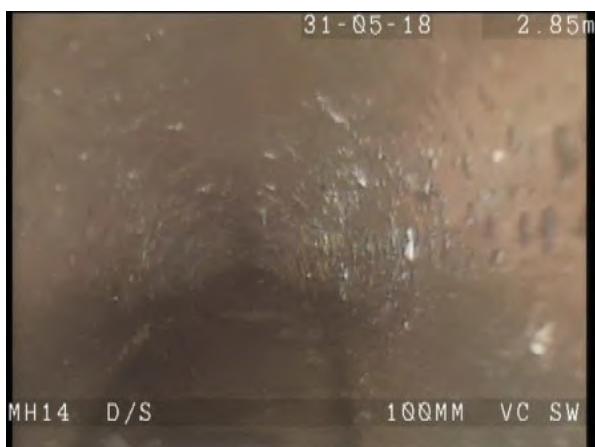
MH14X_cb3f99e3-0051-486d-941d-521f01aa8701_20180604_154912_875.jpg, 00:00:22, 2.90m
Water level, 20% of the vertical dimension

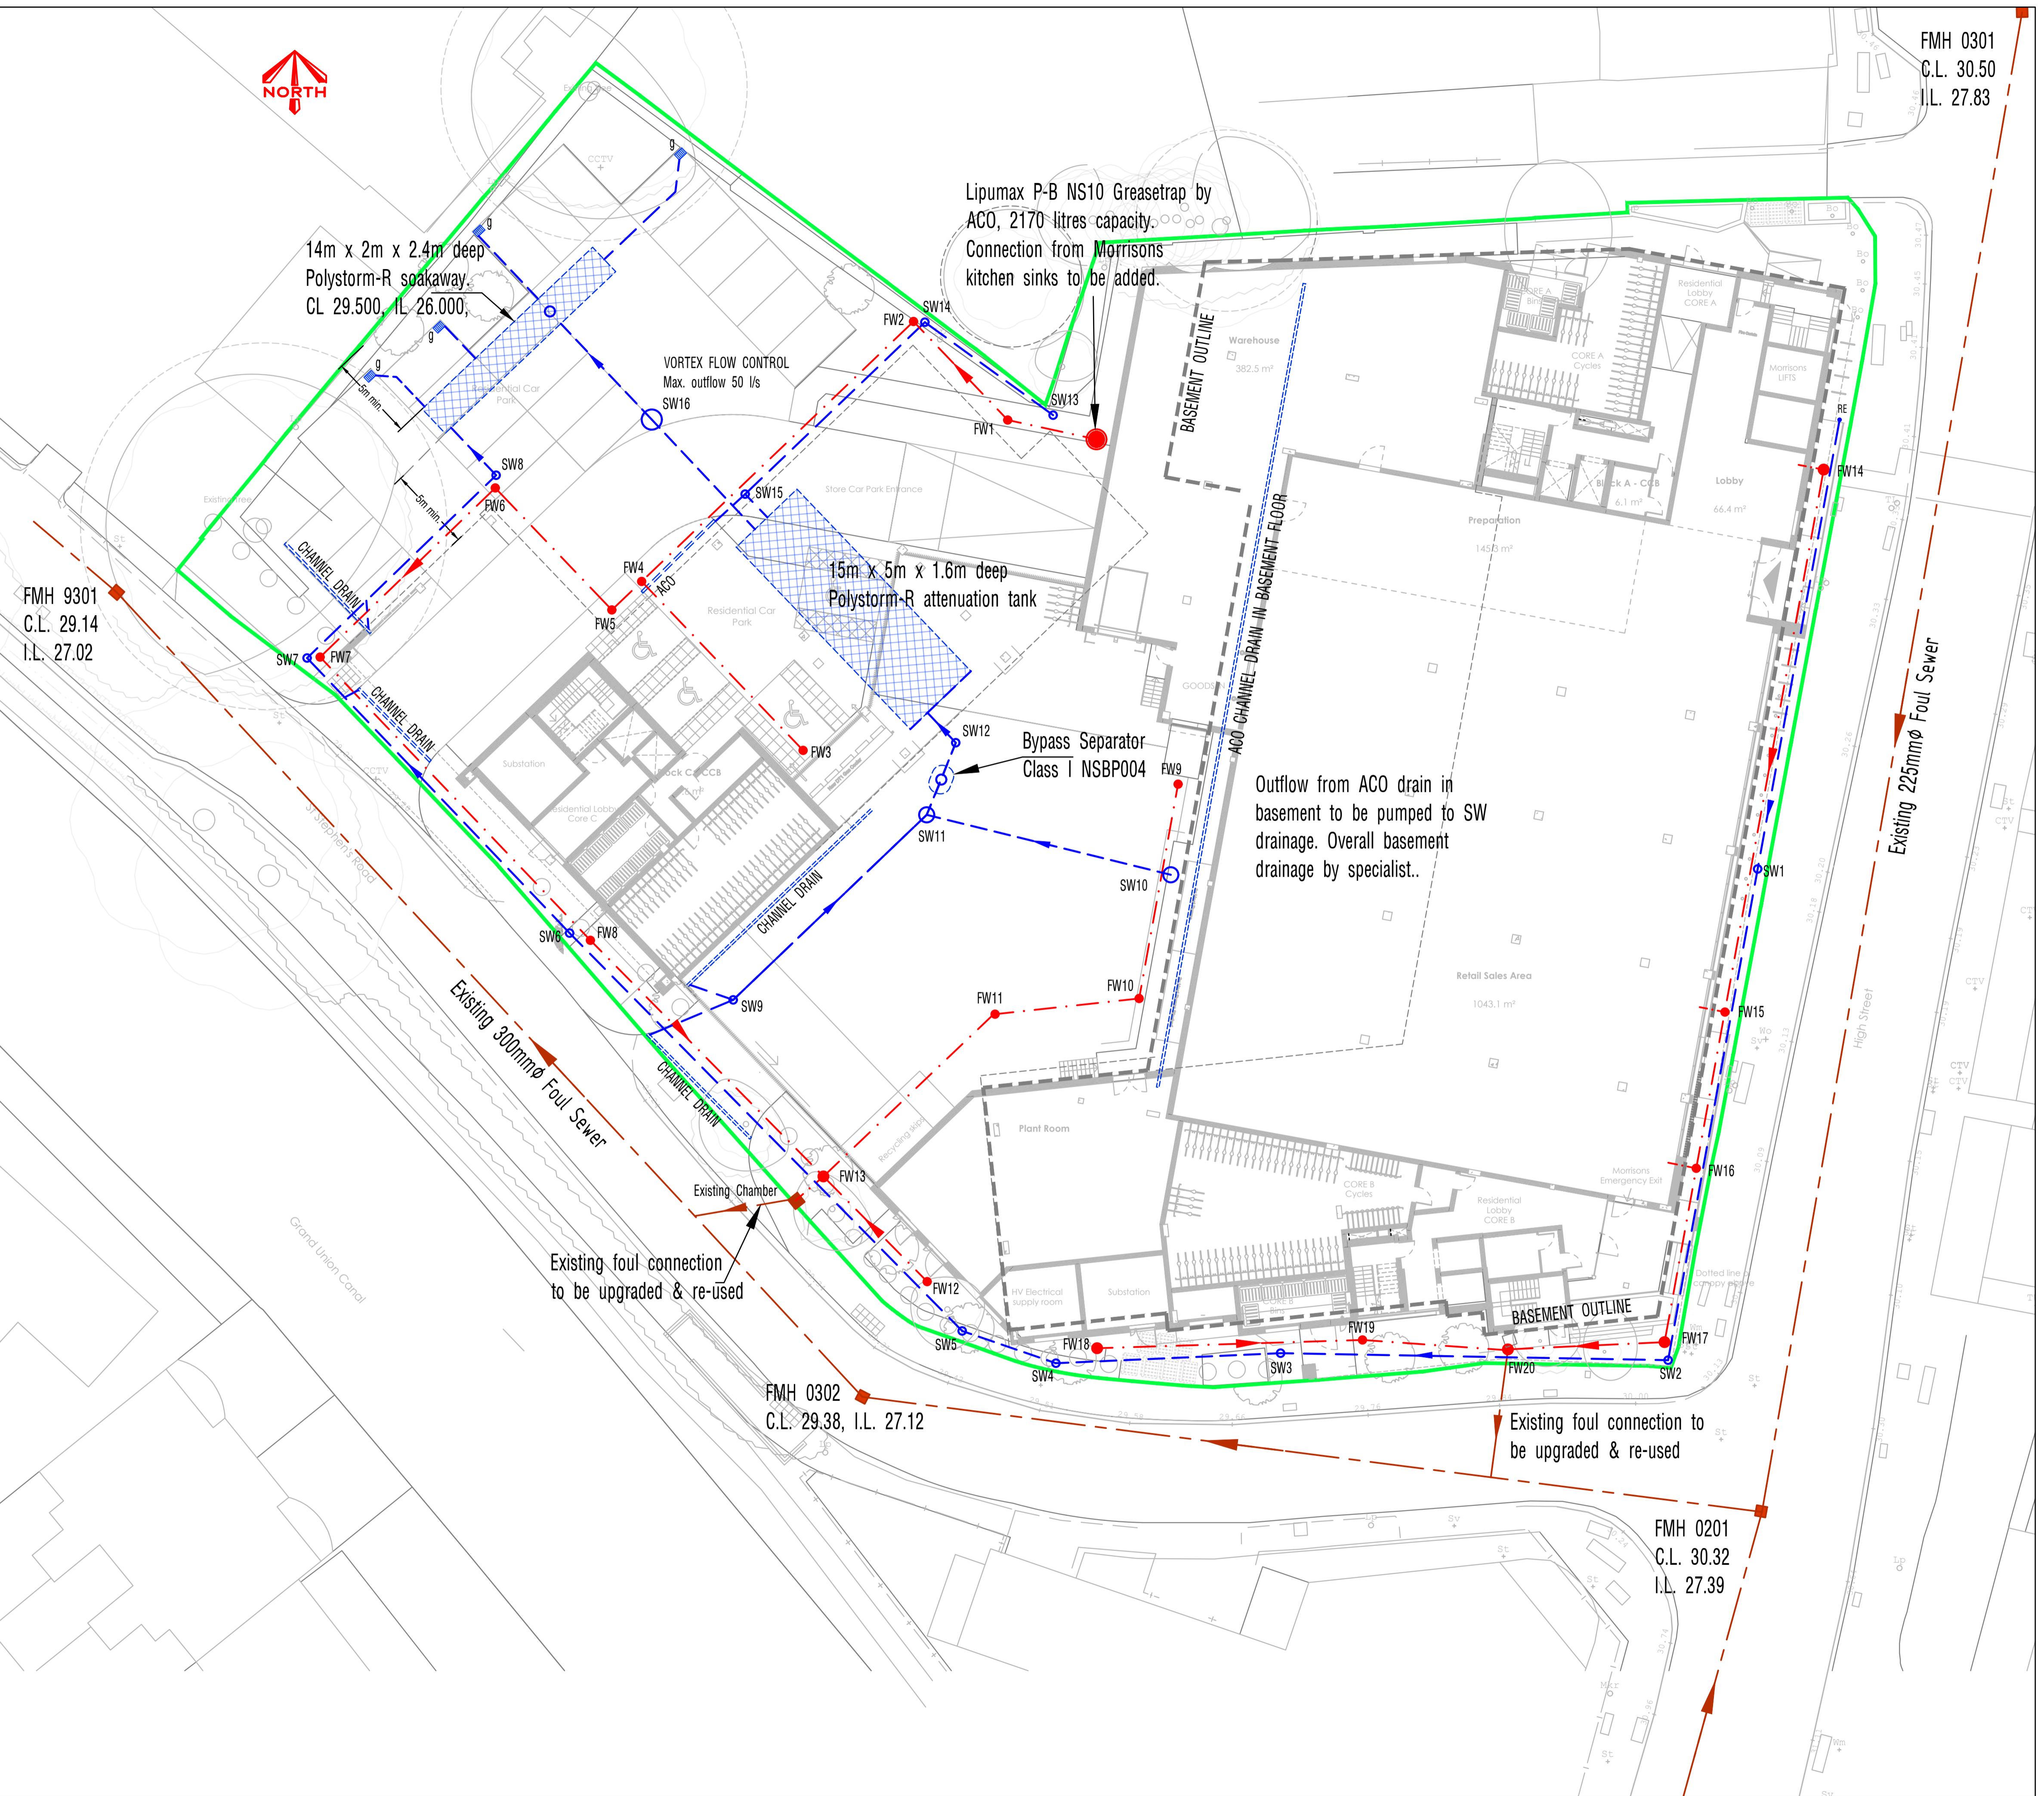
WARD COLE consulting engineers				
■ LINCOLN	□ LONDON	□ NOTTINGHAM		
Fosse House				
Roman Wharf				
Lincoln				
LN1 1SR				
tel 01522 513032				
fax 01522 513559				
e-mail structures@wardcole-lincoln.co.uk				
client:	Harbourside Investments Ltd			
project:	Morrisons, High Street Yiewsley			
drawing title:	Drainage Strategy Plan			
scale:	1:200 (A1)	status:	Preliminary	
job number:	10-4897	drawing number:	SK500	revision:

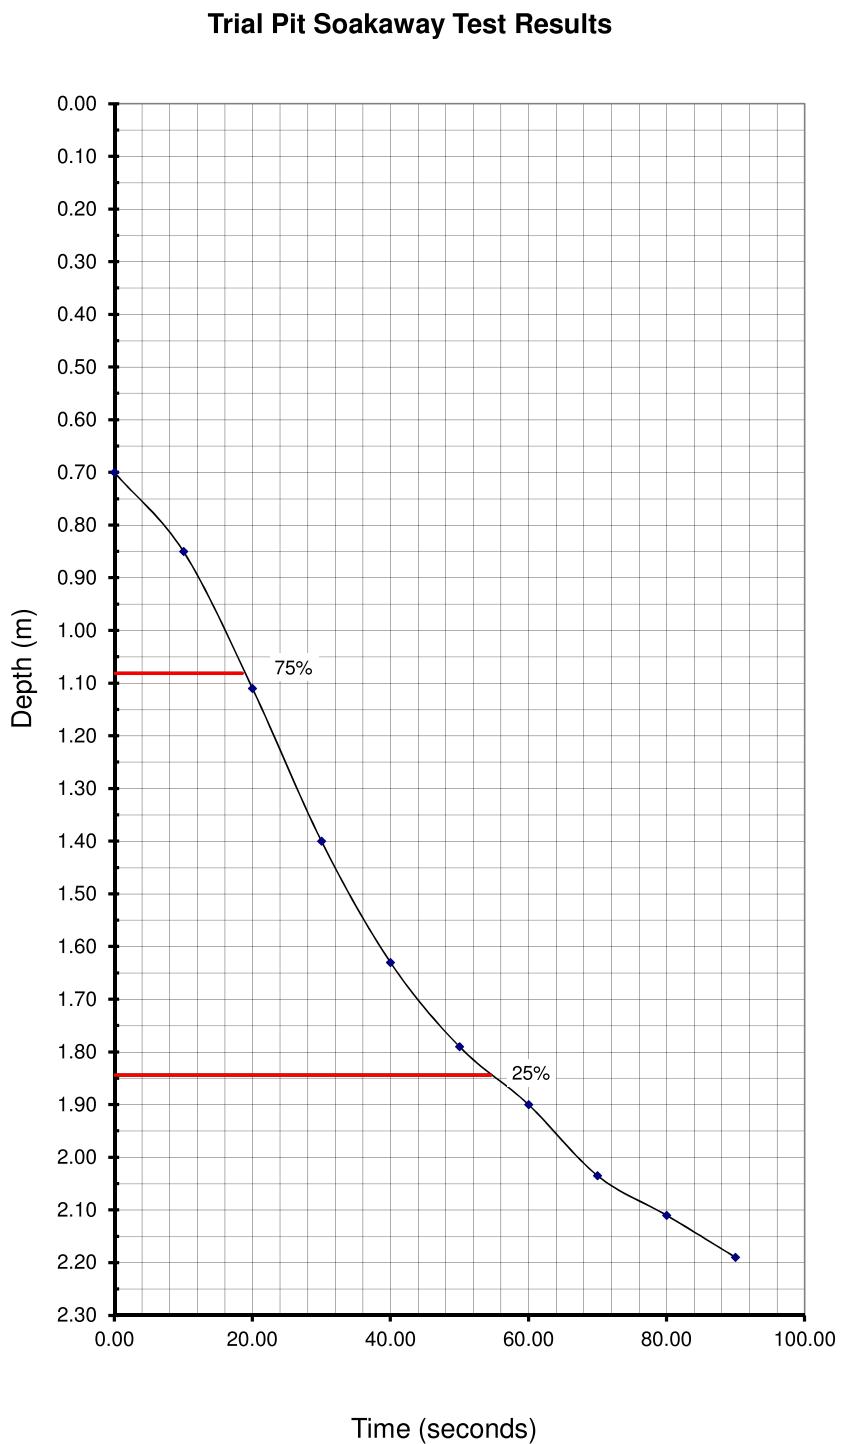
Location	TP1	Test No	Test 1
Client	Deacon and Jones	Length of Trial Pit (m)	1.20
Job Number	1920199	Width of Trial Pit (m)	0.35
Date	24-Sep-18	Water level at start (mbgl)	0.70
Operator	George Andrew	Water level prior to testing (mbgl)	2.23

Vp 75-25 (m3)	0.10
ap 50 (m2)	2.78
tp 75-25 (s)	36.00
Infiltration Rate (m/s)	9.91E-04
