Document:	Flood Risk Assessment and Drainage Strategy		
Project Name:	Mixed Use Retail and Residential Development, Morrisons, High Street, Yiewsley		
Client:	Harbourside Investments Ltd		
Project Reference:	10/4897		
Date of Issue:	December 2022	Rev:	A
Engineer:	D. Mutepfa	Checking Engineer:	W. E. Hansard

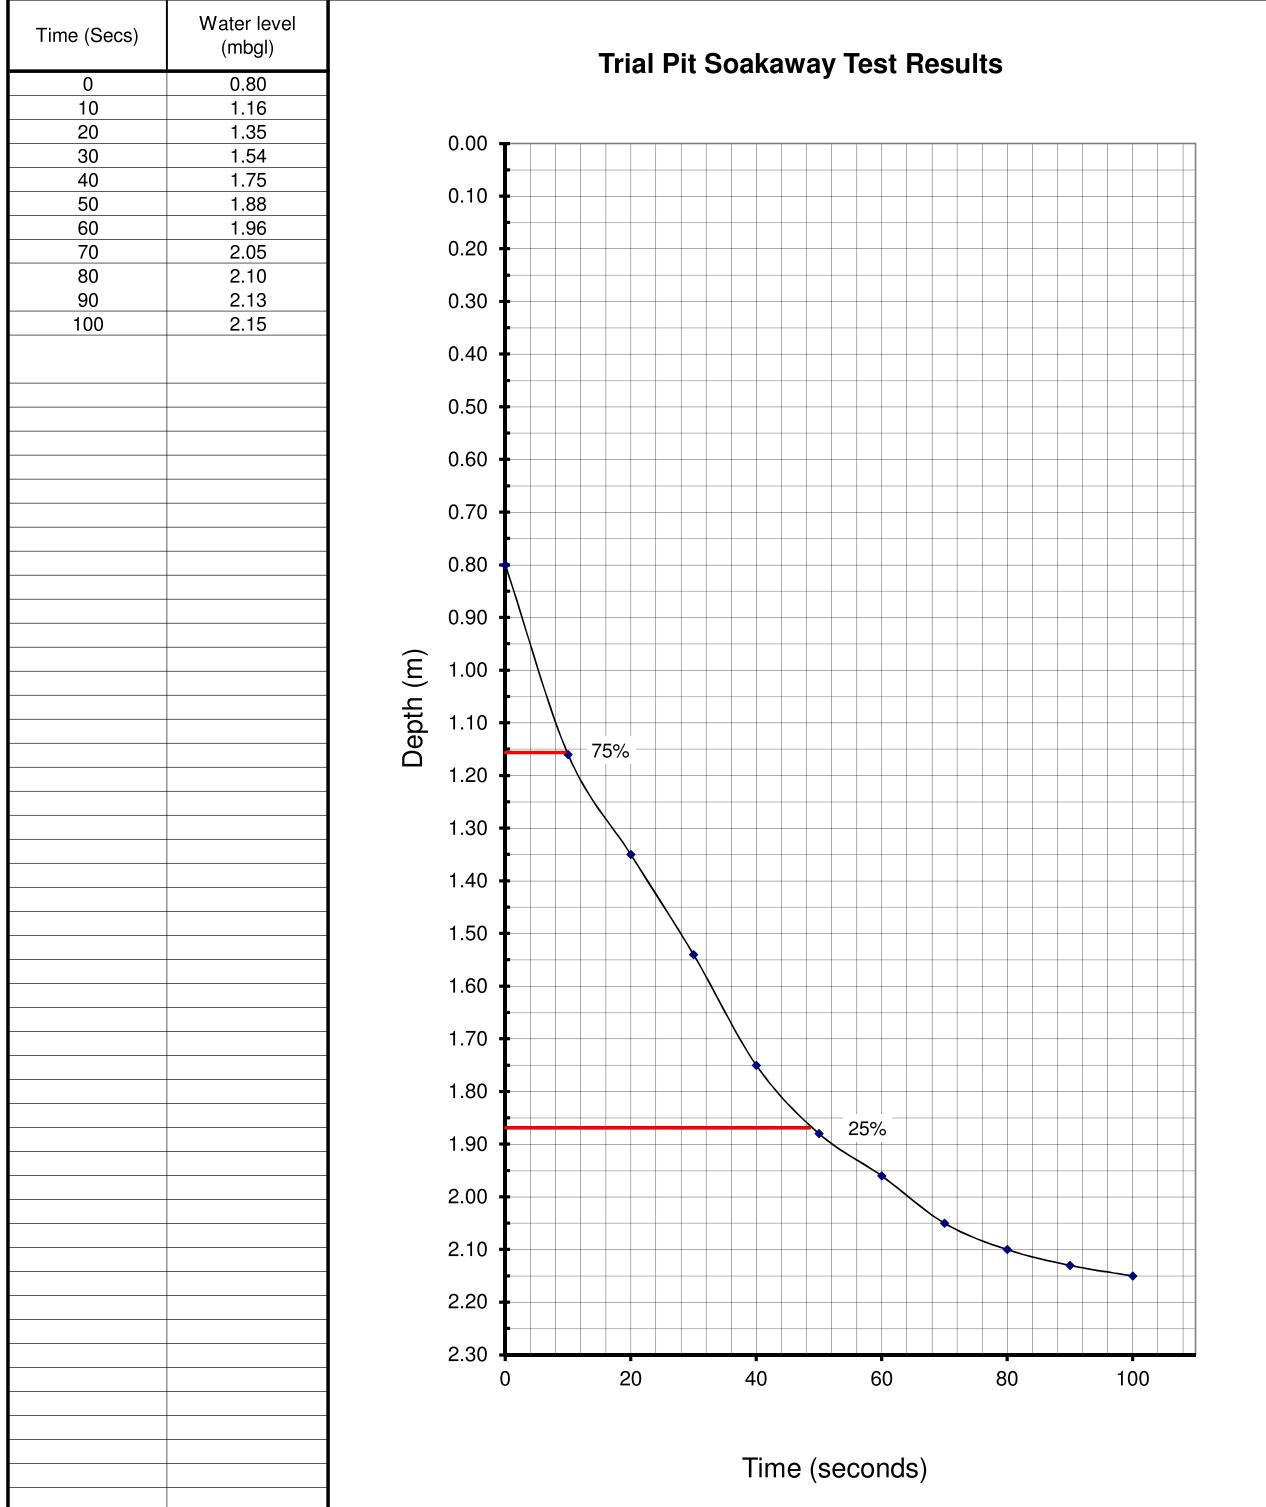
Location	TP1	Test No	Test 1
Client	Deacon and Jones	Length of Trial Pit (m)	1.20
Job Number	1920199	Width of Trial Pit (m)	0.35
Date	24-Sep-18	Water level at start (mbgl)	0.80
Operator	George Andrew	Water level prior to testing (mbgl)	2.23

Vp 75-25 (m3)	0.09
ap 50 (m2)	2.63
tp 75-25 (s)	39.00
Infiltration Rate (m/s)	9.05E-04

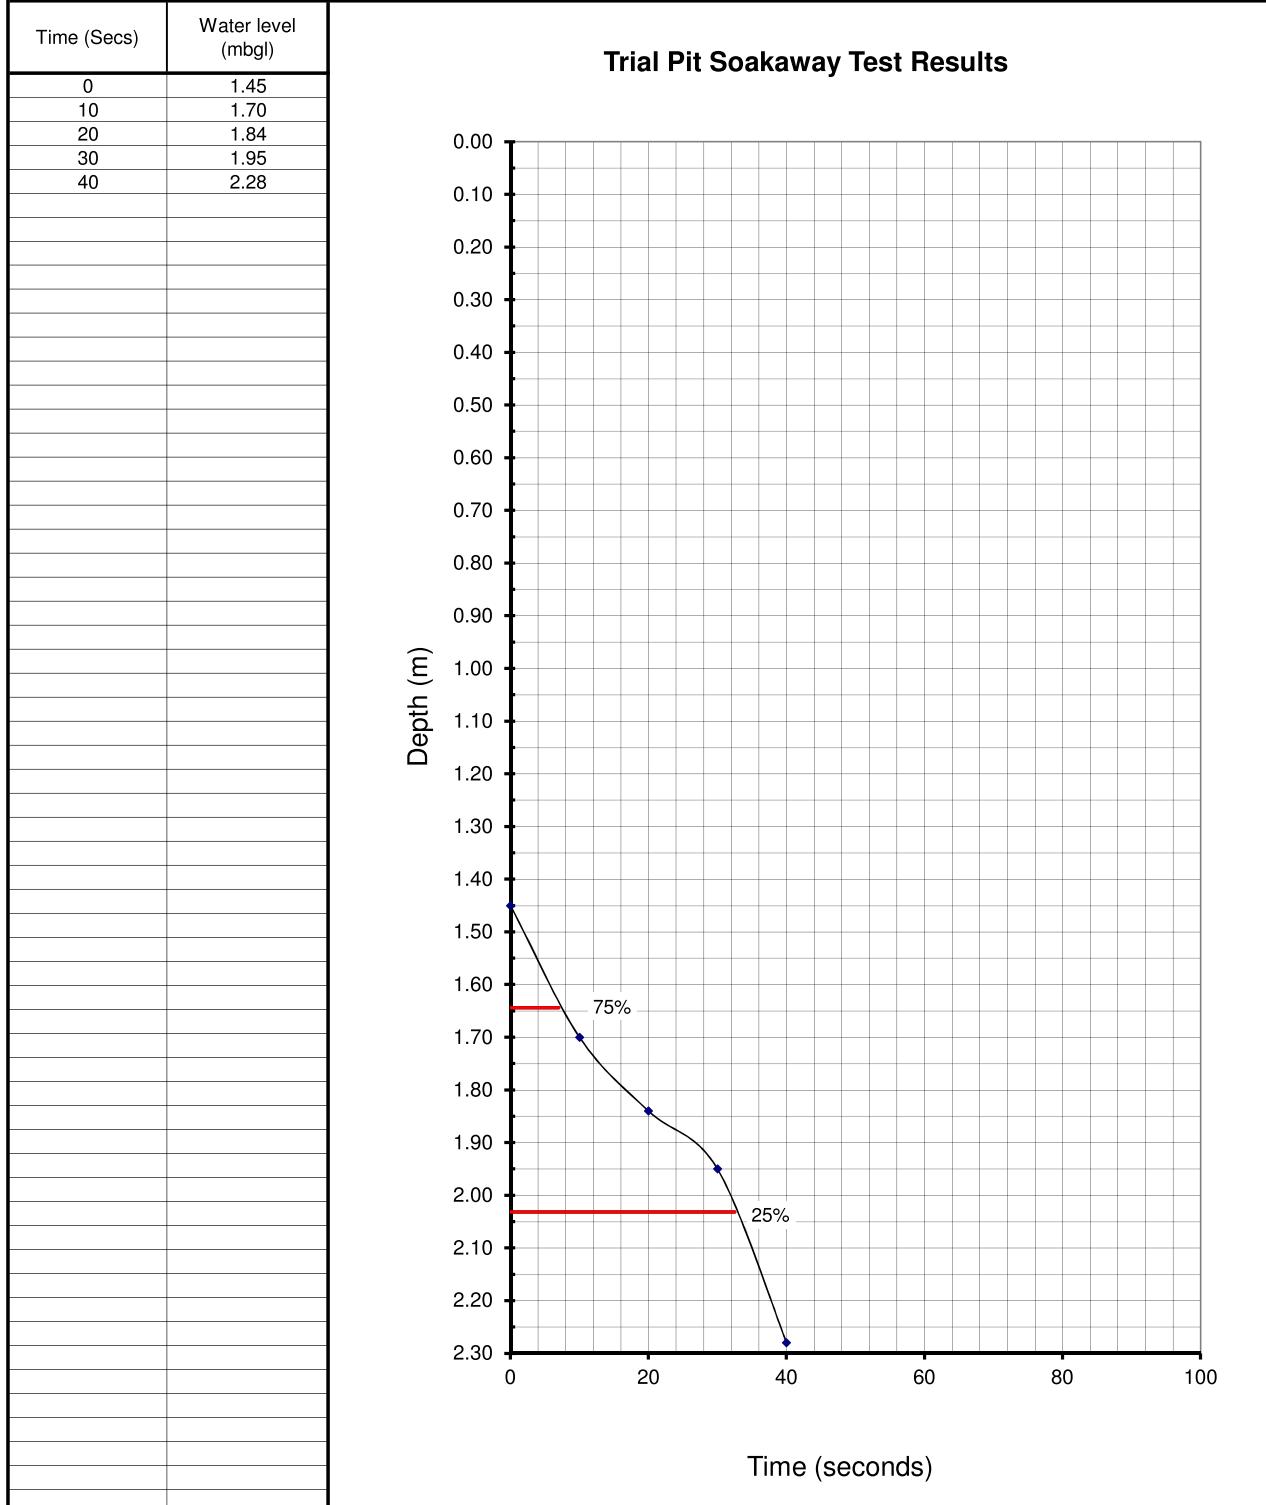
Location	TP1	Test No	Test 1
Client	Deacon and Jones	Length of Trial Pit (m)	1.20
Job Number	1920199	Width of Trial Pit (m)	0.35
Date	24-Sep-18	Water level at start (mbgl)	1.45
Operator	George Andrew	Water level prior to testing (mbgl)	2.23

Vp 75-25 (m ³)	0.05
ap 50 (m ²)	1.62
tp 75-25 (s)	25.50
Infiltration Rate (m/s)	1.22E-03

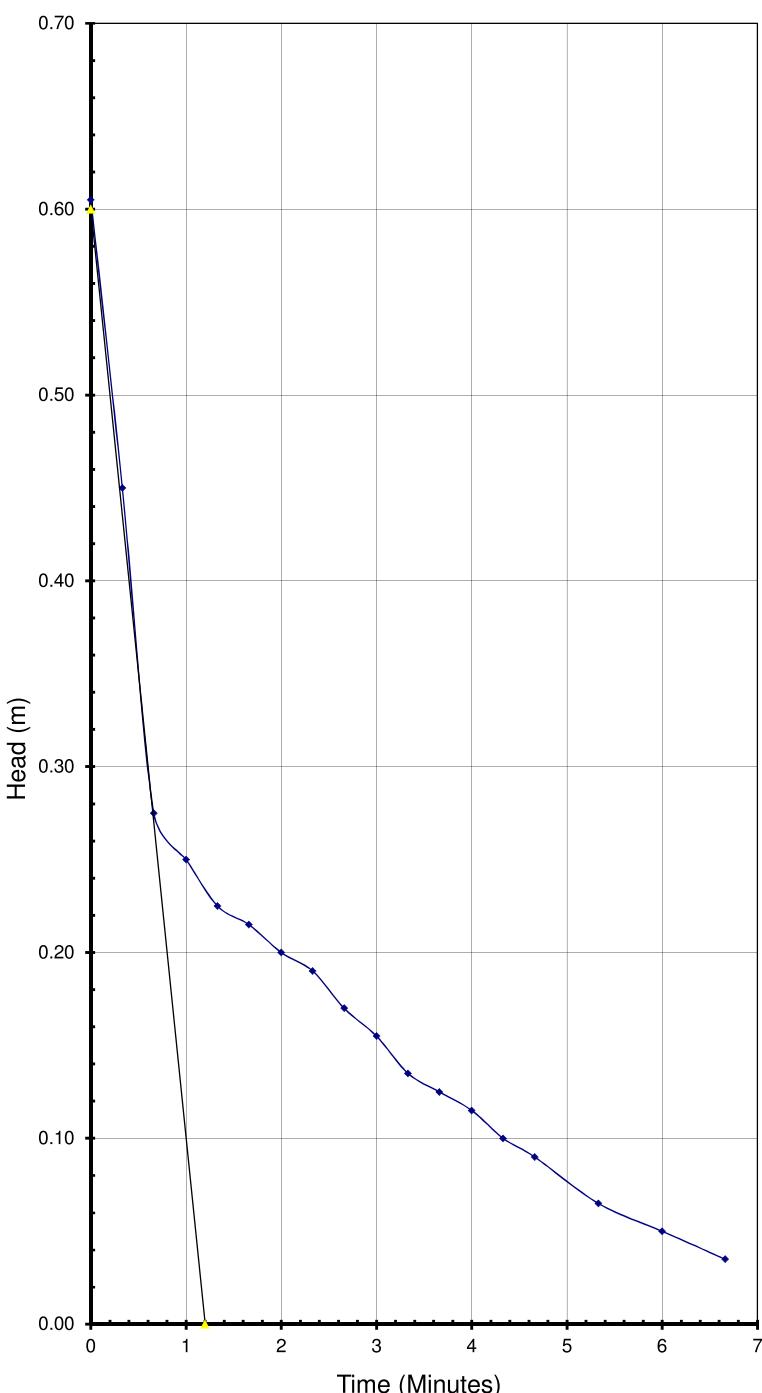
Location	Yiewsley	Diameter of casing (m)	0.033																																										
Client	Deacon and Jones	Diameter of test zone (m)	0.1																																										
Soakaway	WS4	Casing depth (m)	0.7																																										
Date	02-Oct-18	Depth to base of hole (m)	1.45																																										
Operator	George Andrew	Job Number	1920199																																										
Time (Minutes)	Water level (mbgl)	Head (m)	Falling Head Test Results																																										
0.00	0.47	0.61

<p>The graph shows the falling head test results. The initial water level is 0.61 m. At approximately 1.2 minutes, the water level drops to 0.00 m, indicating the end of the infiltration process. The infiltration rate is calculated as the change in head divided by the time taken for the head to drop to zero.</p>

th (mins)	1.20	Comments:
Hp (m)	0.60	
Infiltration Rate (l/m²/min)	1.82	
Infiltration Rate (m/s)	3.03E-05
