Bathymetric Survey

Ruislip Lido
 Hillingdon, London

Sheet 1 of 2

Sediment Thickness

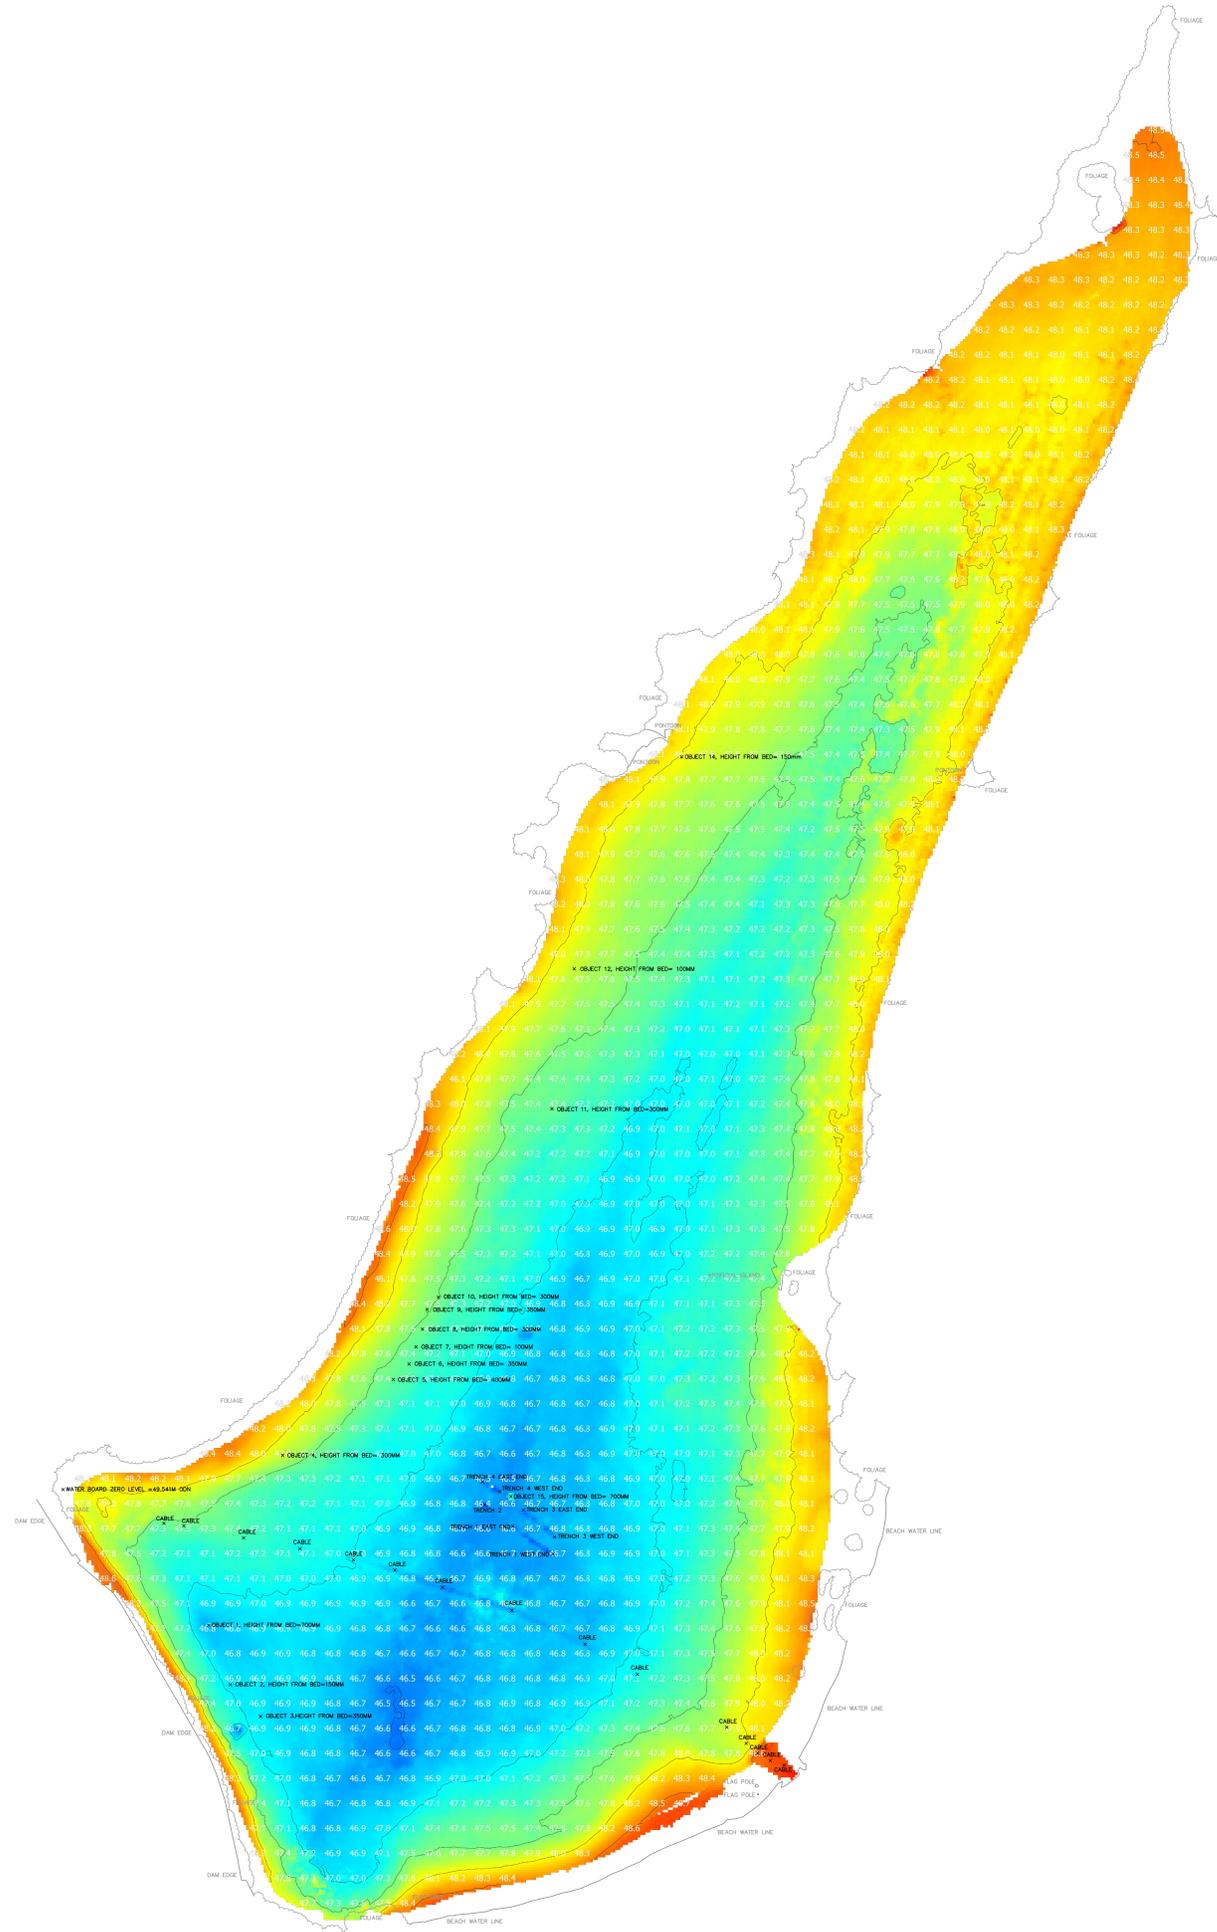
- Survey Notes**
- Multibeam bathymetry was acquired using a North (WBM) Narrow Transom with integrated Applanix Earthstar IMU. Positioning was achieved using dual Applanix S40AP antennas on a fixed baseline, employing VRS RTK corrections via Trimble VRSNow.

- LiDAR data was acquired using a North LiDAR, positioned using the same system as the multibeam.
 - Shallow geophysical data was acquired using an Innomer Compact Sub-Bottom Profiler (SBP), positioned using a Trimble R10 GNSS receiver, employing VRS RTK corrections via Trimble VRSNow.

- Spot heights were obtained using a Trimble R10 GNSS receiver, employing VRS RTK corrections via Trimble VRSNow.
 - Topographic detail was extracted from the LiDAR point cloud and is presented for contextual purposes only. As the vegetation often overhangs or is growing in the water, this is why some multibeam coverage extends beyond the line as drawn.

- Coverage was achieved over all safely navigable areas; gently banking shallow areas around the periphery and some obstructions prevented bank to bank coverage with the multibeam. Coverage with the SBP was less than the multibeam, as it is only able to sample directly below the vessel, whereas the multibeam acquires a lateral swathe of data.

- Potential obstructions and other areas of interest were identified from analysis of both the depth and backscatter components of the multibeam data.

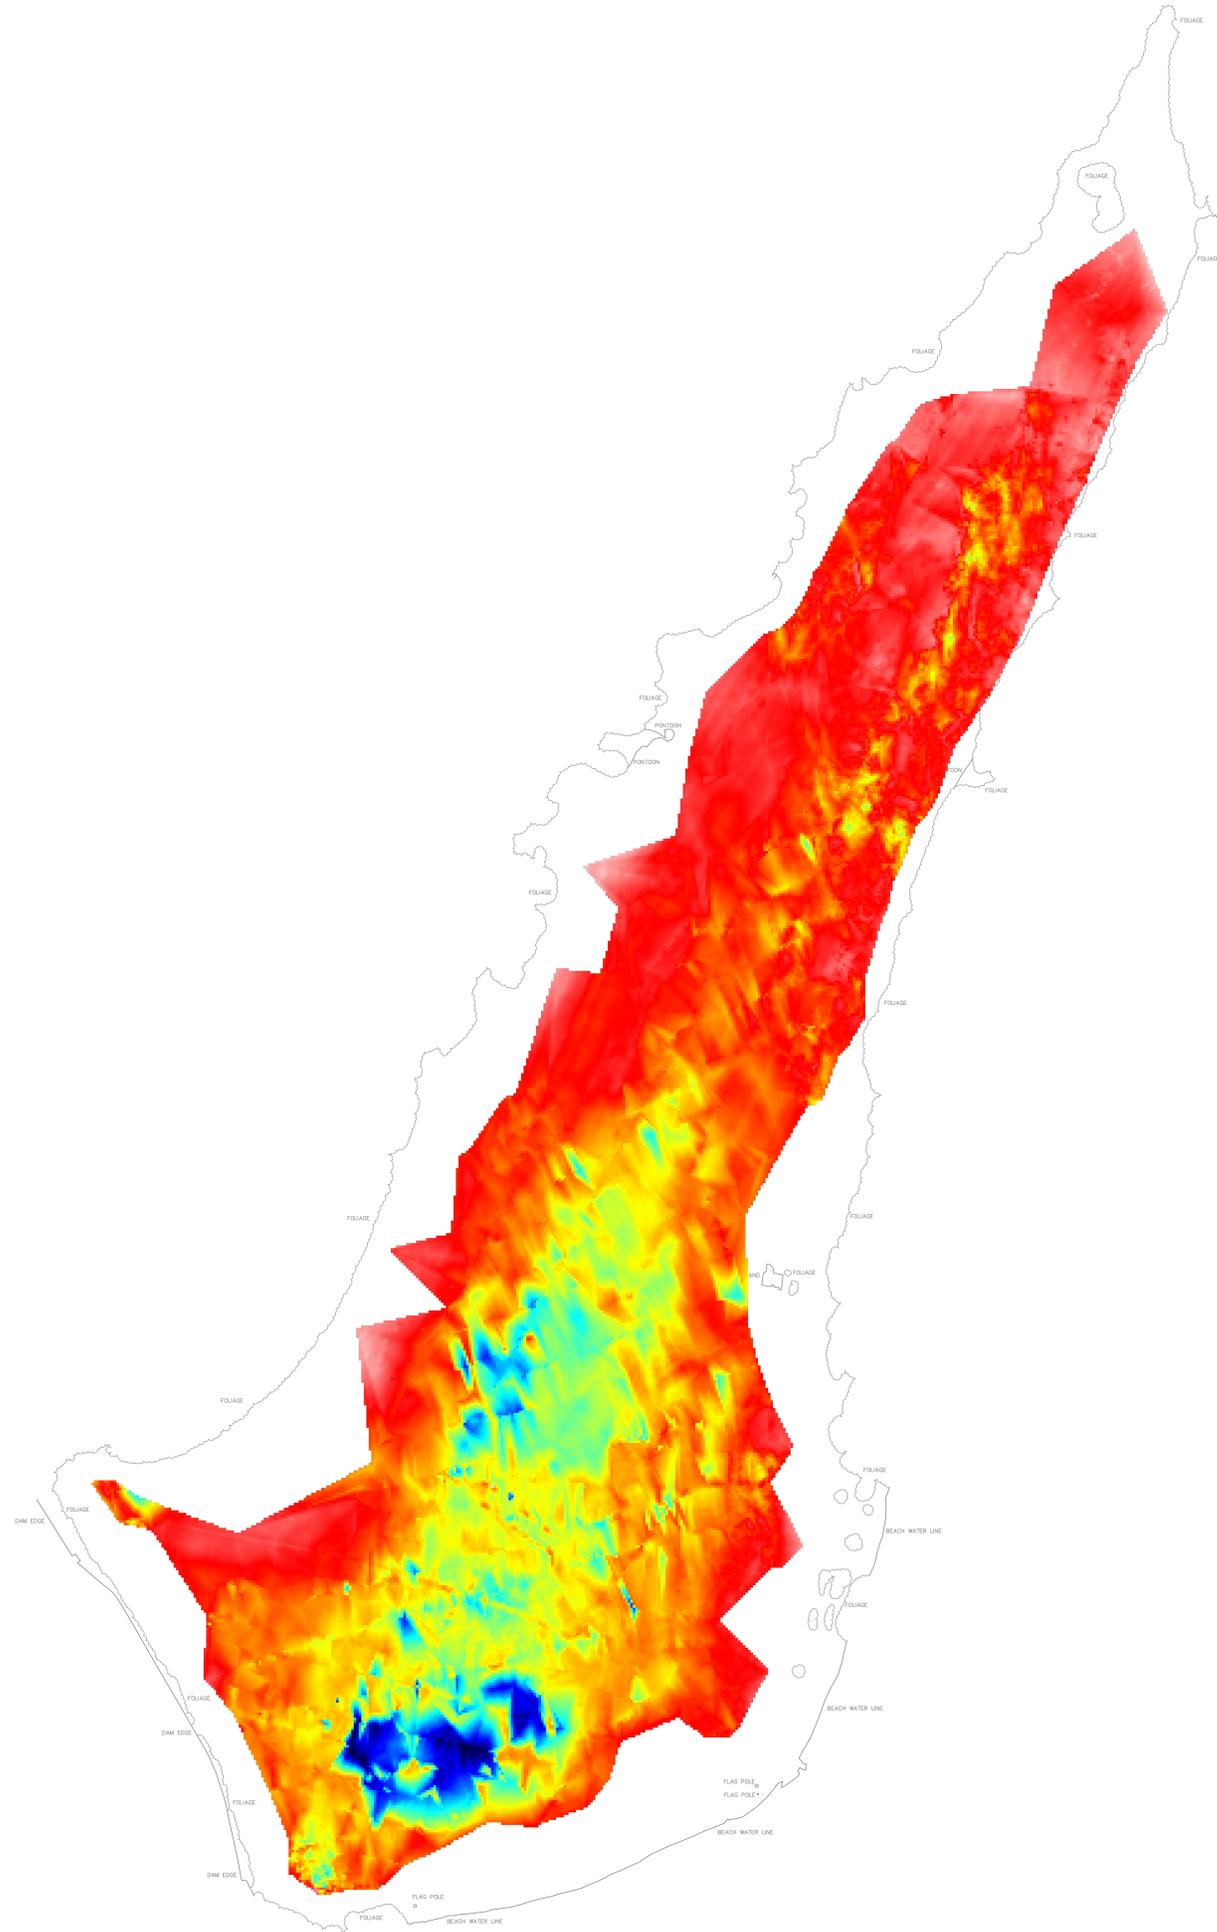
Sheet 2 of 2

Survey Notes

- Multibeam bathymetry was acquired using a Norbit iWBMSi Narrow Transom with integrated Applanix Suthmaster IMU. Positioning was achieved using dual Applanix S40AP antennas on a fixed baseline, employing VRS RTK corrections via Trimble VRSNow.

- LiDAR data was acquired using a North LiDAR, positioned using the same system as the multibeam.
- Shallow geophysical data was acquired using an Innomer Compact Sub-Bottom Profiler (SBP), positioned using a Trimble R10 GNSS receiver, employing VRS RTK corrections via Trimble VRSNow.

- Topographic detail was extracted from the LiDAR point cloud and is presented for contextual purposes only. As the vegetation often overhangs or is growing in the water, this is why some multibeam coverage extends beyond the line as drawn.

- Presented sediment thickness was derived by joining hard bed returns in the SBP data as individual points; a TIN model was then used to create a 3D surface from the individual points, which could then be compared to the bathymetric surface, to give the presented thickness as the difference between the two. Note the hard bottom was masked by the water bottom multiple in the shallowest areas, limiting the areas where picks could be made, resulting in a further reduction in coverage to that explained above.

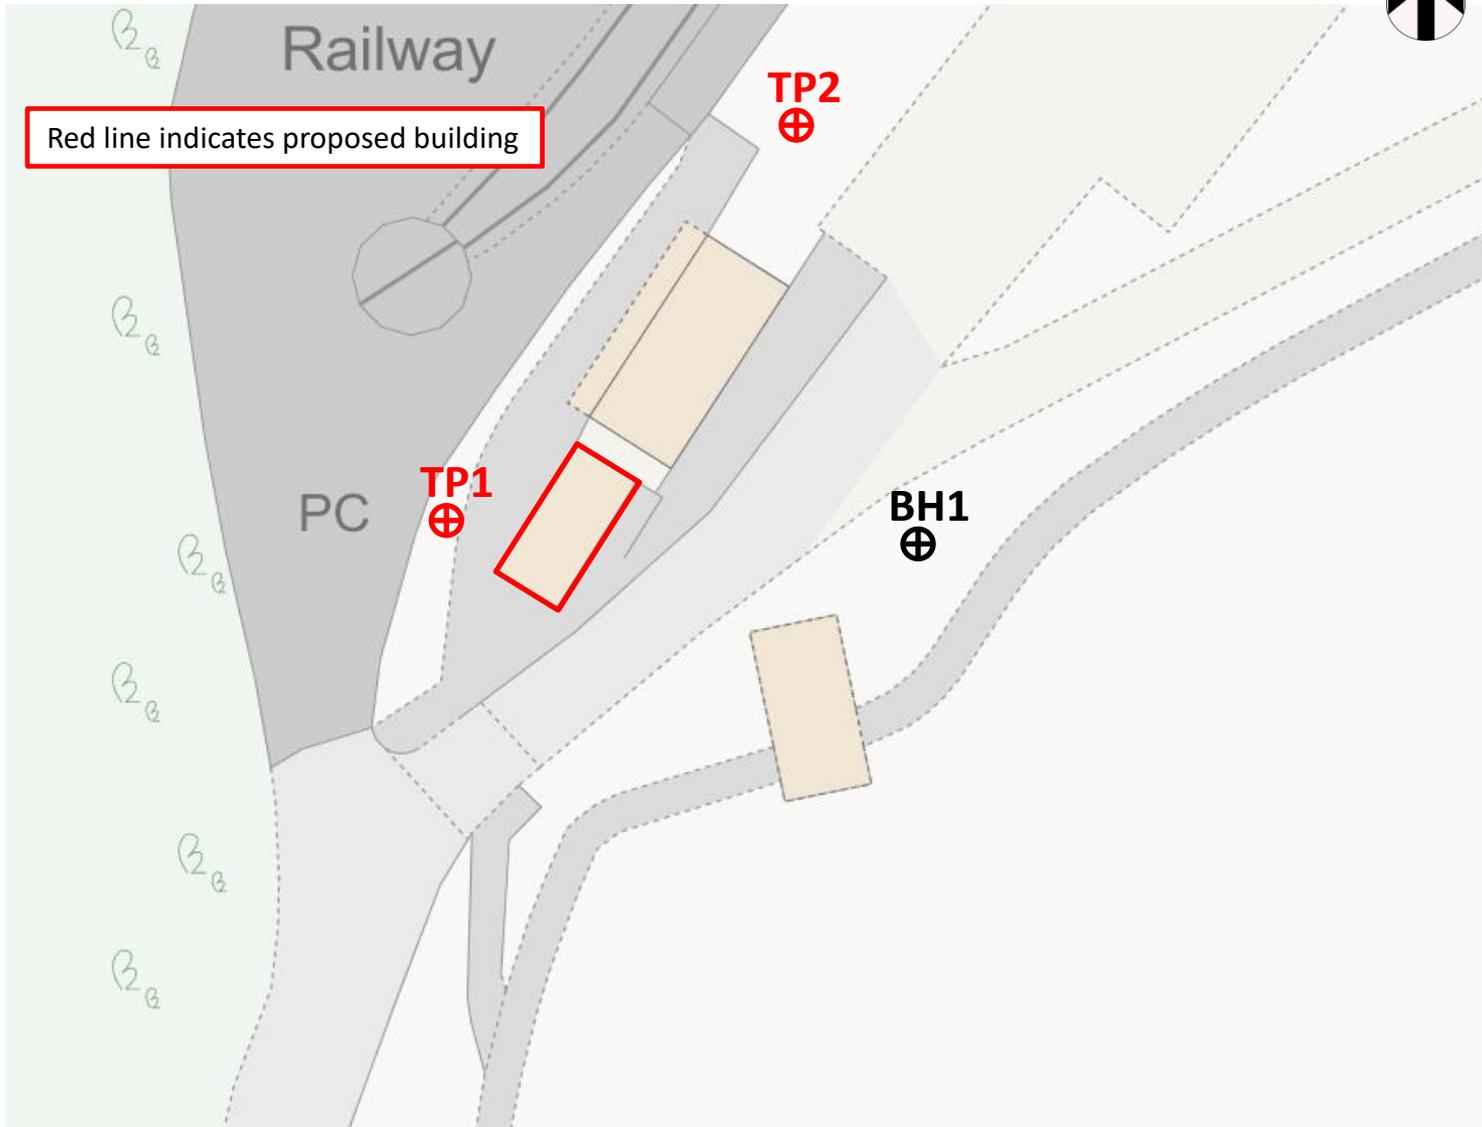
Red line indicates proposed building

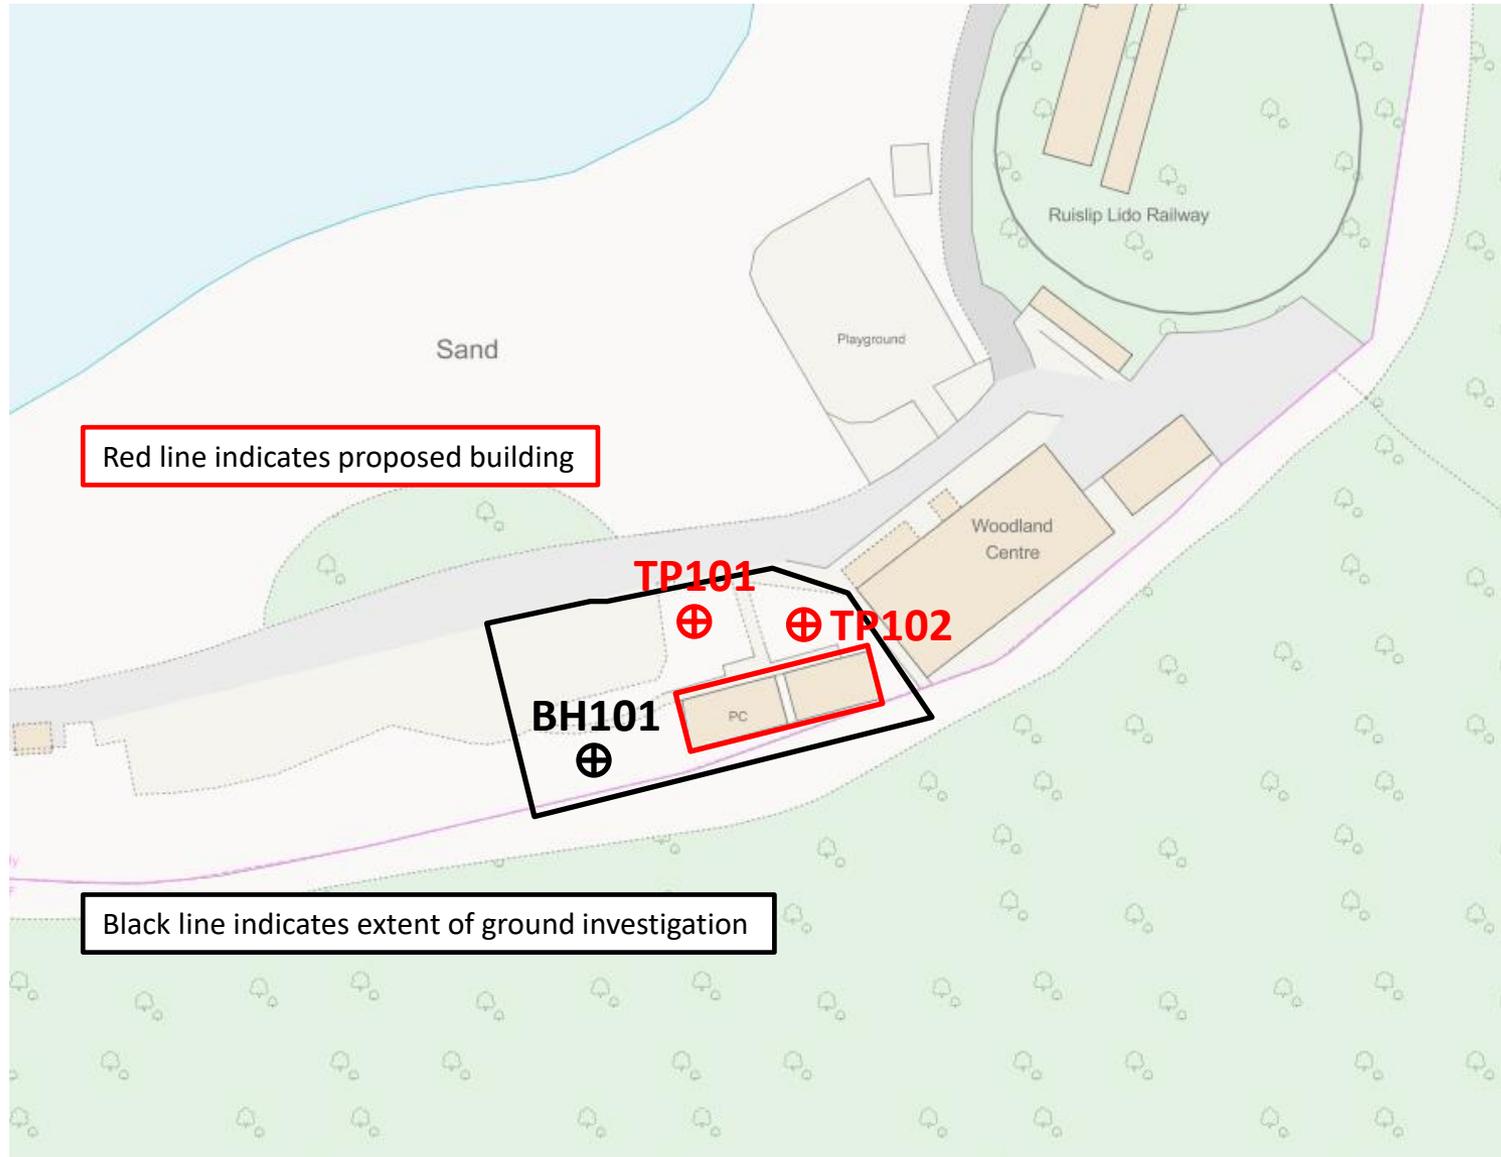
Red line indicates proposed building

Black line indicates extent of ground investigation
