SECOND FLOOR PLAN

OLD WORKHOUSE
BREAKSPAR ROAD NORTH
HAREFIELD
MIDDLESEX

PROPOSED PLAN

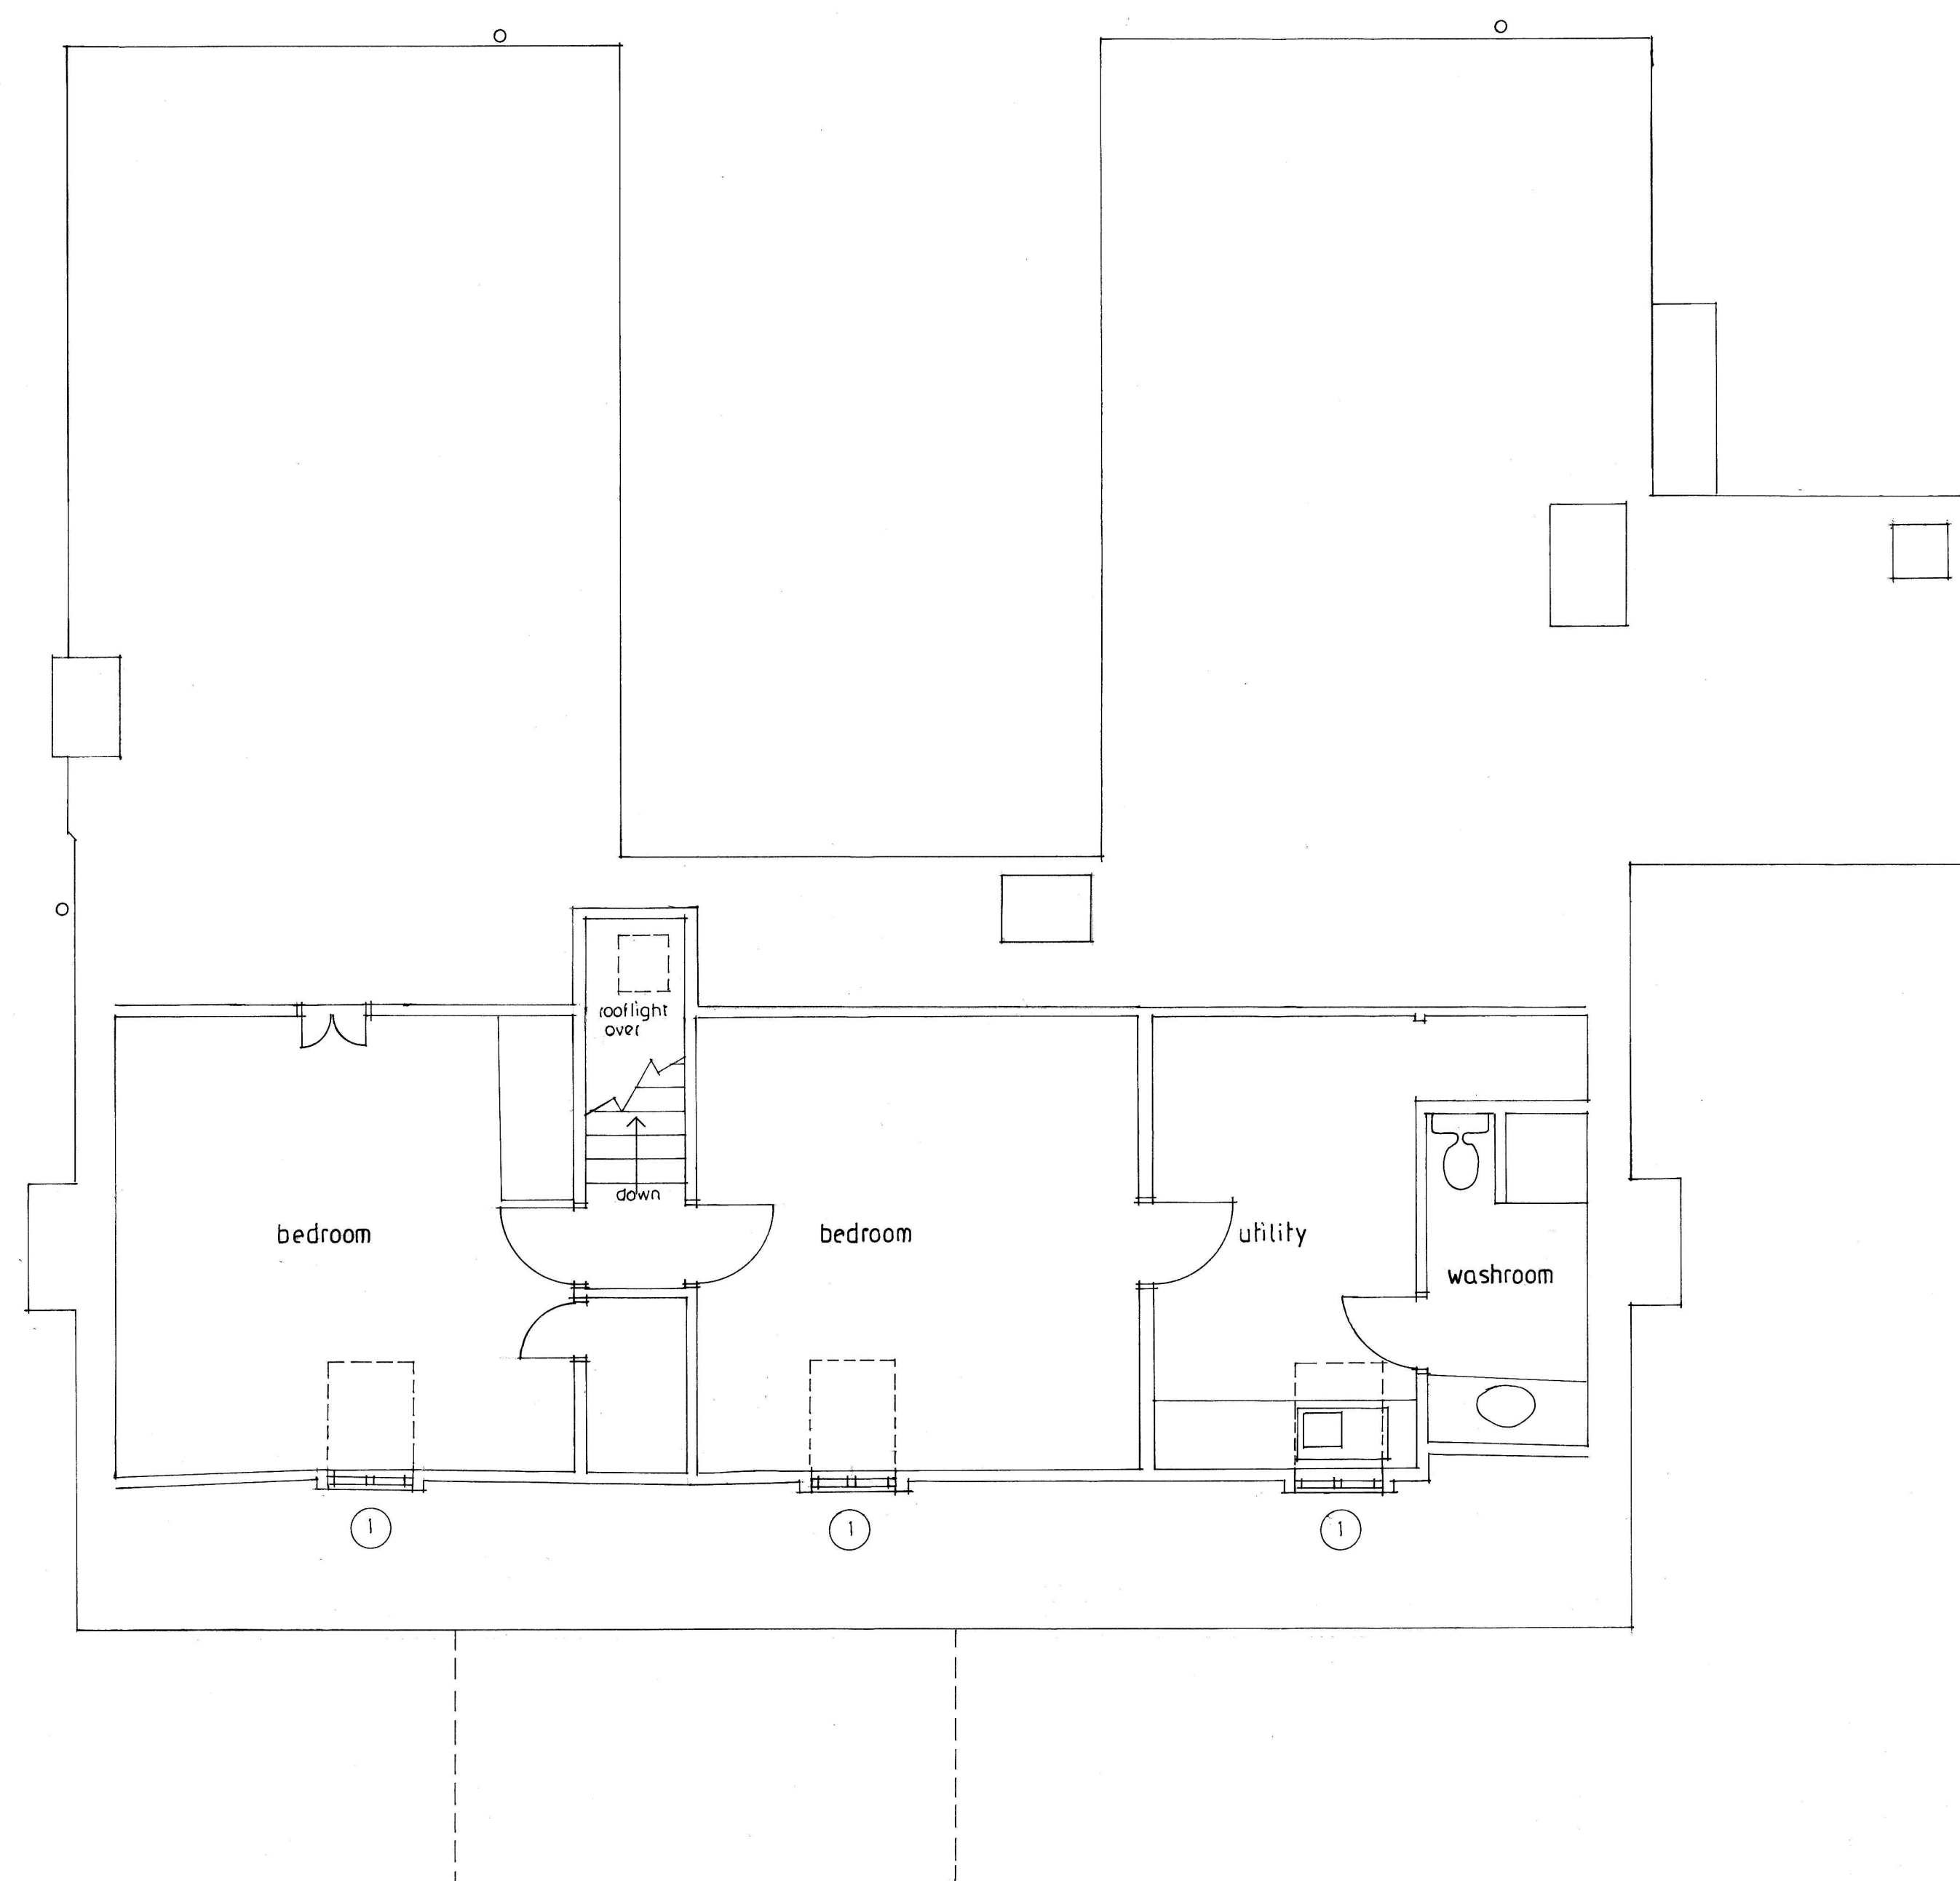
1. Remove cement render from dormers and install lime render finish to gables and cheeks together with replacement Code4/5 lead aprons, abutment flashings and Code 3 lead soakers.
Remove leaded glass to central dormer left-hand side casement window and install new glass with leaded comes to match existing pattern.
Where necessary cut out any rotten timber to the window frames and sills and fit sections of seasoned treated timber.
Joinery to dormer windows to be rubbed down primed where necessary and re-painted with undercoat and white gloss finish.
