# 8.0 Reflected Ceiling Plan - Ground Floor

# 9.0 Design Amendments

# 9.1 New Replacements

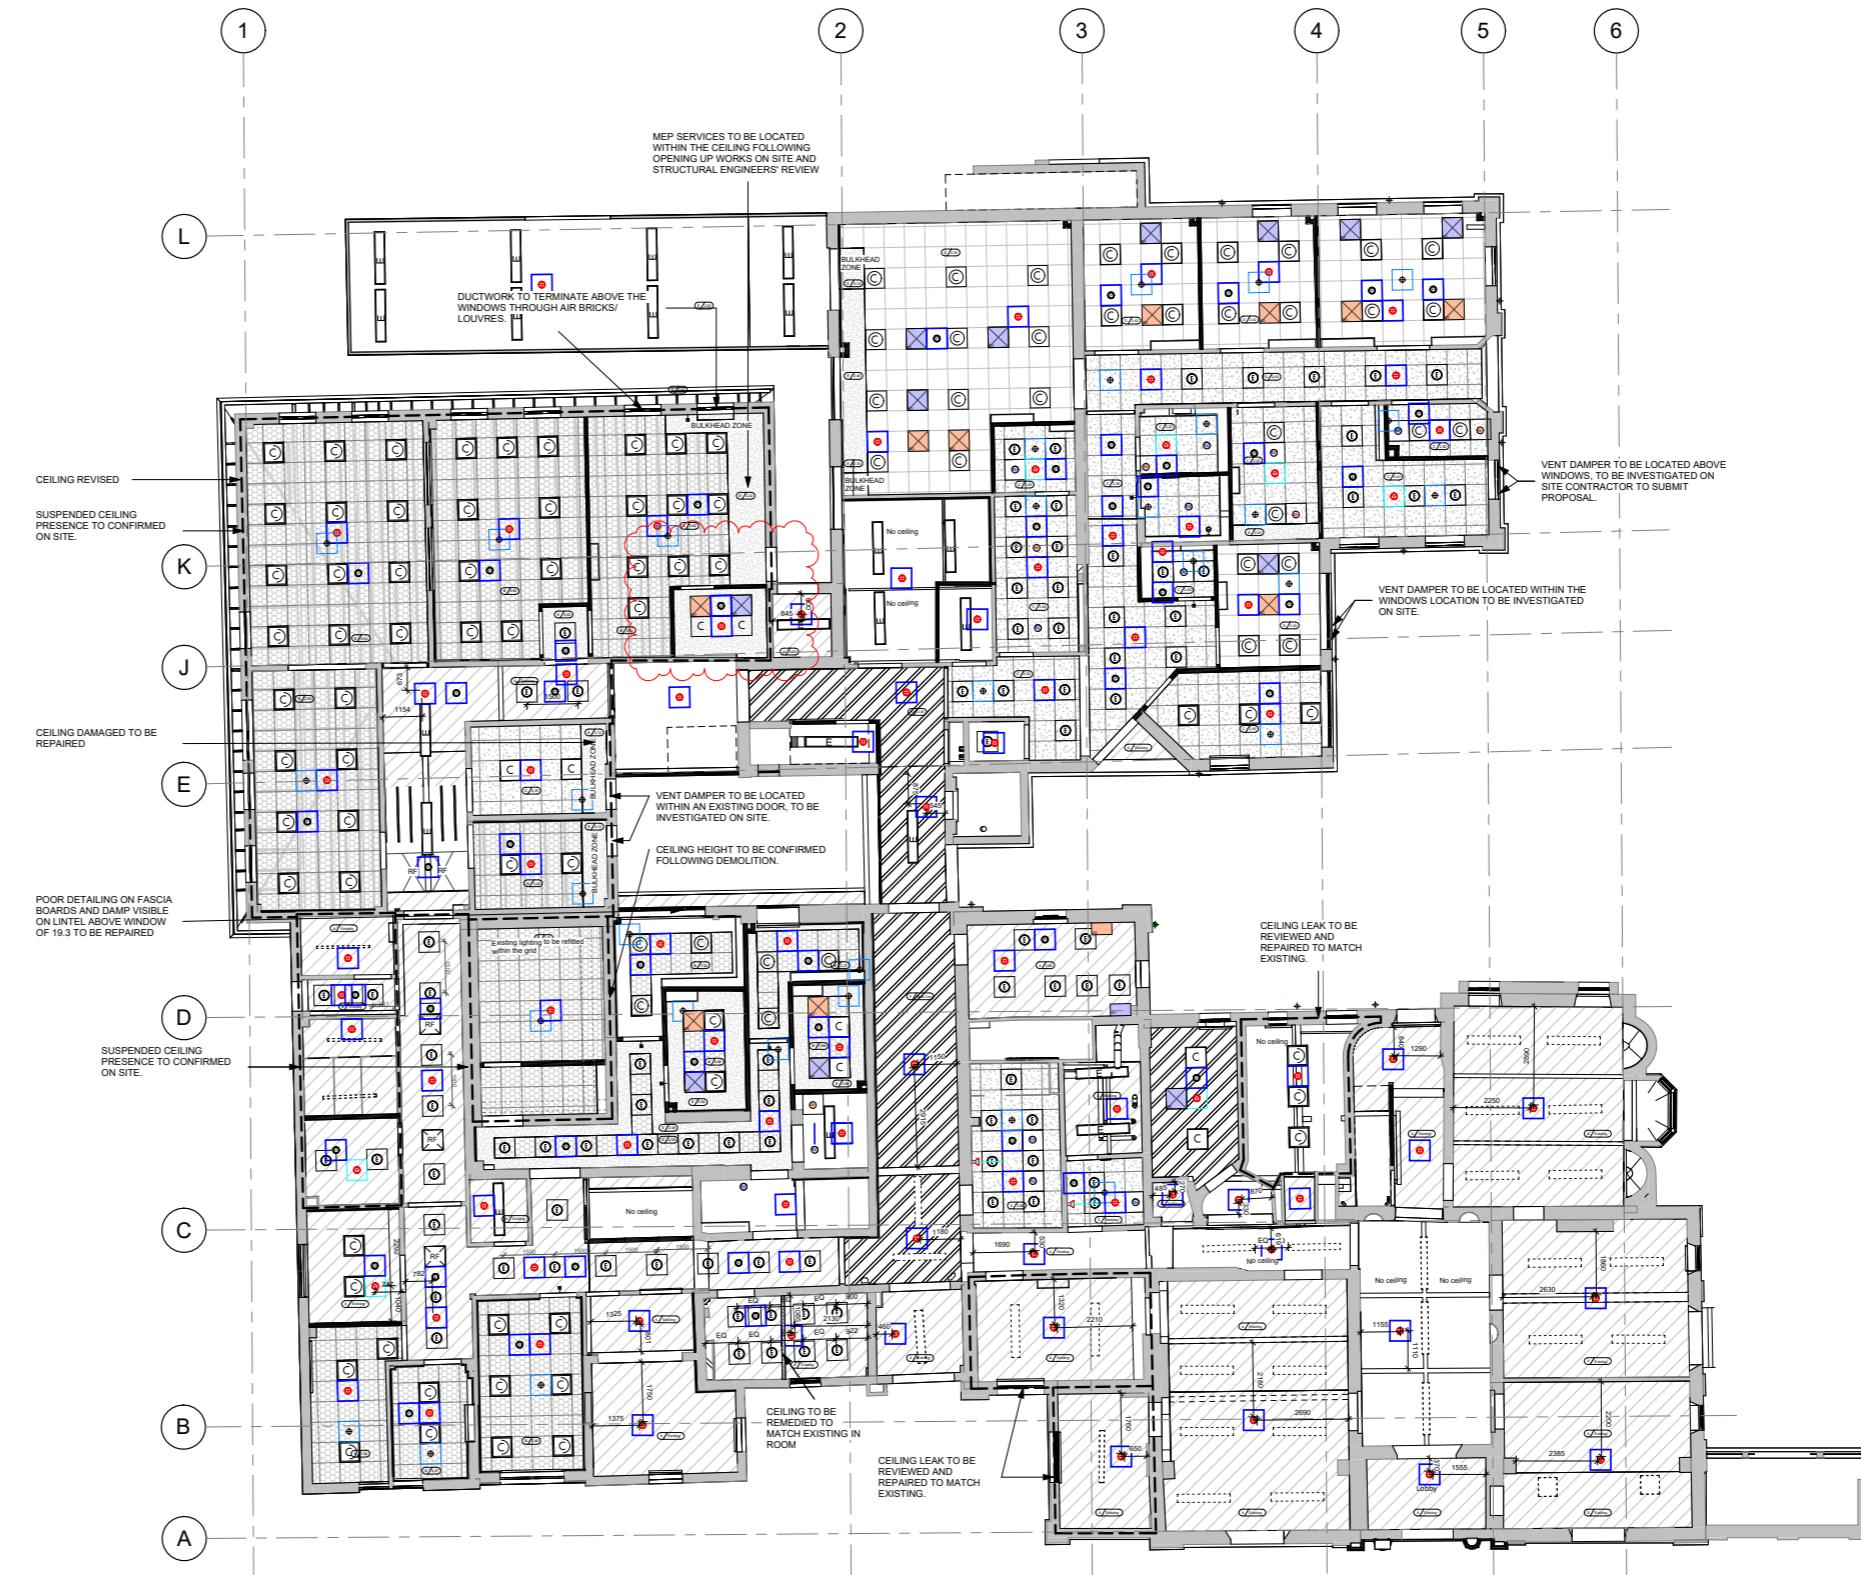
No new proposed ceilings are introduced into the original building, all existing suspended ceiling are to be removed.

Due to electrical wires and minimal interventions required, Boxing out for the routes might be required, however, none of the boxing out is to impact the existing listed features of the existing ceiling.

Furthermore, new proposed suspended ceilings to be introduced within the building, all new ceilings are highlighted with the Reflected ceiling plans with the types of ceilings to accommodate the use of the space

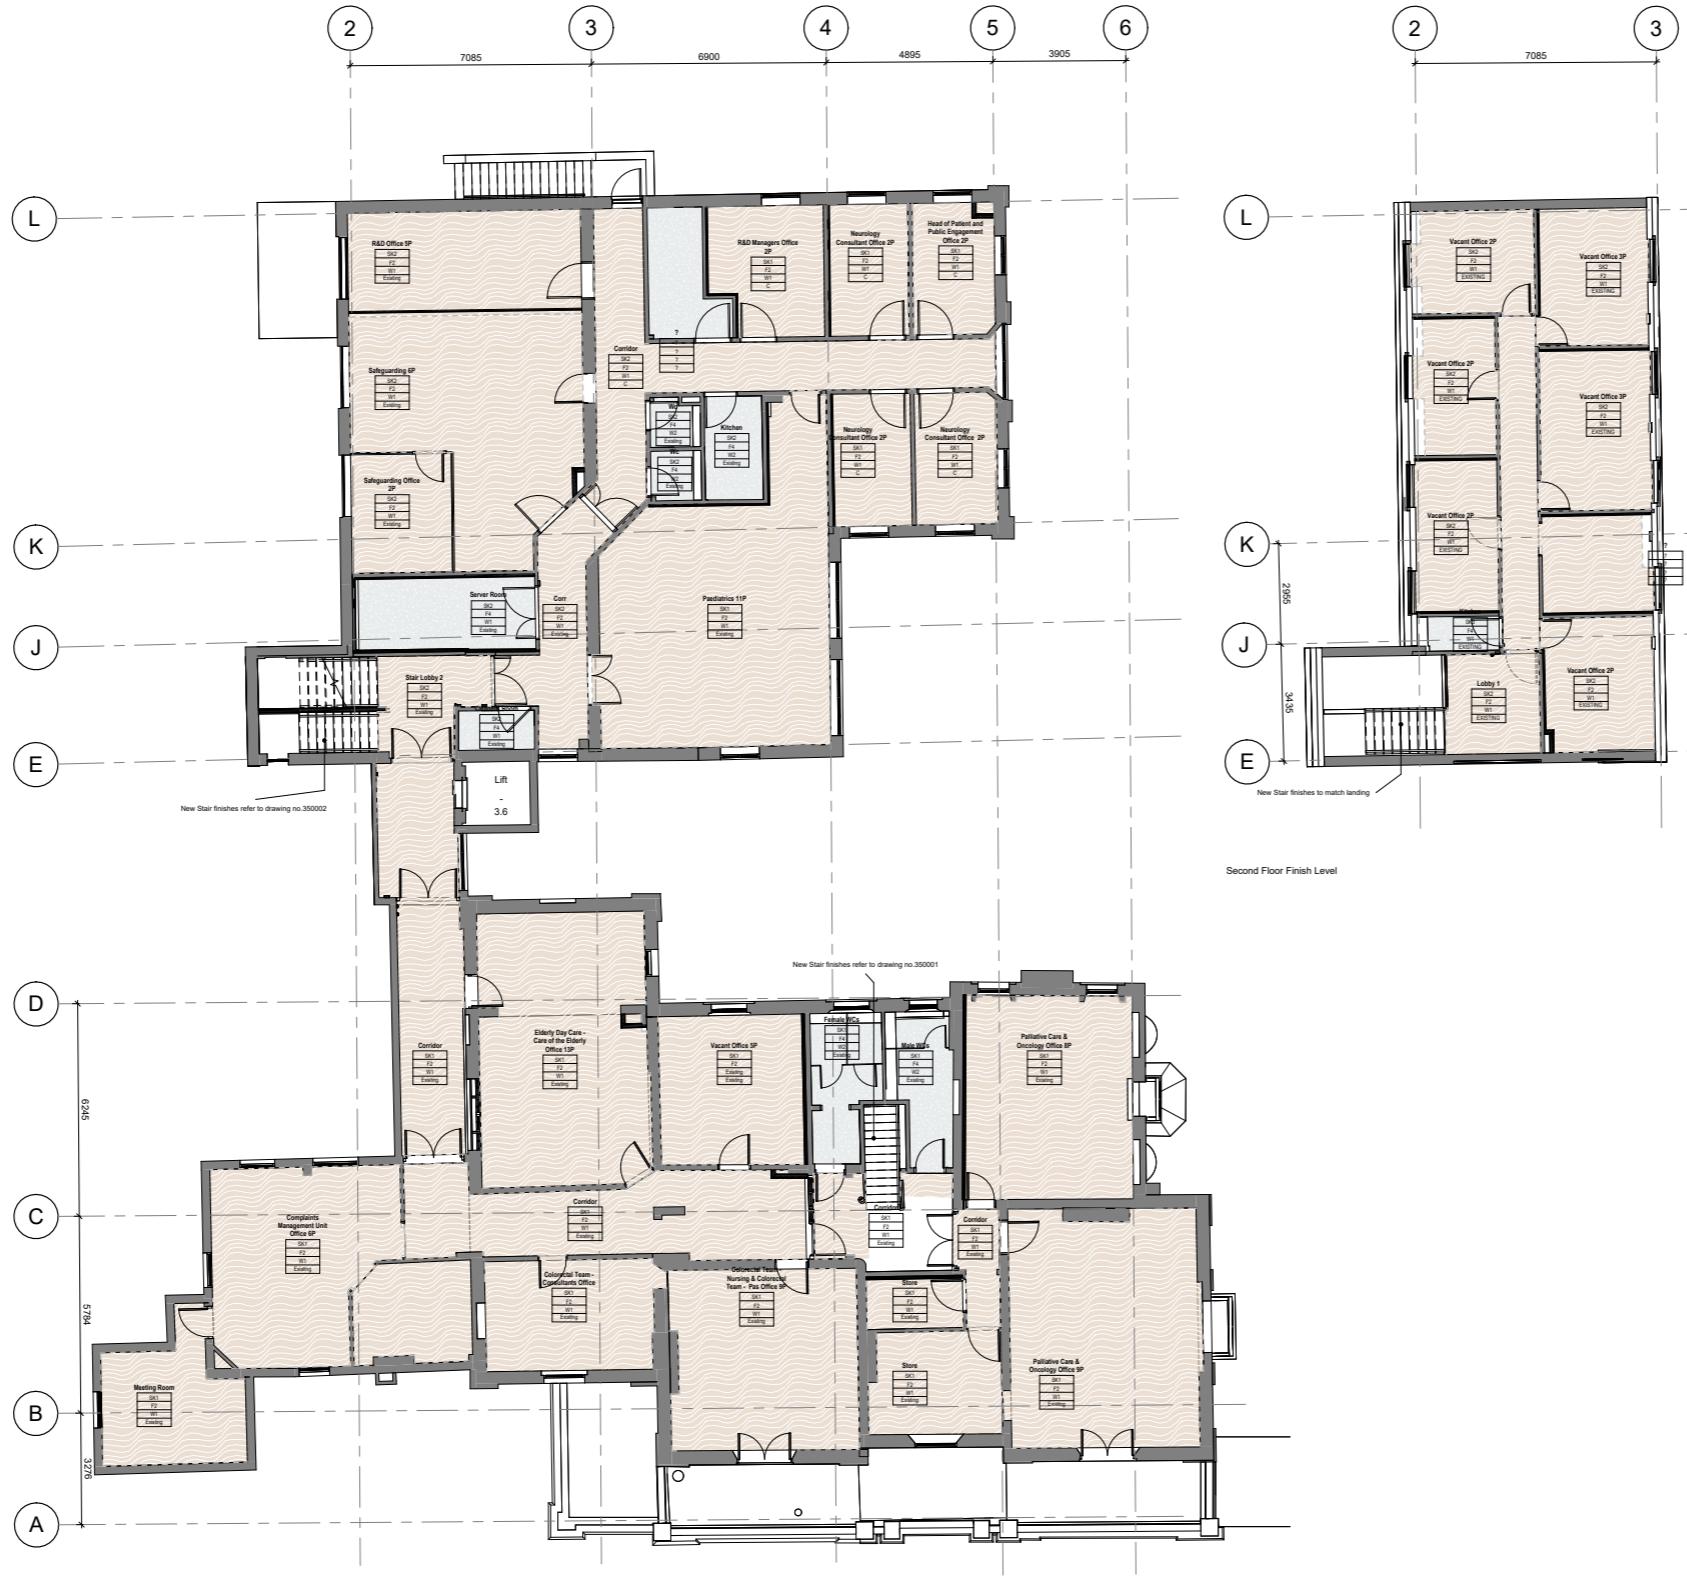
## FIRST FLOOR

## First Floor Finishes Plan

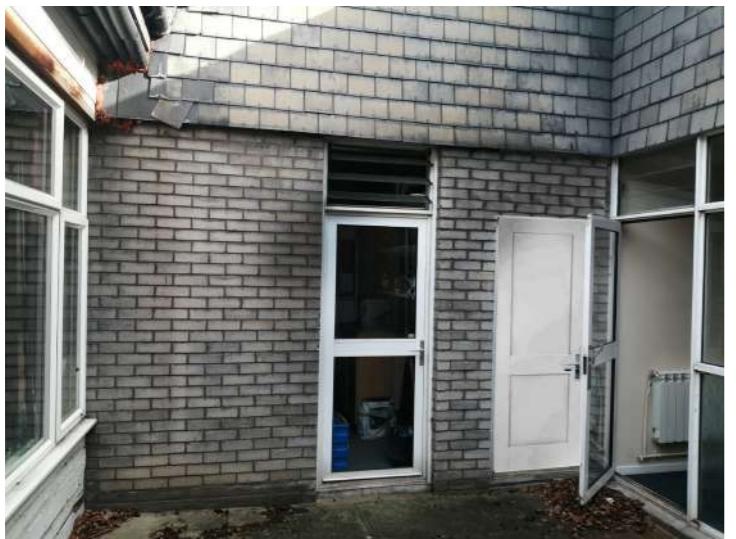
Proposed Elevation

Door ED-00-CY-02 to be replaced with a new external fire door to meet fire strategy requirements (see drawing THHFP1-LDW-ZZ-ZZ-DR-A-000213 for details).

- Door ED-00-CY-02 to be replaced with a new external fire door to meet fire strategy requirements (see drawing THHFP1-LDW-ZZ-ZZ-DR-A-000213 for details).

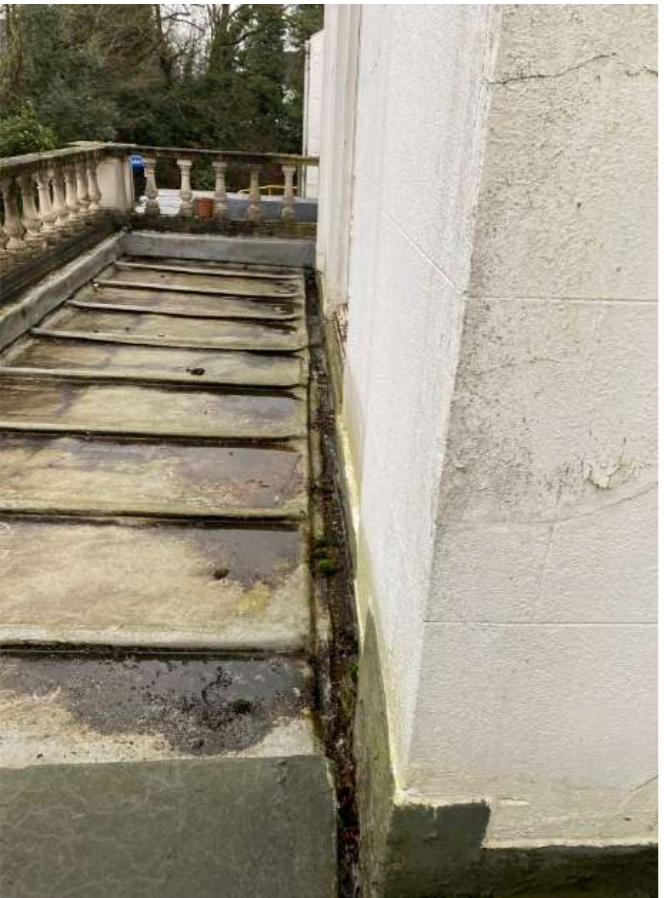
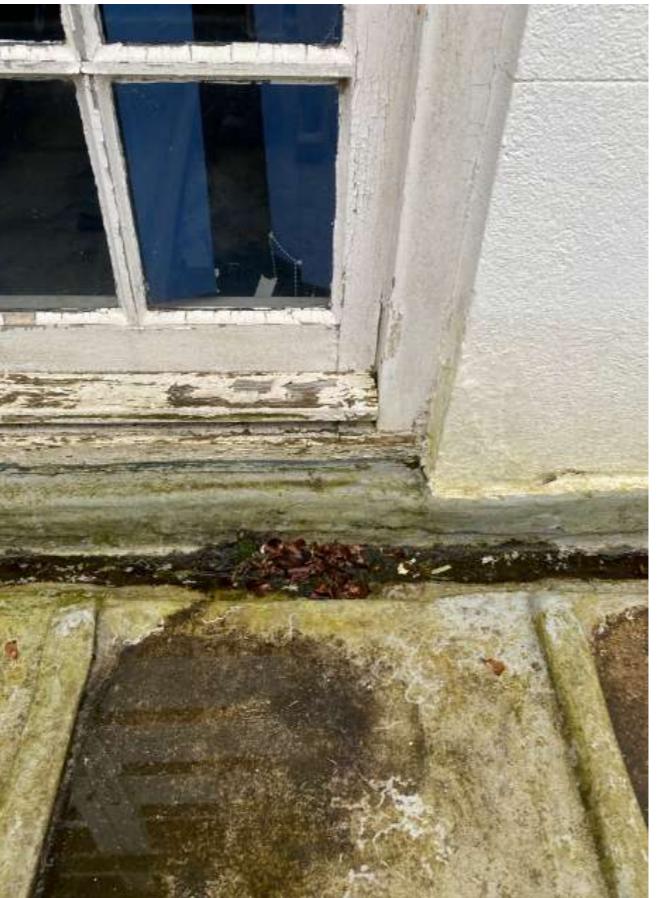
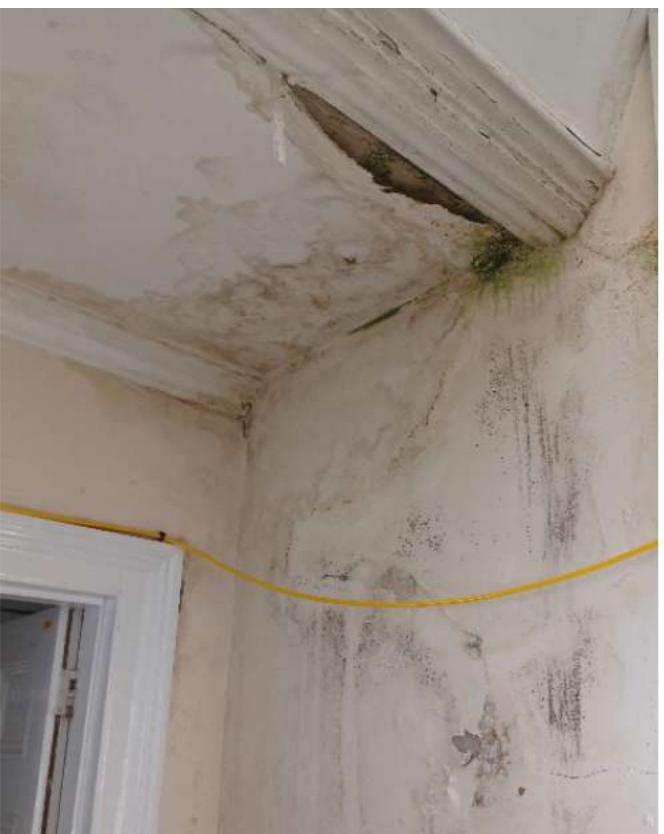
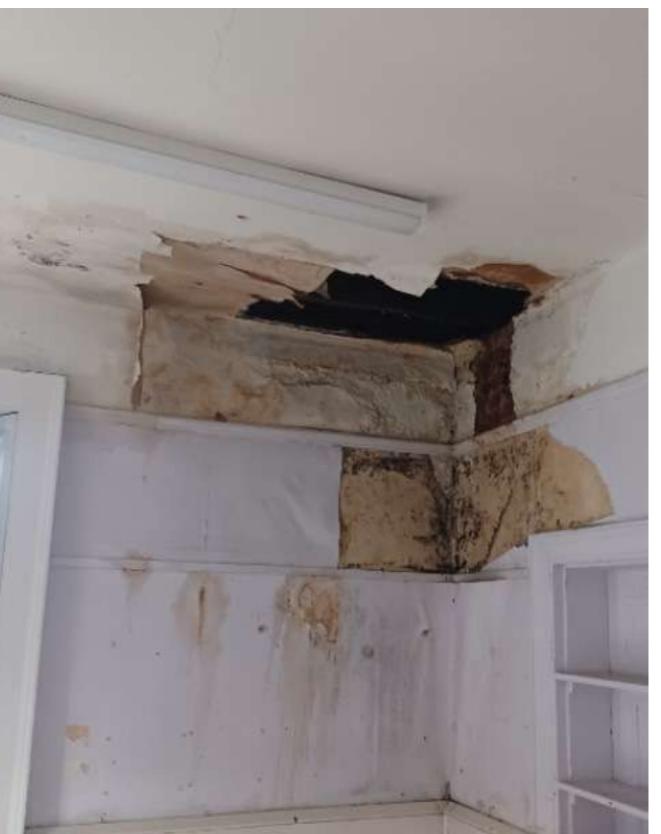
## 9.2 Roof remedial work

A survey of the building's roof identified several areas needing repair or replacement. Here's a simplified summary of the findings and recommendations:

Cracks and splits in the fiberglass-reinforced liquid membrane applied to the lead roof.  
Water infiltration due to the liquid membrane being incompatible with lead's thermal expansion.  
Recommendations:

Remove the liquid membrane to expose the original lead roof.  
Replace all flashings on the upstands to meet current building standards.  
Replace and seal mortar and lead joints for a watertight finish.  
Clean the gully, inspect for damage, and replace any defective parts.

Repairs to slates, parapets, and chimneys show signs of deterioration.  
Water ingress, particularly in Room 40.0, caused by the failure of a liquid membrane applied to the slates and upstands.  
Recommendations:

Clean the lower section of the roof to check for coating or debris.  
Remove any coating to restore the original lead surface.  
Flashing and Sealant Replacement:

Replace all flashings to meet modern standards.  
Seal and secure all mortar and lead joints to prevent leaks.

- Strip back the liquid applied membrane to the lead roof and upstands, restoring them to the original lead finish. Remove all flashing details into the upstands and replace with new, ensuring compliance with current building standards for upstand/threshold allowances. All mortar and lead sealant will be replaced and chased to provide a watertight seal between the parapet mortar and the lead roof.
- Any areas beyond repair will be replaced with new materials.

- All pitched roofs: Strip the perimeter of the slate roof back to the original substrate and treat with a compatible waterproof membrane, following Listed Building Consent. The upstands around the perimeter will also be

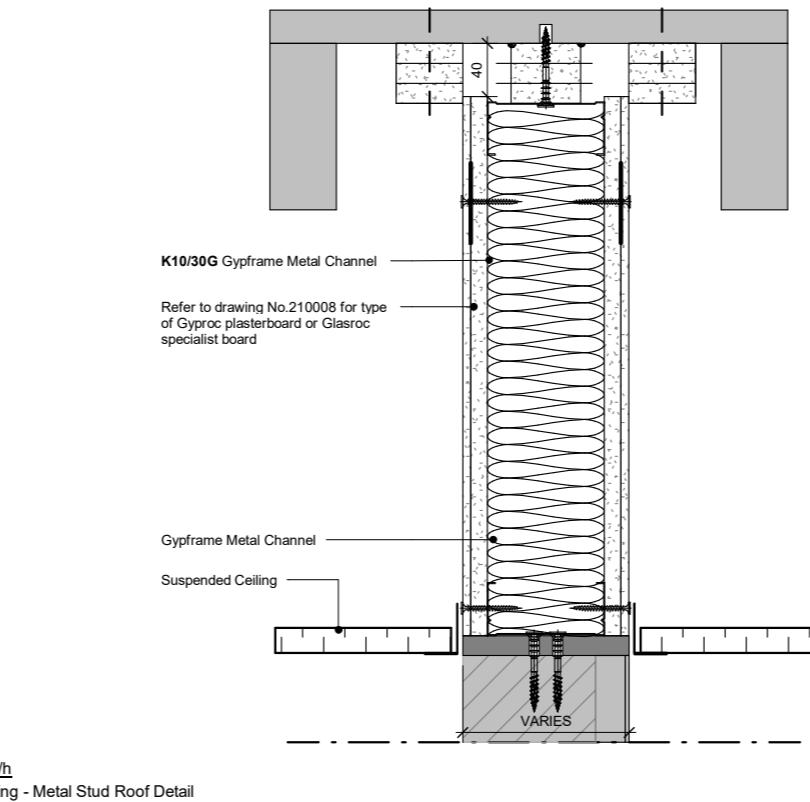
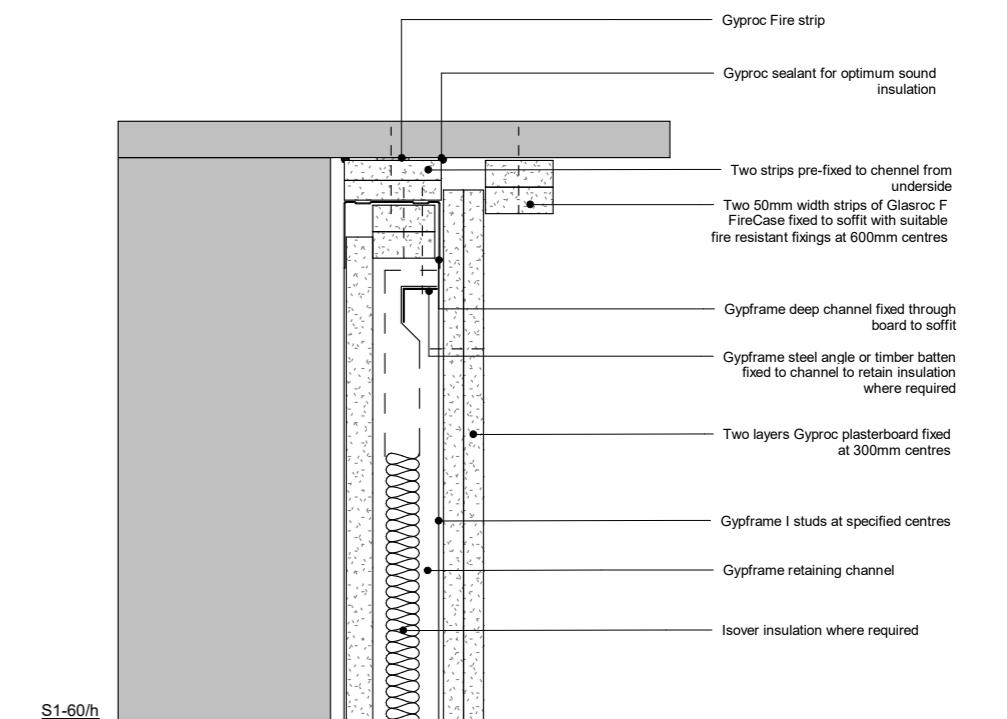
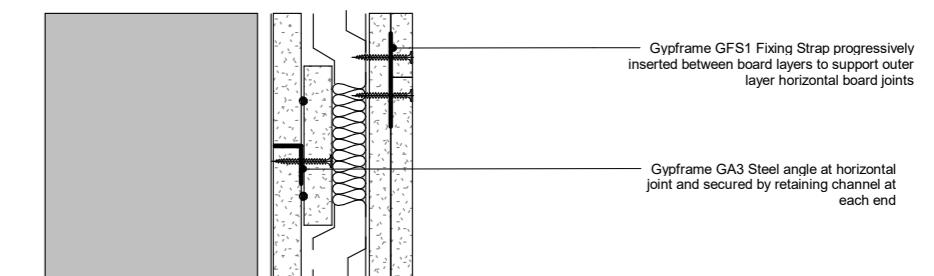
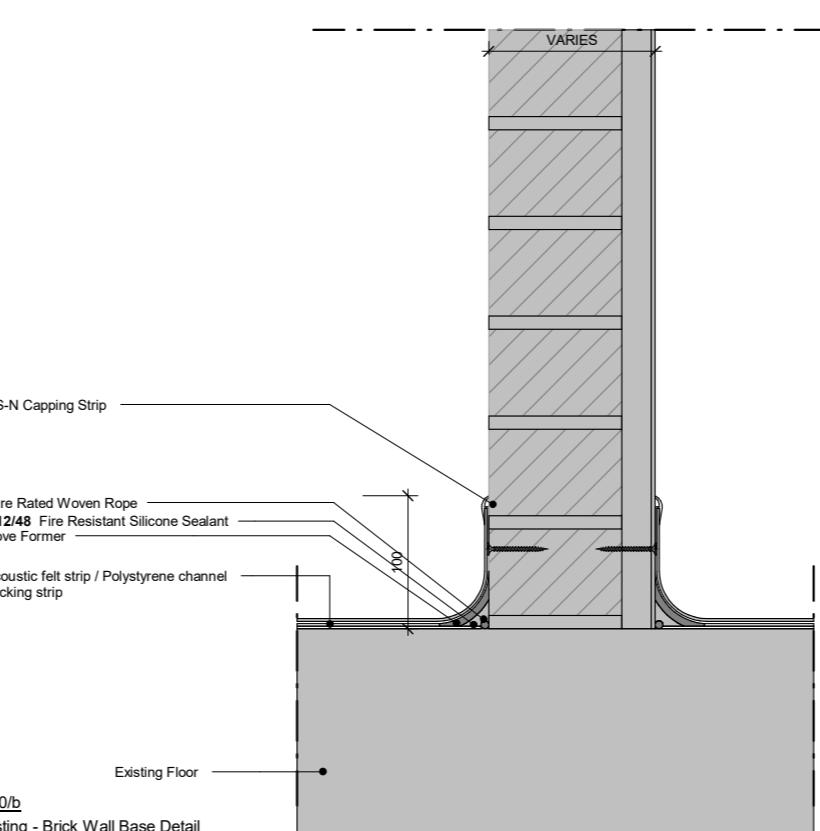
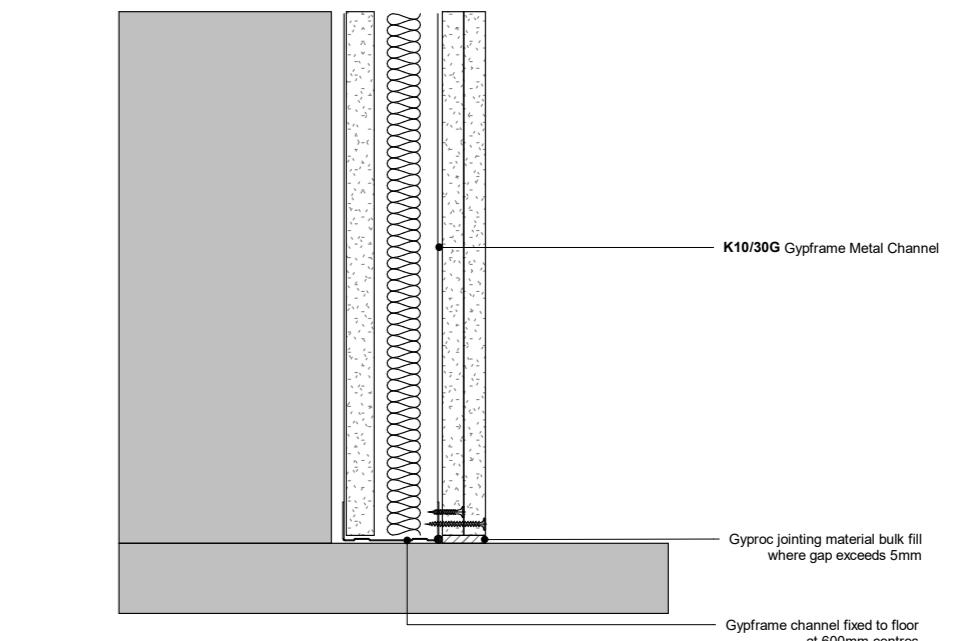
# 9.3 Fire Integrity Strategy

Installing a Fire-Rated Shaft Wall Partition

This solution involves positioning a fire-rated shaft wall partition approximately 50mm away from the existing wall. This method ensures compliance with fire compartmentation requirements while minimising the impact on the building's historic features.

Repairing Existing Walls

In certain cases, repairing the existing walls was deemed sufficient. This approach includes applying fire-stopping measures and fixing dry lining to the existing walls, extending to the underside of the roof or slab to maintain compliance.

### CAVITY VARIES ON SITE

- Shaft wall added to Stair Core 1 for fire compartmentation.
- Shaft walls added to Rooms 28, 25, 29, and between Corridors 2 and 3.
- 120-minute raiser wall added.
- Ceiling repairs in Room 17 and Corridor 2.
- Replacement of Sill from Stone Sill to Timber Sills

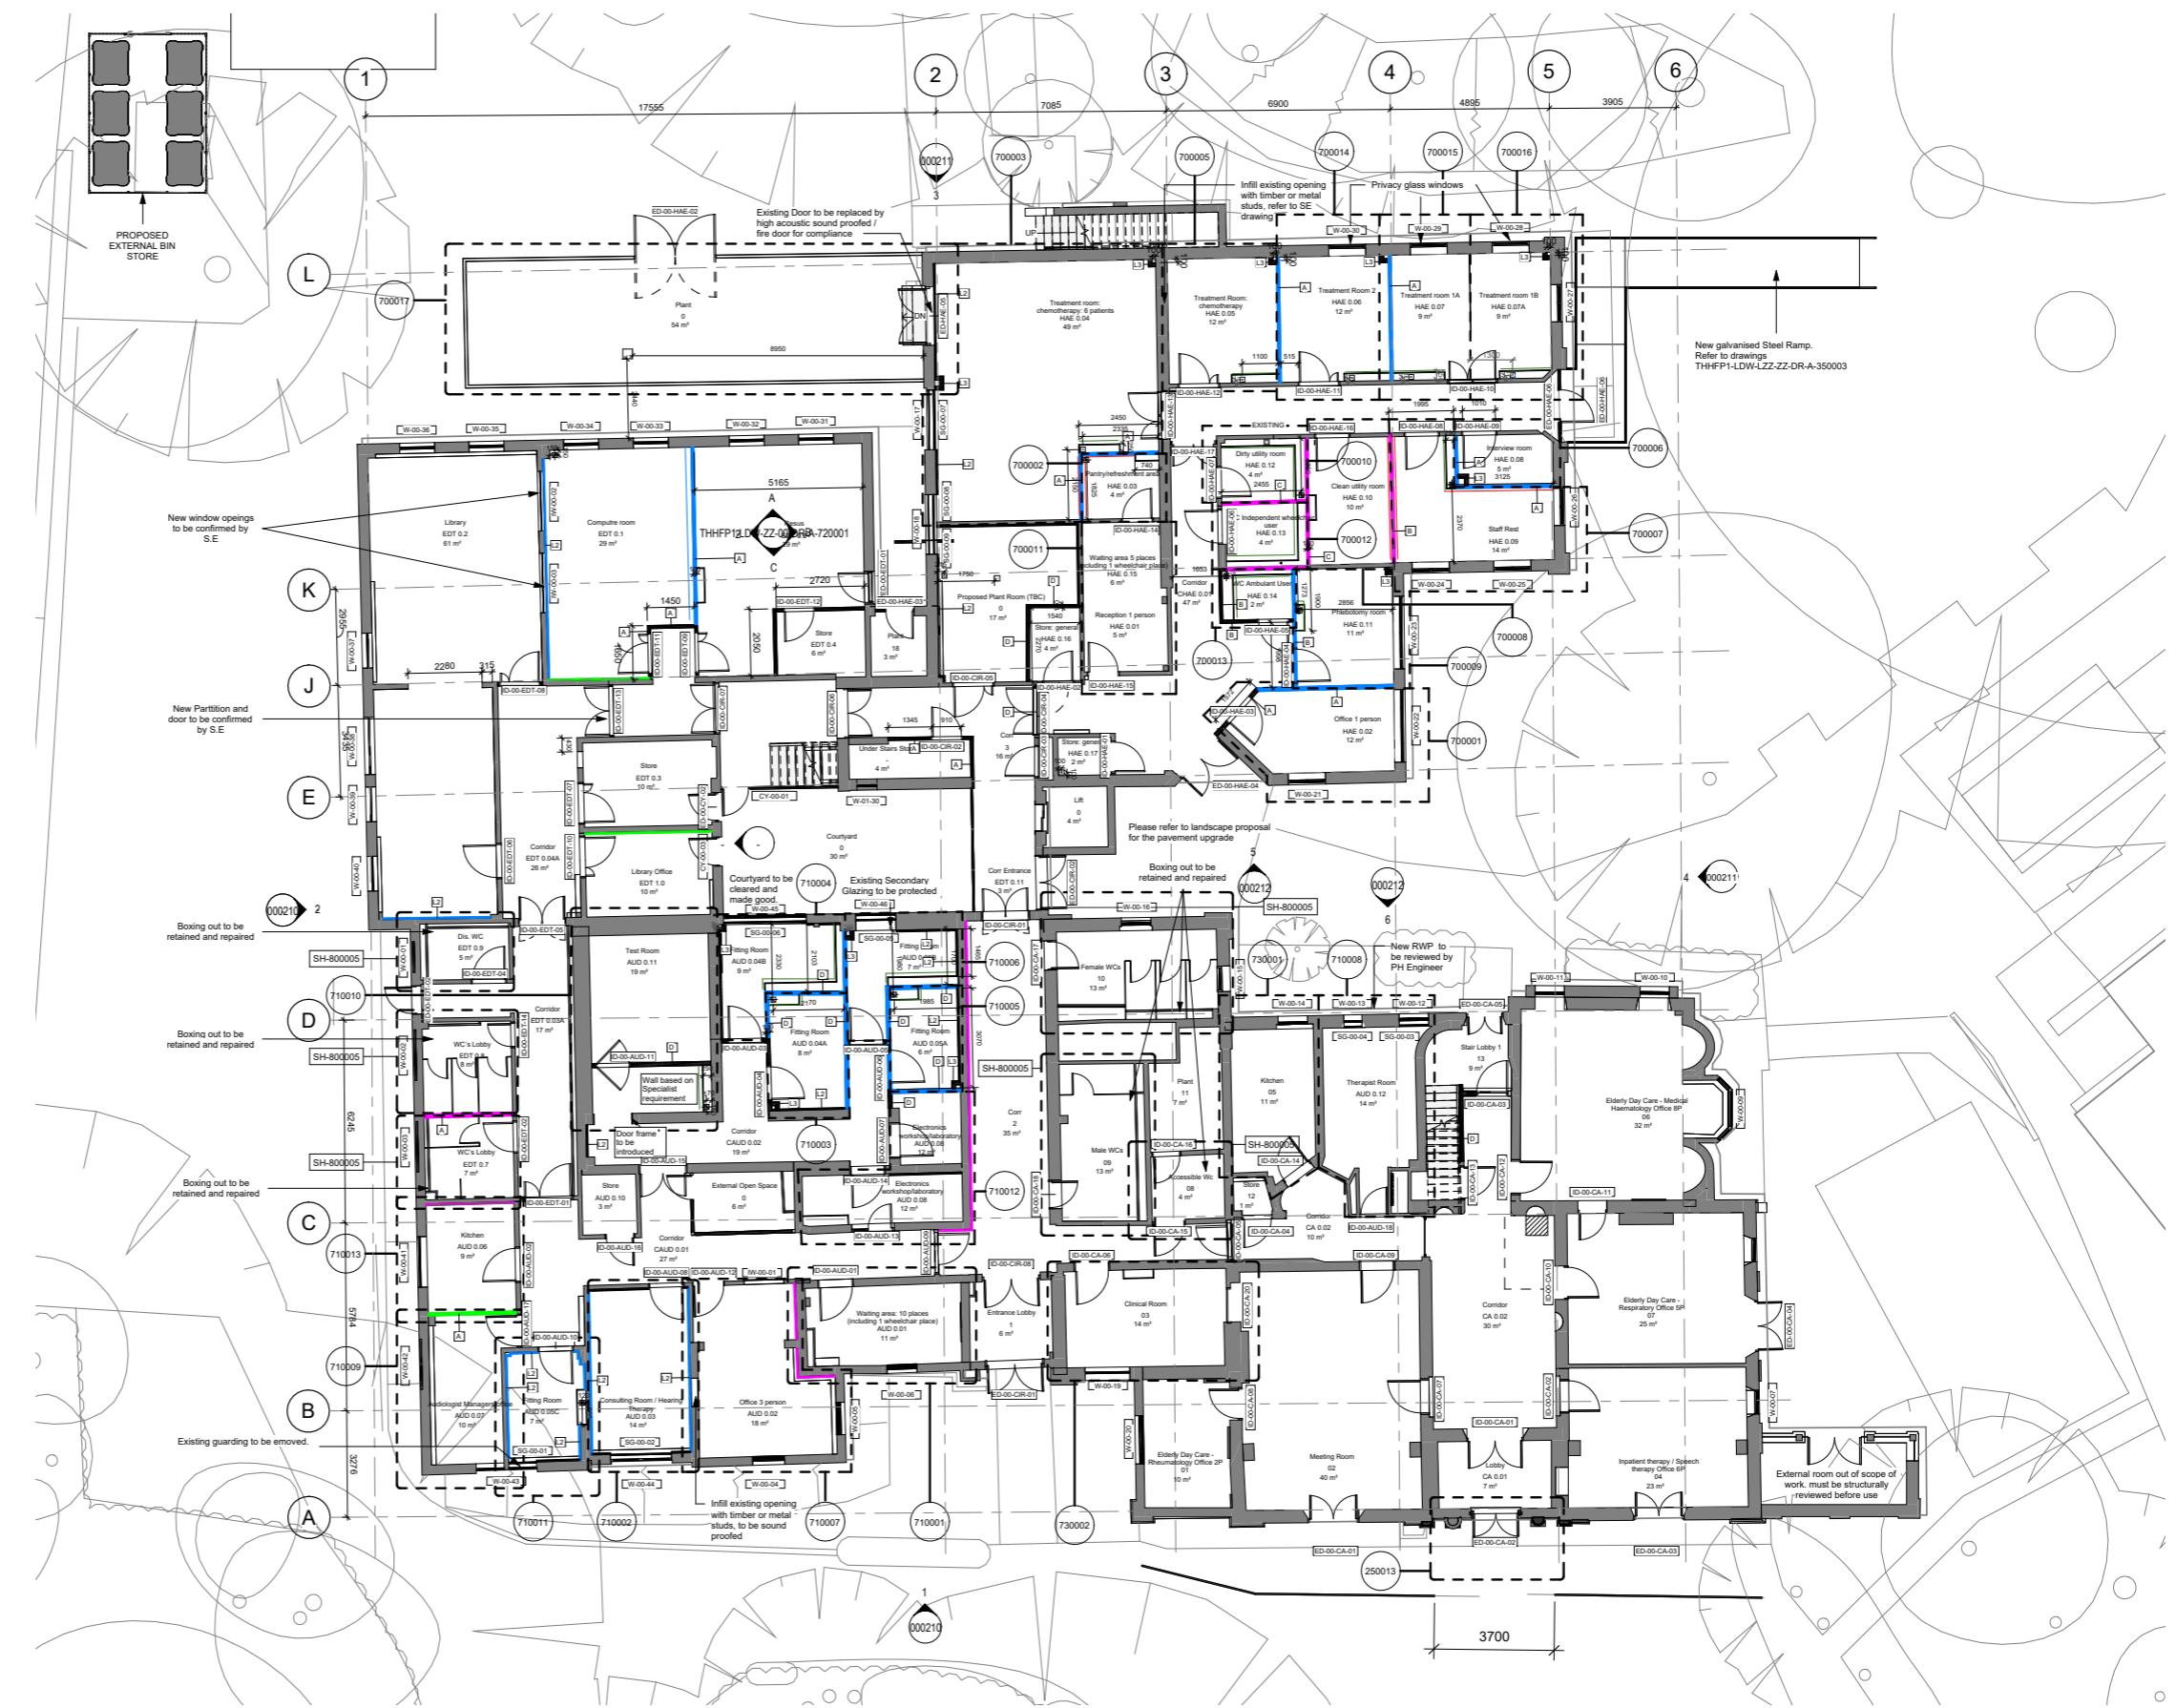
# 9.4 Acoustic Strategy

To meet the BREEAM requirements for achieving a "Very Good" rating, the building's acoustic performance needs to be upgraded. Following a comprehensive survey by Acoustic Engineers, the areas with the lowest acoustic ratings were identified, and modifications were made accordingly. The original structure of the building remains unaffected by these upgrades; however, the extension involved additional lining and the demolition of a few walls to comply with the acoustic recommendations

- Fire lining added to all compartmented rooms to comply with the fire strategy.
- Acoustic lining added to rooms requiring acoustic ratings, in accordance with the acoustic report and HTM-08-0.

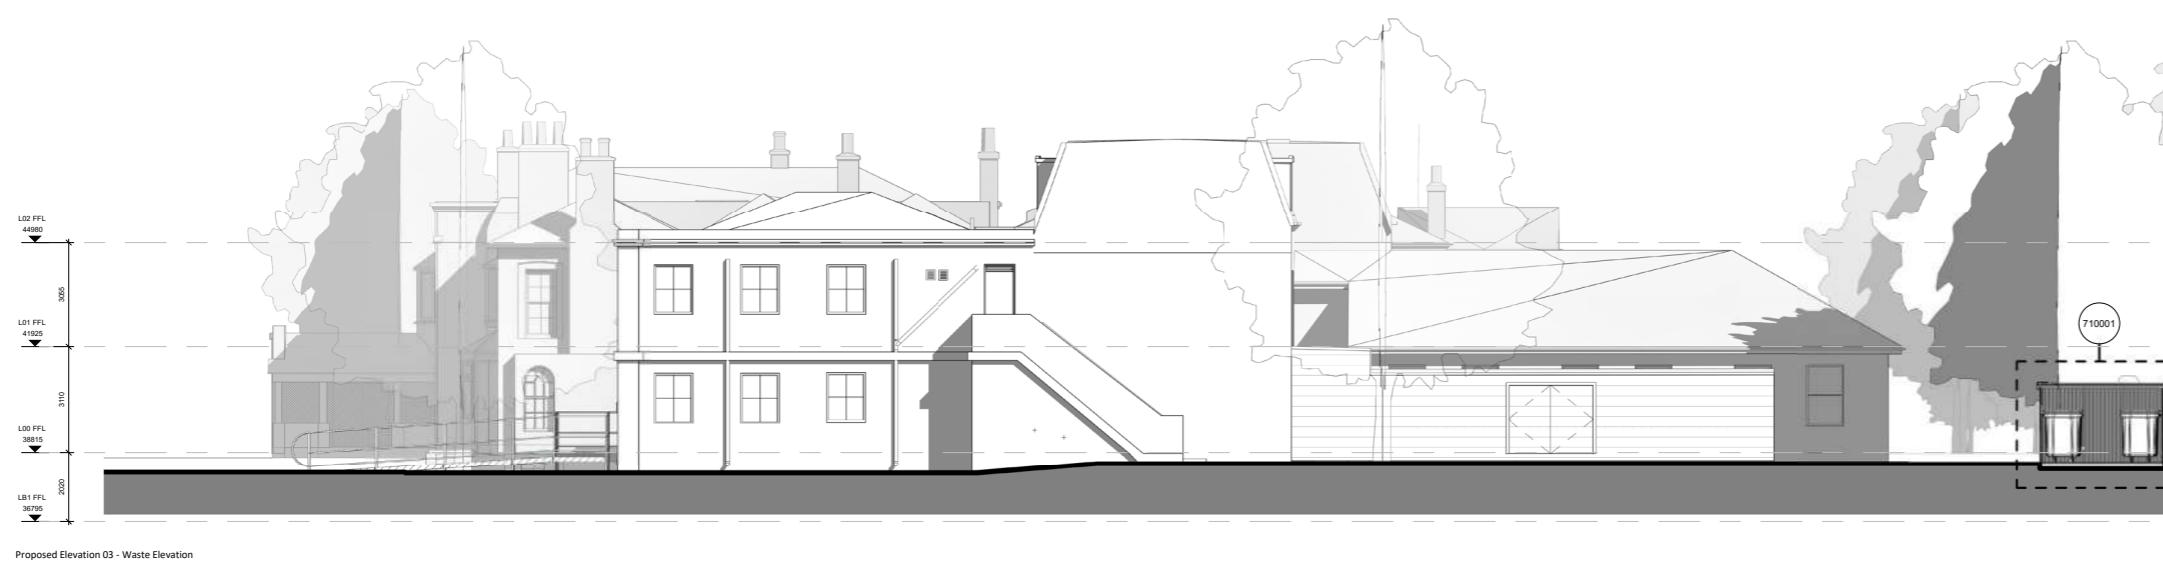
## 10.2 External Waste Hold

The new external bin store has been proposed to safeguard the internal layout of the listed building. To minimize disruption, the existing location had the current bin store has been repurposed; enlarging its dimensions to adhere to HTMs and client requirements. This involved establishing a clear access route between the collection point and waste disposal area, thereby preserving the site's overall arrangement. In addition to this, the lighting along the path leading to the bin store has been carefully designed to illuminate in dark hours while being sensitive to the local bat population.

The pathway will be built using permeable material paving, which will minimize any disturbance to the tree roots in the vicinity. This deliberate choice reflects our commitment to both contemporary functionality and the preservation of Furze's historical and environmental significance.

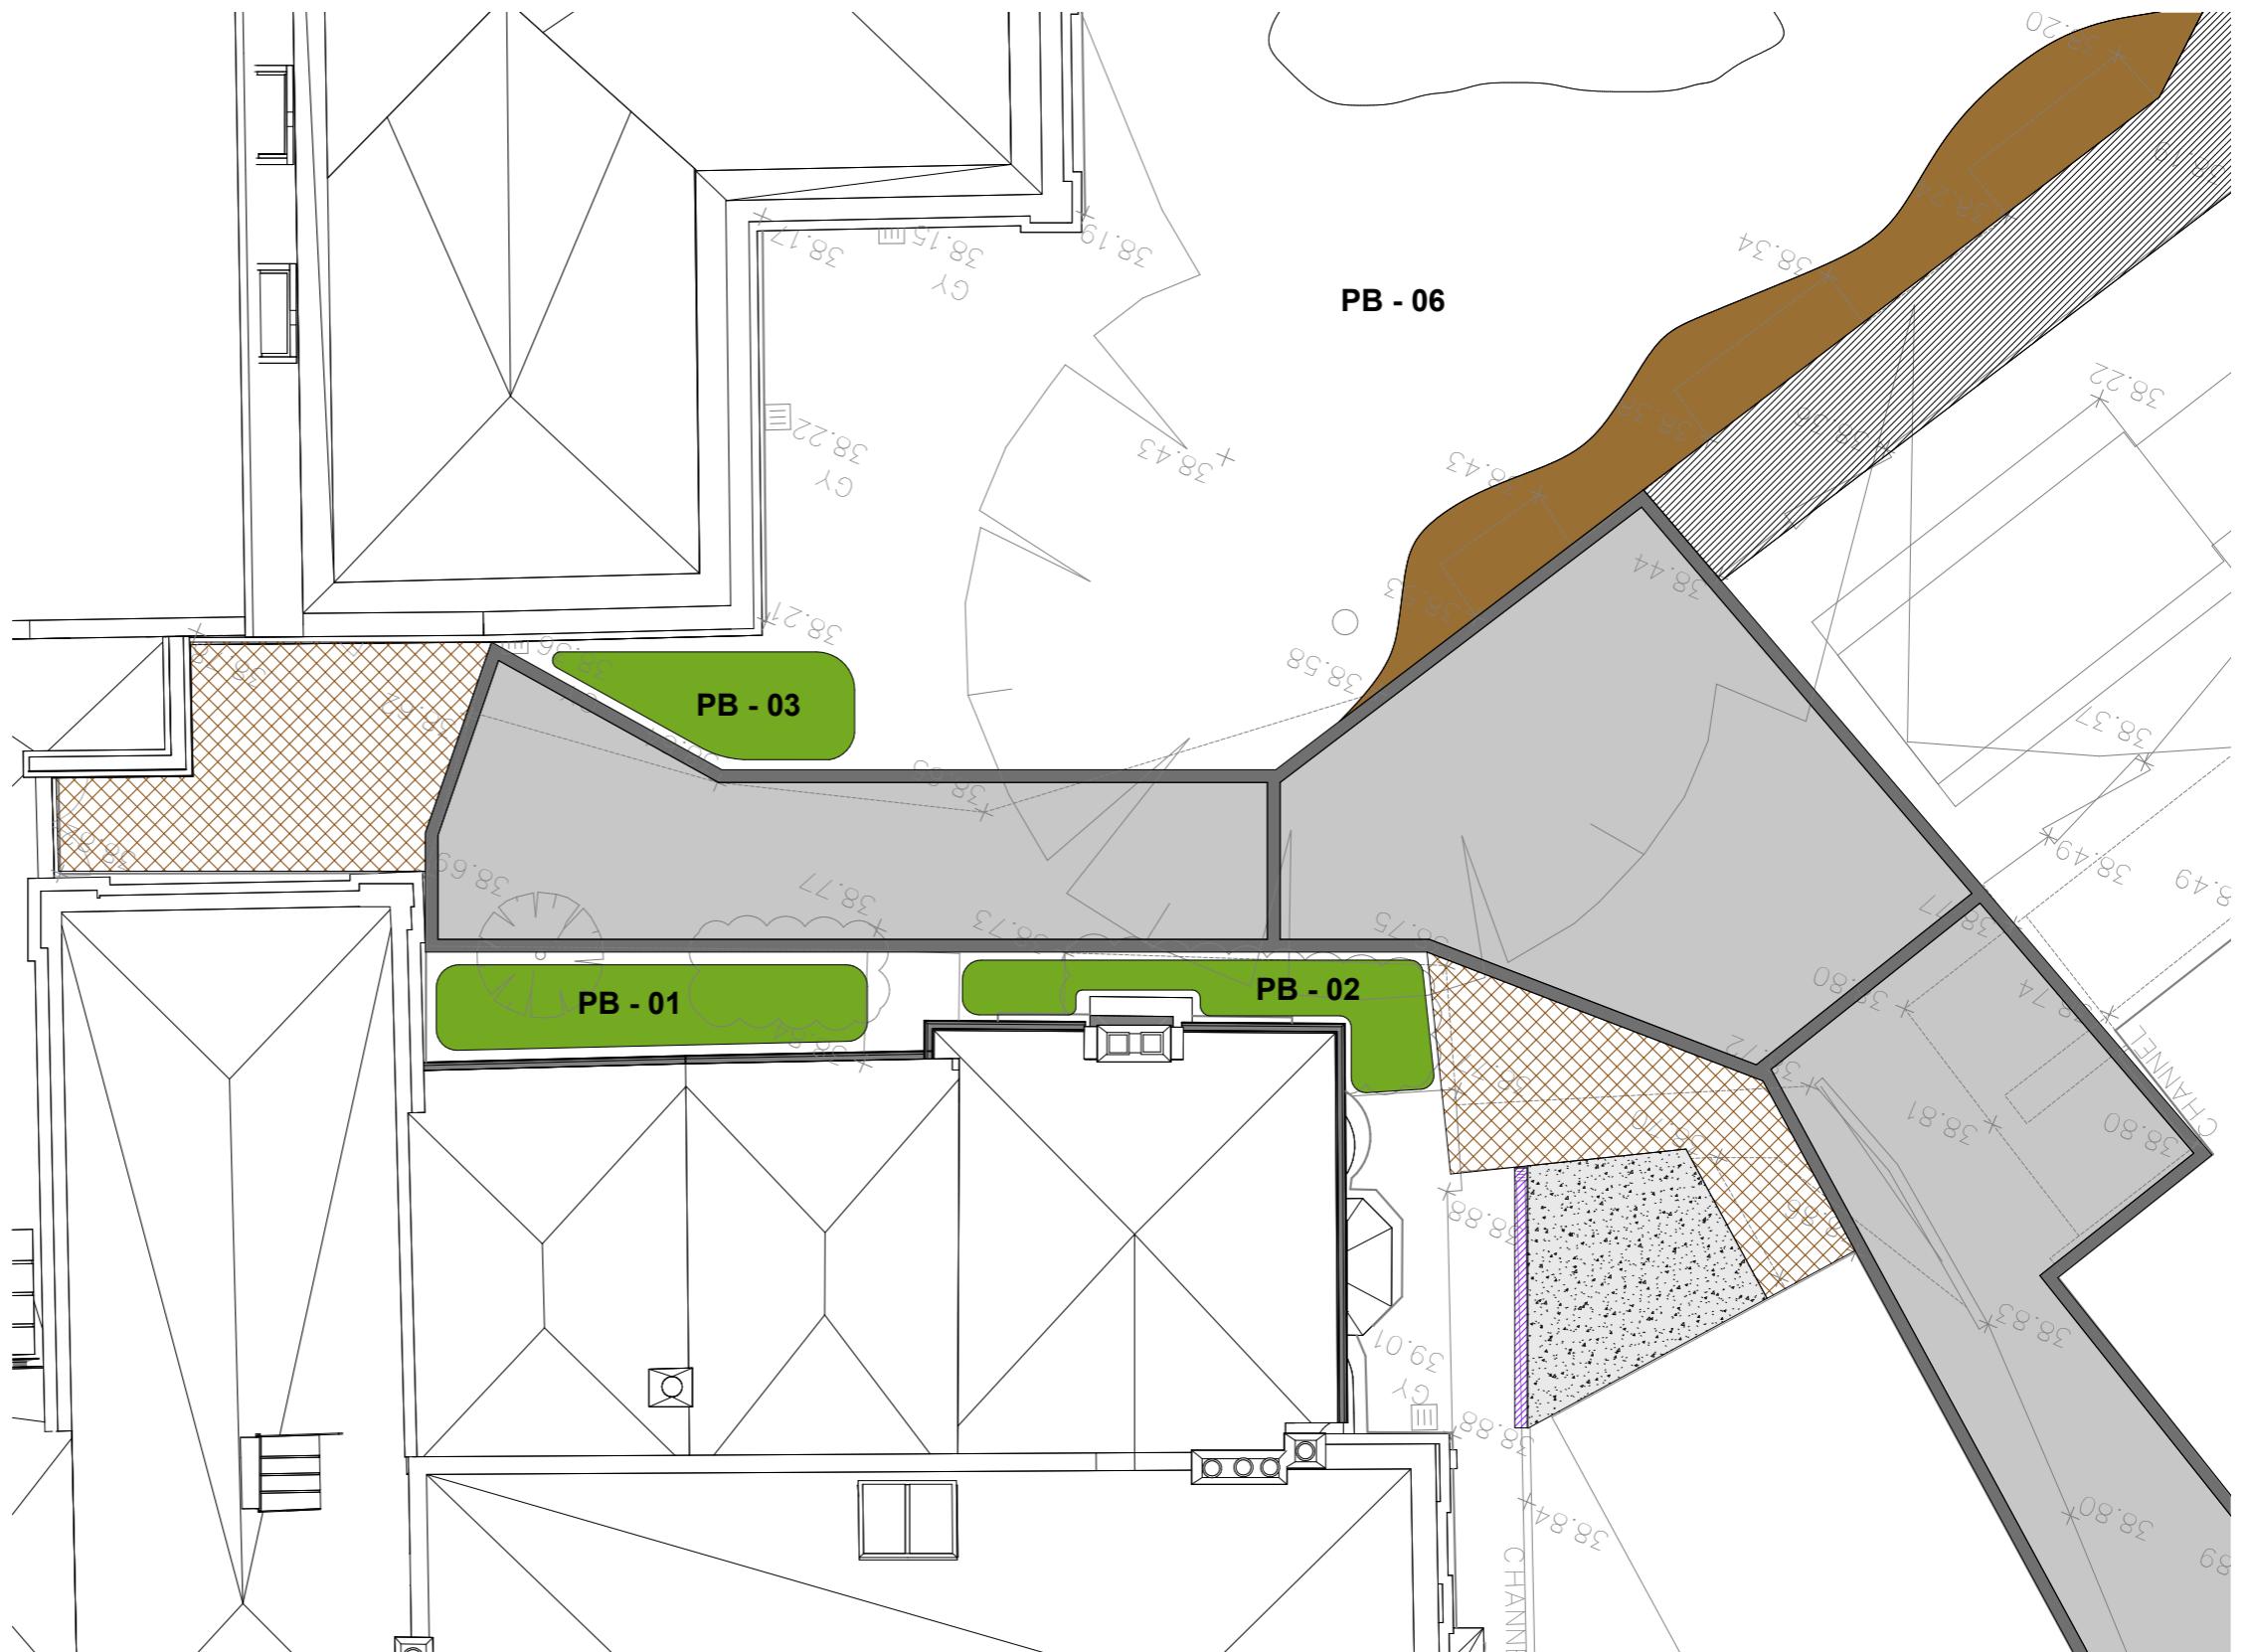
## Demolition

There are many incongruous features in the existing landscape that will be permanently removed. These include kerbs, fixed bollards, and removable bollards. Additionally, there are existing signs which will be temporarily removed, and set aside for probable re-installation.
