# 8.0 Reflected Ceiling Plan - Ground Floor

# 9.0 Design Amendments

# 9.1 New Replacements

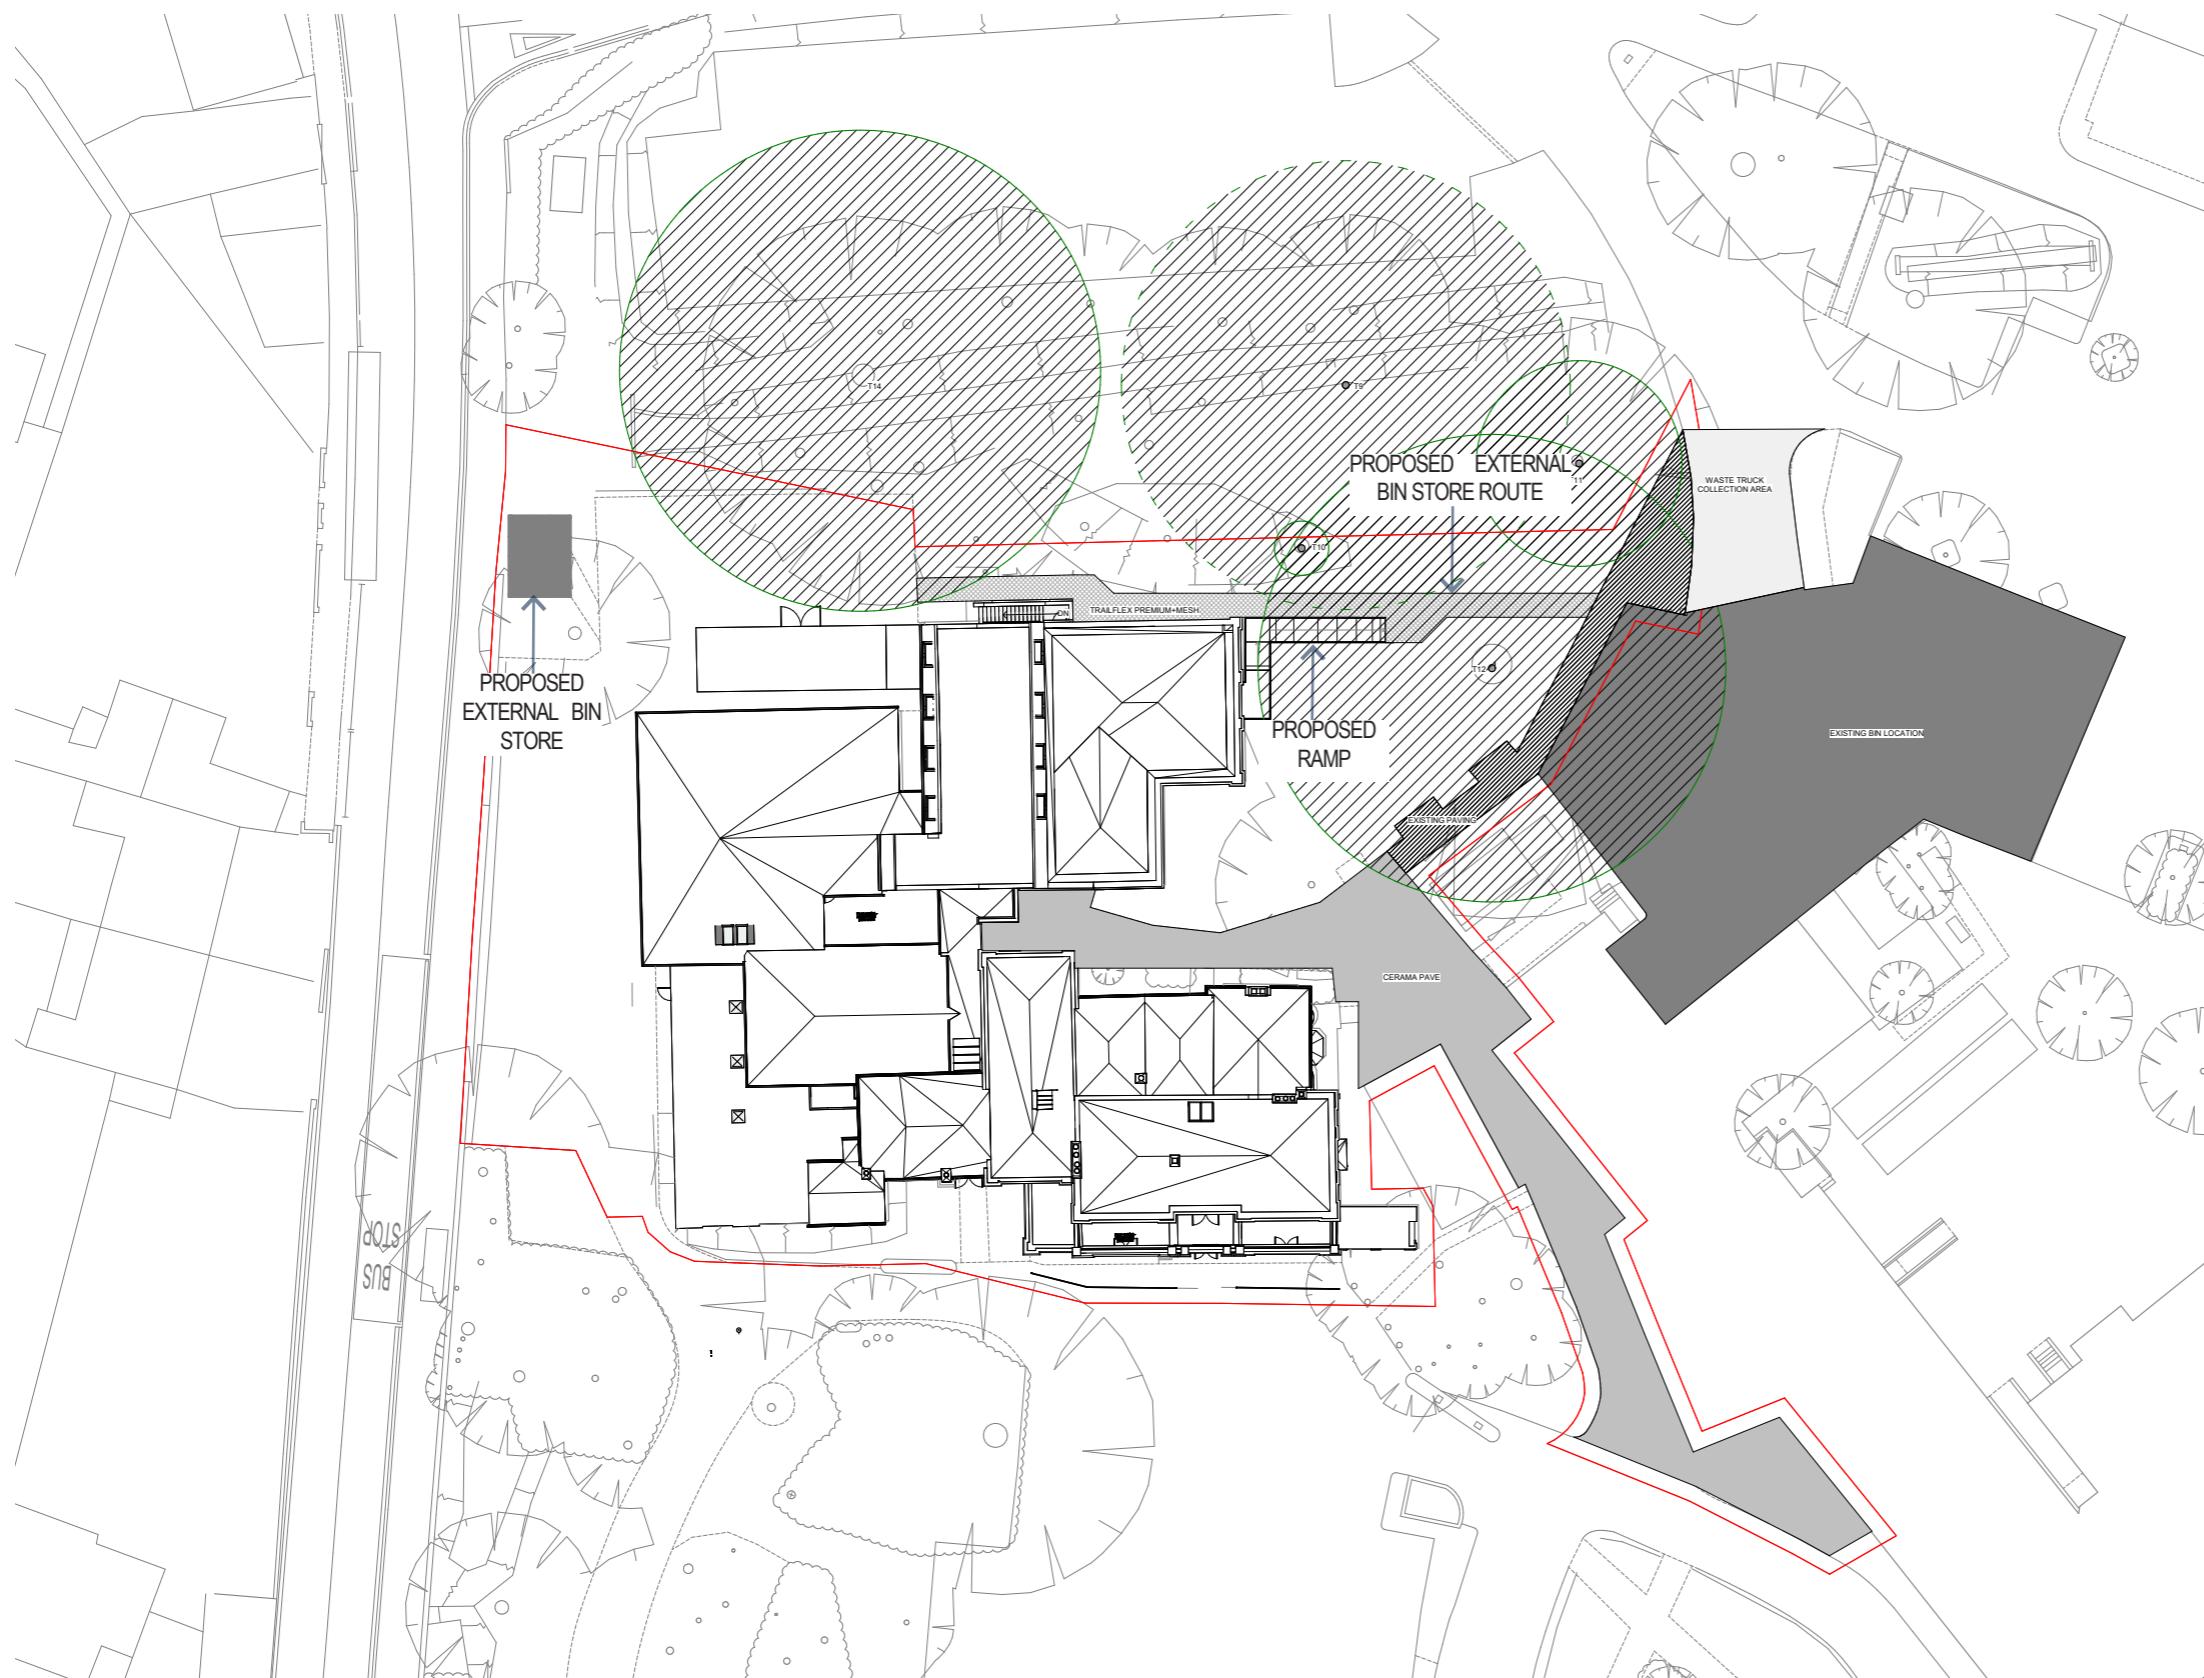
# 10.4 External Landscape

There are very limited areas for planting within the site's area. As part of the removal of the turning head, a new planting opportunity has arisen with all our limited new native shrubs and ground cover to be planted (PB-04). Existing planting areas at the entrances to the force will need to be replanted due to the need to remove plants for all-way access for building repair works. A total of 3 small areas for planting have been identified near the entrances (PB01 to PB03). Additionally, it is proposed to plant a small area of the lawn with flowering bulbs (PB-05) and to overseed most of the lawn with native wildflowers (PB-06). This will, in time, provide some visual delight for users, as well as contributing to biodiversity.

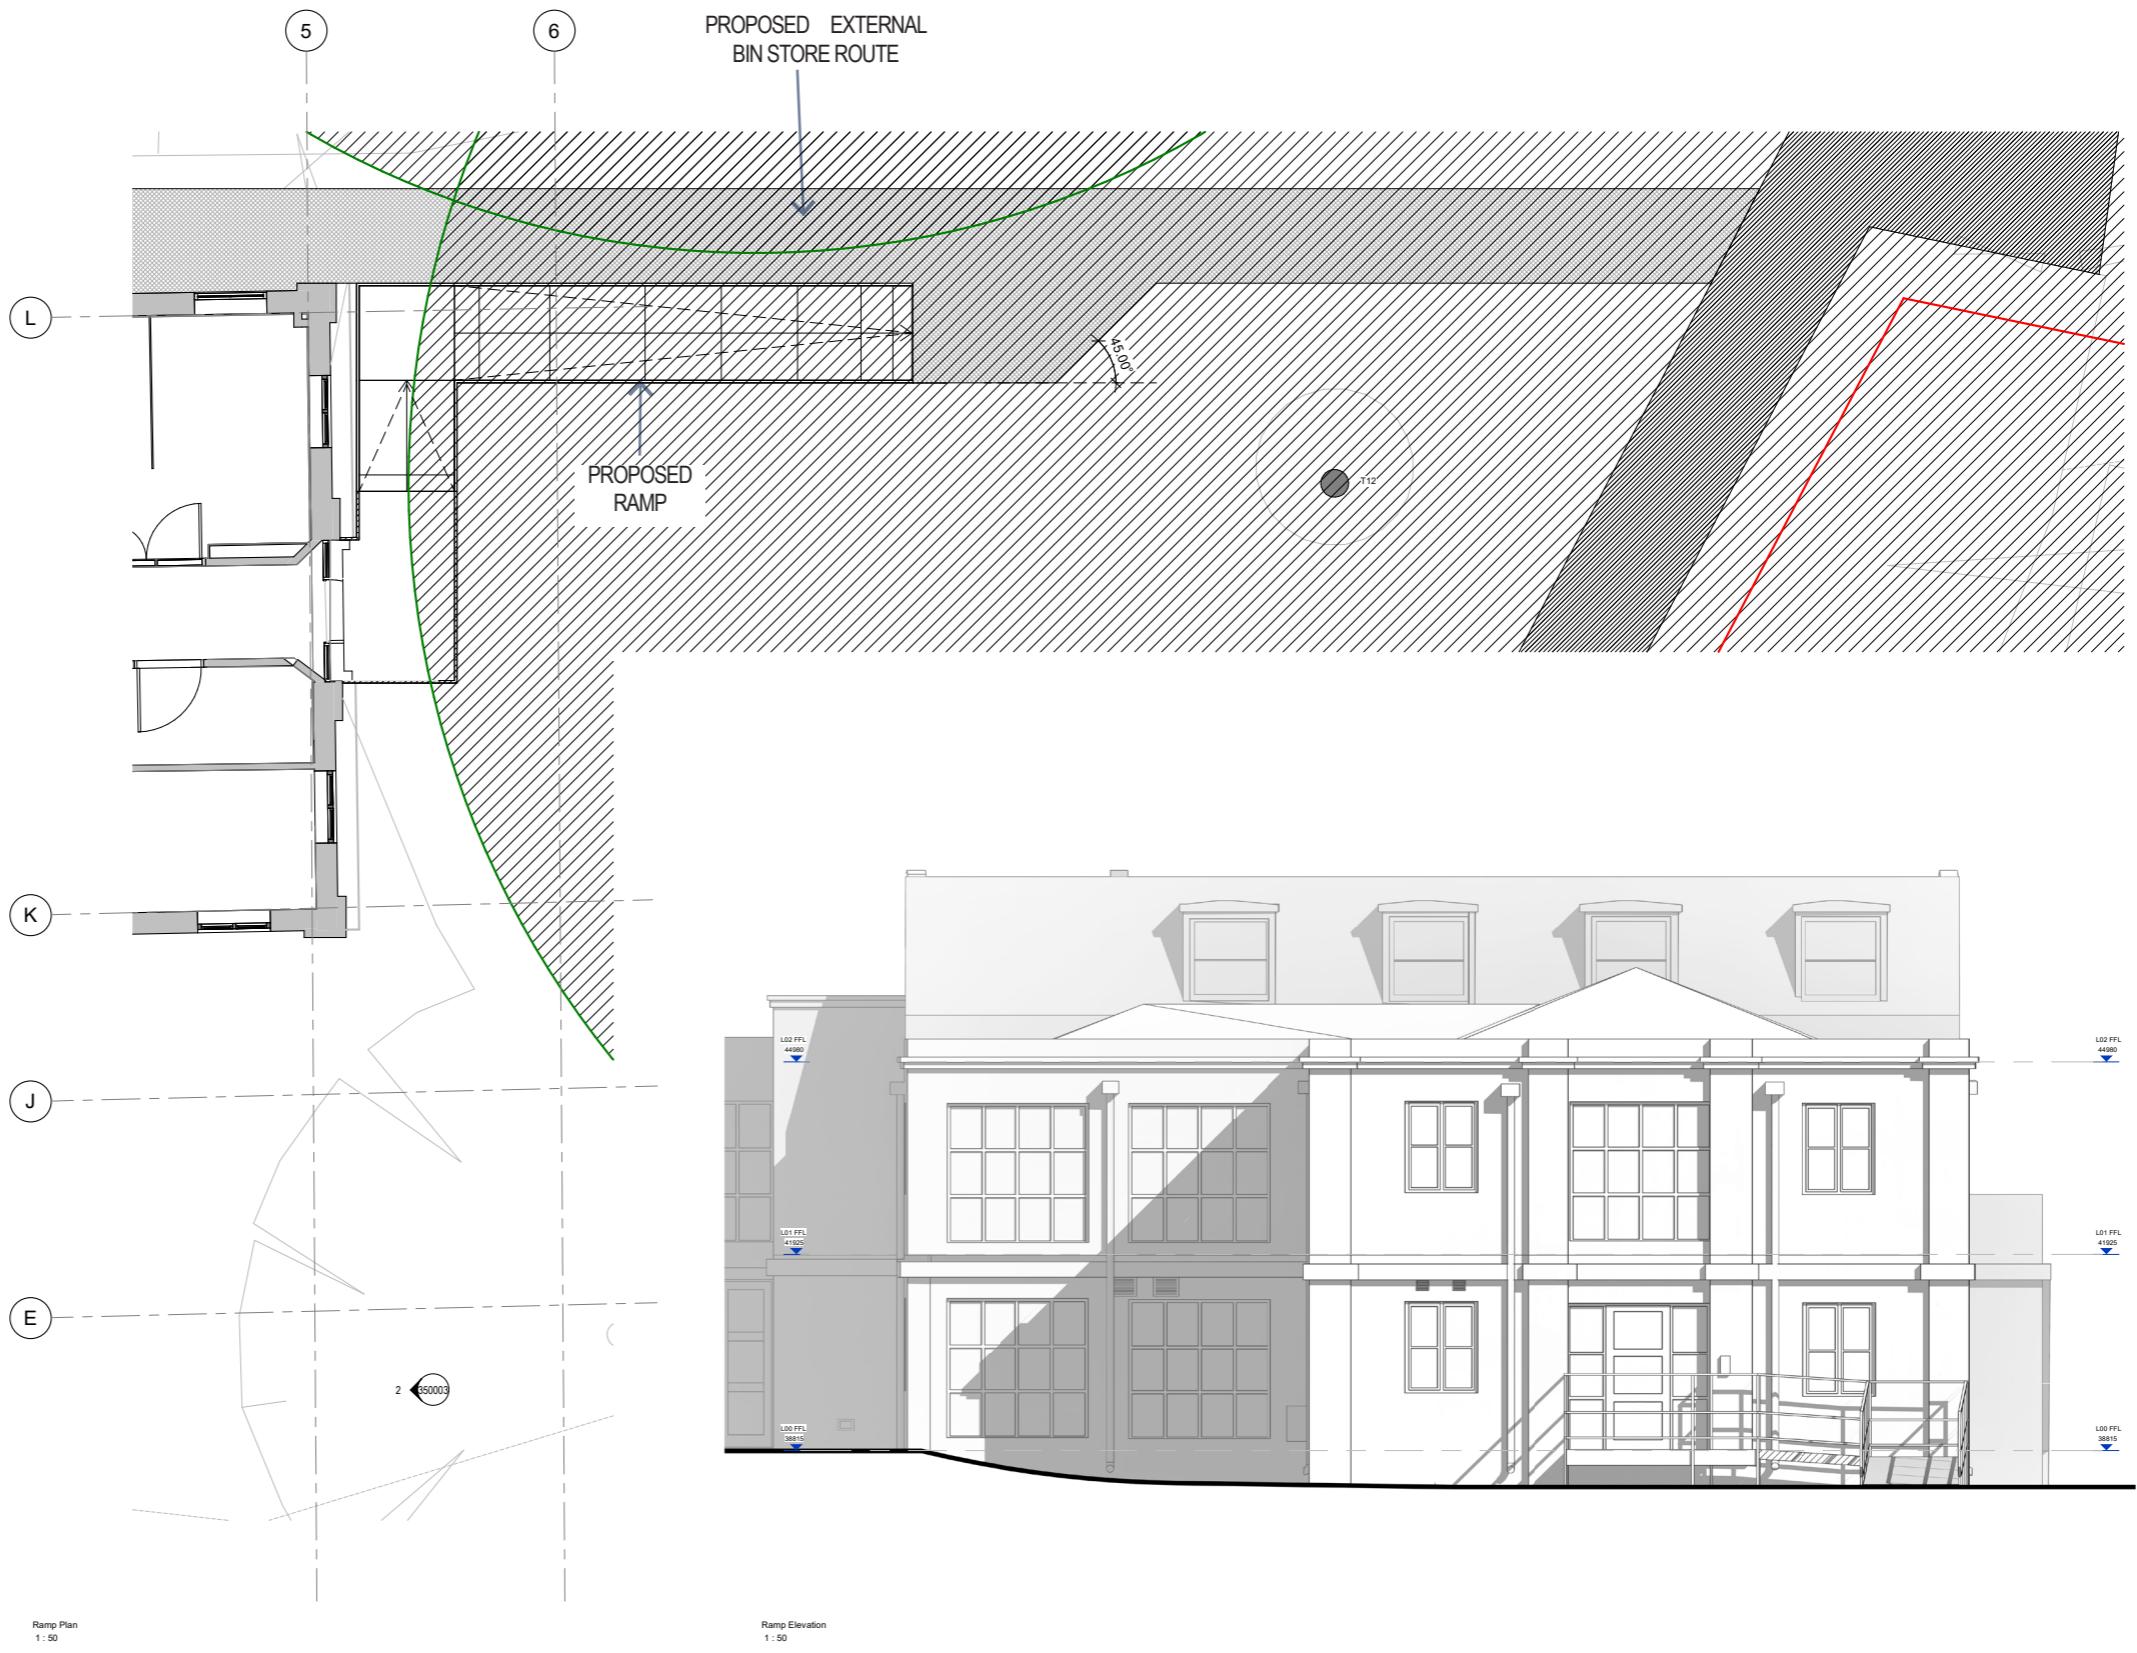
The design team has proposed introducing a new metal ramp on top of the existing concrete ramp. This solution has fewer implications for the existing structure and relocates the ramp's end away from the slip hazard at the exit.

To ensure compliance, the ramp's length must not exceed 10 meters before including a level resting platform of at least 1.5 meters in length. A single ramp with a 500cm rise would have a maximum gradient of 1:20 and a maximum length of 10 meters. Therefore, a ramp of 550mm would require a landing halfway.

A minimum 100mm high kerb may be necessary along the edge of the ramp, and handrails must be provided on either side of the ramp.

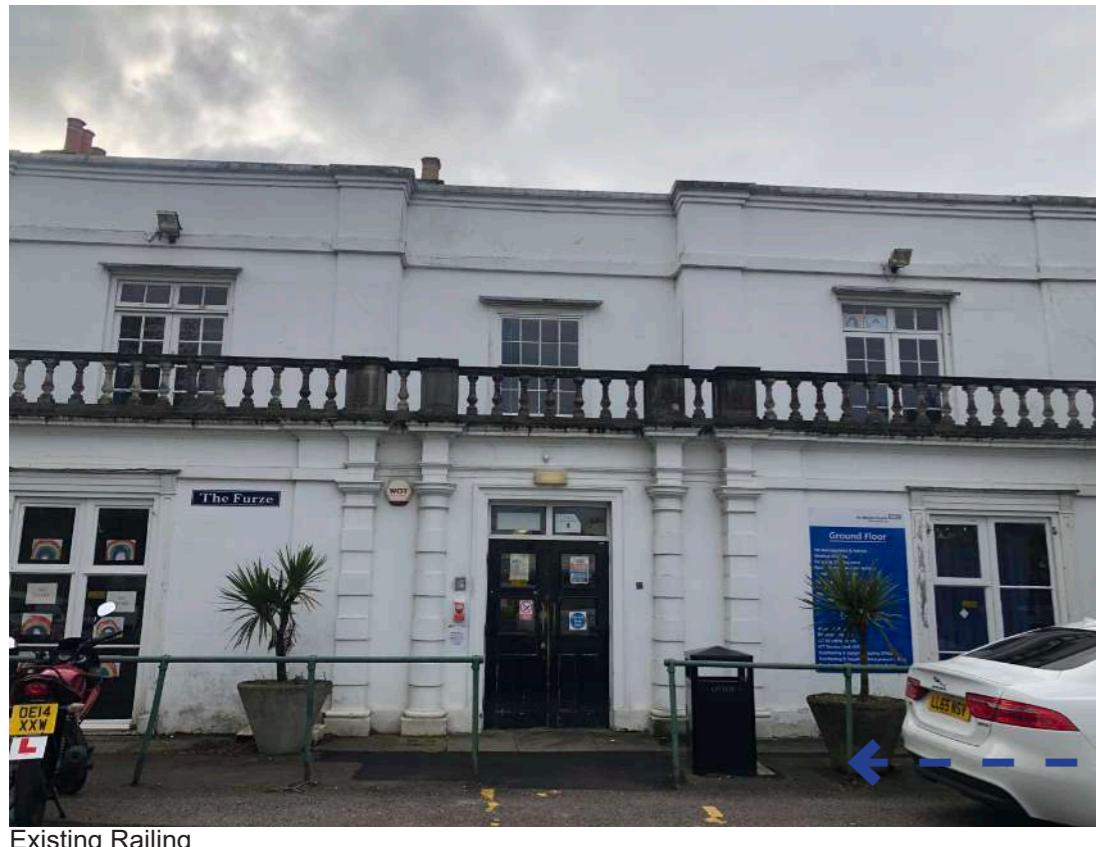
Existing Railing

Due to the poor condition of the guardrail at the front of the Furze building, we would need to replace it with a new one. The design team has explored the design options and came to the conclusion that the best option would be to replace it like-for-like. We propose to match it with the adjacent guardrail within the Furze (yellow guard-rail as shown in the images).

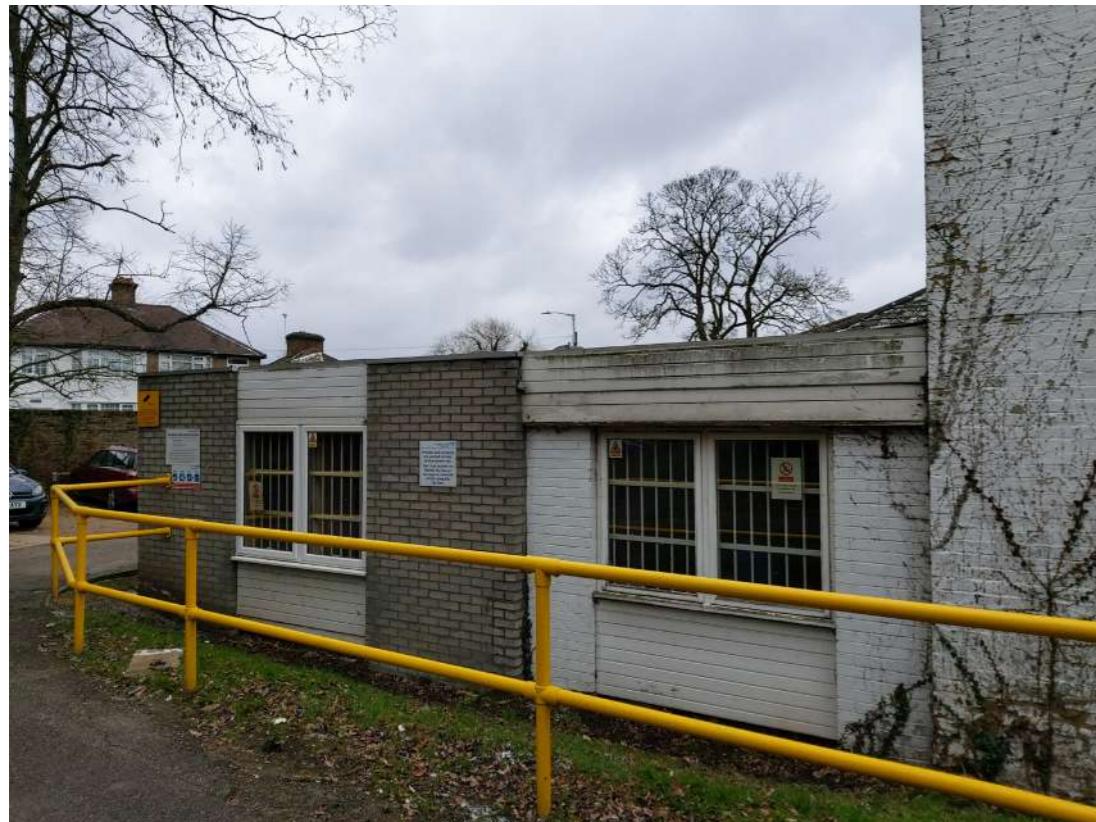
Proposed Railing

The guardrail is necessary for pedestrian safety and to prevent any parking in front of the Furze, which would enhance the safety of the façade.
