# The Furze Design and Access Statement

Provision of Adult Audiology  
Haematology, Education  
Centre and Clinical Admin Offices at  
The Furze

THHFP1-LDW-XX-XX-RP-A-10001

REV P05

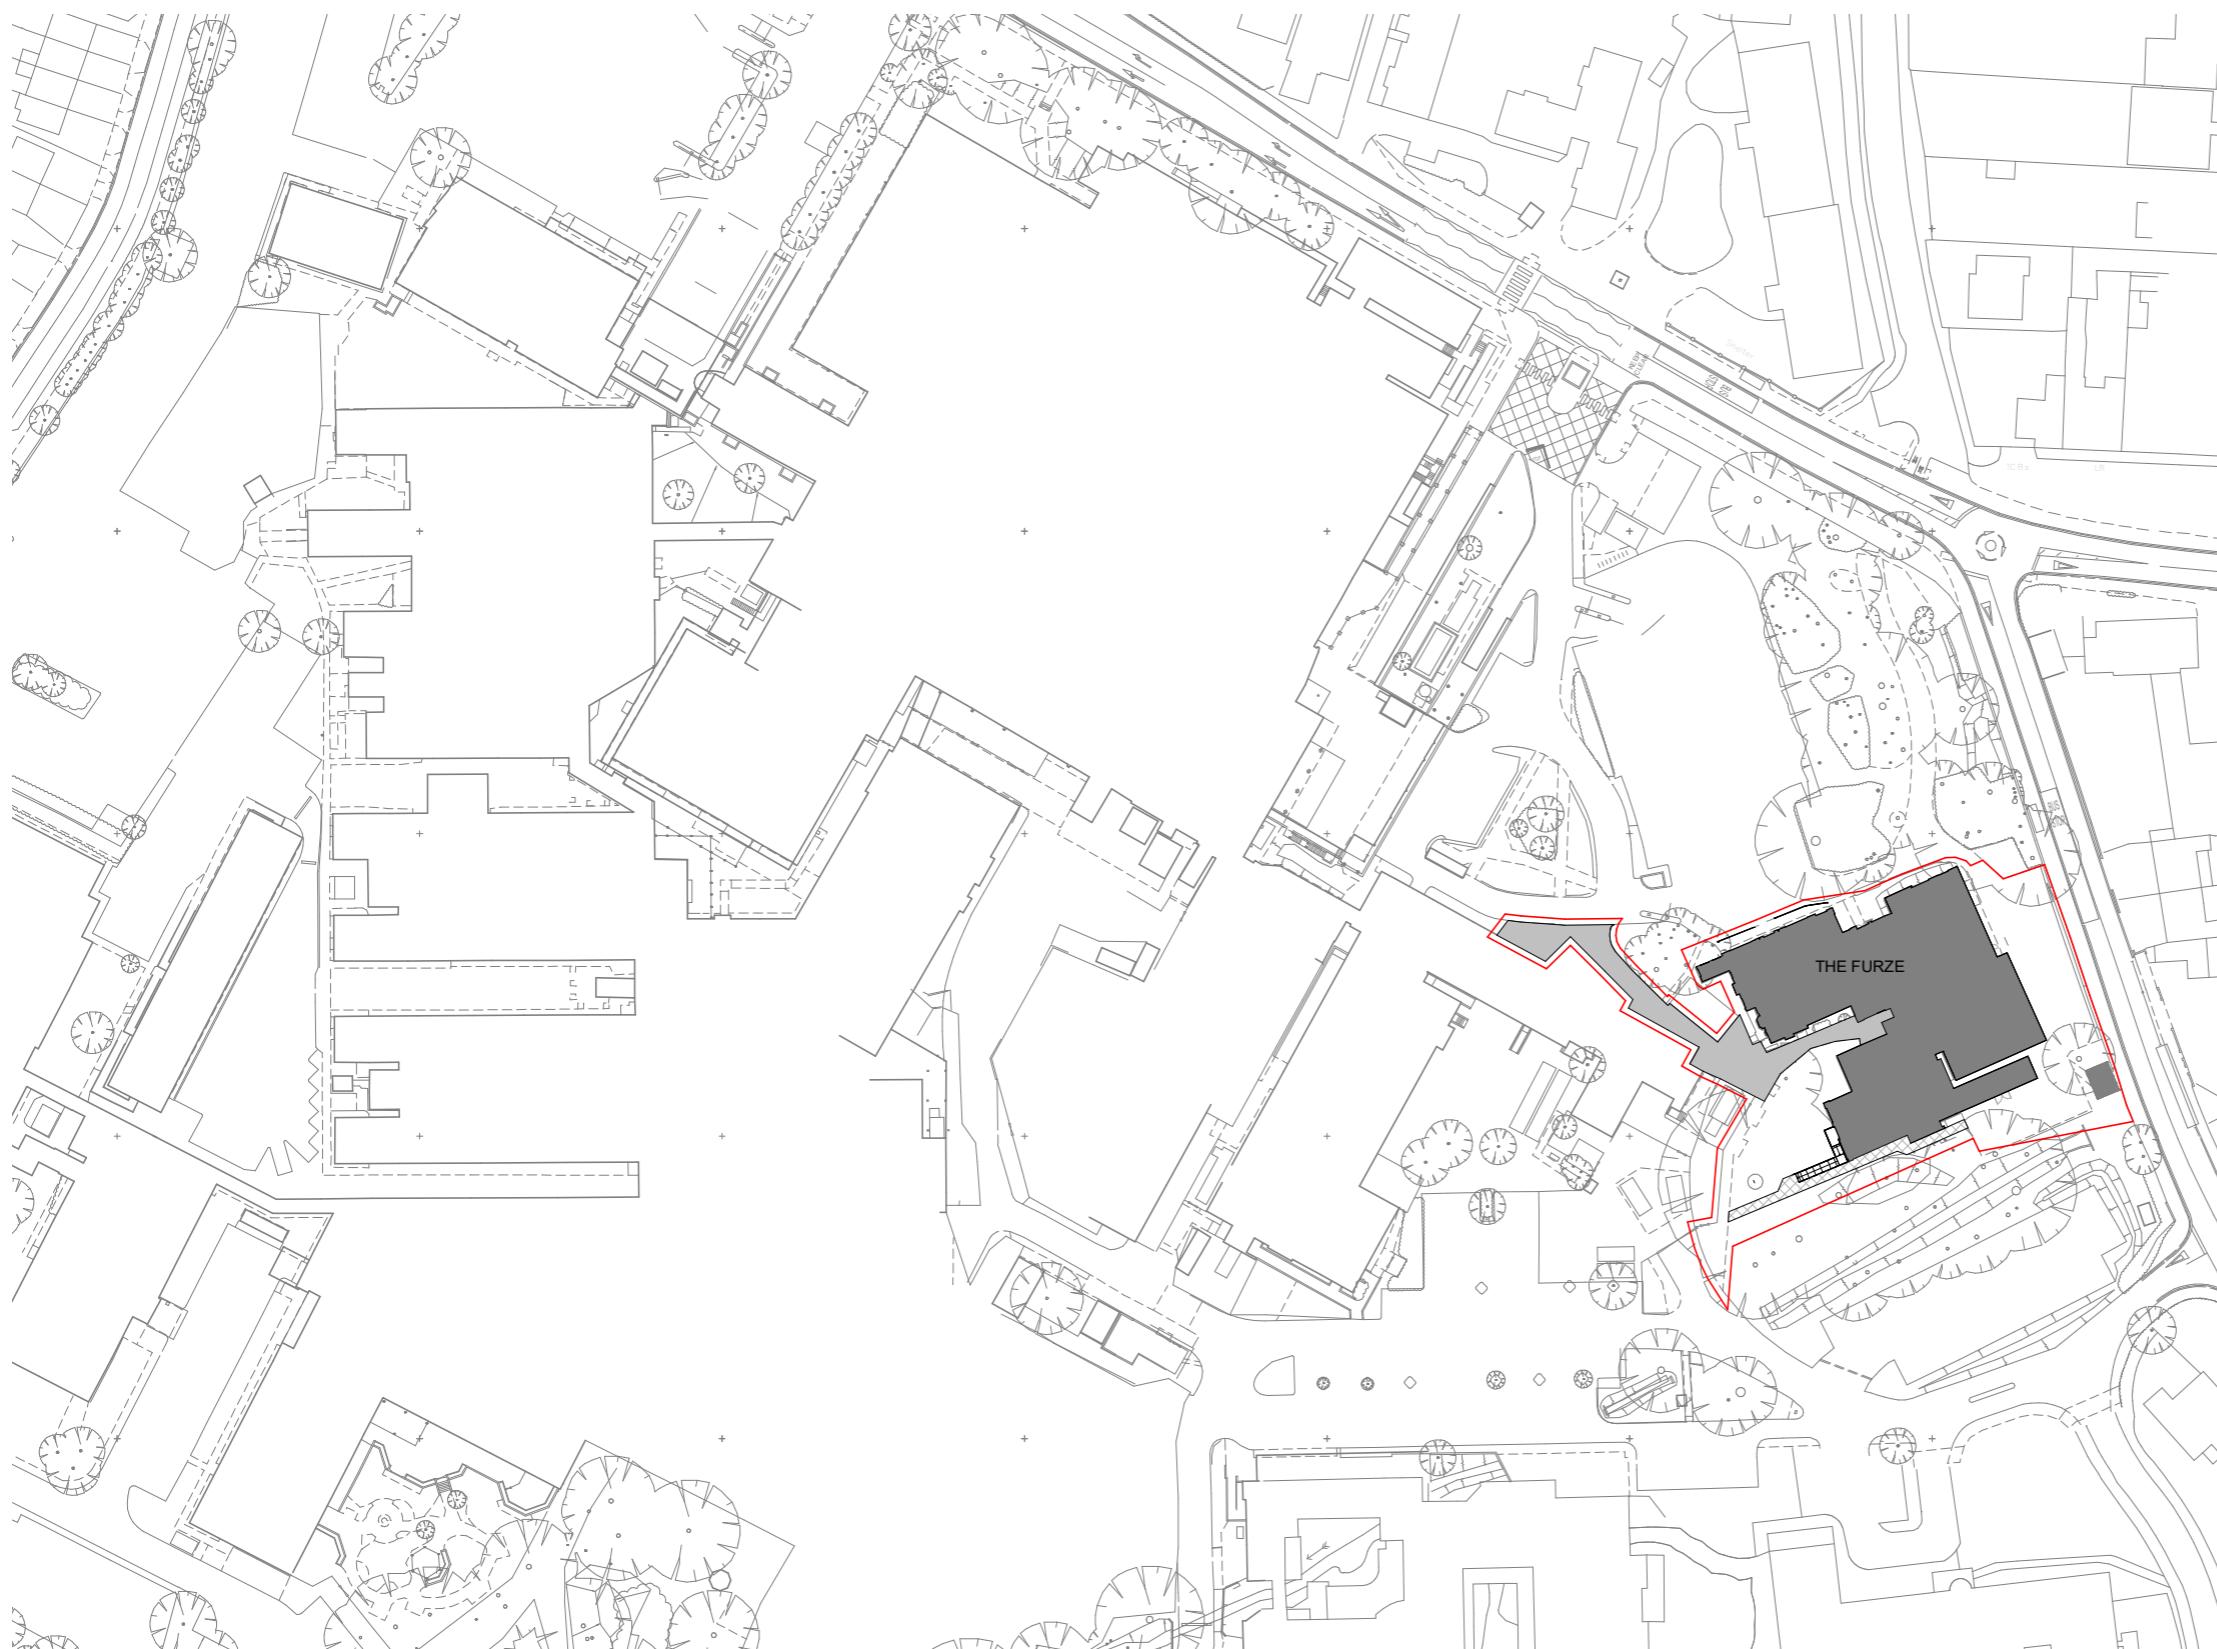
Figure 2.1, Site Boundary Plan

The extent of land covered by the proposal is set out in Figure 2.1. within the red boundary line.

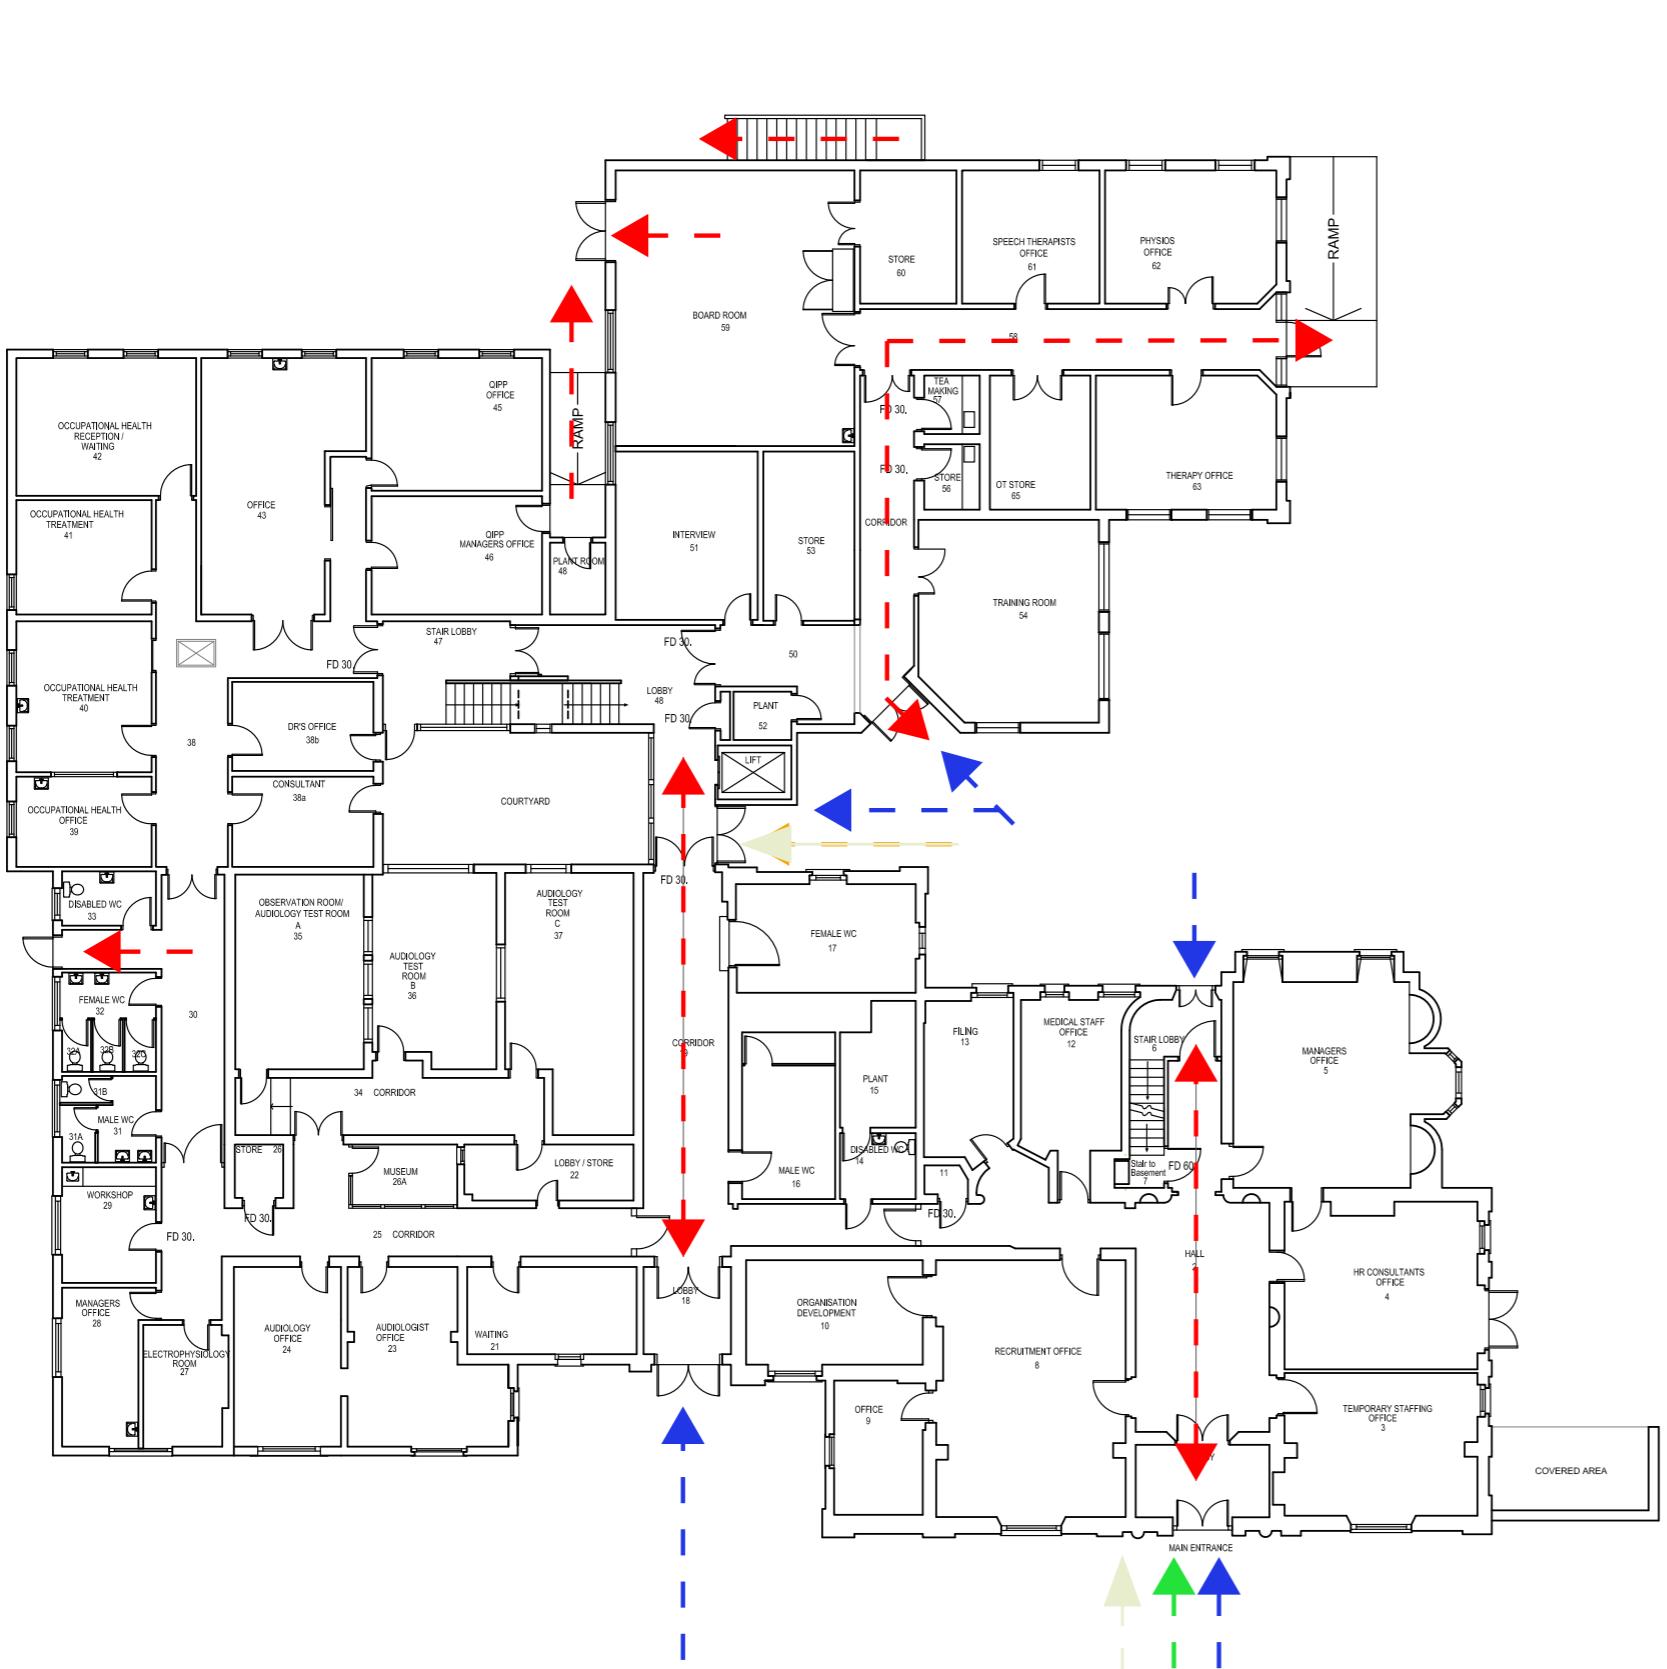
## 2.3 Existing Circulation & Access

The original building was designed as a home and not for the current purpose. However, The Furze is easily accessible from all points of the site. There are fire door restrictions on each corridor, sectioning the buildings into departments.

The design must support dignified and easy access to and within historic buildings for disabled people. Suitable disabled access, which does not compromise a building's special interest, can normally be achieved if treated as part of an integrated review of access requirements for all users. Two points of disabled access are noted on the drawing.

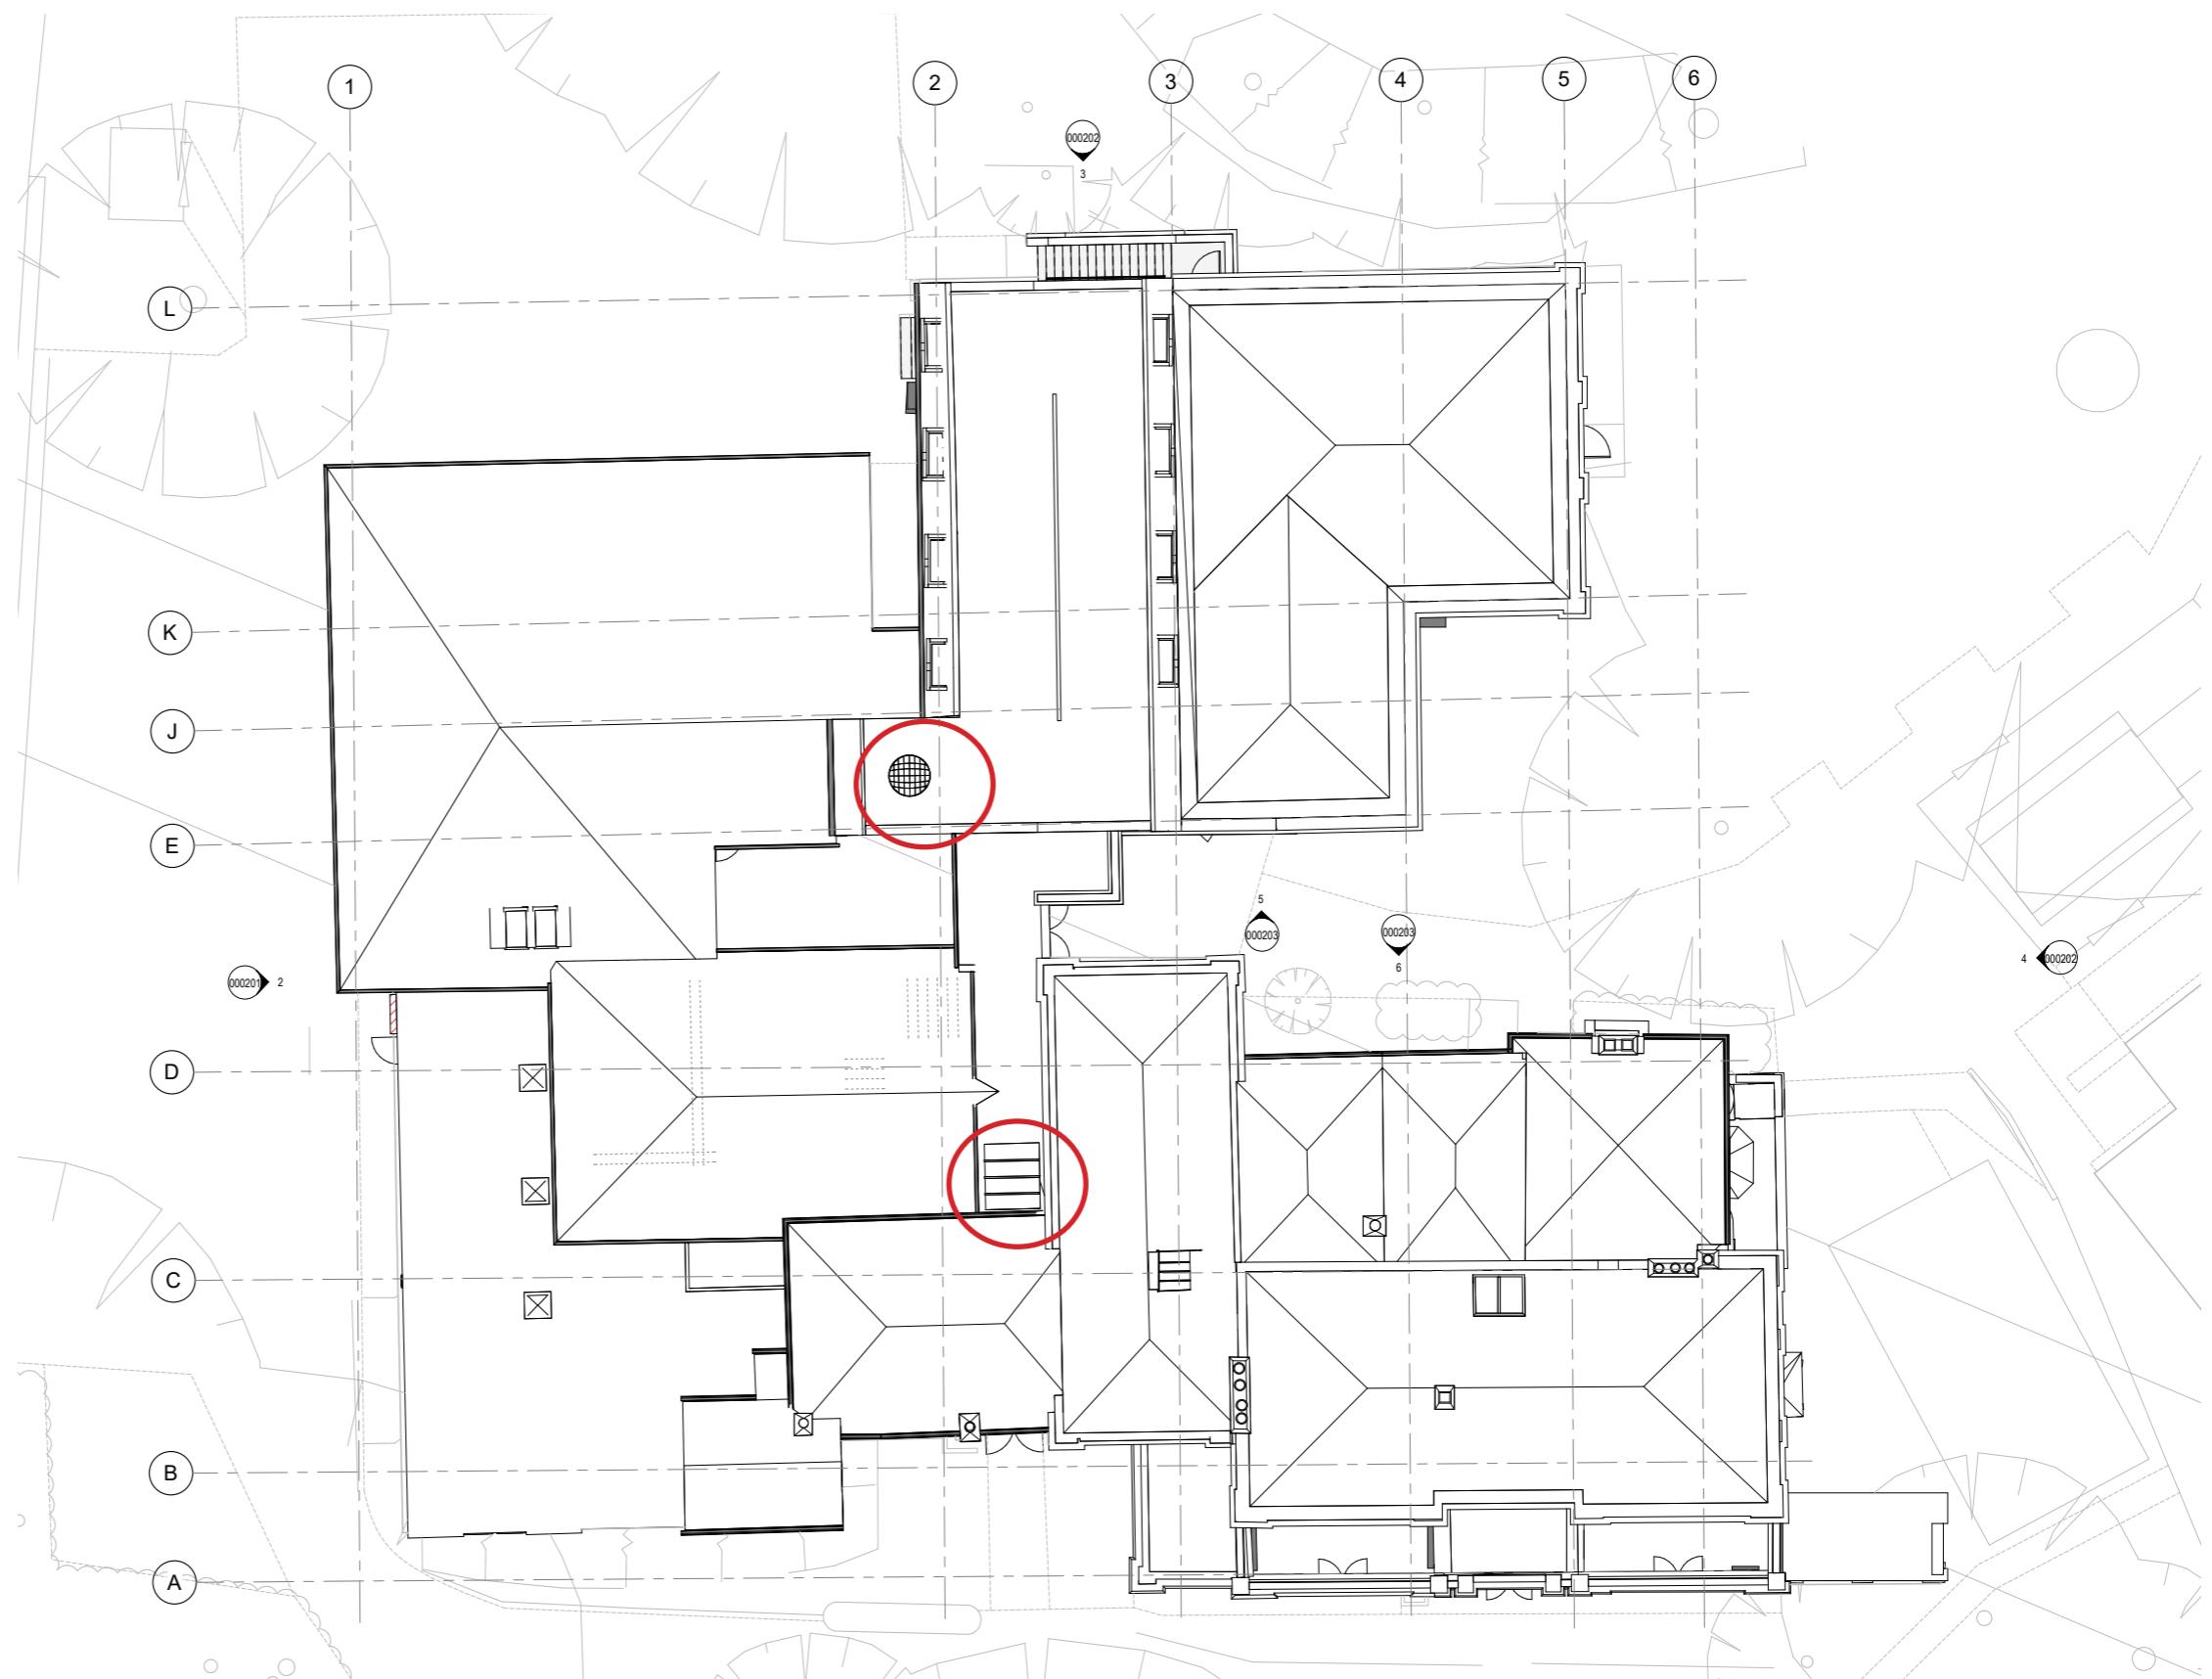
## 2.5 Existing Roof Plans

The roof of the Furze has not been maintained for years; lack of maintenance caused blockage of the gutters, missing lead, broken tiles ..etc, the project team has been requested to retain the existing roof and repair where needed.

A roof survey conducted via a drone has identified issues with the roof. Missing lead flashing and tiles are currently causing leaks and damp problems within the building, as determined through visual inspection and the condition survey. The team has identified various issues with the roof and recommends extensive remedial works. Therefore, a damp survey was undertaken by the specialists at 'Heritage House' to understand the extent of the damage, and they have suggested a repair method. Since many of the walls have been painted with modern paint, we need to replace the paint with lime wash, clay, and breathable paint to allow the building to breathe properly. However, a further internal roof survey is required to determine the extent of the necessary works, as we need to understand the source of the problem in order to eliminate it.

Furthermore, the roof light to the rear extension on the second floor & first floor (highlighted in red) are damaged and covered to minimize rainwater leaks. Therefore, it has been recommended to Remove the redundant damaged roof light and close up the opening. Reinstate the area to match the rest of the roof.

3. Remove the redundant damaged roof light and close up the opening. Reinstate the area to match the rest of the roof.

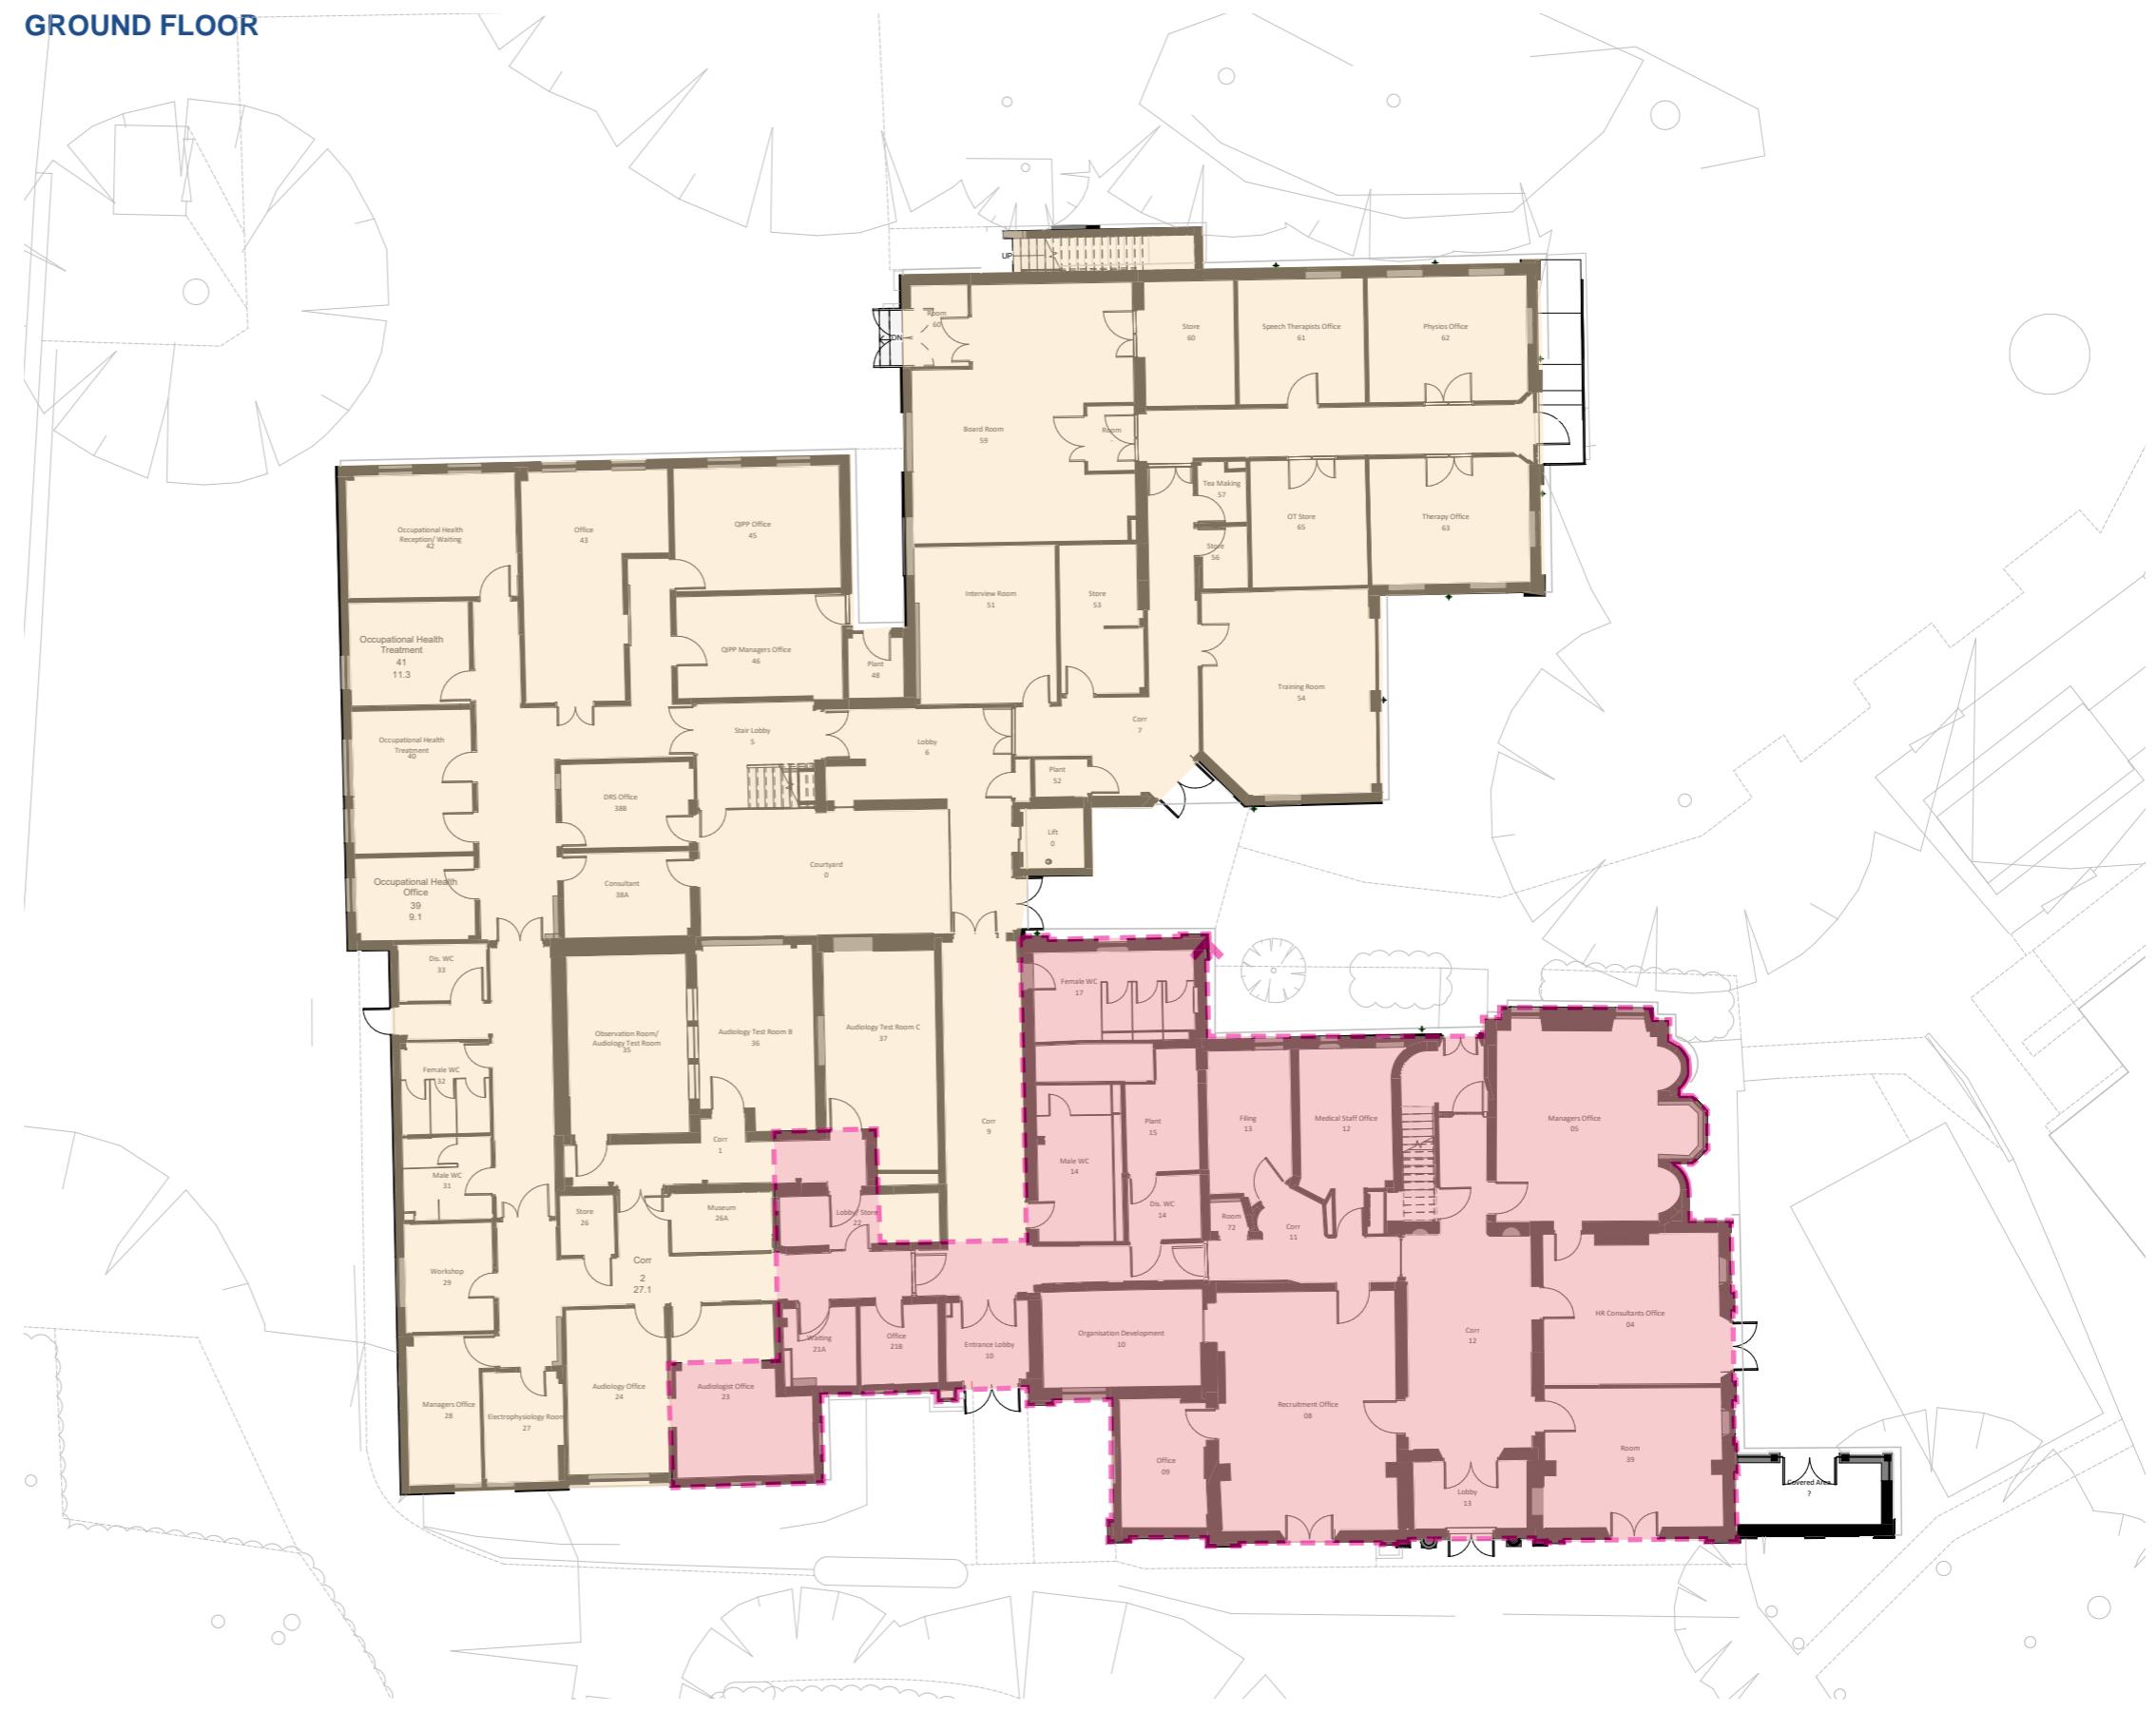
## 2.10 Historic Fabric & Later Date Extensions

Illustrating the extent of the original Georgian building from the early 19th Century, which is highly protected and for which only minimal alterations would be acceptable, such as repair, making good, and replacing like for like. (All original internal partitions are to be retained.)

Illustrating the extent of later extensions, ranging from the Victorian era to the 1990s, the Trust's Heritage consultant is of the opinion that alterations and removal of internal partitions would not be contentious in historic building terms. Furthermore, any alterations to the external fabric should be acceptable if they result in an improvement.

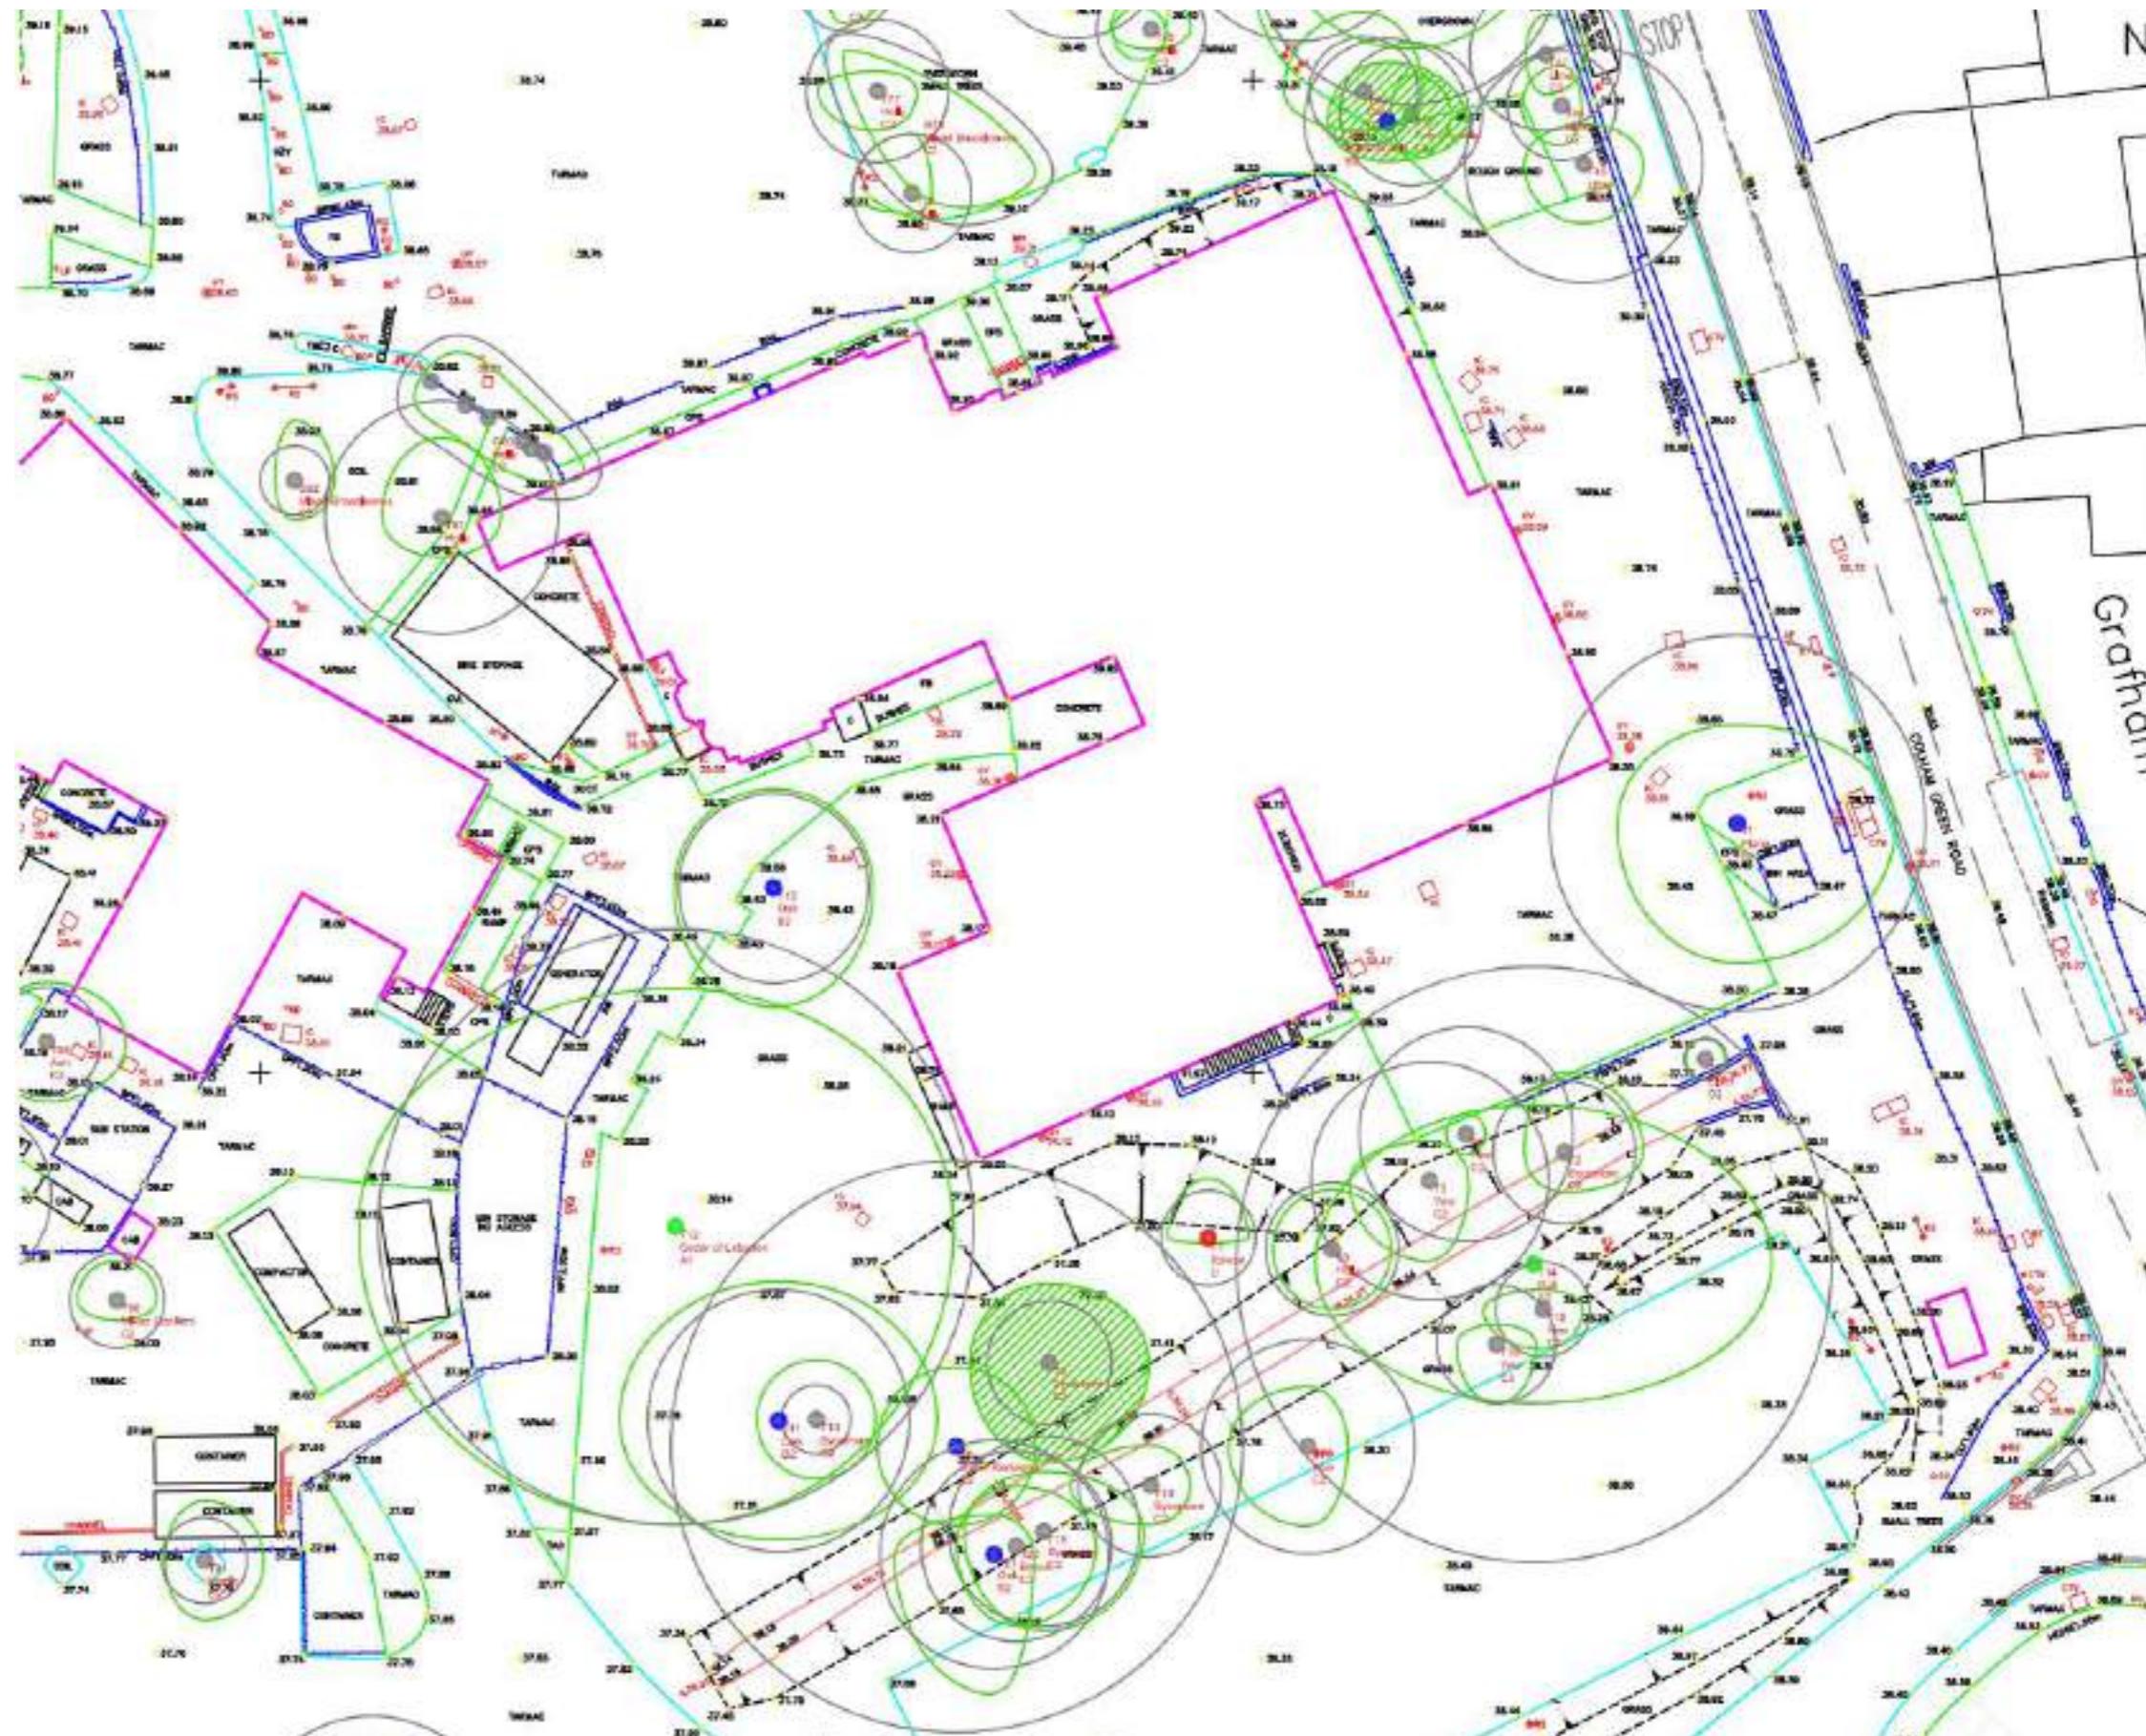
## 2.11 Listed Landscape - Protected Trees, Topographical Plan

Law protects certain trees within the UK through Tree Preservation Orders (TPOs) and planning conditions within the planning system; therefore, any changes and alterations to the locations of the existing listed trees will require planning permission first.

The current proposal is to retain all the trees, as no extension to the building is proposed; therefore, the roots of the existing trees do not cause any issues.

Tree Constraints Report by Landmark trees states the need to retain the Category A and B trees. Most Category C trees are in fair condition and are fairly protected but could be removed and relocated if necessary. The arbor culturalist's recommendation is to retain the trees where possible.

The diagram illustrates a tree with the following categories and protection areas:

- Category A** (Green circle): High Quality
- Category B** (Blue circle): Moderate Quality
- Category C** (Grey circle): Low Quality
- Category U** (Red circle): Trees Unsuitable for Retention
- Root Protection Area**: A green circle centered on the tree's base.
- Crown Spread**: The area covered by the tree's canopy.
- Tree Number**: Number 13
- Species**: Bird
- Category**: Category A
- Tree Position Approximate**: (not shown on original survey)

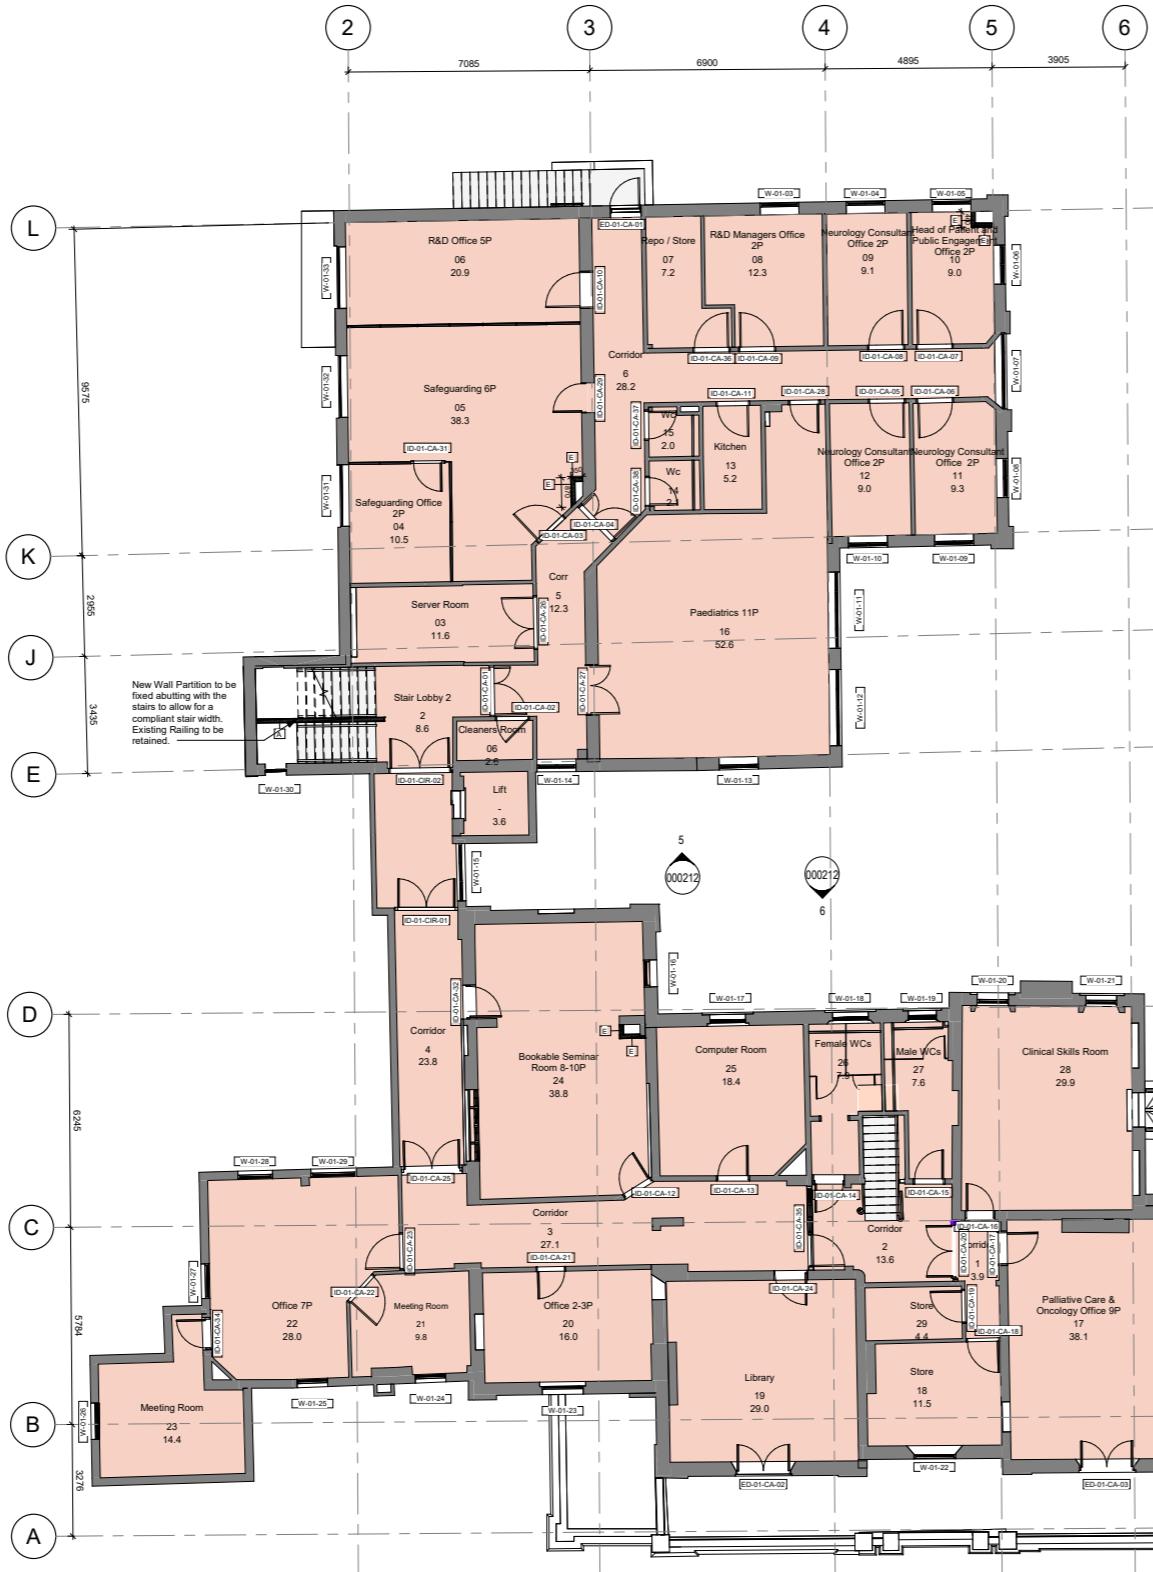
## FIRST FLOOR

The first-floor has been assigned to the clinical admin. Therefore, only office spaces will accommodate this space. the layout has been retained with minimum demolition work of one partition to allow for larger spaces and replacement / reprise of few damaged doors/ floor and ceilings following water damage internally.

All replacements will be set like for like.
