# The Furze Design and Access Statement

Provision of Adult Audiology  
Haematology, Education  
Centre and Clinical Admin Offices at  
The Furze

THHFP1-LDW-XX-XX-RP-A-10001

REV P05

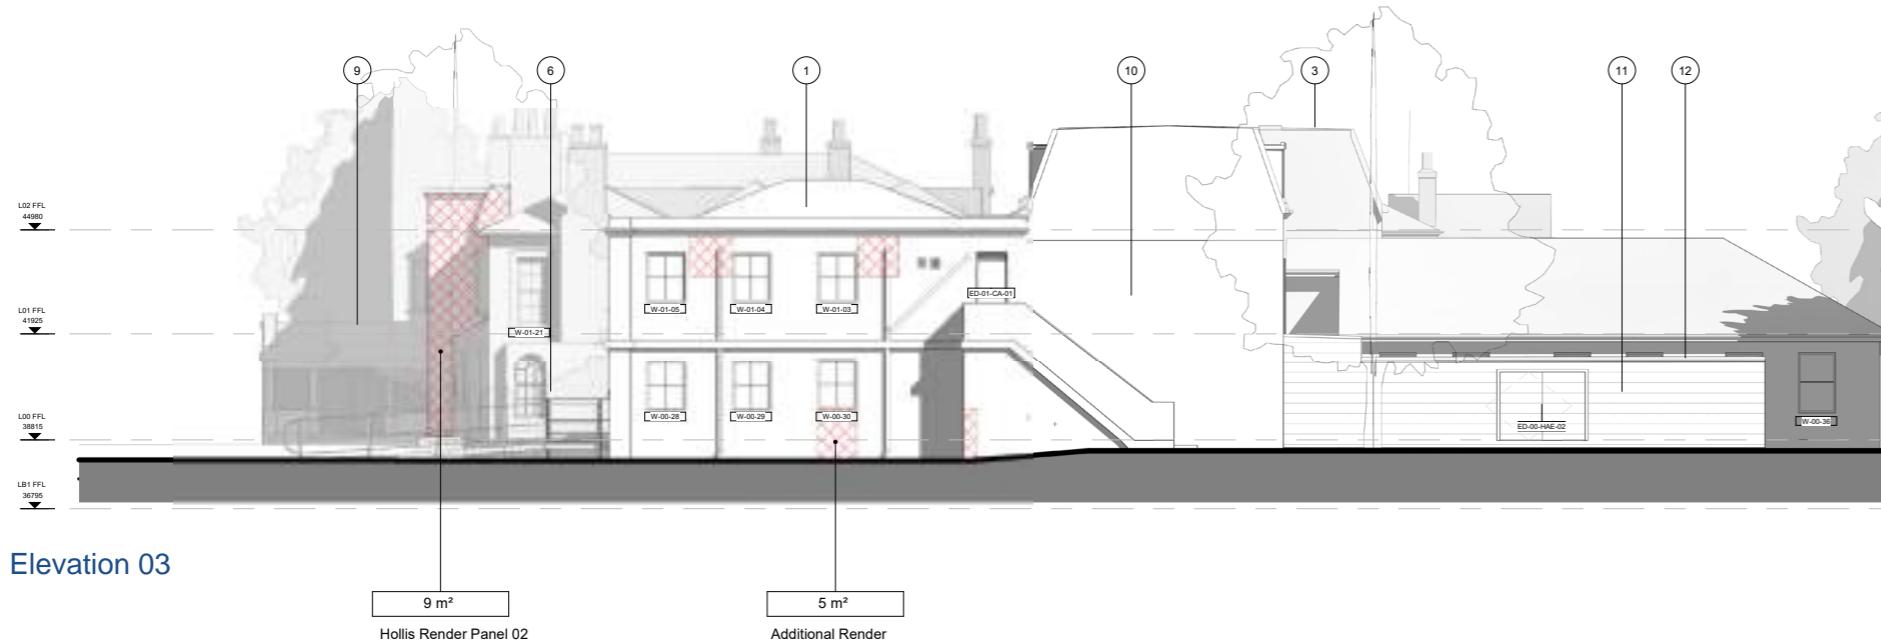
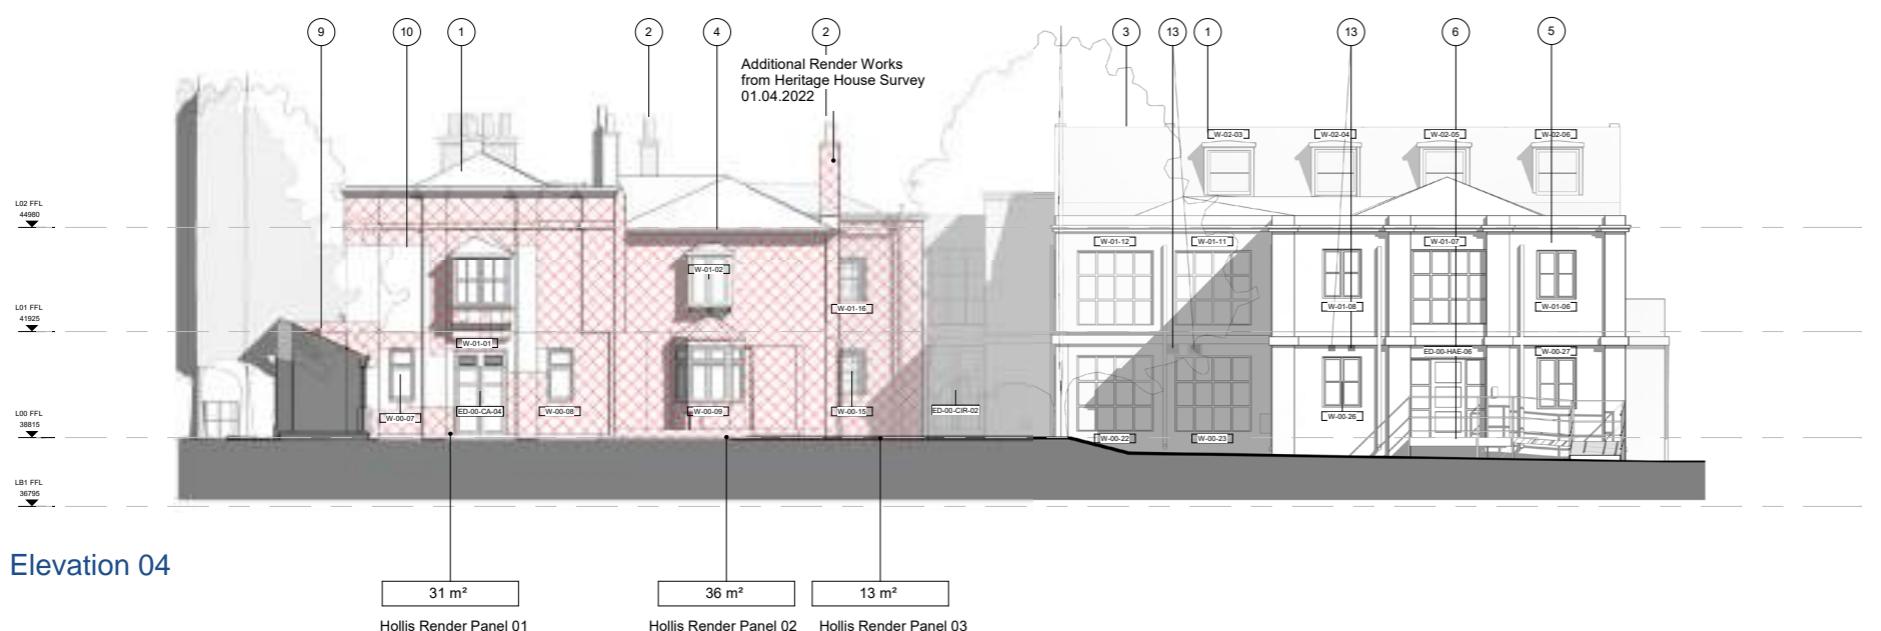
## 3.4 Proposed Elevation

1. Existing roof is to be retained and refurbished or replaced like for like where repair is not possible, including flashing and gutters. (refer to drawing THHFP1-LDW-Z-RF-DR-A-000123)

2. The chimney brick to be repointed to match existing and all flashing to be made good
3. Remove the redundant damaged roof light and close up the opening. Reinstate the area to match the rest of the roof.

4. All existing guttering to be made good and replaced like for like where needed.
5. New paint finish to replace existing decaying painted brick walls painted to match colour of Georgian stucco finish. (Extent of the work to be agreed with local authority following further assessment and secured by planning condition) Paint to better match the existing limewash paintwork.

6. New ramp to be installed for compliance with Building Regulation
7. Existing windows & doors to be repaired or replaced like for like where needed.
8. Existing decaying timber spandrel panels to be carefully removed to allow fire stopping to be made good. New rendered rainscreen panel non-combustible cladding system to be installed in lieu of the removed timber.

9. Following clients confirmation - Shed space to be retained and not repaired. Architect recommendation for the shed to remain closed and not used.
10. Re-Render in a hot lime render (NOT NHL3.5 or 2) areas that are to be rendered in the lime render are the old parts of the building (Solid wall construction) Other areas which are the later additions, with modern construction can be rendered in standard sand and cement. Hollis - draft schedule of condition 14 August 2023 120937-100/met/cbK

11. New treated timber fence enclosure to A/C Plant to be positioned in front of existing facade (Refer to drawing THHFP1-LDW-ZZ-00-DR-A-700017).
12. Roof covering to be added to the plant area for compliance with HTM 03-01 document, (When refurbishing or changing the use of an existing building, plant space should be created to house the ventilation plant and other services. If located at ground level they should be secured within a plantroom to prevent unauthorised access.) (refer to THHFP1-LDW-ZZ-00-DR-A-700017).

13. New Grille to be installed following MEP Design Change in existing vents and replacement of locations according to MEP design based on usage of building. (refer to THHFP1-LDW-ZZ-ZZ-DR-A-210005).

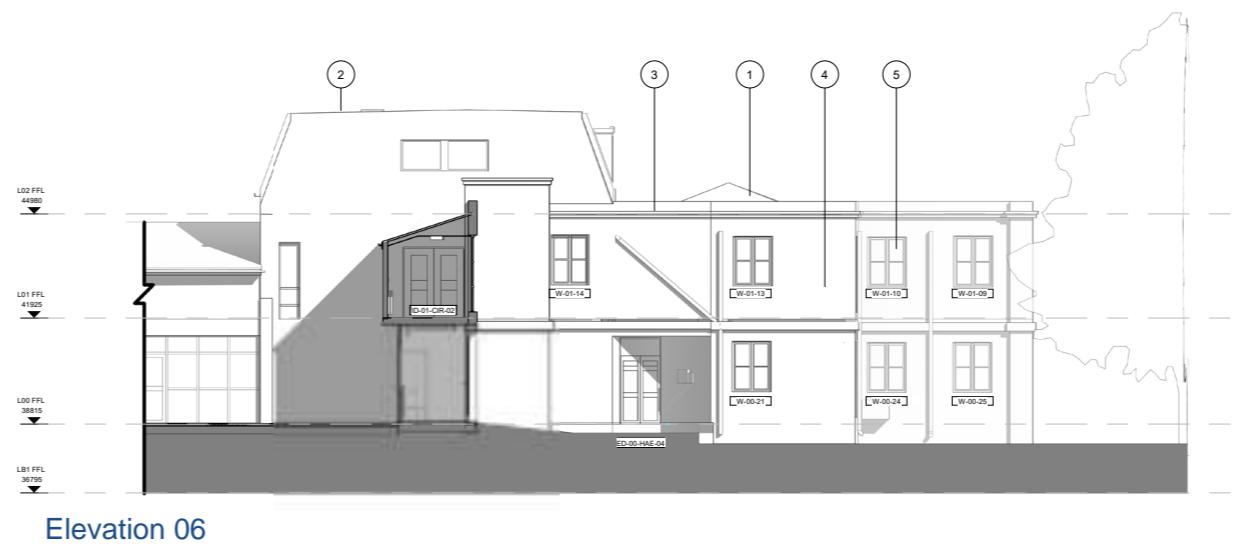
Elevation 06

1. Existing roof is to be retained and refurbished or replaced like for like where repair is not possible, including flashing and gutters. (refer to drawing THHFP1-LDW-Z-RF-DR-A-000123)

2. Remove the redundant damaged roof light and close up the opening. Reinstate the area to match the rest of the roof.

3. All existing guttering to be made good and replaced like for like.

4. New paint finish to replace existing decaying painted brick walls painted to match colour of Georgian stucco finish. (Extent of the work to be agreed with local authority following further assessment and secured by planning condition)

5. Existing windows & doors to be repaired or replaced like for like where needed.

6. Missing RWP to be replaced by a new RWP.

7. Re-Render in a hot lime render (NOT NHL3.5 or 2) areas that are to be rendered in the lime render are the old parts of the building (Solid wall construction) Other areas which are the later additions, with modern construction can be rendered in standard sand and cement. Hollis - draft schedule of condition 14 August 2023 120937-100/met/cbK

8. New Grille to be installed following MEP Design. Change in existing vents and replacement of locations according to MEP design based on usage of building. (refer to THHFP1-LDW-ZZ-ZZ-DR-A-210005).
