# NCP Flightpath Drainage Strategy

*For Heathrow NCP Property Ltd*

*Doc ref:* 23795-HYD-XX-XX-RP-C-7000

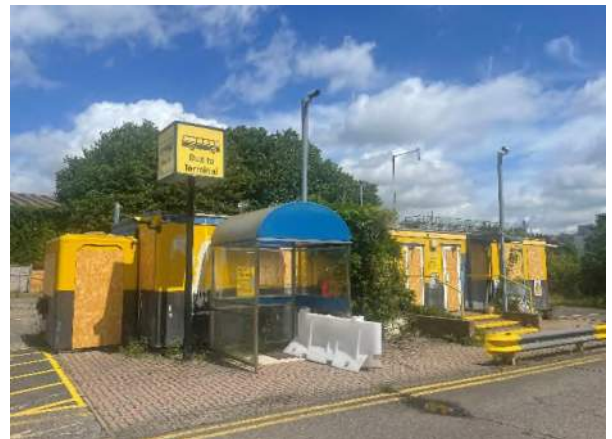
Figure 2.4: Customer Service cabin and bus stop towards the north of the site. Services including street lighting, an aerial, outdoor plug sockets and CCTV can be seen around the structure. It is unknown if services are live.

Figure 2.4: Customer Service cabin and bus stop towards the north of the site. Services including street lighting, an aerial, outdoor plug sockets and CCTV can be seen around the structure. It is unknown if services are live. ....	6
Figure 2.5: Disused metal shed at the north-east corner of the site. ....	6
Figure 2.6: Brick structure containing electrical equipment along the western site boundary. ....	6
Figure 2.7: Locked secondary access gate along the western site boundary.....	7
Figure 2.8: Car parking area viewed from the south-west corner of the site. Parking bays with an aggregate surface are overgrown with weeds and grass. Asphalt roads provide an accessway to the parking bays. Street lighting and CCTV facilitate the car park. ....	7
Figure 2.9: Superficial deposits. ....	11
Figure 2.10: Solid geology. ....	11

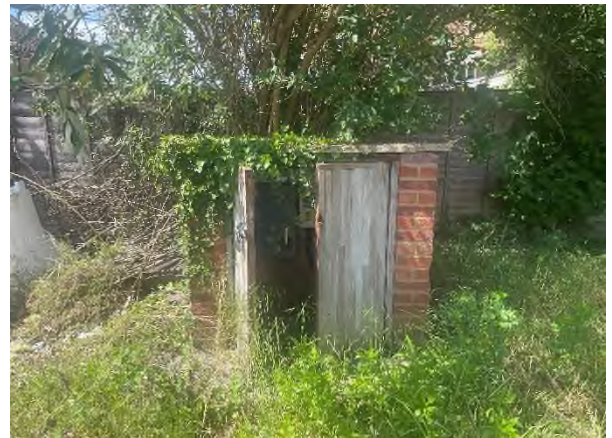
Figure 2.6: Brick structure containing electrical equipment along the western site boundary.

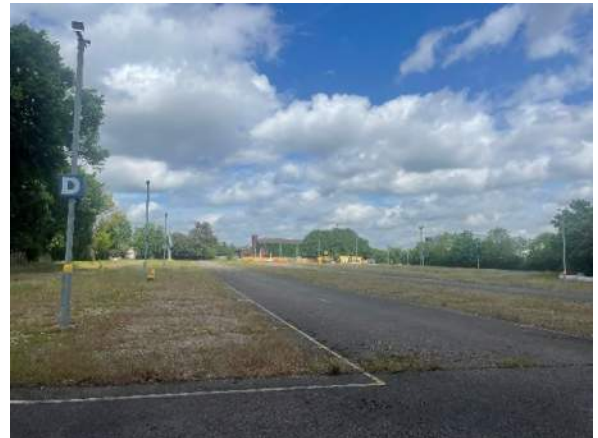
Figure 2.8: Car parking area viewed from the south-west corner of the site. Parking bays with an aggregate surface are overgrown with weeds and grass. Asphalt roads provide an accessway to the parking bays. Street lighting and CCTV facilitate the car park.
