## MAPLE & POPLAR

### NHBC Cantilever Balcony Design Timeline

#### Original Base Design

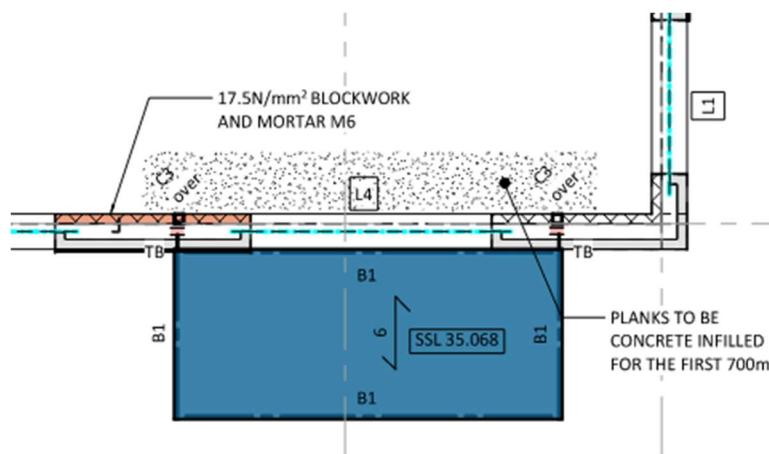
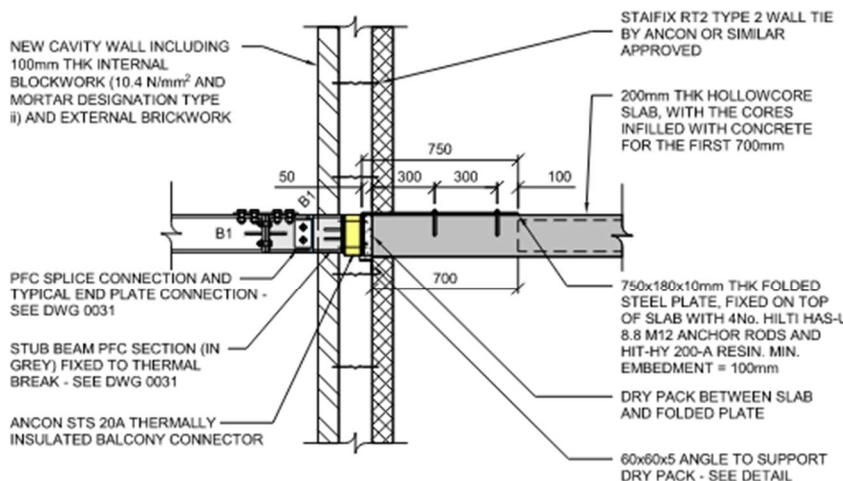
#### TYPICAL BALCONY TO SLAB DETAIL

This design was based on the precast slabs being solid in the location of the balconies onto which the back cantilever span of the balcony steels was bolted, as can be seen in the below 2 screenshots.

(SCALE 1:20)

The original cantilever balcony design and calculations pack was issued to both NHBC and Building Control.

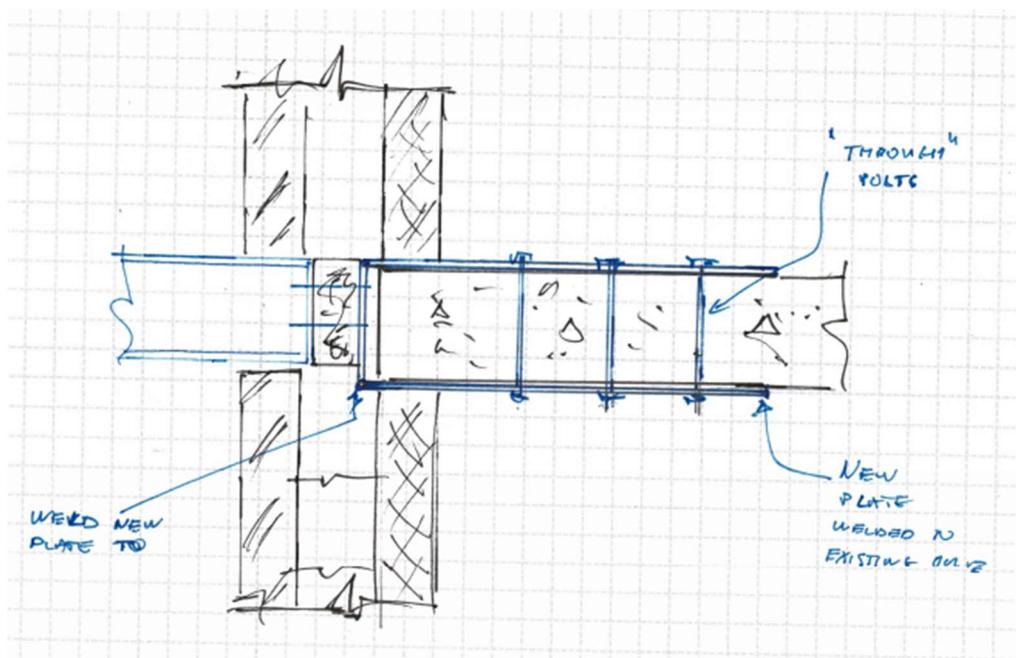
#### Option 1 – Clamping of Precast Slab

The details here would have been to open up the soffit below each affected balcony position and install a plate beneath the one already installed and then resin bolt this up to the soffit (slightly different from below screenshot which shows bolts going right through slab). We would also have had to open up the external block and brickwork to weld this onto the exiting plate.

NHBC reviewed this option and although again it structural worked, as it was unconventional they would not approve this design option.

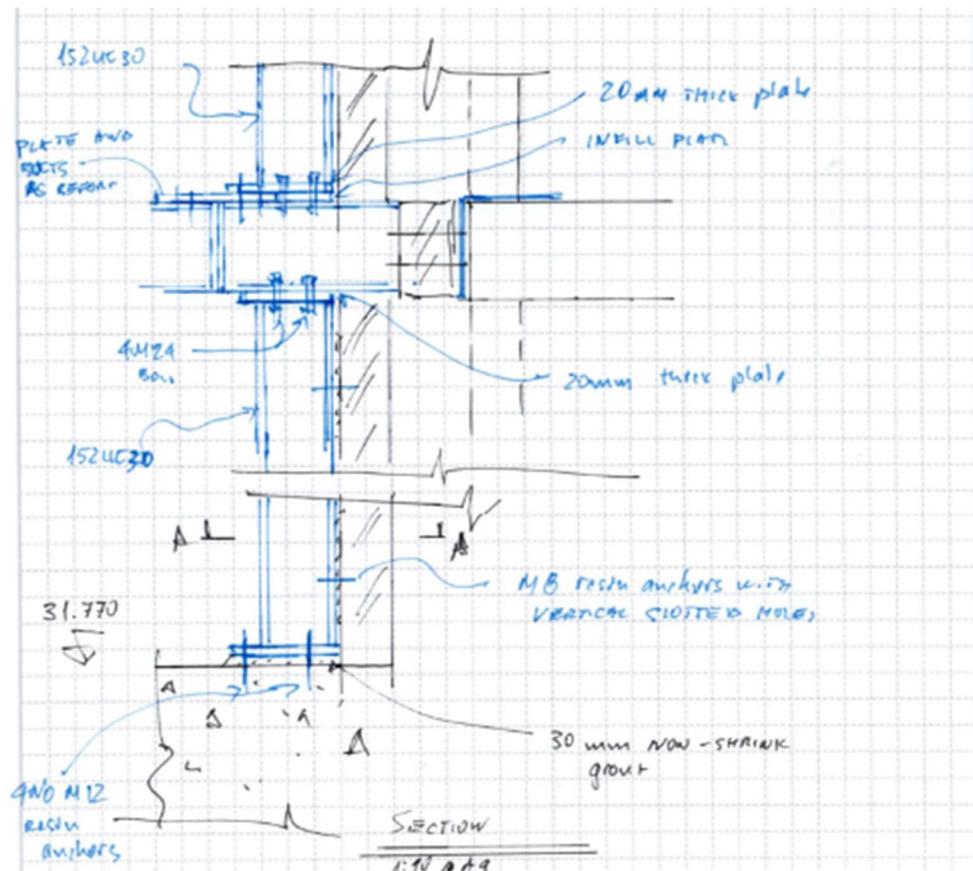
## Option 2 – External Columns Tight to Brickwork

This design introduced new steel columns up against the external brickwork to eradicate the forces of concern by the NHBC. This design by its nature would change the external appearance of the building , hence why it was our second option.

A full information and structural pack was presented to NHBC on this design option and a meeting held with their engineers to discuss it in detail. The proposed columns would have been galvanised and spray painted to match the window / balcony fascia RAL colour.

Below is screenshot of the connection design, and below that marked up elevations of where the posts would be on the South Block.

Unfortunately again although the NHBC engineers liked the out the box proposal and could be proven to work, they would not accept this as it was unconventional.

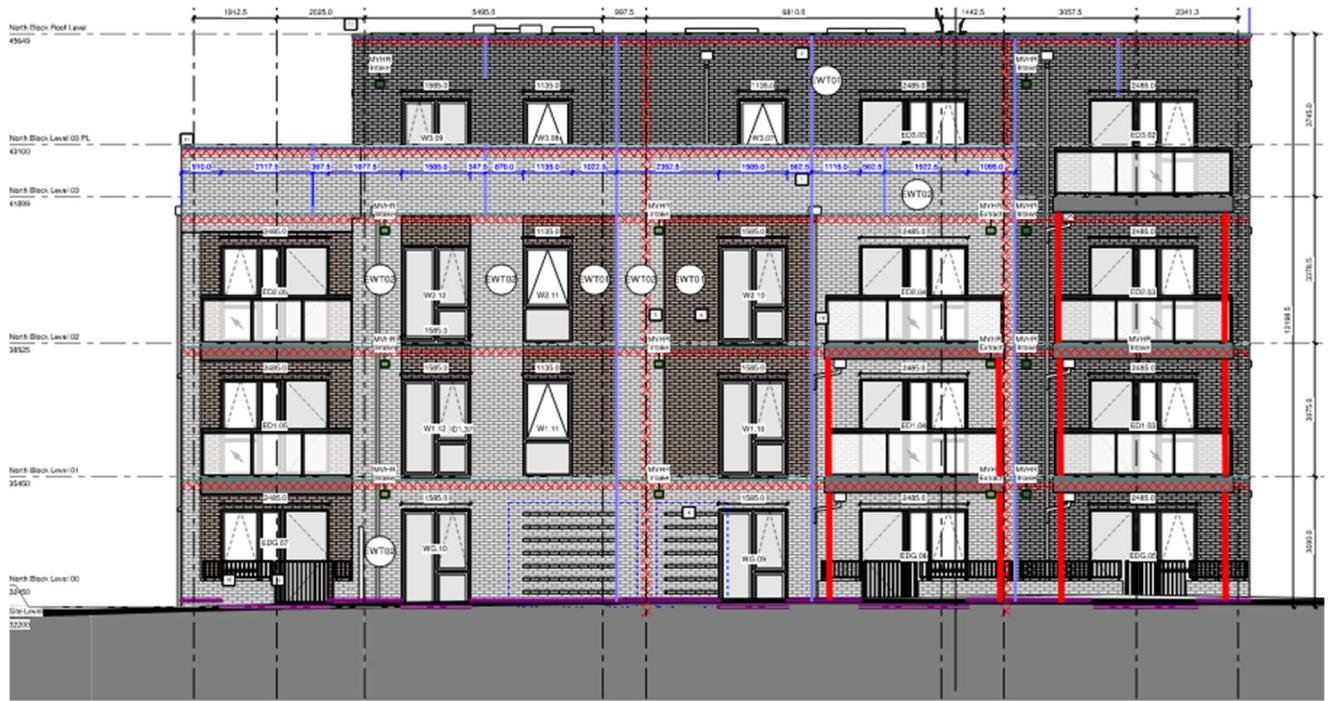
### North Block East Elevation

I have marked up the affected elevations in red on both blocks below for ease of reference. Once drawn up Neilcott will submit an NMA for these changes and the reasoning behind them to the planners.

Note it only affects 2 sets of balconies on the North Block, which are on the side east elevation, the remainder of the balcony are simply supported already.

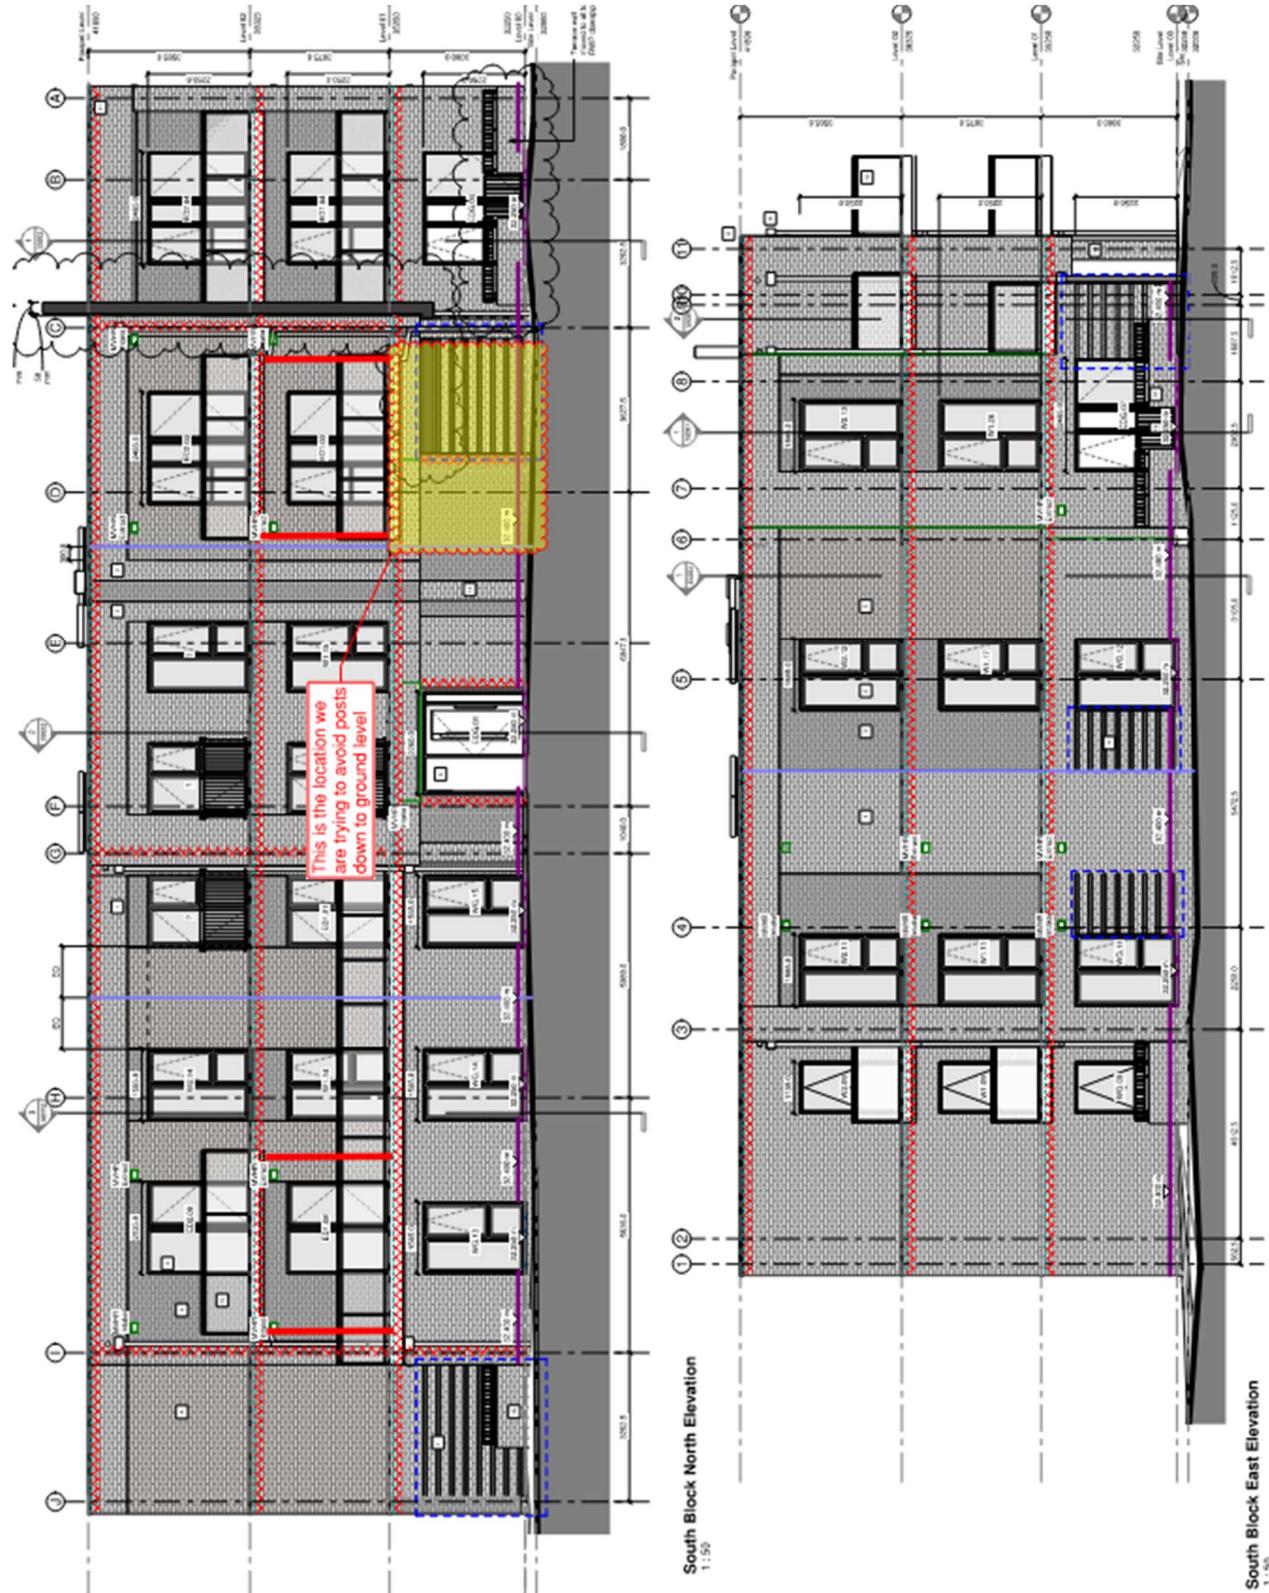
## South Block North & East Elevations

All the columns would come down into the ground floor garden terrace walls and their foundation so those are easy, it is just 2 balconies on the front of the South Block which we are looking at independently to see if we can avoid a column from the first floor down to ground as this is on the entrance route to the block. If this location there is a huge 305 steel, so we are looking to use that to support the first and second floor balconies.
