## ADDENDUM TECHNICAL REPORT ON A SUBSIDENCE CLAIM

**40 Swakeleys Road  
Ickenham  
Uxbridge  
UB10 8BE**

Date of Report 10 April 2017

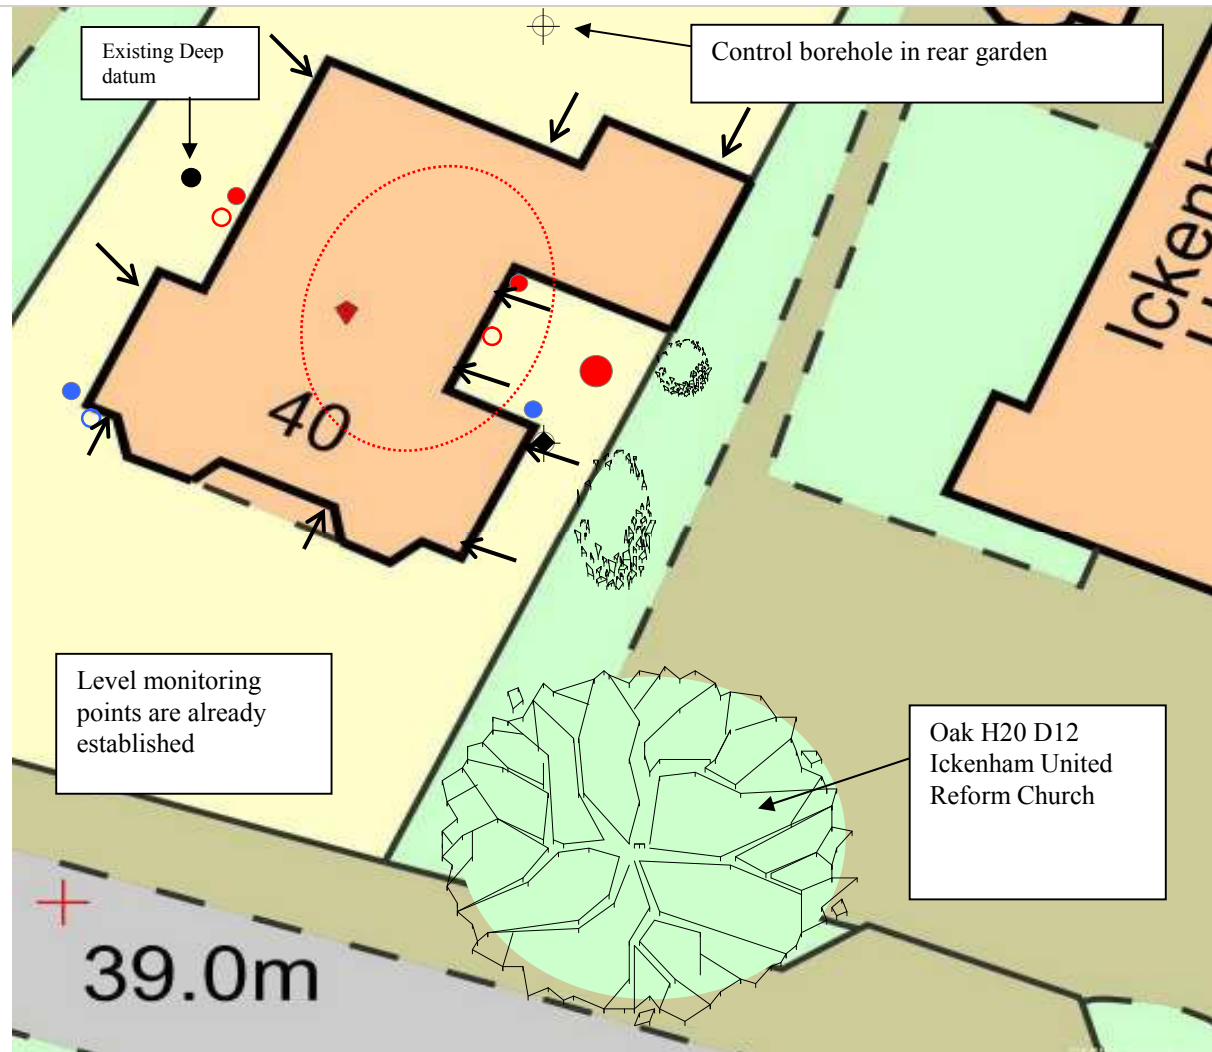
## Site Plan

This plan is diagrammatic only and has been prepared to illustrate the general position of the property and its relationship to nearby trees etc. The boundaries are not accurate, and do not infer or confer any rights of ownership or right of way. Position of utilities is only indicative and contractors must satisfy themselves regarding actual location before commencing works.

Referring to their report, MWA implicated the Church owned Oak tree, T1. The tree was last reduced in 2009 by 40% according to search into previous permissions granted. Tree felling has been recommended as the best measure of ensuring long term property stability considering this is the third claim to the property involving the Oak tree.
