project
Dower House, 393 High Street, Harlington

title
East Elevation- Proposed Repairs and Alterations.

scale	status
1:50 @A2	PLANNING
job no.	dwg no.
784	D-037
	status/revision
	PL01

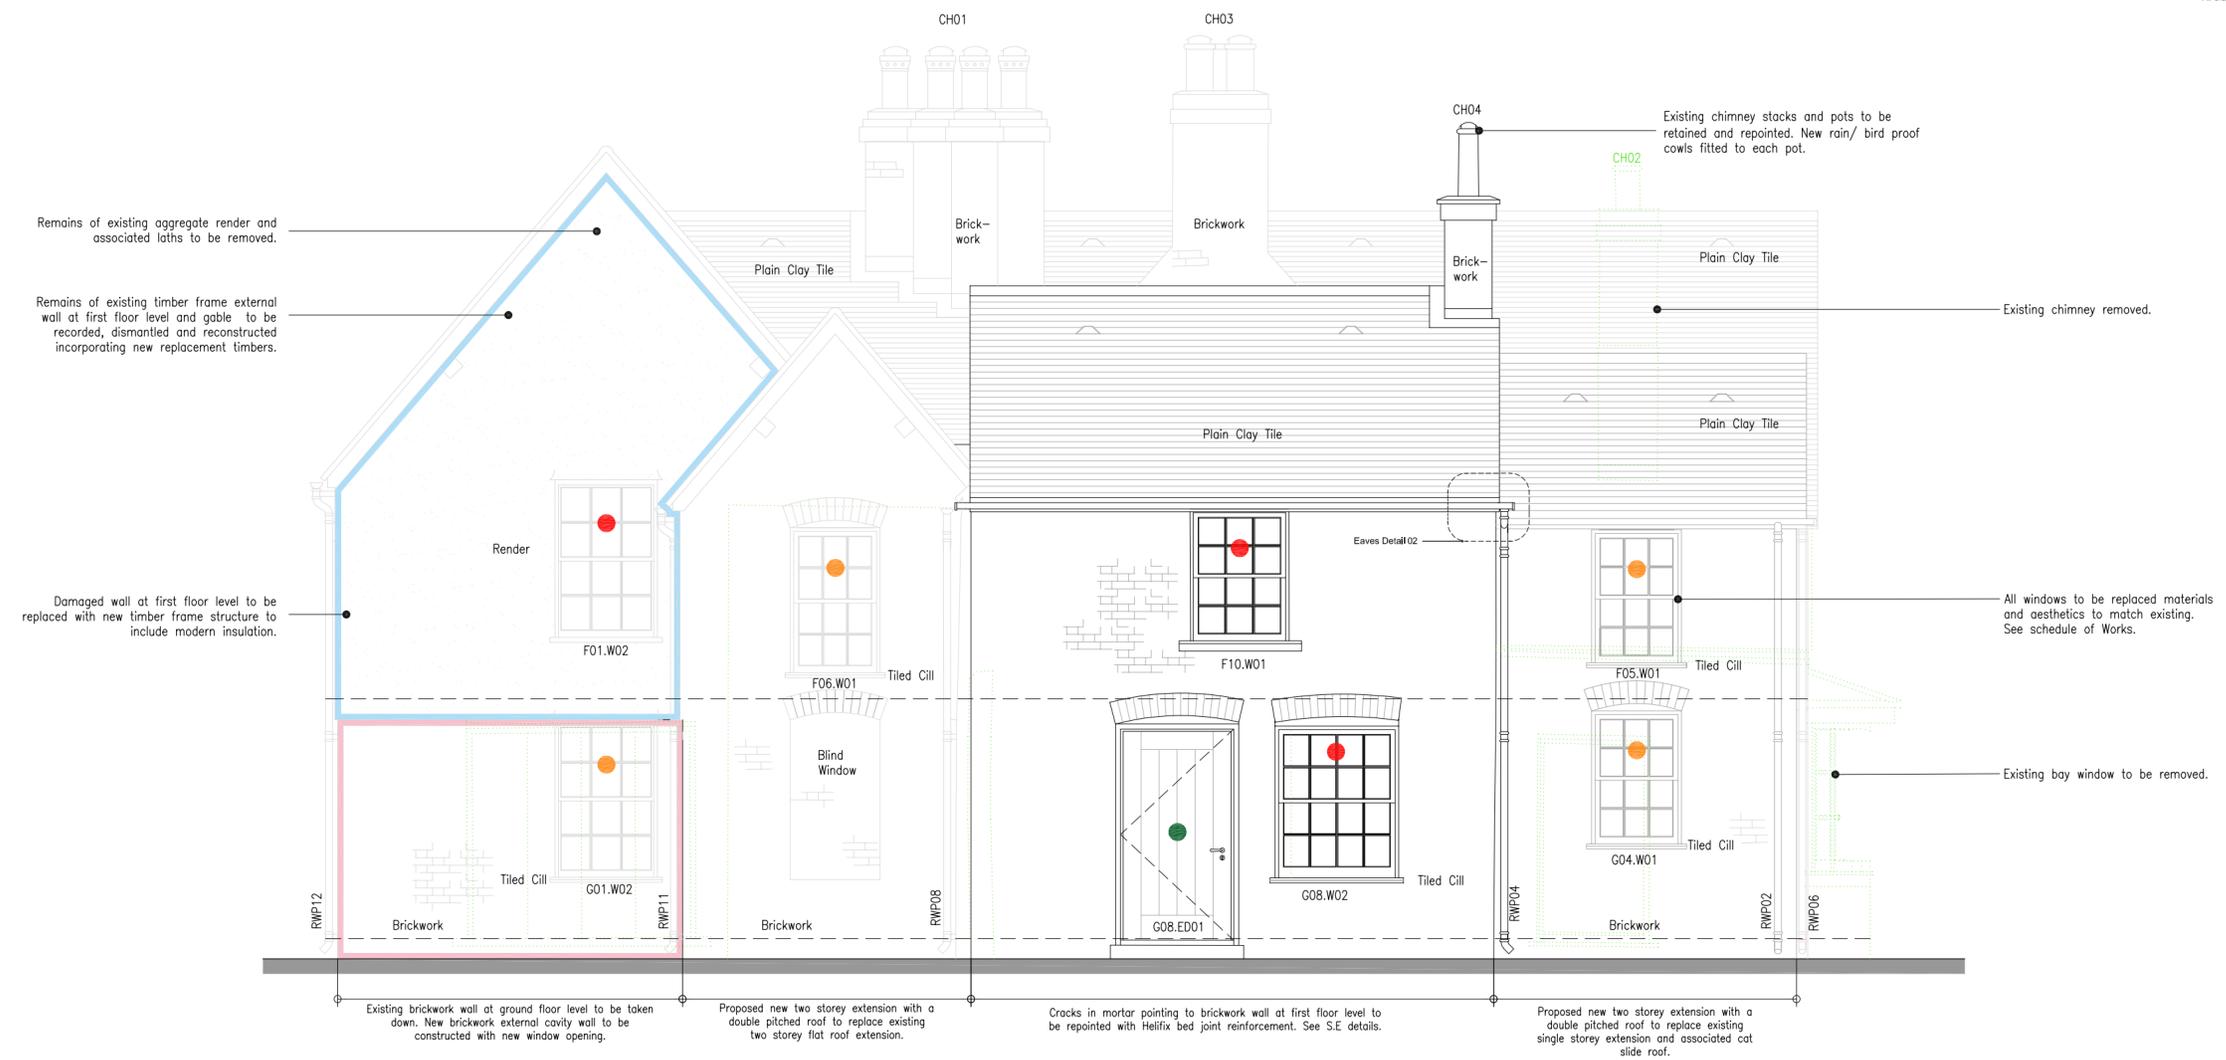
01 EAST ELEVATION
1:50

- Key
- Taking down/demolition & removal.
 - External doors all to be replaced with new door and frame.
 - Replace existing timber sash / casement timber window and associated frame. Paint to match existing on a like for like basis including moulding and cill details.

- Existing sash window removed or door. Existing window opening adjusted to . New timber vertical sliding sash window installed and opening adjusted to suit.

- New external door and frame in new brickwork opening with segmental arch.
 - Existing external brickwork wall to be dismantled and rebuilt to match existing on a 'like for like basis'.

- Existing fire damaged timber frame to external wall to be dismantled, repaired and re-assembled in former position with new timber frame elements to replace existing timbers beyond repair.

- New brickwork bedded and jointed in lime mortar to match existing bond & course heights on a 'like for like' basis.

ROOF COVERINGS: Remains of existing roof coverings to be removed. New reinstated and existing roofs to be covered in new handmade plain clay tiles with long Back ridge tiles, bonnet hip tiles and swept valley tiles.

RAINWATER GOODS: All existing eaves, gutters, downpipes and associated brackets and fixings are to be removed and replaced with cast iron rainwater goods.
