**REMEDIATION STRATEGY & VERIFICATION PLAN**  
**of a site at**  
**LAND ON THE EAST SIDE OF NEWPORT ROAD, HAYES,**  
**UB4 8JX**  
**for**  
**WESTWAY CONSTRUCTION LTD**

**Project No 2077**

**Report ref: 2077-P3E-1**

**Issued: 31 August 2021**

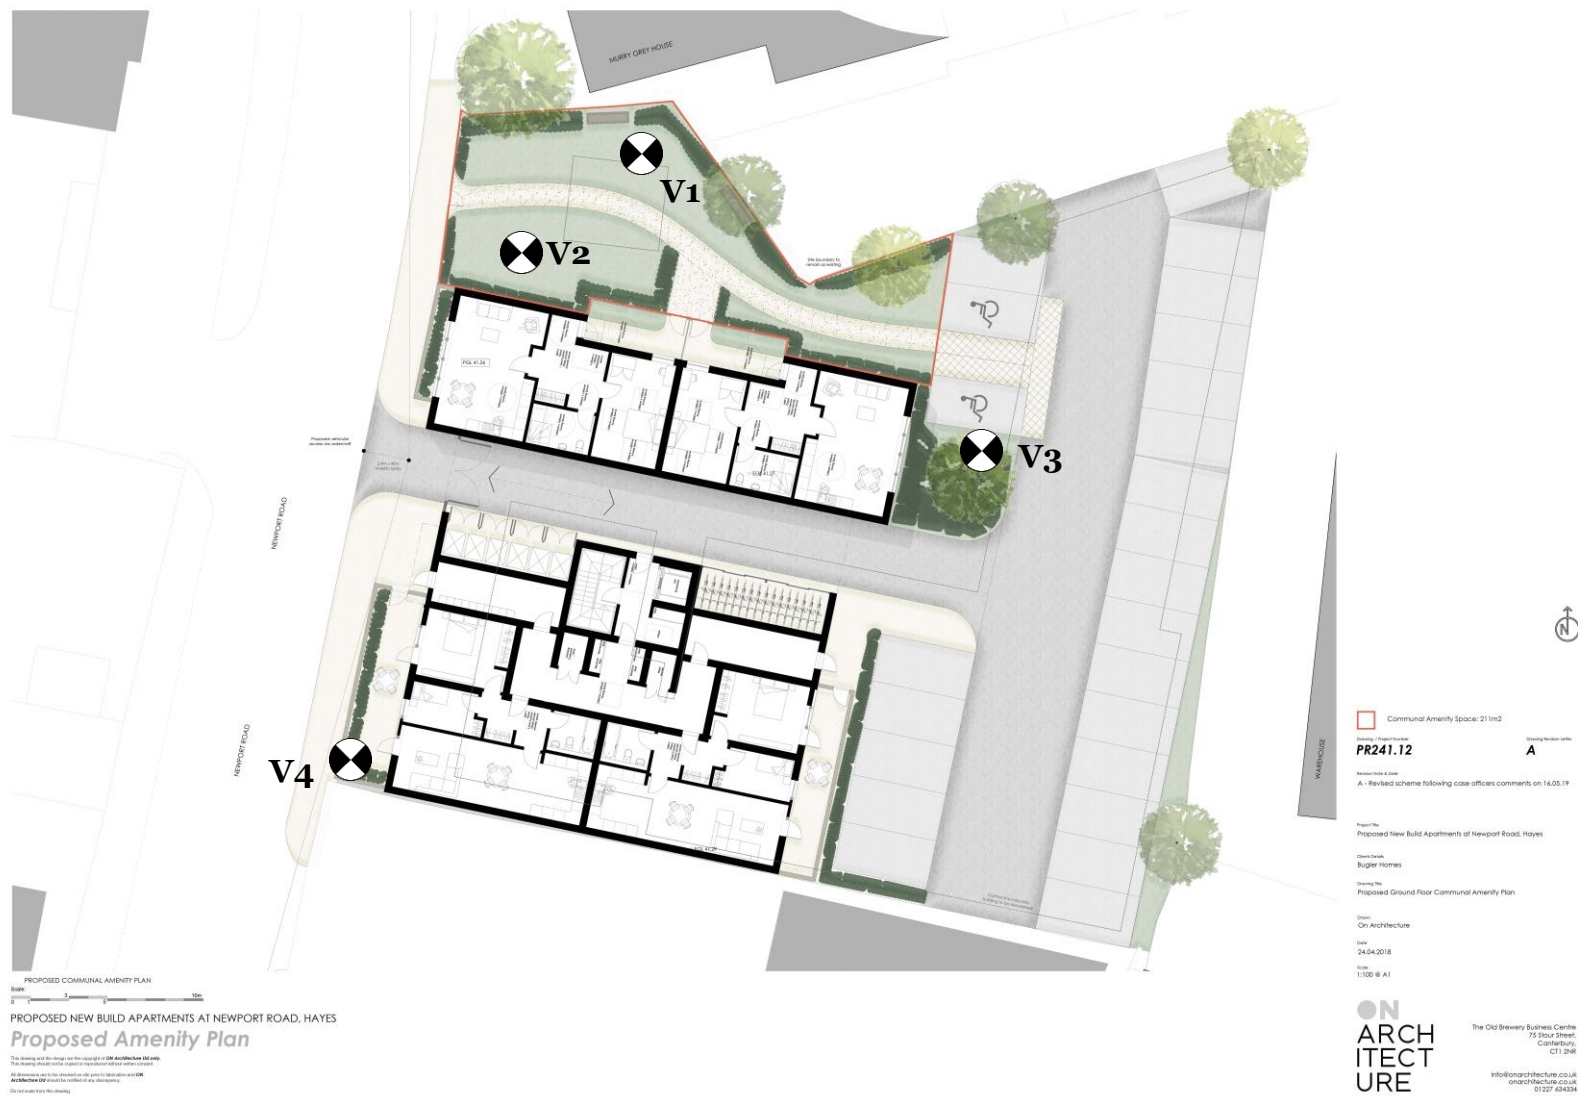
## **Appendix B – Indicative Sample Location Plan**

Verification sampling locations

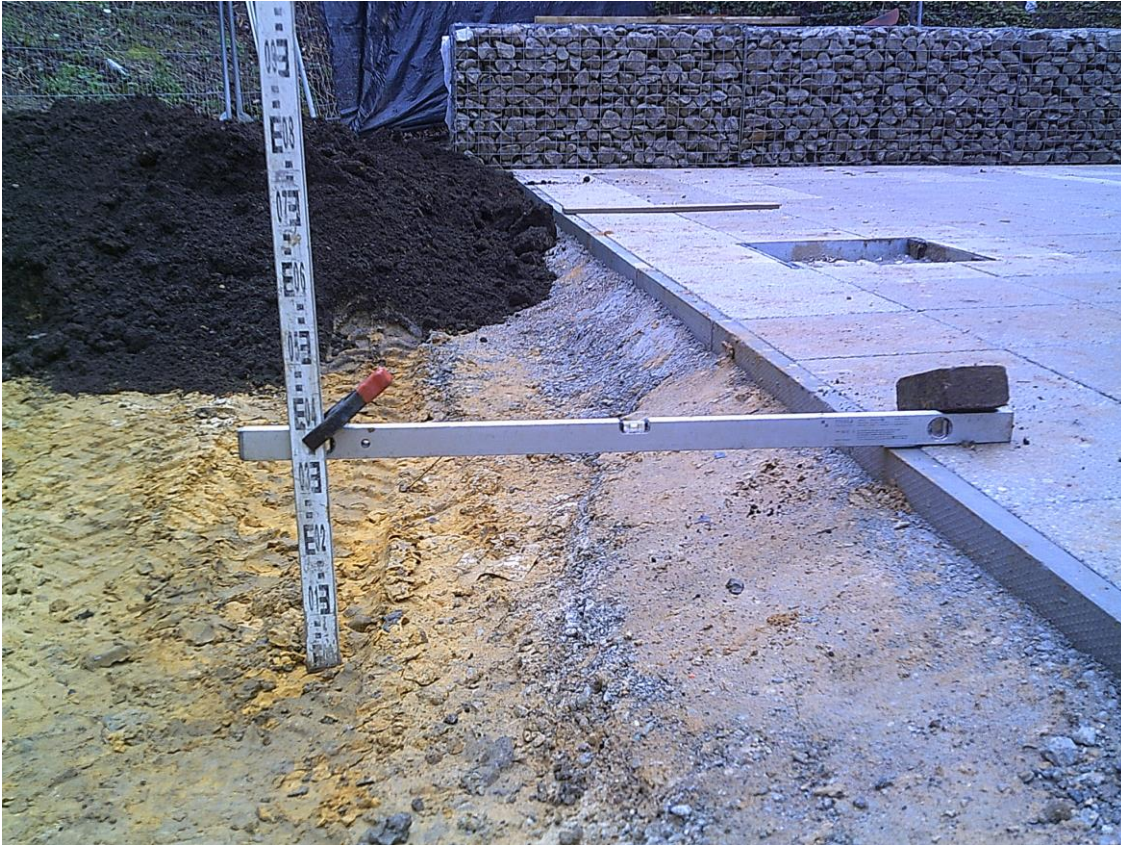
Example A: Close up, showing the depth clearly.

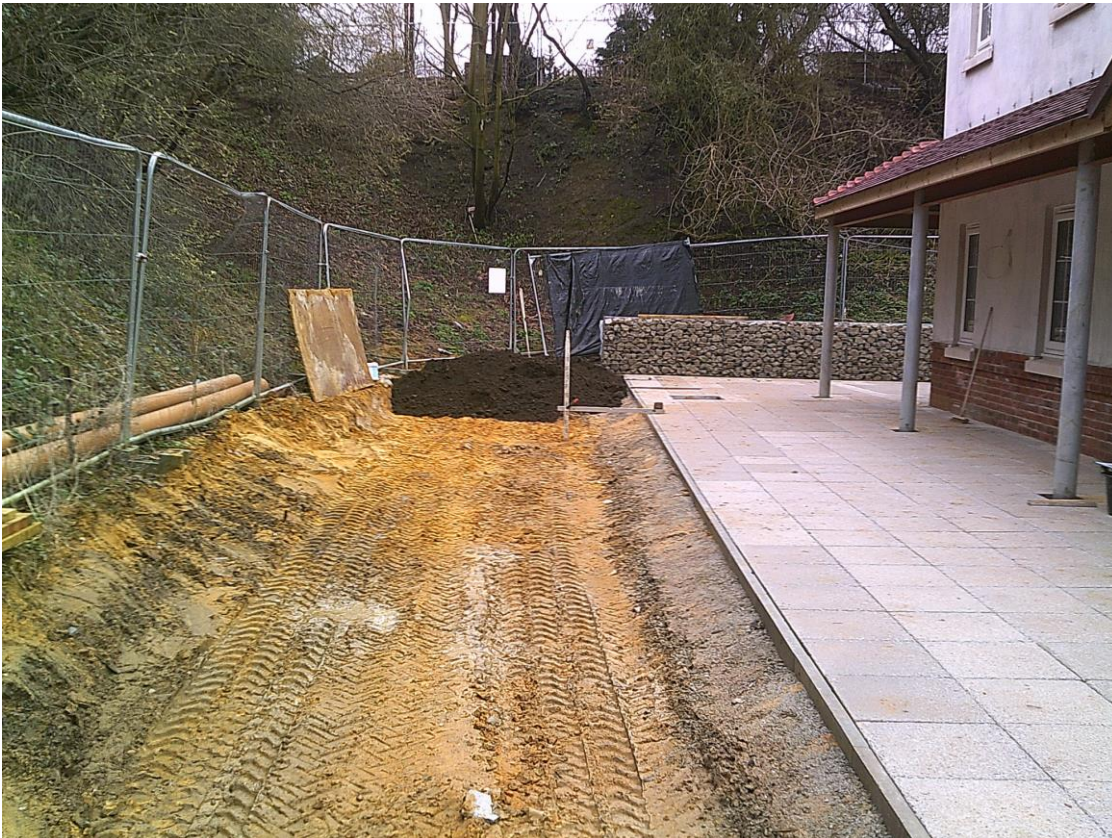
Example A: Showing the location of the close up

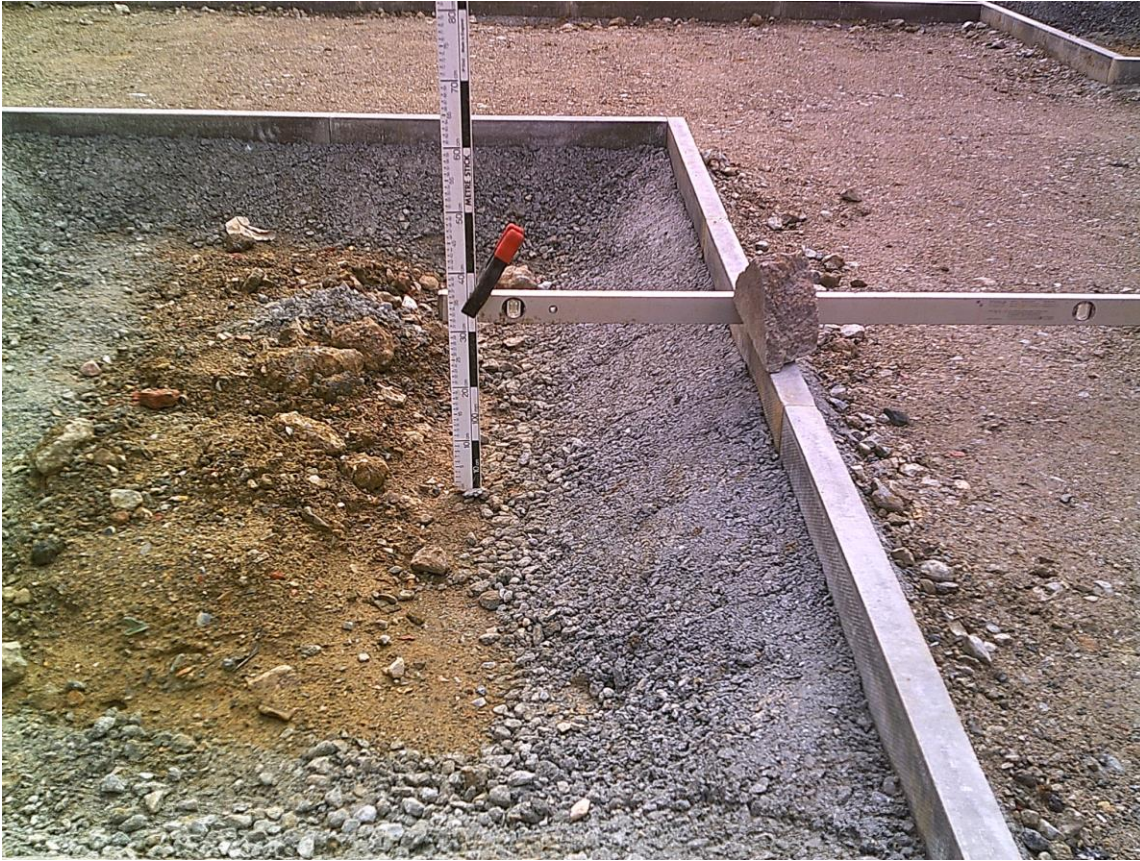
Example B: Close up, showing the depth clearly

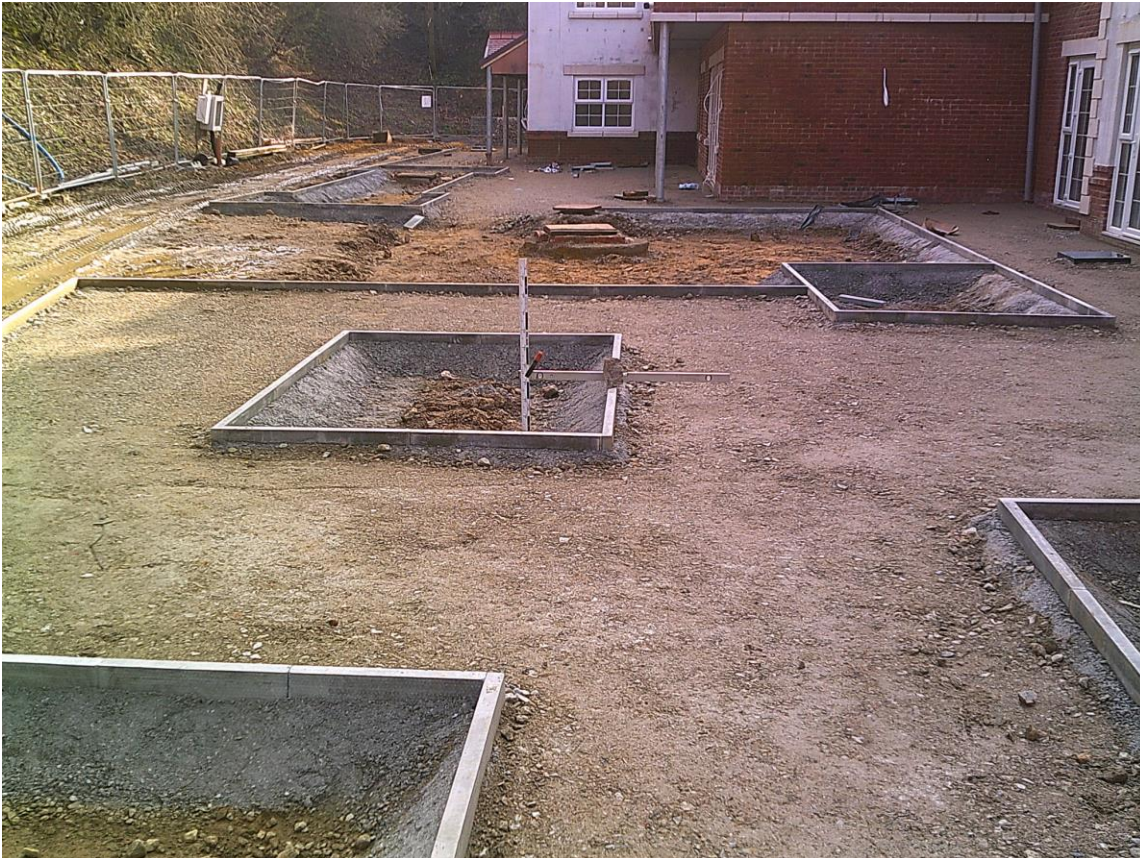
Example B: Showing the location of the close up
