# Preliminary Geo-Environmental Risk Assessment

**Land at Stone Close, West Drayton, UB7 8JU**

**Presented to St James Place UK Plc c/o Orchard Street Investment Management LLP**

Delta-Simons Project No. 17-0685.01

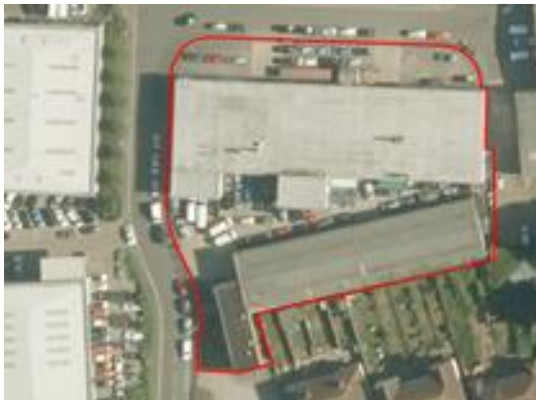
| <p>Contains OS data ©, Crown Copyright and Database Right (2017)<br/>Contains Data from, © 2017 Landmark Information Group Ltd</p> | | <p>Contains Data from, © 2017 Getmapping Plc<br/>Contains Data from, © 2017 Landmark Information Group Ltd</p> | |
|---|---|---|---|
| Current Site Use | <p>Delta-Simons conducted a Site visit on 17<sup>th</sup> November 2017. A relevant Feature Plan is included as Figure 1 and a photographic log is presented as Appendix D. Pertinent information that was observed or reported on-Site is summarised as follows:</p> <ul style="list-style-type: none"> <li>▲ The Site comprises two vacant light industrial units with integral office space, service yard; and limited soft landscaping. Anecdotal evidence and observations on Site indicate that the Site's former use was associated with vehicle body repairs;</li> <li>▲ The Site was secured by metal fencing and barriers, preventing vehicle access to the Site. A manual entrance gate was present in the south-west of the Site providing access to the southern car park area; an inoperative motorised gate was present at the western boundary providing access to the central service yard; and locked bollards were present at the northern boundary providing access to the northern yard area. Concrete security blocks were placed at each access point, in addition, members of the public were noted to be parked around the whole western and northern boundaries of the Site preventing access from Stone Close;</li> <li>▲ A compressor room was present on the northern elevation of the northern unit;</li> <li>▲ A possible interceptor and suspected former plant housing (wooden enclosure on the northern elevation) was also present to the north of the northern unit;</li> </ul> | | |
