**REMEDIAL STRATEGY  
AND  
VERIFICATION PLAN**

**PROPOSED DEVELOPMENT AT  
BEACHES YARD, HORTON ROAD, WEST DRAYTON, UB7 8HX**

**Report Title:** Remedial Strategy & Verification Plan for Beaches Yard, Horton Road, West Drayton, UB7 8HX

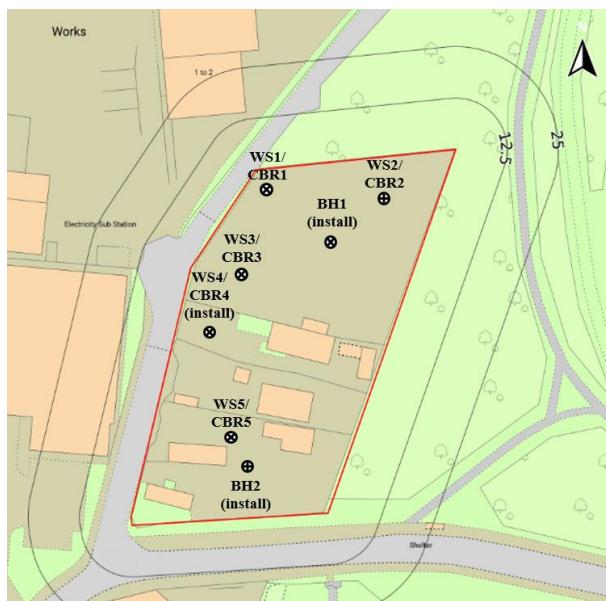
2.2.7 Figure presented below, shows location of exploratory holes: BH1 - BH2 and WS1 - WS5.

2.2.3 A strong hydrocarbon odour was noted in the Made Ground in exploratory location BH2 at a depth of 3.5m- 5.3mbgl.

2.2.4 Possible asbestos containing materials (ACMs) were noted in the Made Ground in exploratory location BH2 (0.0m – 1.1mbgl).

2.2.5 Black staining was noted in the Made Ground in exploratory locations WS3 (1.6m – 5.45mbgl) and WS4 (1.1m – 4.0mbgl) .

2.2.6 Groundwater was reported during the drilling process in BH1 at 2.70m bgl (rose to 2.40m bgl after 20 minutes) and in BH2 at 2.60m bgl (rose to 2.10m bgl after 20 minutes). During return monitoring groundwater was reported at depths of between 1.07m and 2.82m bgl, within wells extending to 5.33mbgl.
