1. Can the applicant please provide the chemical analysis test result for imported soil materials brought to the site in February 2025?

2. Whilst the proposed applicant remedial strategy of providing a combination of hardstanding and a simple cover system to areas of soft landscaping is noted, we have no evidence of excessive trees on site to prevent the installation of the agreed 460mm clean cover system on the site.

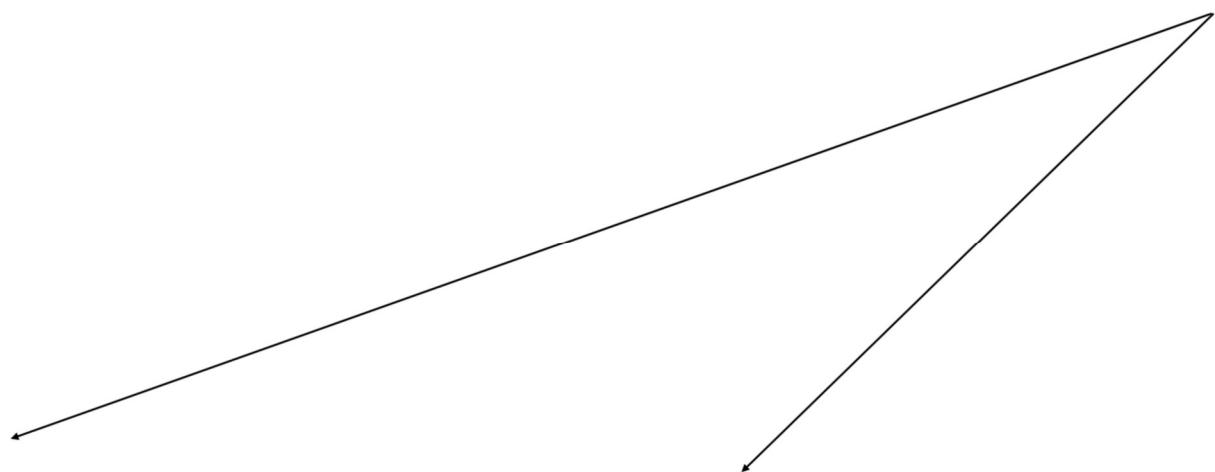
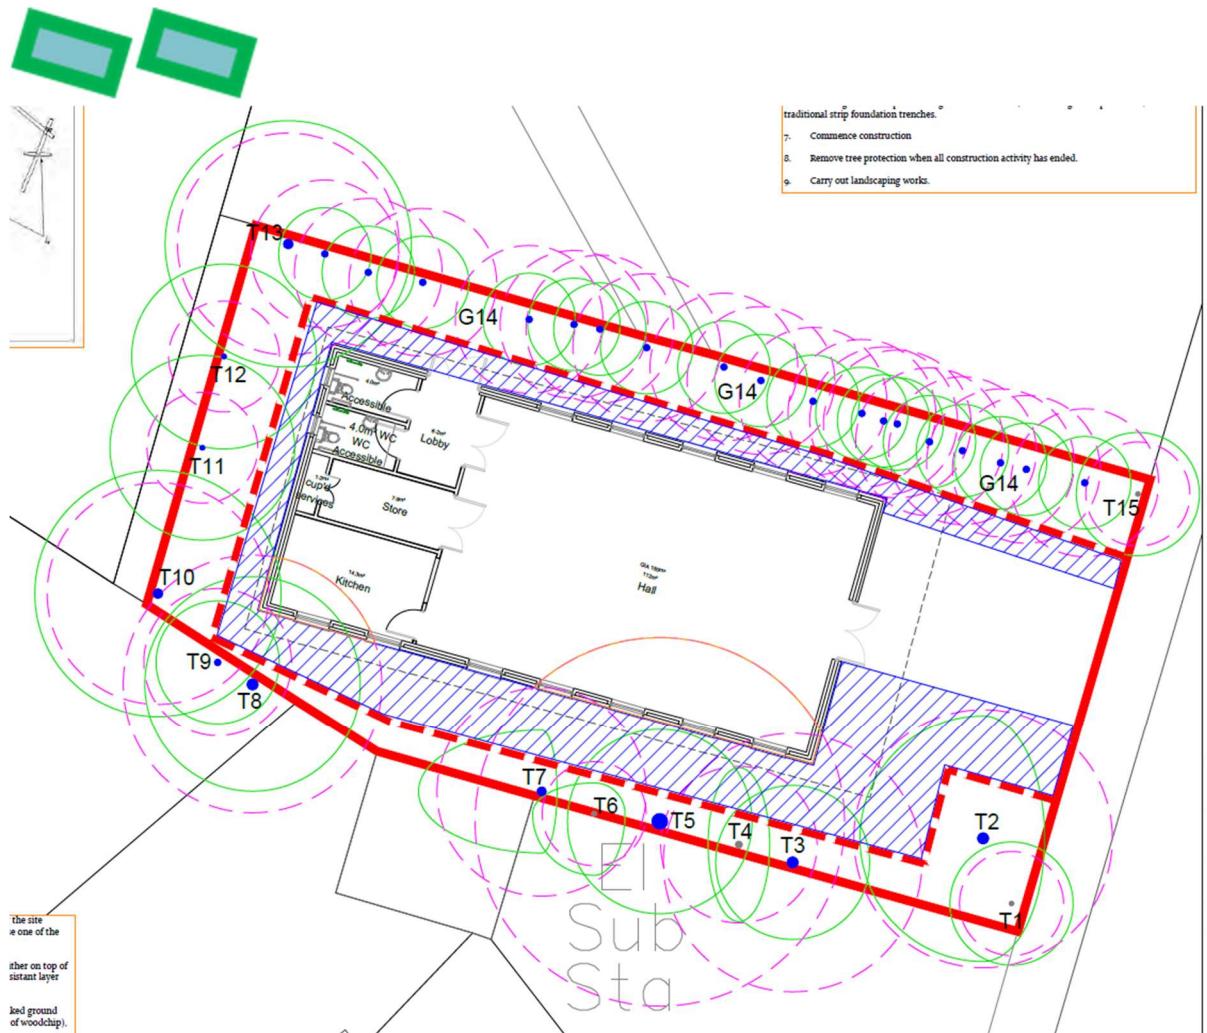
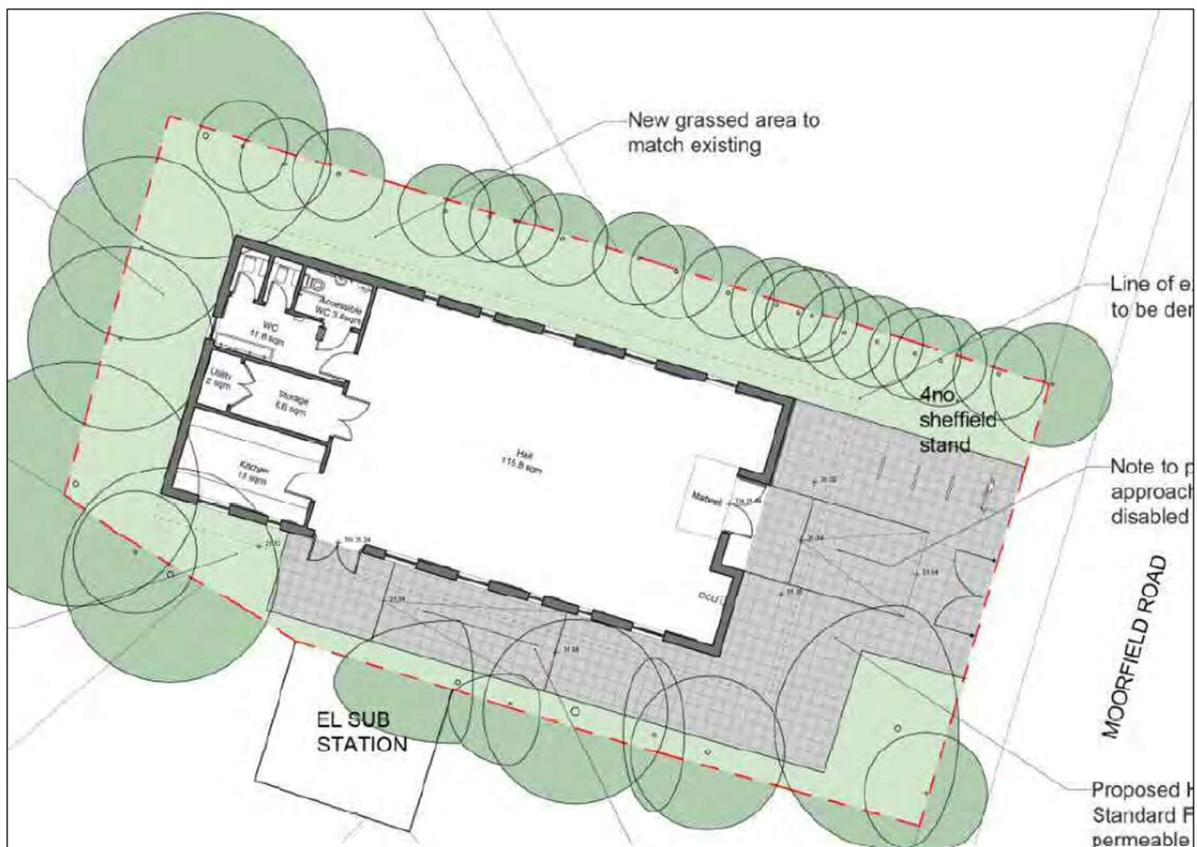
The following drawings which were appended to the latest Verification Statement, make it clear that the majority of the site is either subject to provision of hard landscaping (blue hashed areas on the left hand drawing and grey areas on the right hand drawing) or within root protection zones (pink dashed circles). For clarity, the only area of soft landscaping, which is not restricted by the root protection zones, or by provision of hard landscaping (which mitigates the requirement for a simple cover system) is highlighted

in green below. Alternatively, we would welcome a site visit to help in providing a better understanding of the site layout and restrictions.

As noted above, the soil cover strategy has been developed to take account of the on-site restrictions associated with the proposed final levels and root protection zones in accordance with the NCLOG guidance, therefore we would welcome a meeting to discuss why the NCLOG guidance is not suitable for this site and to assist in the development of an alternative strategy. The submitted report confirms that the installed capping within areas of soft landscaping comprises a geotextile marker membrane, overlain with a layer of clean imported topsoil, which is in turn overlain with Tensar SS20 which has been further dressed with additional imported clean topsoil to cover the layer of geogrid. The nature of this cover system is such that the two layers of geotextile and geogrid will prevent end users of the site from digging into any underlying residual contamination, acting as a physical barrier, which we consider to be in accordance with the NCLOG guidance for root protection zones within managed areas of communal soft landscaping.

As noted above, the simple cover system applied at the site comprises a geotextile marker membrane at the base, clean imported topsoil and then Tensar SS20 geogrid, dressed with a final layer of clean imported topsoil, which has been applied as an additional layer of physical barrier to end users inadvertently digging through the clean topsoil and into any underlying potentially contaminated made ground.
