**FLOOD RISK ASSESSMENT  
& DRAINAGE STRATEGY REPORT**  
*PREMIER INN LONDON UXBRIDGE HOTEL  
PHASE, RIVERSIDE WAY  
UXBRIDGE  
UB8 2YF*

**JOB NO:** P24-0616  
**DATE:** 30<sup>th</sup> January 2026  
**ISSUE NO:** 2

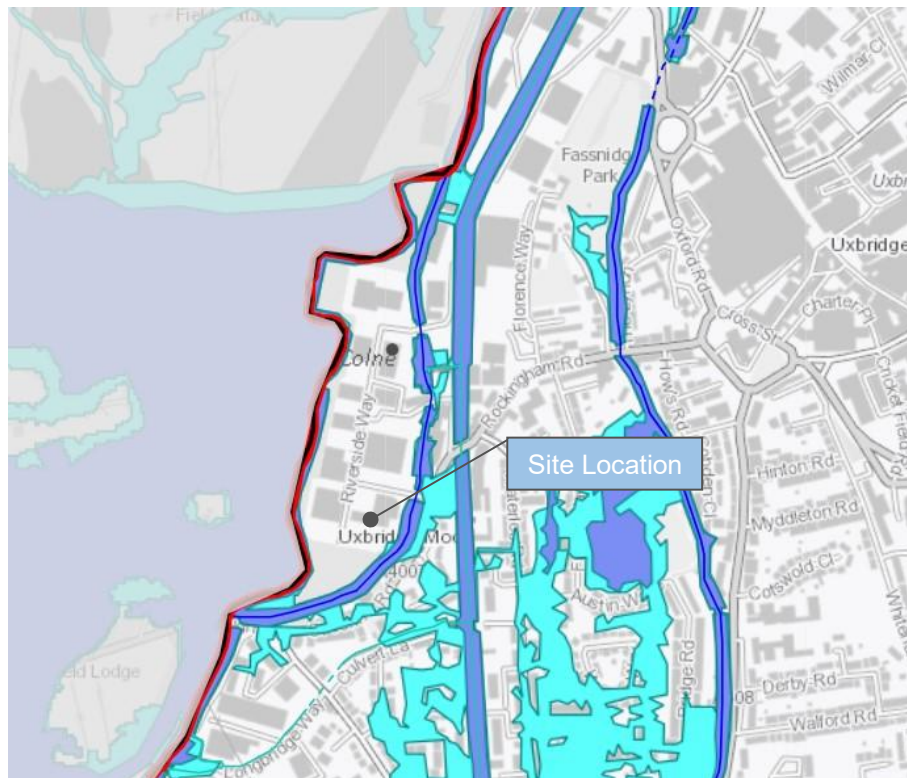
Figure 6: SFRA Flood Zone Mapping

4.5 Figure 6 shows the Flood Zone mapping extracted from the SFRA which concurs with the EA Flood Zone mapping.

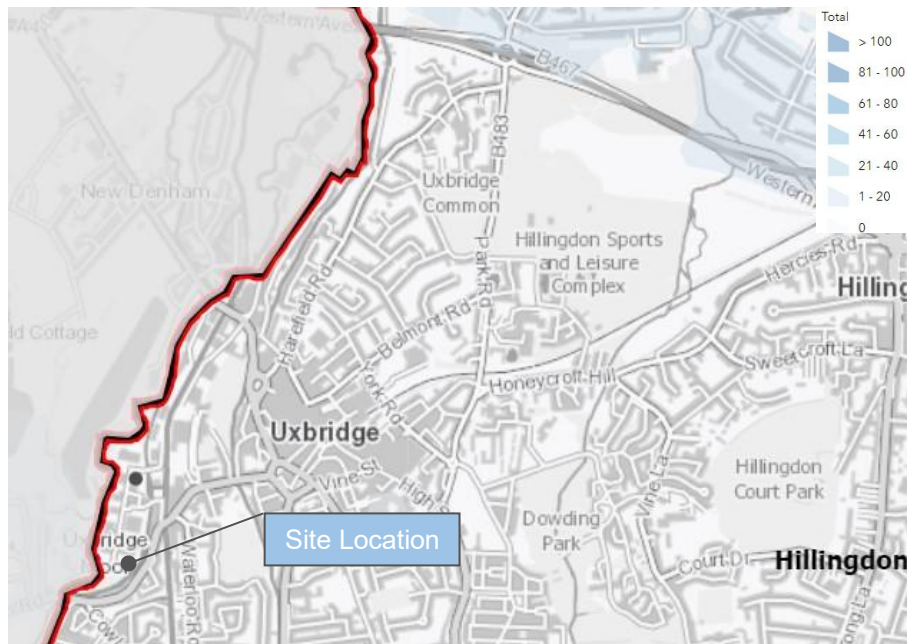
Figure 10: SFRA Sewer Flooding Records Map

- 4.17 Sewer flooding occurs due to sewer infrastructure failure or due to an increased flow and volume of water entering a sewer system which exceeds its hydraulic capacity, causing the system to surcharge. If sewer outfall points are either blocked or submerged due to high water levels, water can back up in a sewer system and cause flooding. These issues can result in water overflowing from gullies and manholes, causing flooding in the local area.
- 4.18 Thames Water is the sewerage undertaker for the sub-region. *Figure 10* below shows the sewer flooding records map extracted from the SFRA. It shows the site to not have experienced any sewer flooding incidents.
