DAYLIGHT AND SUNLIGHT STUDY

Tormead, 27 Dene Road
by Love Design Studio

January 2023
PR442_V4

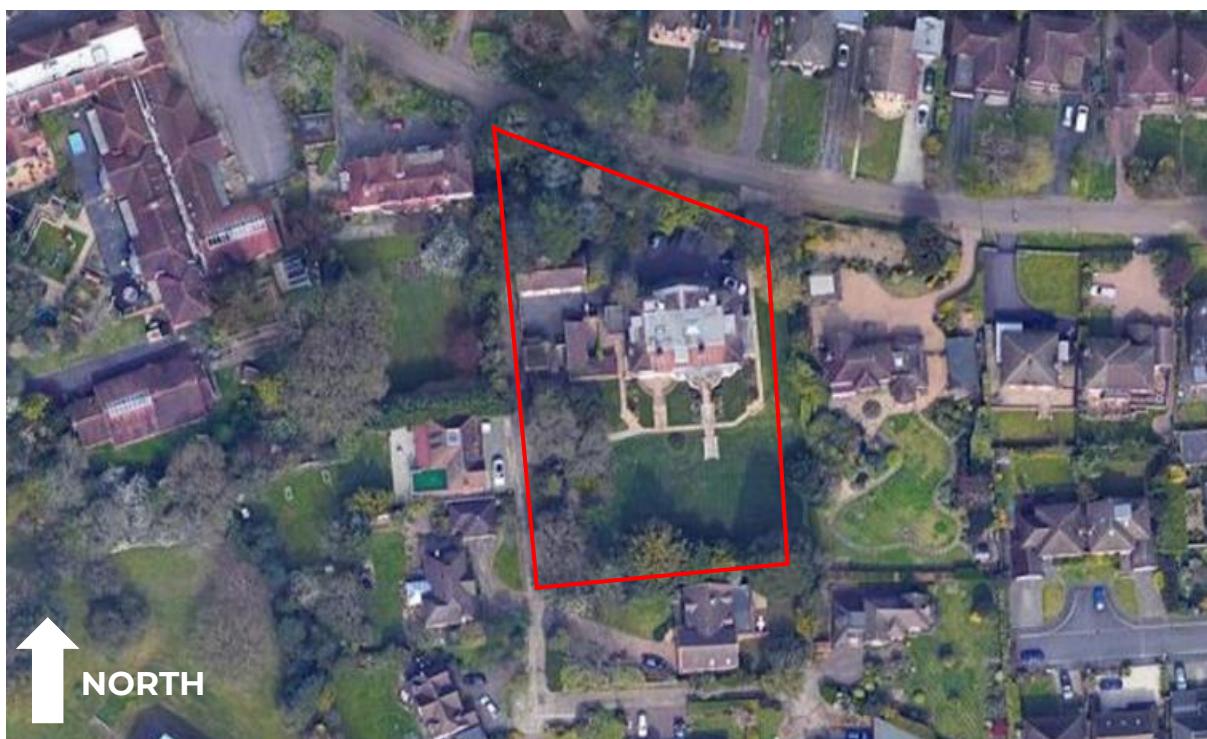
Figure 1: Existing Site (Tormead, 27 Dene Road, Red)

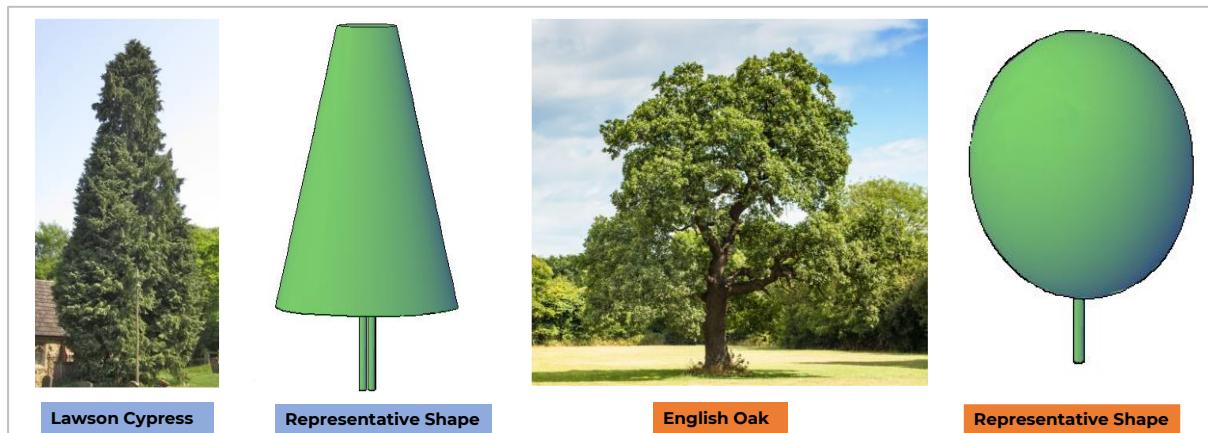
Figure 2: Example of a Lawson Cypress (©Tree Guide UK) and English Oak (©GardenersWorld) illustrated with their representative shape used for modelling

Furthermore, to model a representative shape of the surrounding trees, the trees were identified to be either an ellipsoid or cone-like shape. For example, Figure 2 illustrates an example of a Lawson Cypress, which was a species of tree found across the proposed site and was accordingly modelled using a cone-like shape. Comparatively, the English Oak tree, which was another species of tree found across the proposed site, was accordingly modelled using as an ellipsoid shape. Although the trees were modelled using simplified shapes, the dimensions extracted from the Arboriculture Report were still applied for each individual tree.

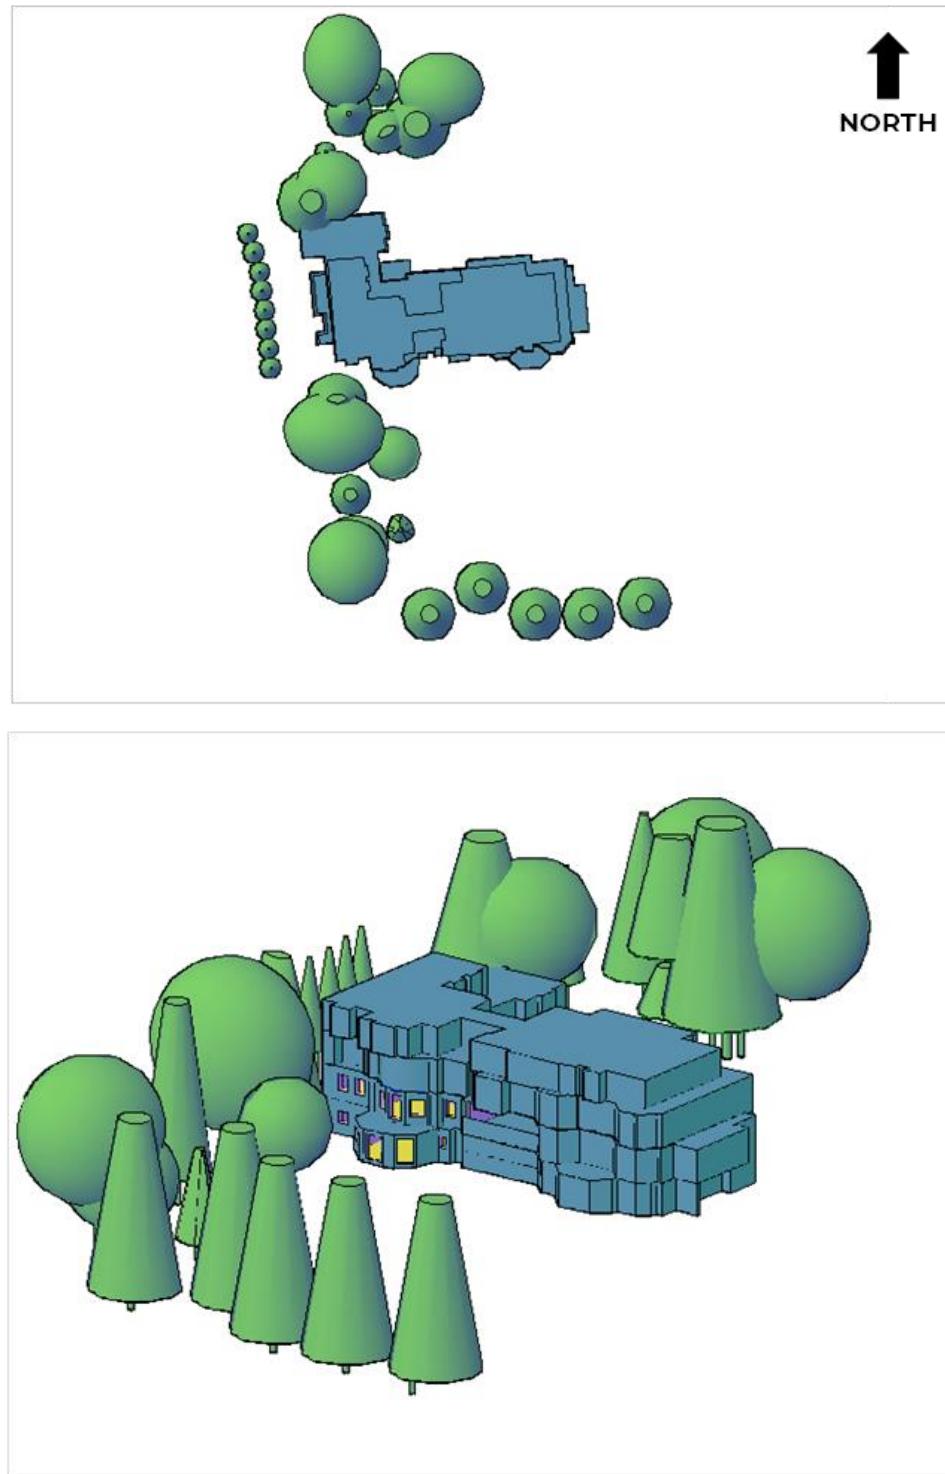
Figure 3: Aerial views of the daylight and sunlight model for the proposed development and surrounding trees (plan view, top; southeast view, bottom)

For reference, please see below images of the constructed model from the relevant software; this is for illustrative purposes only.

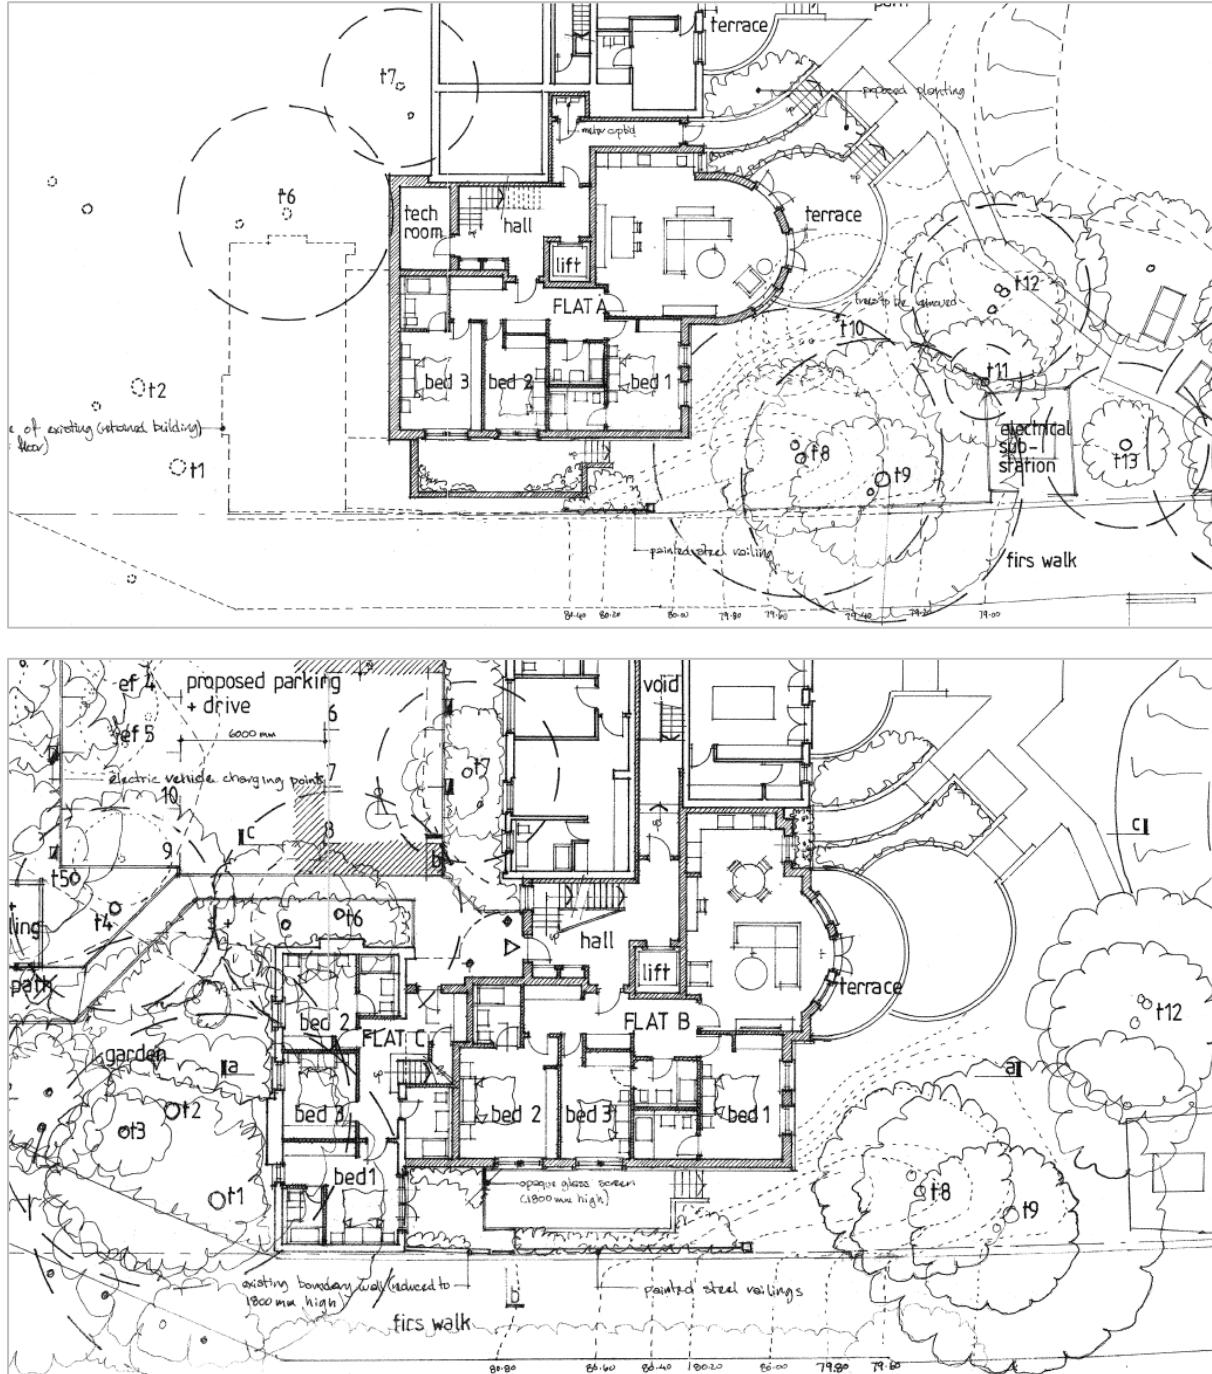
Figure 4: GNP Architects Lower Ground Floor rooms at Flat A (top) and Ground Floor rooms at Flats B and C (bottom).

For reference, please see below images of the pdf drawings used to model the internal layouts.

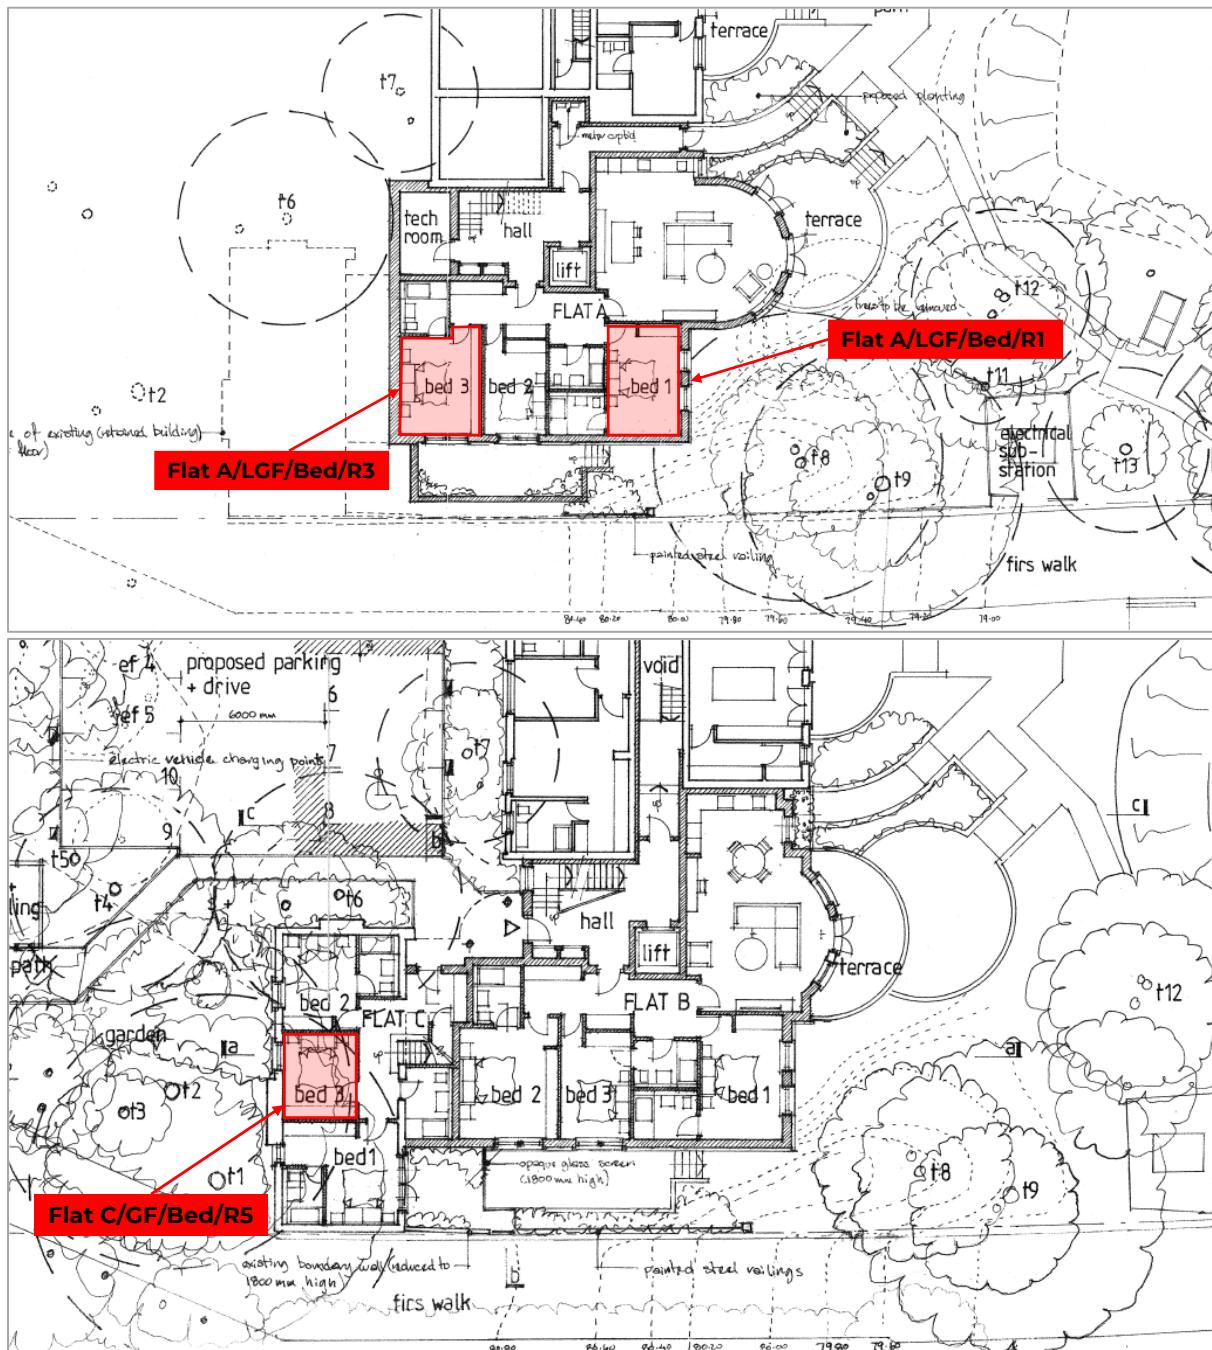
Figure 5: GNP Architects Lower Ground Floor rooms in Flat A (top) and Ground Floor rooms in Flats B and C (bottom) illustrating the rooms impacted by the surrounding trees in the winter (red).

The BRE guidelines place a higher priority on achieving daylight targets in living rooms over other habitable rooms; also, daylight is appreciated more in the winter than the summer. Both the LKDs to Flats A and B (Flat C LKD not assessed) exceed daylight targets in the winter months.

Overall, three bedrooms fall short of daylight targets, namely two out of the three bedrooms assessed in Flat A and one out of the three bedrooms in Flat C. Additionally, all bedrooms within Flat B exceed daylight targets. Thus, all assessed dwellings have a minimum of one bedroom receiving adequate daylight in the winter.

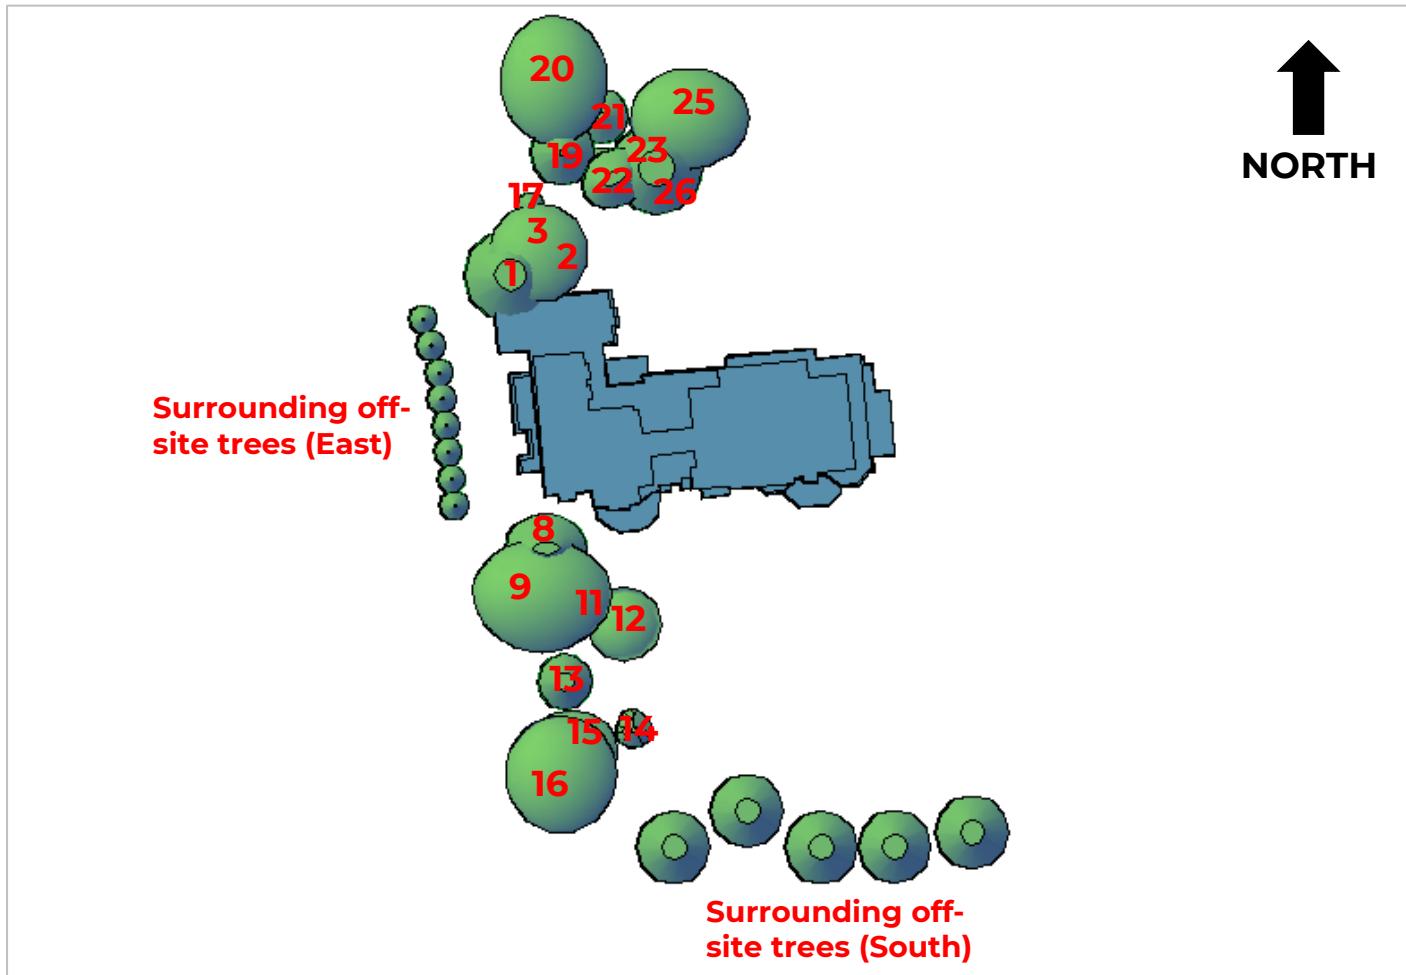
Figure 6: Plan view of the proposed site with the modelled surrounding trees

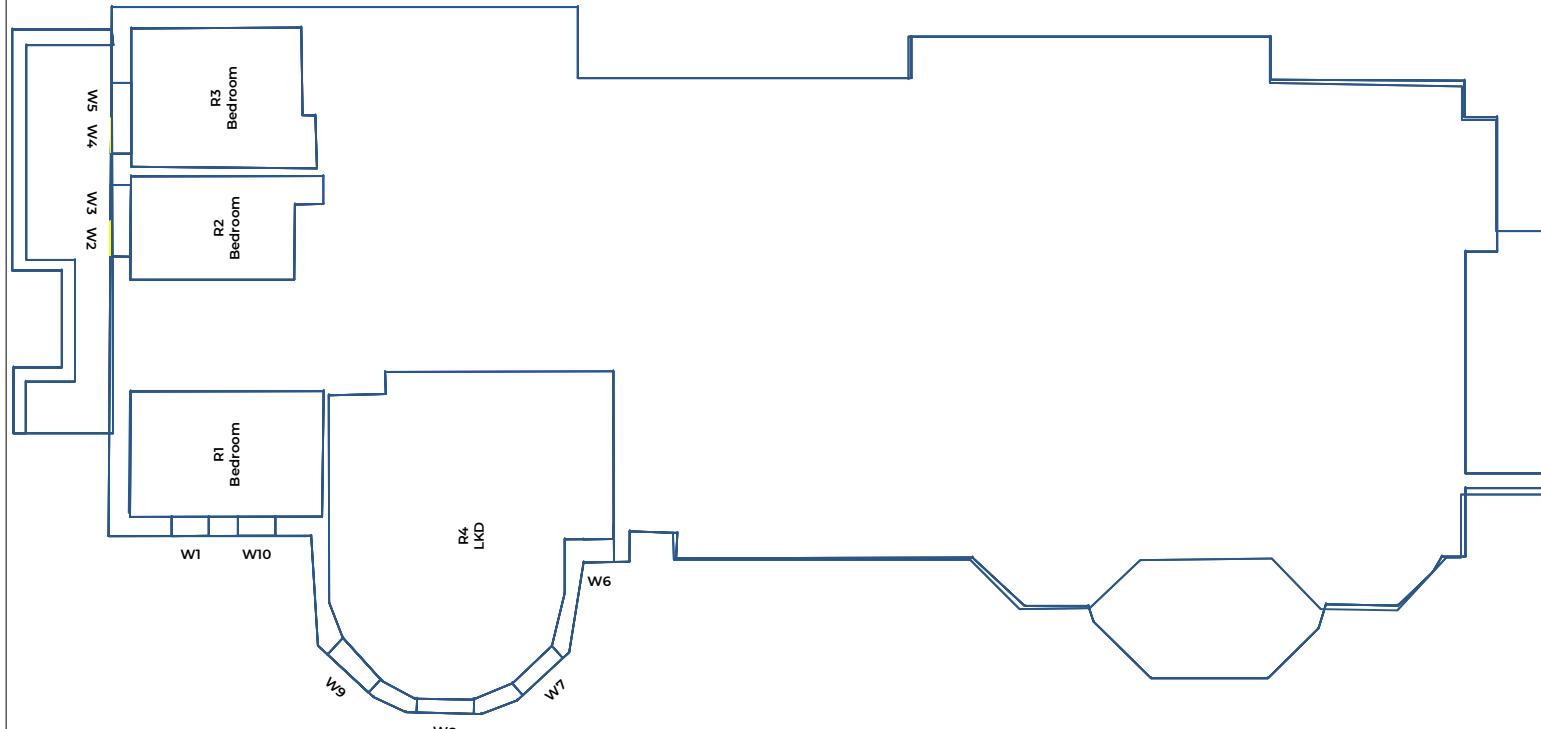
Date: 01/06/2022
Drawing: 442-27DR-WR/RR-LGF
Issue: 00A

Tormead, 27 Dene Rod
Lower Ground Floor
Window Ref
Room Ref

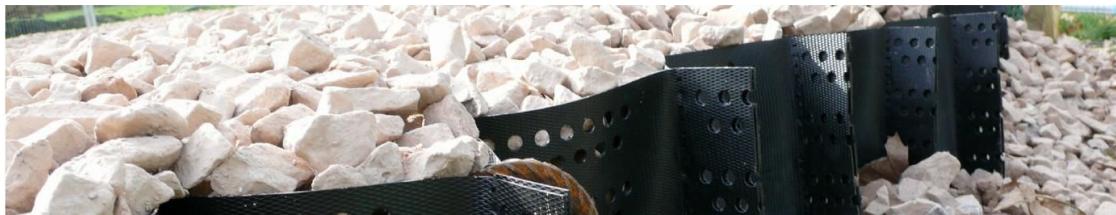
Cellweb® TRP Key Functions

Cellweb® is a 'no dig' solution which is constructed directly on the existing ground surface. This eliminates the requirement for excavation, preventing root severance.

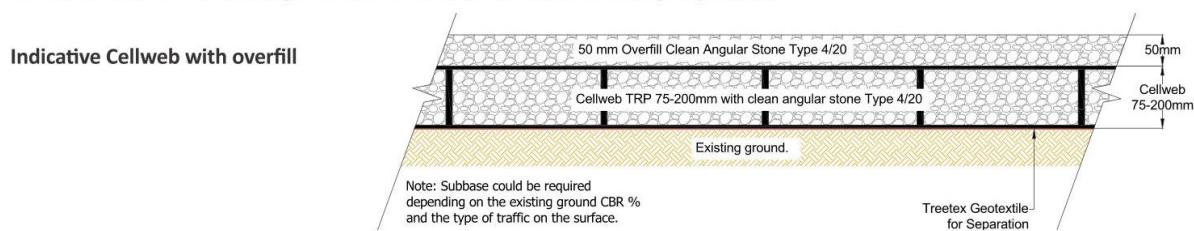
Which depth of Cellweb® TRP?

The Cellweb® System is provided in four different depths; 200mm, 150mm, 100mm and 75mm. The depth required is determined by the proposed traffic loadings and the site ground conditions. Geosynthetics in house engineering department can provide a free site specific technical recommendation. For free technical and engineering support please contact Geosynthetics Ltd 01455 617139 or the full installation guide can be found on our website www.geosyn.co.uk.
