# DENVILLE HALL, 62 DUCKS HILL ROAD, LONDON

## Demolition and Construction Management Plan (DMP/CMP)

**SITE INVESTIGATION REPORT**

**DENVILLE HALL, 62 DUCKS HILL ROAD, NORTHWOOD, HILLINGDON HA6 2SB**

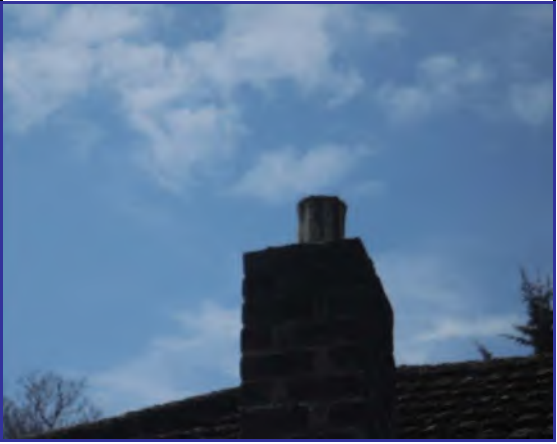
| <b>Building</b><br>Bungalow | <b>Job no</b><br>13366/192 | <b>Sample No</b><br>SES / Xa | <b>Photo</b><br> | |
| <b>Location</b><br>Roof, Chimney stack | <b>Type of material</b><br>Moulded cement | | | |
| <b>Installation</b><br>Moulded Cement Cowl | <b>Content</b><br>STRONGLY PRESUMED ASBESTOS<br>Significant | | | |
| <b>Material Assessment Score</b> | <b>5</b> | <b>RISK CATEGORY</b> | <b>D</b> | <b>General remarks</b><br>The moulded cement cowl is installed to the roof top chimney stack. The cowl should be removed by a competent contractor prior to any removal works. |

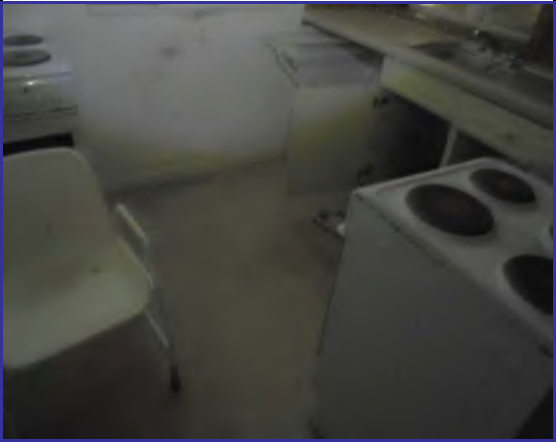
| <b>Building</b><br>Flats | <b>Job no</b><br>13366/192 | <b>Sample No</b><br>SES / 02 | <b>Photo</b><br> | |
| <b>Location</b><br>Kitchen Floor | <b>Type of material</b><br>Thermoplastic asbestos | | | |
| <b>Installation</b><br>Plastic Tiles | <b>Content</b><br>CHRYSTILE<br>Significant | | | |
| <b>Material Assessment Score</b> | <b>2</b> | <b>RISK CATEGORY</b> | <b>D</b> | <b>General remarks</b><br>The plastic floor tiles are laid to the kitchen floor area within flat 3. The tiles should be removed by a competent contractor prior to any works commencing. |

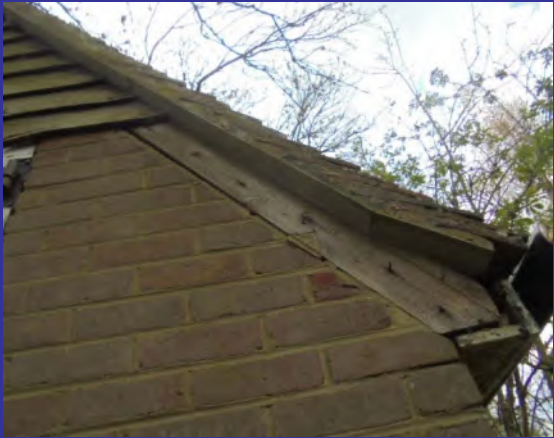
| <b>Building</b><br>Garage | <b>Job no</b><br>13366/192 | <b>Sample No</b><br>SES / 05 | <b>Photo</b><br> |
| <b>Location</b><br>Roof Edges | | <b>Type of material</b><br>Cement sheet | |
| <b>Material Assessment Score</b><br><b>3</b> | <b>RISK CATEGORY</b><br><b>D</b> | <b>General remarks</b><br>The cement undercloak is fitted beneath the roofing tiles on one side of the pitch on both the front and rear gable ends. The cement sheets should be removed by a competent contractor prior to any works commencing. | |

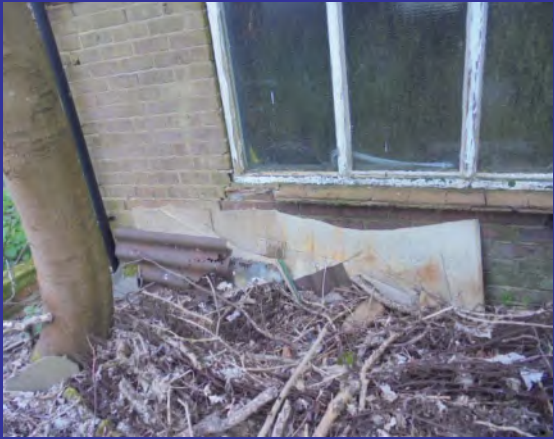
| <b>Building</b><br>Garage | <b>Job no</b><br>13366/192 | <b>Sample No</b><br>SES / 06 | <b>Photo</b><br> |
| <b>Location</b><br>Rear Elevation | | <b>Type of material</b><br>Cement sheet | |
| <b>Material Assessment Score</b><br><b>4</b> | <b>RISK CATEGORY</b><br><b>C</b> | <b>General remarks</b><br>The redundant cement sheets are store externally to the rear of the garage. The cement sheets should be removed by a competent contractor prior to any works commencing. | |

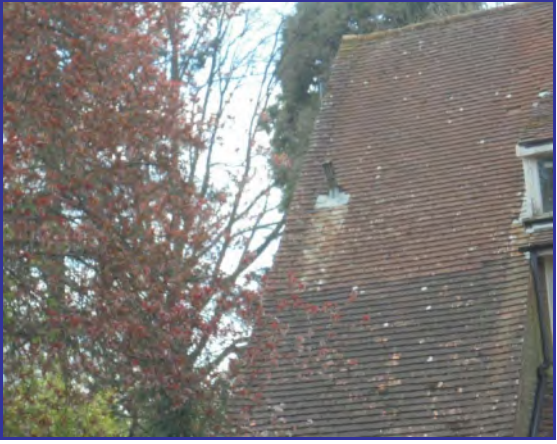
| <b>Building</b><br>Flats | <b>Job no</b><br>13366/192 | <b>Sample No</b><br>SES / Xb | <b>Photo</b><br> |
| <b>Location</b><br>Rear Roof | | <b>Type of material</b><br>Moulded cement | |
| <b>Installation</b><br>Moulded Cement Cowl | | <b>Content</b><br>STRONGLY<br>PRESUMED<br>ASBESTOS<br>Significant | |
| <b>Material Assessment Score</b> <b>5</b> <b>RISK CATEGORY</b> <b>D</b> | | | <b>General remarks</b><br>The moulded cement cowl is installed to the roof.<br>The cowl should be removed by a competent contractor prior to any removal works. |

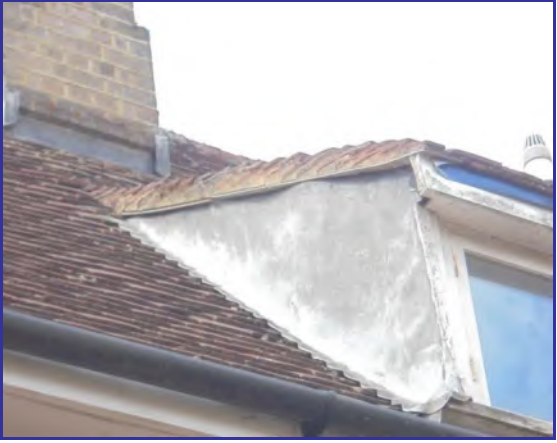
| <b>Building</b><br>Flats | <b>Job no</b><br>13366/192 | <b>Sample No</b><br>SES / Xc | <b>Photo</b><br> |
| <b>Location</b><br>Rear Roof Dormer Bays | | <b>Type of material</b><br>Insulation Board | |

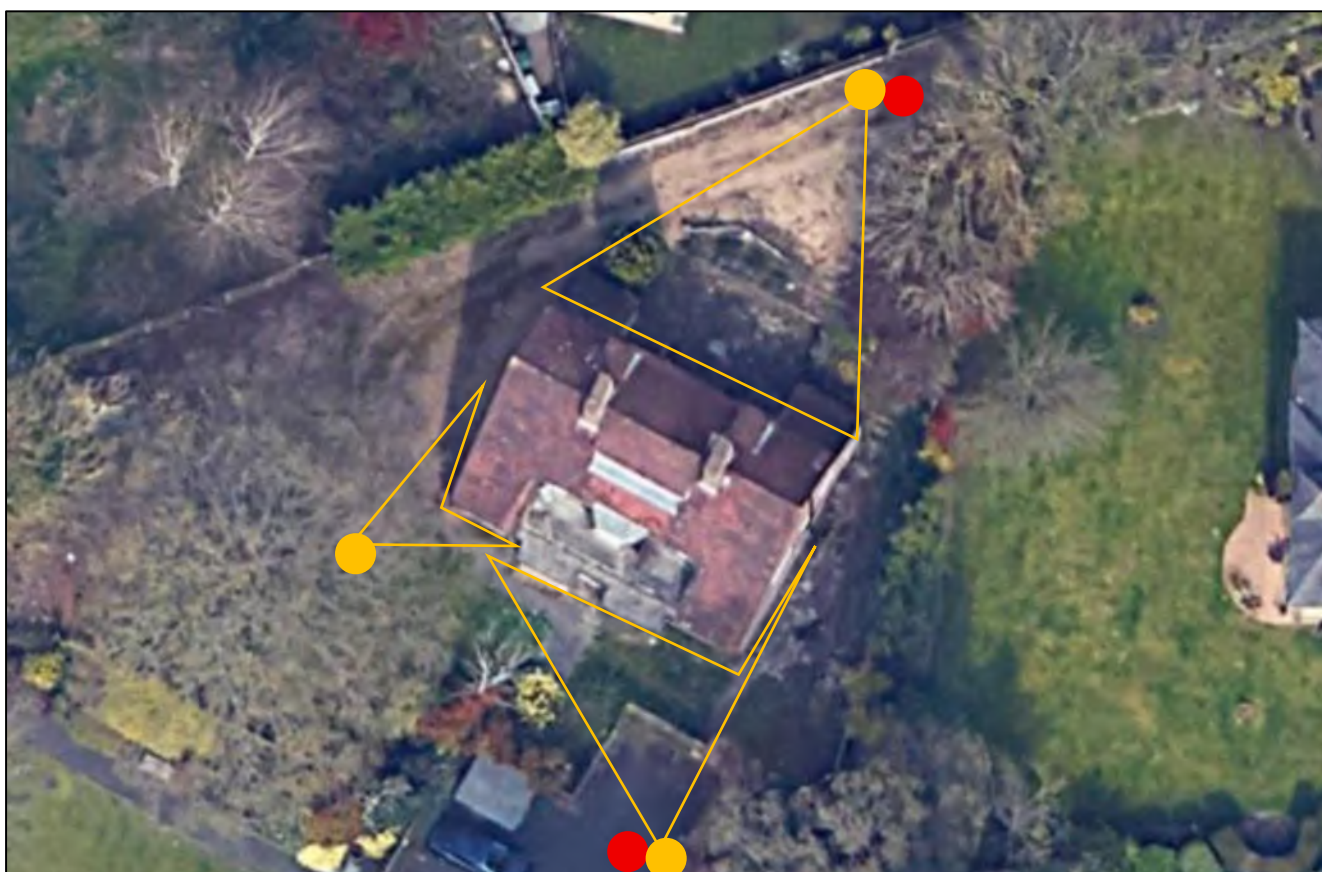
**Figure 1.** An aerial image of the site, showing the positions of surveyors (red dots) and night-vision cameras (orange dots). Images produced courtesy of Google maps (map data ©2026 Google).

The surveys focused upon the hanging tiles covering the dormer window, and both aspects of the roof, using two surveyors and three thermal/night-vision cameras positioned according to Figure 1. From these positions, surveyors could see all features potentially suitable for roosting bats that were identified during the initial bat scoping survey.

- 3 x Echometer Touch 2 Pro detectors with Apple recording devices
- 2 x Pixfra XA613 thermal cameras paired with a surveyor
- 1 x Nightfox Nova night-vision camera paired with an Echometer Touch detector and Apple recording device and supported by infra-red torches.

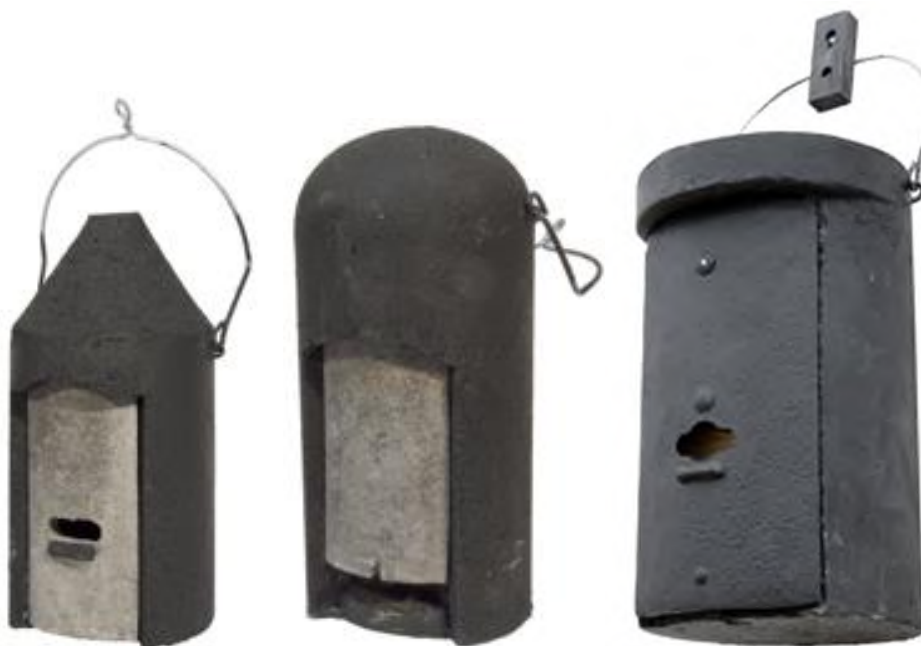
**Figure 1.** Left to right, the 2F, 2FN and the 1FS bat boxes produced by Schwegler. These and other brands are available at many on-line wildlife stores. These are constructed of 'woodcrete' (a mixture of cement and woodchip) and are designed to be durable and replicate the stable thermal properties of trees and buildings. They may be attached to trees or buildings.

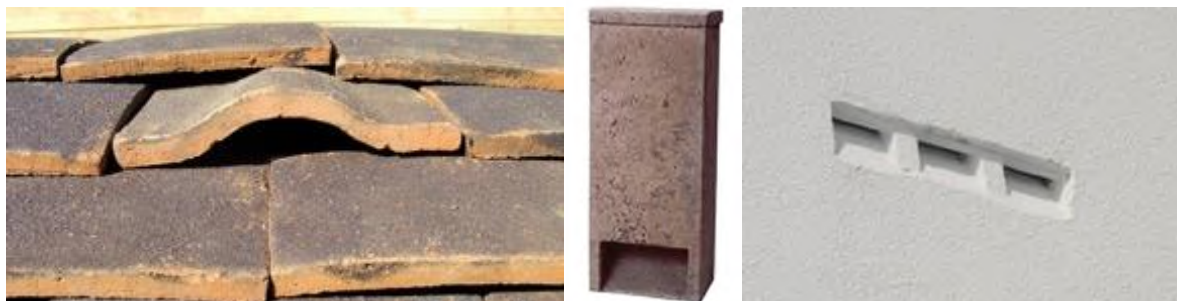
**Figure 2.** Examples of integral bespoke bat roosting features that may be incorporated into buildings during construction/renovation. From left to right: an example of bat access tile into loft space; the 2FR bat tube; and an example of 2FR bat tubes installed into a house wall in a series of three. Other brands and designs are available.
